# JOINT TRANSPORTATION RESEARCH PROGRAM

## Large Culvert Inspection Procedures: Guidelines for INDOT

**Scott M. Grier, Christopher S. Williams**

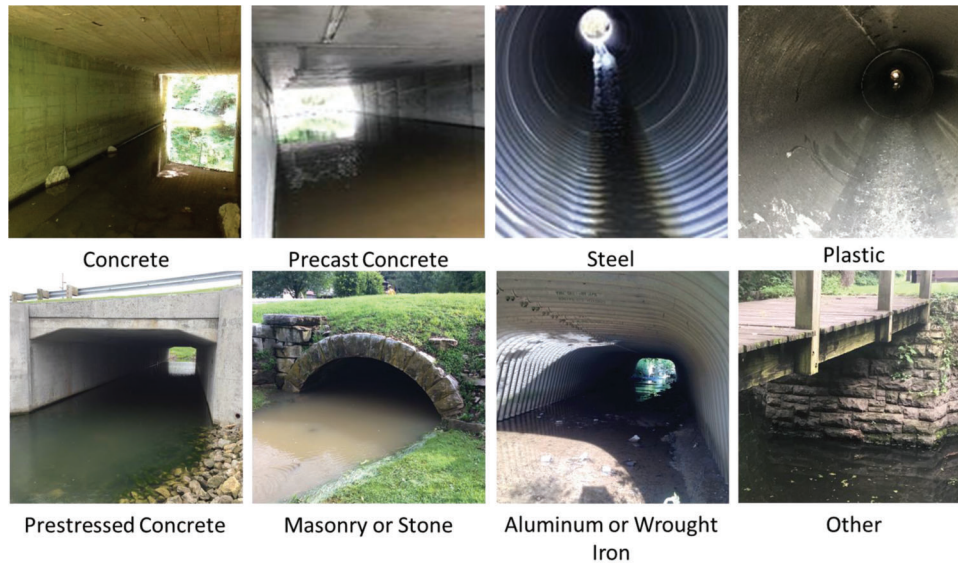
**Figure 4.1** Material type categorizations within large culvert inventory (A. Rearick, personal communication, June 10, 2022).

INDOT has eight different large culvert material classifications present within the large culvert inventory. INDOT's material type categorizations for large culverts are based on the material types listed in Item 43 of the FHWA *Recording and Coding Guide for the Structural Inventory and Appraisal of the Nation's Bridges* (FHWA, 1995) with modifications made to include material types common for large culvert structures (i.e., precast concrete, plastic vinyl, and masonry or stone). Knowing the distribution of material types within the inventory is important as different materials experience unique types of deterioration and undergo deterioration at different rates. The eight material classifications are represented in Figure 4.1.

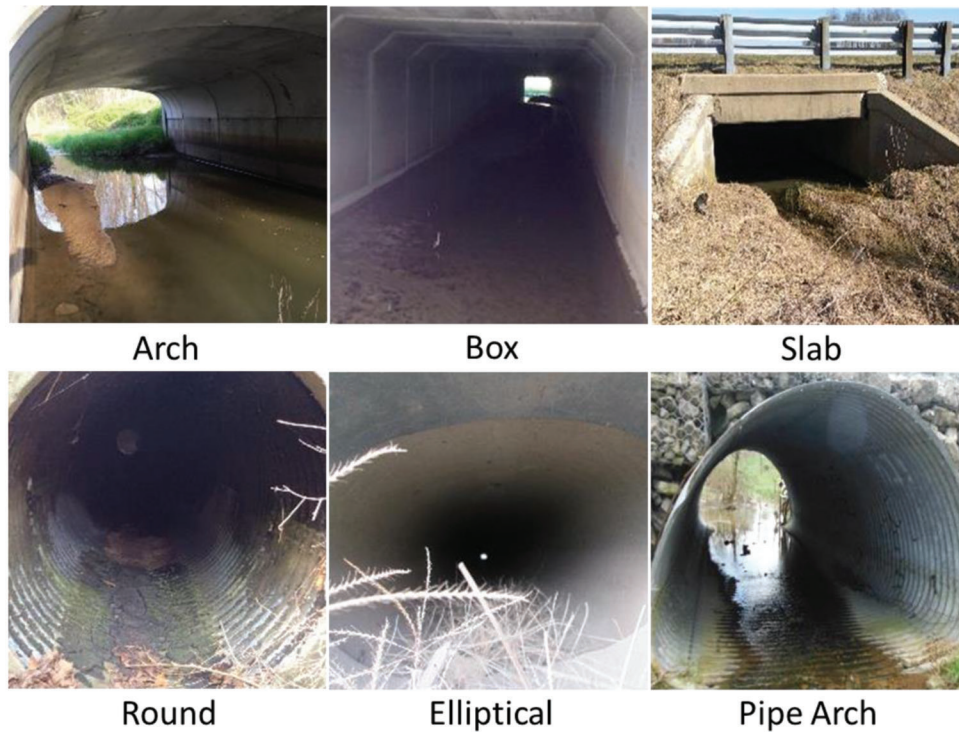
**Figure 4.2** Shape categorizations within large culvert inventory (A. Rearick, personal communication, June 10, 2022).

Six distinct large culvert barrel shapes are present within INDOT's large culvert inventory. These six shapes are each represented in Figure 4.2.

The categorization of the large culvert inventory based on shape is presented in Table 4.2. Understanding the shape of the barrel is especially important for flexible culverts because the shape will influence how the structure deflects when it experiences uneven soil pressure. Box and round culverts together comprise nearly 80% of the large culvert inventory. Pipe arch is

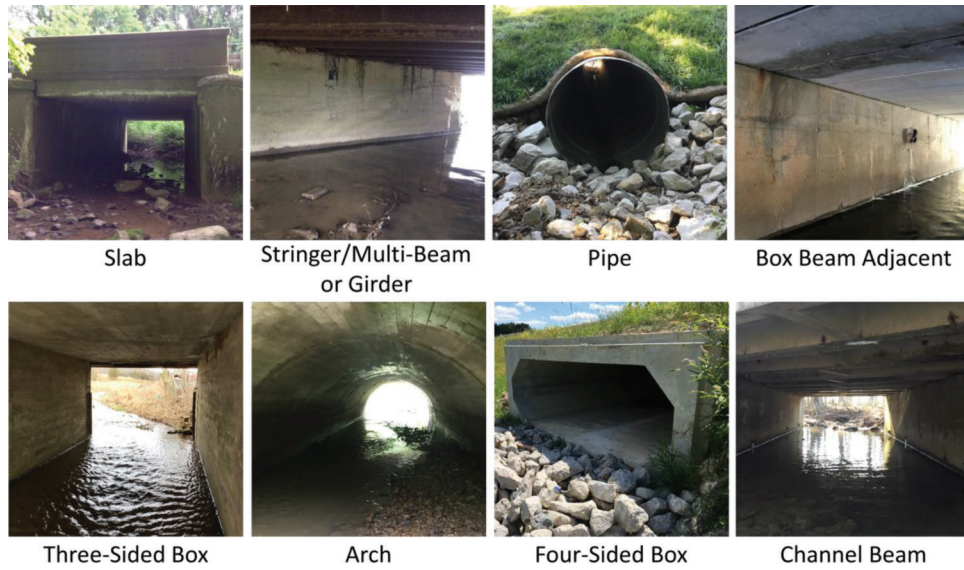
**Figure 4.3** Structure type categorizations within large culvert inventory (A. Rearick, personal communication, June 10, 2022).

INDOT's structure type categorizations for large culverts are based on structure types listed in Item 43 of the FHWA *Recording and Coding Guide for the Structural Inventory and Appraisal of the Nation's Bridges* (FHWA, 1995) with modifications made to include structure types common for large culvert structures (e.g., pipe, three-sided box, and four-sided box). The primary structure types used to categories large culverts in INDOT's inventory are shown in Figure 4.3.

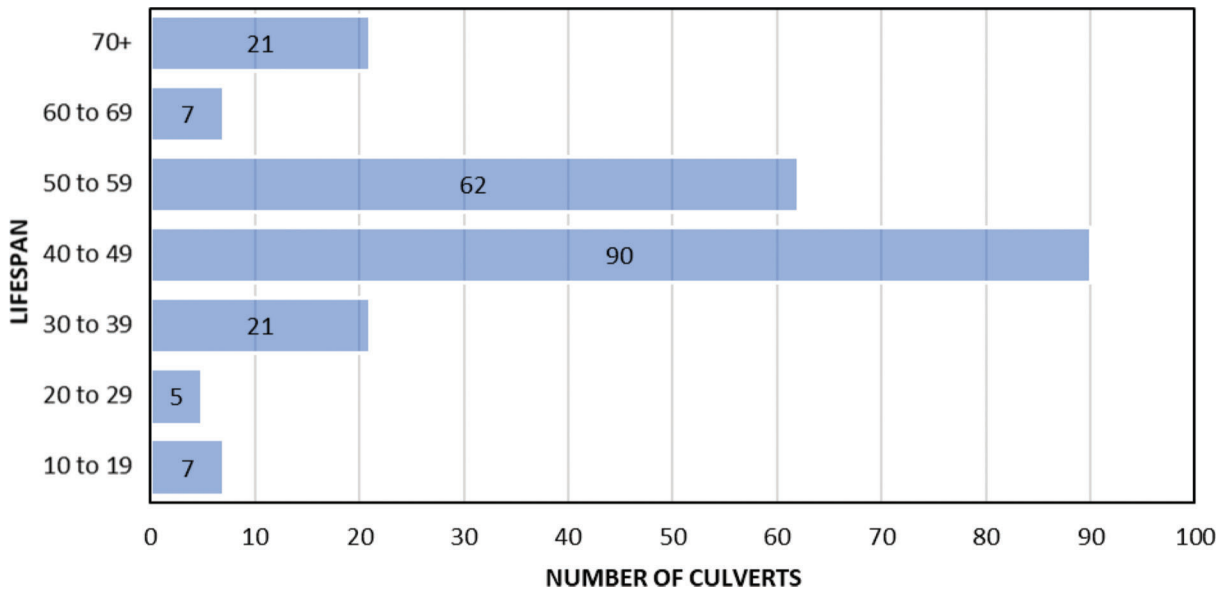
Figure 4.5 Lifespan of large culverts based on year-built data.

For a small population of large culvert structures, year-built information for the original culvert at a specific site was available along with the date when the original culvert was replaced with the structure currently existing at the site. For these cases, the available dates indicate the lifespan of the original culvert structure. Using these data, the lifespans of 213 large culverts were collected. The results are presented in Figure 4.5. Lifespan information from these historical data was beneficial for the development of inspection frequency recommendations based on culvert material type as it provides a means to estimate expected lifespans of culverts constructed with specific materials (see Section 5.2).

For further consideration, the 213 culverts presented in Figure 4.5 for which estimated lifespans are available were grouped based on material type (concrete/precast concrete vs. steel). The resulting average lifespans of the culverts are presented in Table 5.3. Based on this relatively small subset of culverts, the data suggest that concrete and precast concrete culverts outlast steel structures by approximately 12 years on average.

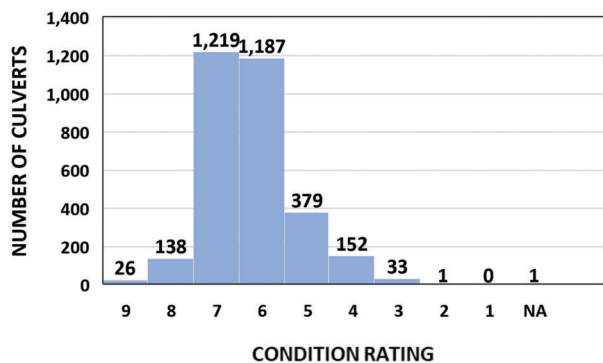
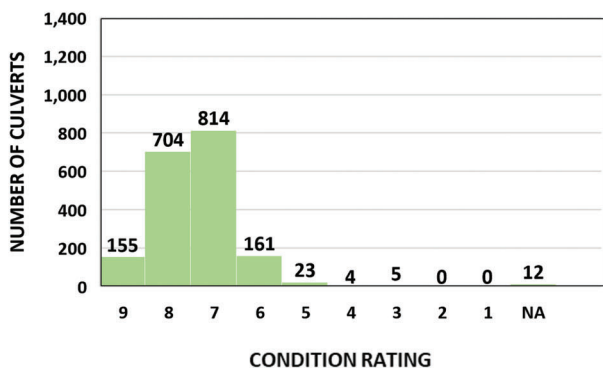
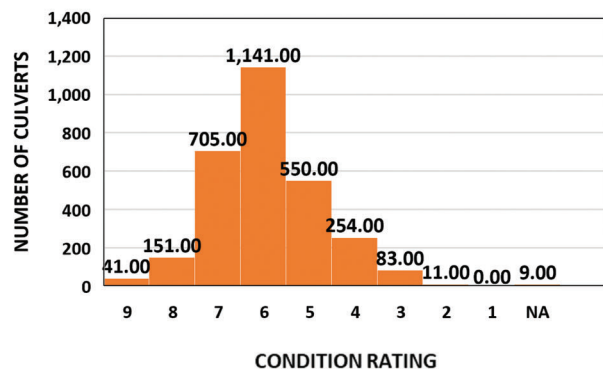
(a) Concrete

(b) Concrete Precast

(c) Steel

Figure 5.2 Condition rating values of large culverts by material.

The distribution of the condition ratings assigned to culverts during the most recent inspections of the structures are provided in Figure 5.2 for the three most common material types (see Table 4.1). Considering the condition ratings indicated by the data in Figure 5.2 along with the ages of culverts, the seemingly superior

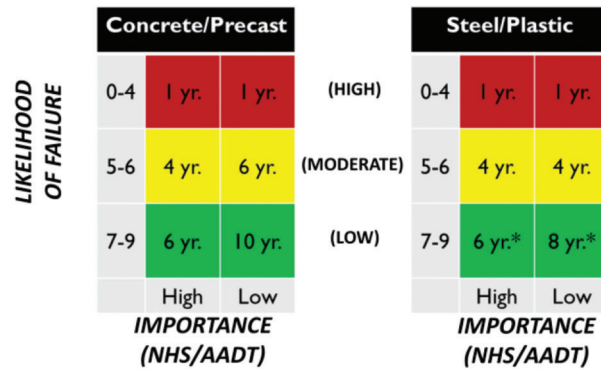
Notes:  
 Regardless of condition, large metal culverts with flowing water present should be limited to a maximum inspection interval of 48 months.  
 All plastic lined structures are restricted to a maximum inspection interval of 48 months.

Figure 6.1 Recommended inspection frequencies using a risk-based approach.

The suggested inspection frequencies for large culverts are presented in Figure 6.1 in the form of a simplified risk matrix. The frequency values were determined by analyzing both the condition rating data available for large culvert structures in the BIAS database and year-built data collected as described in Section 4.3. As indicated in Figure 6.1, inspection frequencies are similar between the two levels of importance when the overall condition rating is low but are different as the condition rating values increase. The inspection frequency values for low importance structures are also different based on the material groupings. These decisions were made following the analysis of the available condition rating histories described in Chapter 5. It is noted in Figure 6.1 that large metal culverts with flowing water present should be limited to a maximum inspection interval of 48 months. This limitation is recommended due to the potential for relatively rapid deterioration caused by the flowing water. A similar limitation of 48 months is also placed on all plastic lined structures due to the use of the material being relatively new for large culvert structures.

As an alternative to the proposed inspection frequencies presented in Figure 6.1, a second option is introduced in Table 6.2. This alternative is suitable if a distinction of culverts based on AADT and NHS status is not desired. The proposed frequencies are modified from the current inspection frequencies for large culverts followed by INDOT (INDOT, 2020) and incorporate the consideration of the condition of the multiple components of a culvert instead of relying solely on the condition of the barrel to determine the allowable inspection frequency. The modified inspection frequencies in Table 6.2 provide weighted preference to the condition rating values of the major components of the structure while also incorporating limitations for the ratings of the minor components to

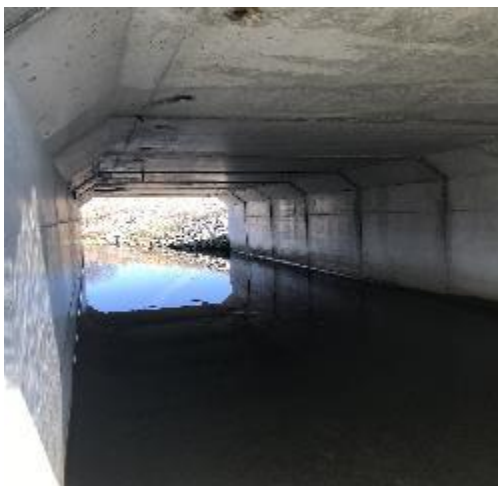
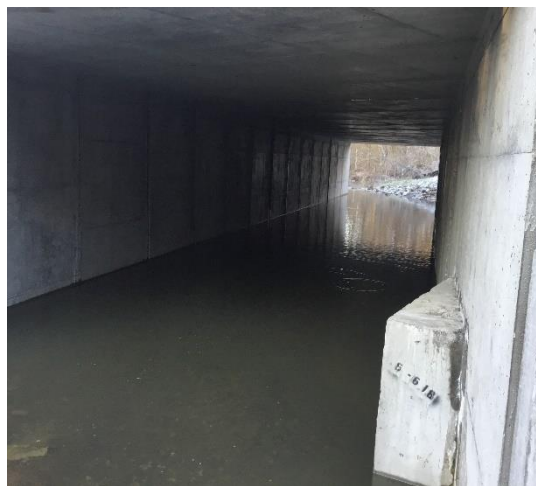
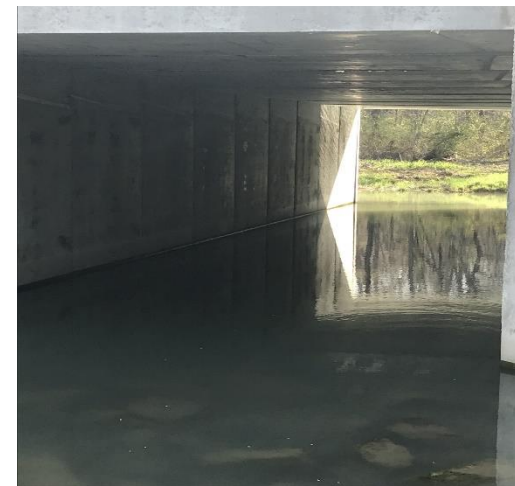
CONCRETE - 9

9 EXCELLENT NEW CONDITION ISOLATED DAMAGE FROM INSTALLATION MAY BE PRESENT.

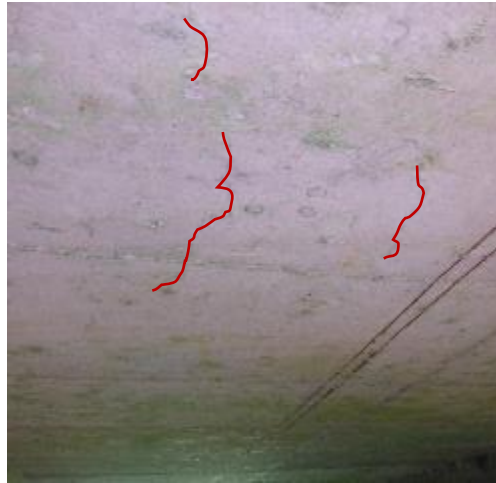
## CONCRETE - 8

**8 VERY GOOD HAIRLINE CRACKING (WIDTHS LESS THAN 0.01 IN.) WITHOUT EFFLORESCENCE, LEAKAGE, AND/OR RUST STAINING. NO DETERIORATION FROM SCALING OR ABRASION. NO SPALLING OR DELAMINATIONS.**

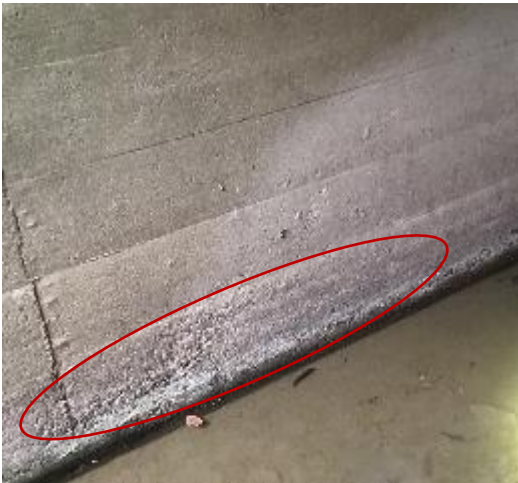
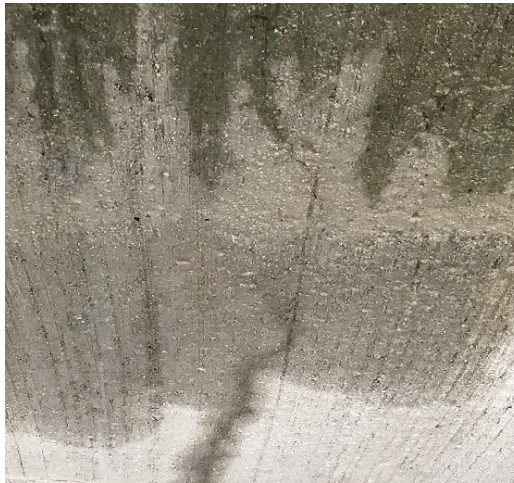
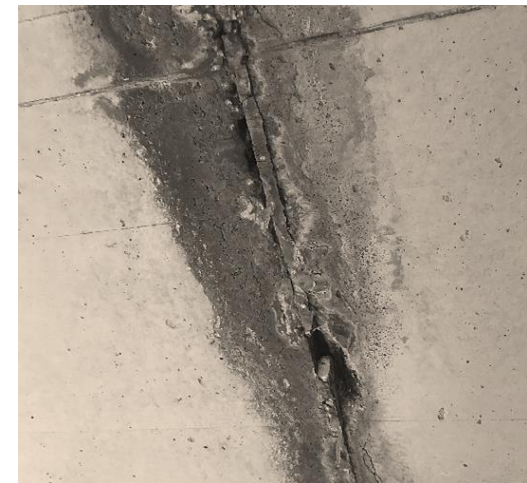
## CONCRETE - 7

**7 GOOD** CRACK WIDTHS LESS THAN 0.02 IN. MINOR EFFLORESCENCE AND/OR MINOR LEAKAGE WITHOUT RUST STAINING PRESENT. SCALING/ABRASION LESS THAN 0.125-IN. DEEP COVERING LESS THAN 10% OF SURFACE AREA. DELAMINATED OR SPALLED AREA LESS THAN 1% OF SURFACE AREA. SINGLE INDIVIDUAL SPALL IS LESS THAN 6 IN. IN DIAMETER AND LESS THAN 1-IN. DEEP.

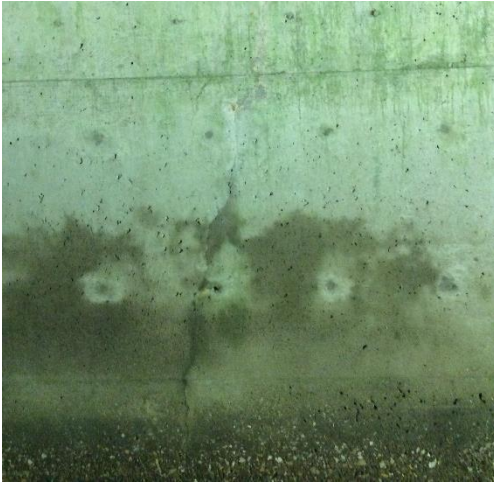
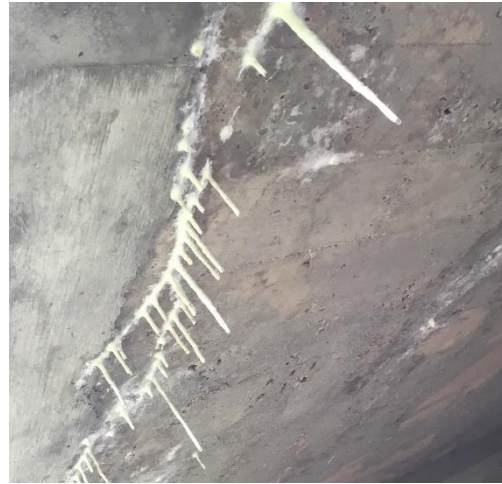
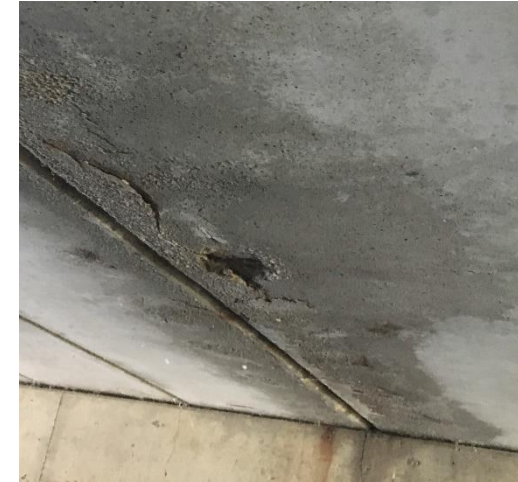
## CONCRETE - 6

**6 SATISFACTORY** CRACK WIDTHS LESS THAN 0.0625 IN. EFFLORESCENCE AND/OR MINOR LEAKAGE WITHOUT RUST STAINING PRESENT. SPACING OF CRACKS TRANSVERSE TO TRAFFIC 3 FT OR GREATER. SCALING/ABRASION LESS THAN 0.25-IN. DEEP COVERING LESS THAN 20% OF SURFACE AREA. TOTAL DELAMINATED AND SPALLED AREAS LESS THAN 5% OF SURFACE AREA. INDIVIDUAL SPALLS ARE LESS THAN 6 IN. IN DIAMETER AND LESS THAN 1-IN. DEEP.

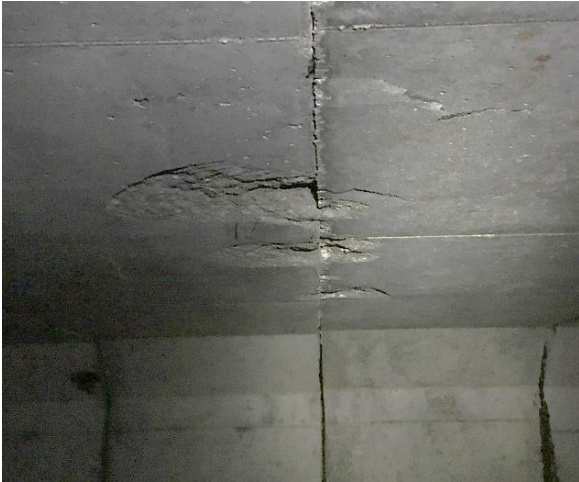
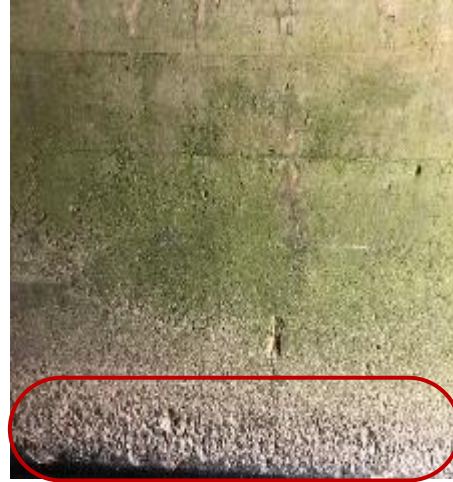
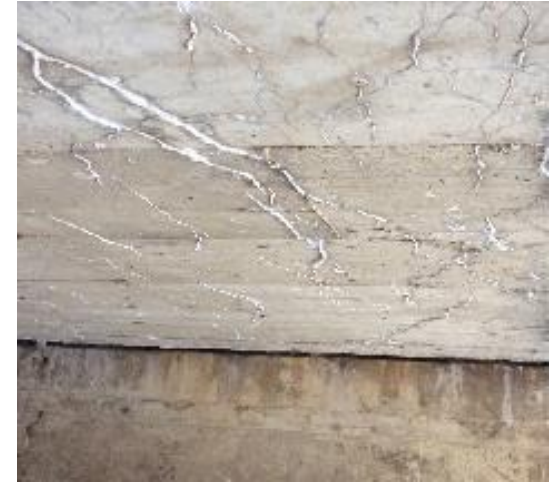
## CONCRETE - 5

**5 FAIR** CRACKS WIDTHS LESS THAN 0.125 IN. PARALLEL TO TRAFFIC OR LESS THAN 0.0625 IN. TRANSVERSE TO TRAFFIC. EFFLORESCENCE, LEAKAGE, AND/OR RUST STAINING PRESENT. SCALING/ABRASION GREATER THAN 0.25-IN. DEEP COVERING LESS THAN 30% OF SURFACE AREA. TOTAL DELAMINATED AND SPALLED AREAS LESS THAN 15% OF SURFACE AREA. SPALLING HAS EXPOSED REINFORCING STEEL. INDIVIDUAL SPALLS ARE GREATER THAN 6 IN. IN DIAMETER OR GREATER THAN 1-IN. DEEP.

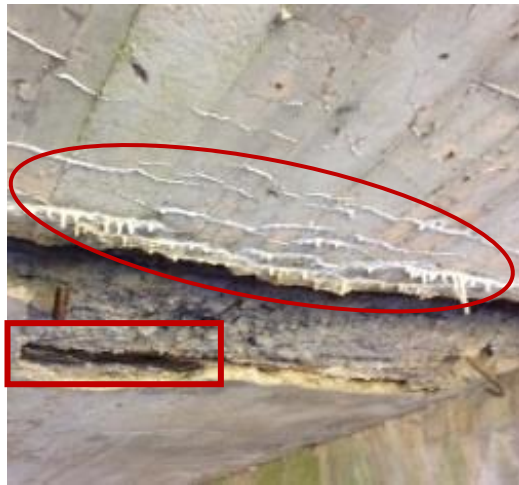
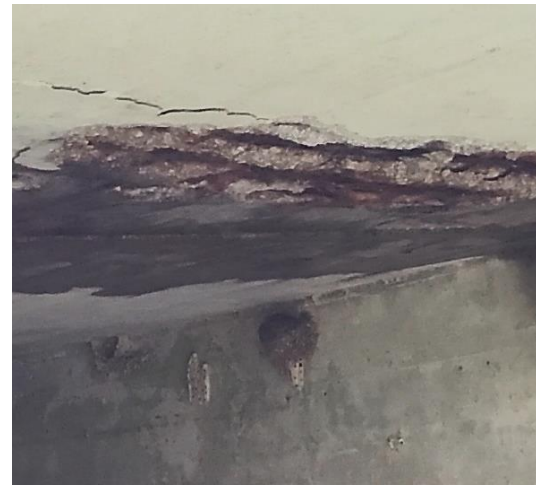
## CONCRETE - 4

**4 POOR** EXTENSIVE CRACKING WITH CRACK WIDTHS GREATER THAN 0.125 IN. SPACING OF CRACKS TRANSVERSE TO TRAFFIC BETWEEN 1 FT AND 3 FT. SCALING/ABRASION GREATER THAN 0.5-IN. DEEP COVERING LESS THAN 50% OF SURFACE AREA. TOTAL DELAMINATED AND SPALLED AREAS LESS THAN 25% OF SURFACE AREA. SPALLING HAS EXPOSED CORRODED REINFORCING STEEL.

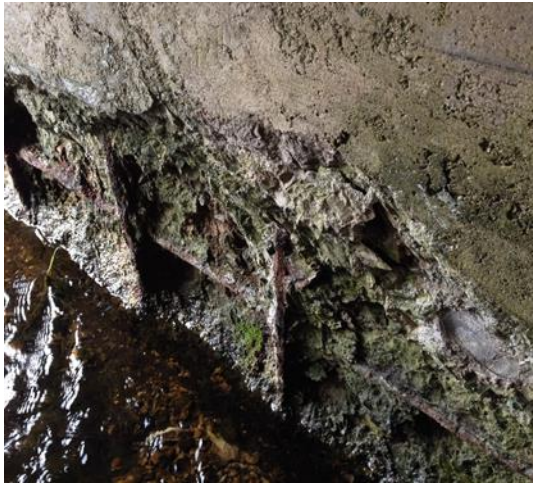
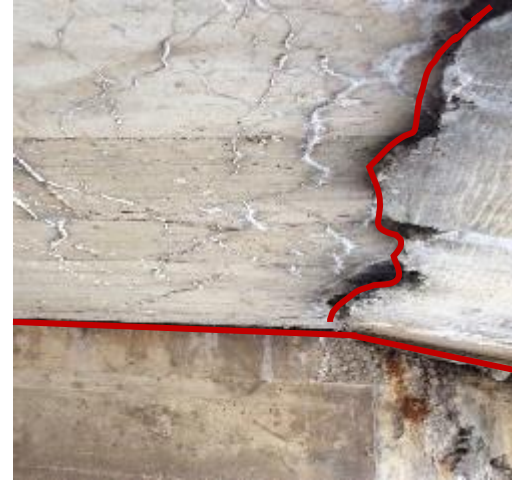
## CONCRETE - 3

**3 SERIOUS** SOFT CONCRETE. EXTENSIVE CRACKING WITH CRACK WIDTHS LESS THAN 0.25 IN. DIFFERENTIAL MOVEMENT AT CRACK(S). SCALING/ABRASION GREATER THAN 0.5-IN. DEEP COVERING GREATER THAN 50% OF SURFACE AREA. LESS THAN 50% OF THE SURFACE AREA IS DELAMINATED OR SPALLED.SPALLING HAS EXPOSED MUCH OF THE PERIMETER OF REINFORCING BARS.

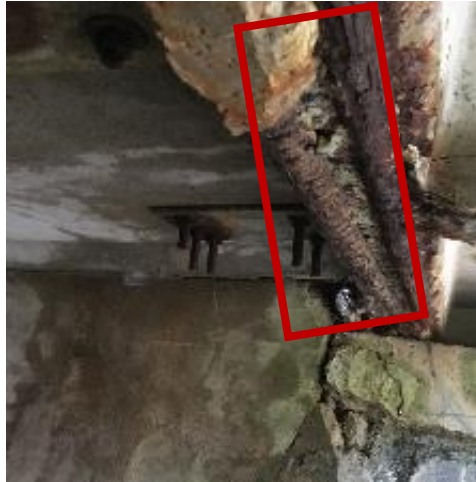
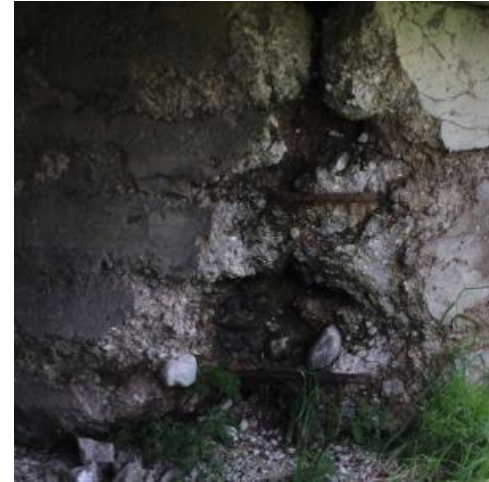
## CONCRETE - 2

**2 CRITICAL** CONCRETE COMPLETELY DETERIORATED IN ISOLATED LOCATIONS CREATING THROUGH-DEPTH HOLES. EXTENSIVE CRACKING WITH CRACK WIDTHS GREATER THAN 0.25 IN. SEVERE DIFFERENTIAL MOVEMENT AT CRACK(S). GREATER THAN 50% OF THE SURFACE AREA IS DELAMINATED OR SPALLED. SPALLED AREAS WITH EXPOSED REINFORCING STEEL COVER APPROXIMATELY 25% OF SURFACE AREA. REINFORCING BAR PERIMETER IS COMPLETELY EXPOSED AND BARS EXHIBIT EXTENSIVE SECTION LOSS.

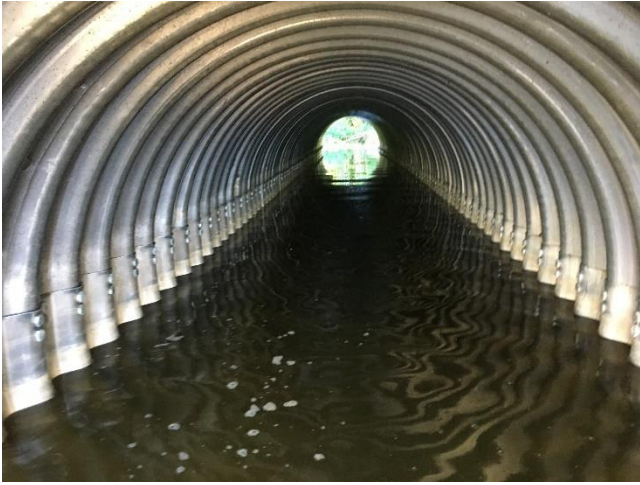
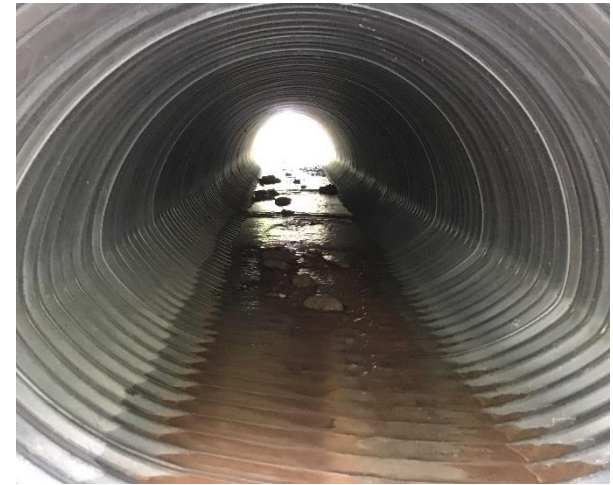
## METAL - 9

9 EXCELLENT NEW CONDITION. CULVERT RETAINS ORIGINAL SHAPE.

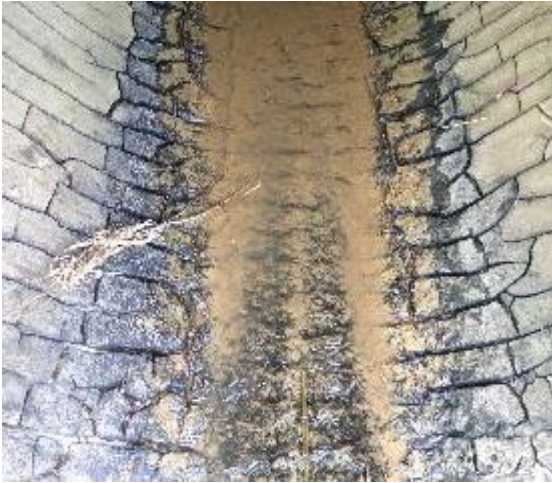
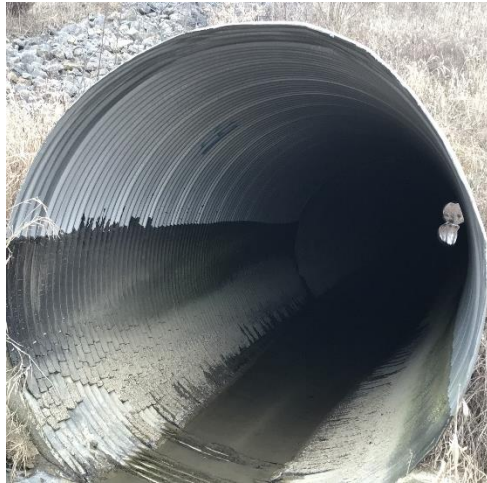
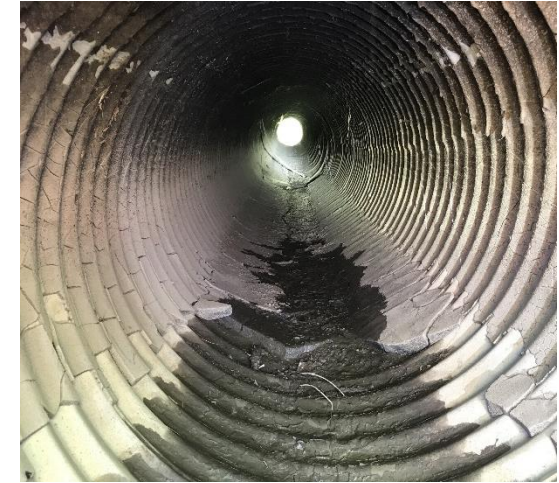
## METAL - 8

8 VERY GOOD DISCOLORATION OF SURFACE. PROTECTION PARTIALLY GONE ALONG INVERT BUT NO LAYERS OF RUST.

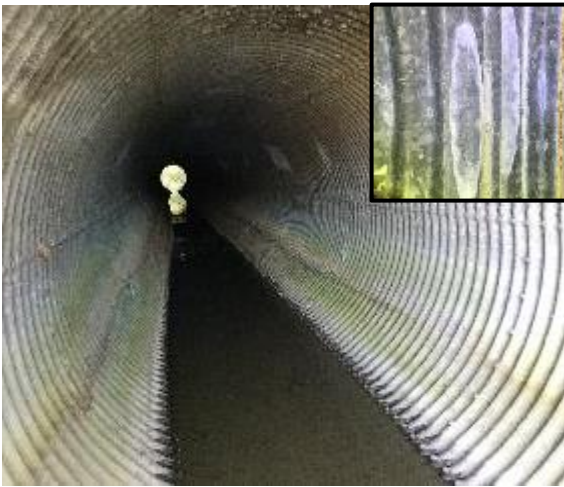
Photo 1

Photo 1: Wearing of galvanized material along surface is observed, indicating that protection is almost gone along waterline and invert.

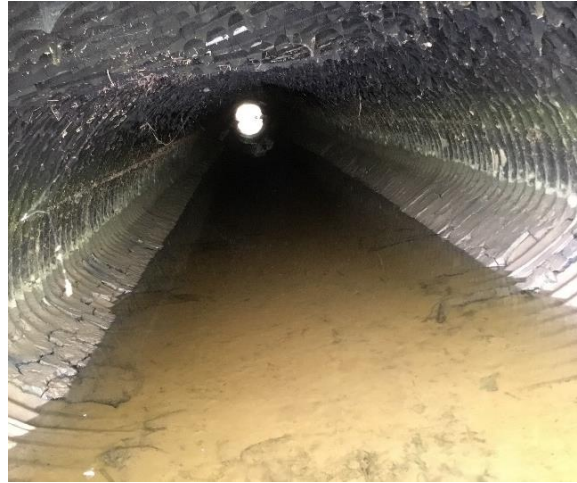
Photo 2

Photo 2: Impact damage near end of pipe has created a localized dent along the top of the pipe structure but does not result in a penetration of the structure.

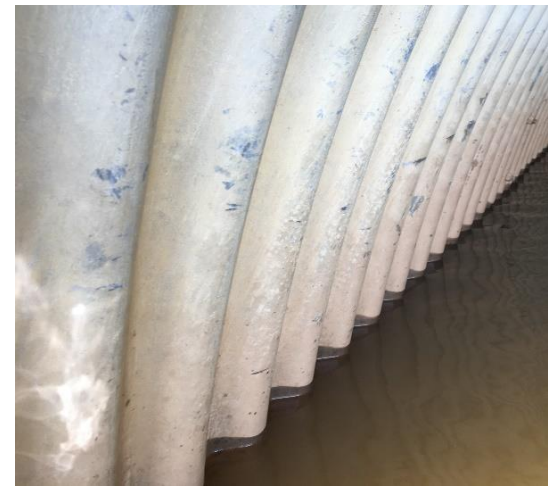
Photo 3

Photo 3: Freckled rust can be observed along interior of pipe structure.

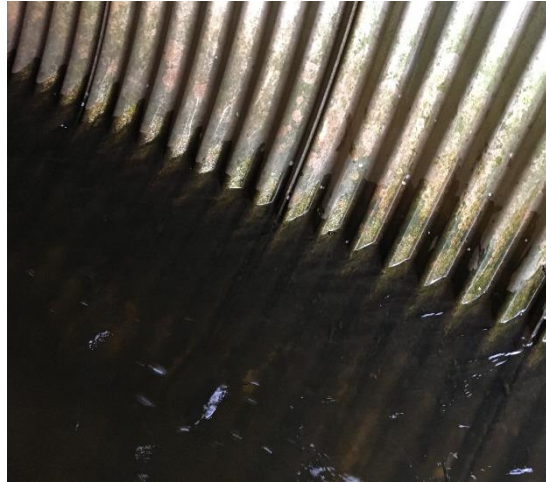
Photo 2

Photo 2: Layers of rust are observed along waterline of pipe structure.

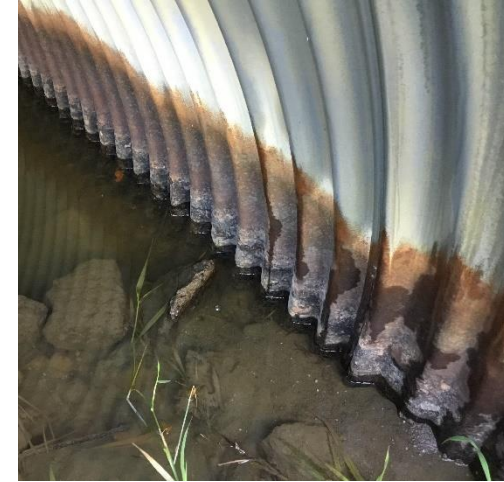
Photo 3

Photo 3: Buildup of rust layers along pipe structure are beginning to cause section loss along waterline.

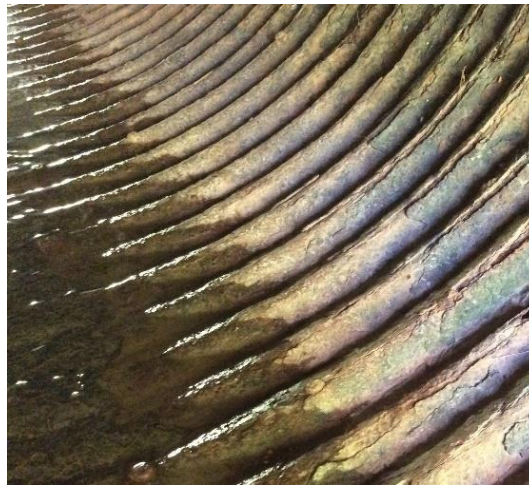
Photo 2

Photo 2: Section loss less than 15 in.<sup>2</sup>/ft<sup>2</sup> is observed along interior of pipe structure. Rust and scaling are also observed.

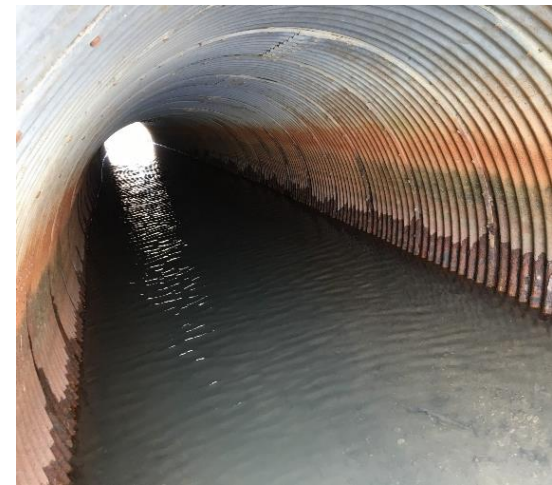
Photo 3

Photo 3: Heavy rust is observed throughout pipe structure.

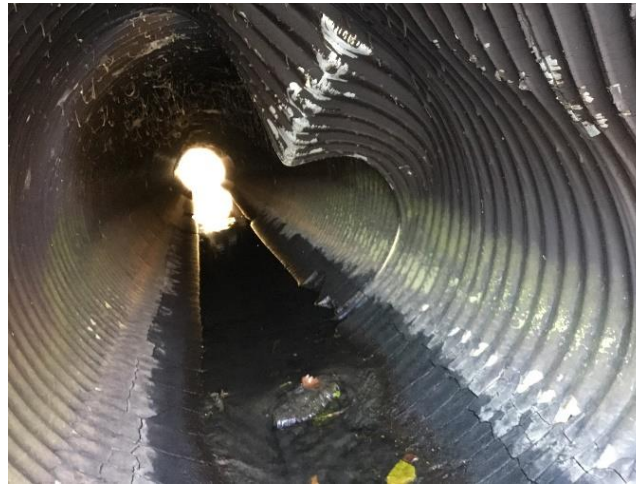
Photo 2

Photo 2: Impact damage near end of pipe has created a localized area of wall penetration. No evidence of soil infiltration is present.

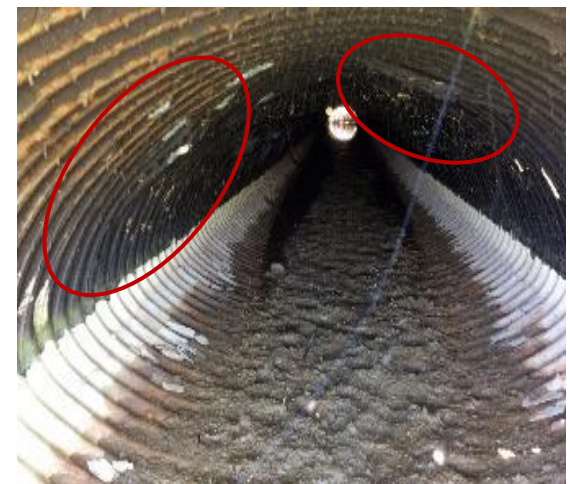
Photo 3

Photo 3: Shape of structure exhibits flattening and distortion along length. Layers of rust are observed along invert of pipe structure.

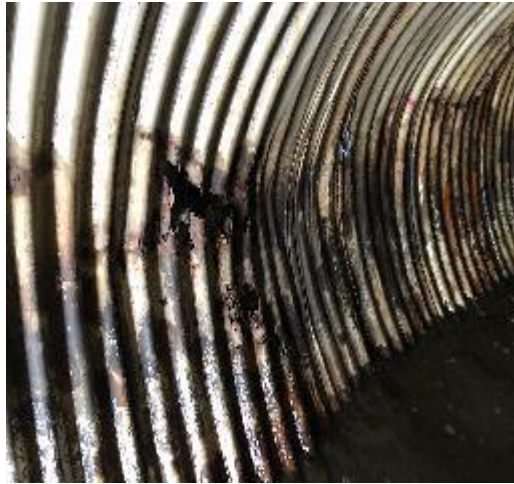
Photo 1

Photo 1: Perforation is observed along wall of pipe structure. Area of perforation is less than 36 in.<sup>2</sup>/ft<sup>2</sup>. Shape of pipe wall also appears to be distorted surrounding the perforation.

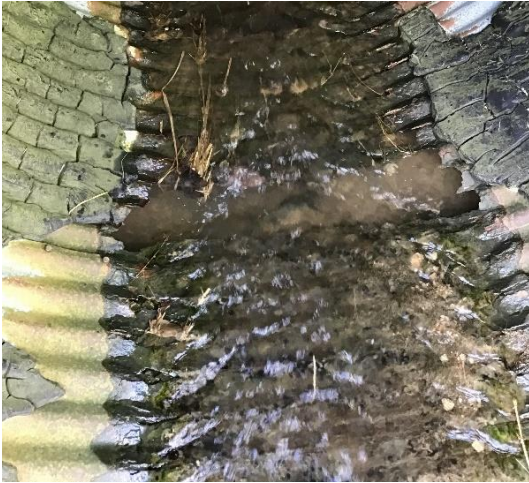
Photo 1

Photo 1: Visible perforation equal or greater in size than 36 in.<sup>2</sup>/ft<sup>2</sup> along invert of pipe structure is observed.
