# Historic Appraisal Review and Geometric Characterization of Old Masonry Buildings in Lisbon for Seismic Risk Assessment

V. Bernardo, R. Sousa, P. Candeias, A. Costa & A. Campos Costa

<sup>a</sup>Earthquake Engineering and Structural Dynamics Unit Structures Department, National Laboratory for Civil Engineering, Lisbon, Lisbon, Portugal; <sup>b</sup>CDRSP - Polytechnic of Leiria, Leiria, Portugal; <sup>c</sup>Department of Civil Engineering, University of Aveiro, Aveiro, Portugal

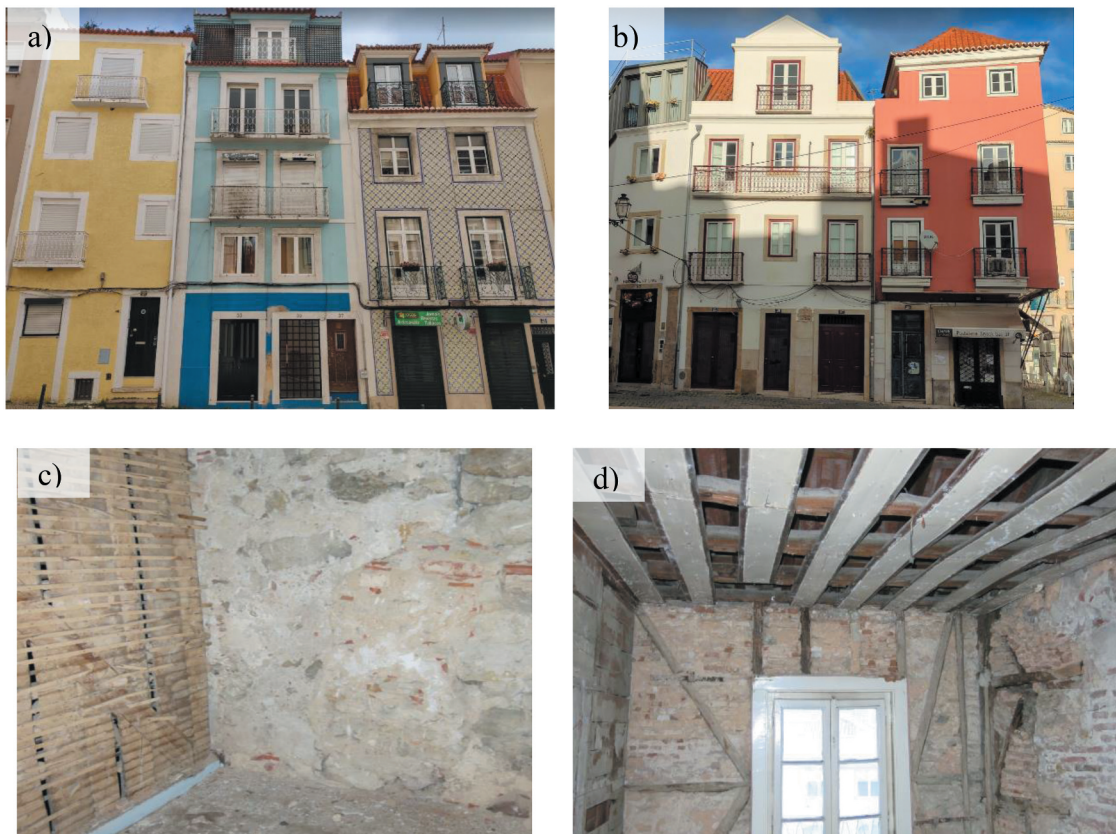
**Figure 5.** “Pre-Pombalino” typology: (a) and (b) example of building facades aesthetic; (c) “Tabique” in exterior walls supporting the timber floor; (d) “Tabique” in partition walls.

The “Pre-Pombalino” buildings (Figure 5a) are a Portuguese typology characteristic before the 1755 Lisbon earthquake. In general, they are recognized by the irregular geometry, reduced dimensions in plan, narrow facades, up to four stories high, high density of walls made with poor quality masonry and reduced number of openings. In residential buildings, the access to upper floors was materialized with a single flight of stairs, next to the side walls in buildings with narrow facades, or at the center in buildings with longer facades. The ground floor was usually reserved for commerce and, in some cases, setback with respect to the upper floors (Figure 5b). In this period, the buildings did not provide any sanitary facilities.

stones or even pieces of bricks connected with earth-based mortar or lime mortar; (iii) rammed earth masonry, common in rural buildings or millennial constructions; (iv) “tabique” walls. In “Pre-Pombalino” buildings the “tabique” walls were very common in partition walls (Figure 5c) — a set of vertical long boards connected by horizontal small wood stripes, normally filled with pieces of bricks and lime mortar — or even in interior or exterior structural walls, constituted by a timber framed structure filled with rubble stone or brick pieces of masonry and lime mortar (Figure 5d).

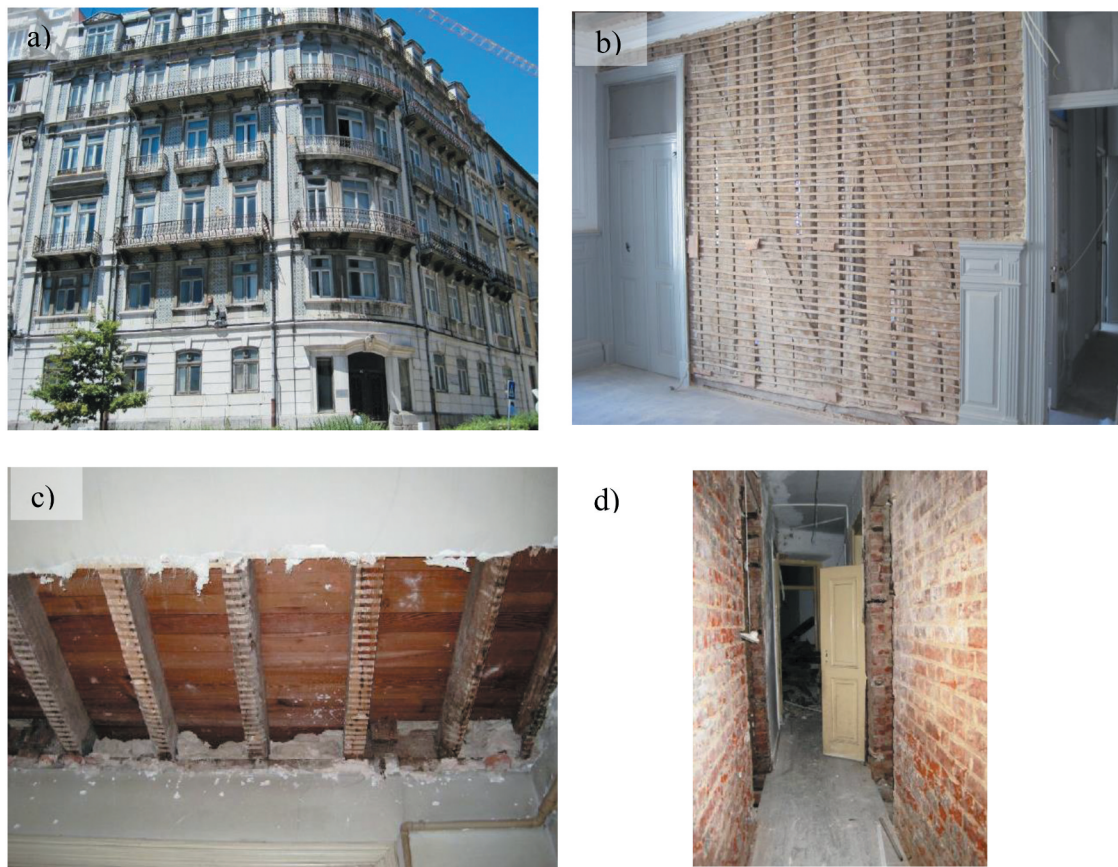
**Figure 7.** “Gaioleiro” typology: (a) aesthetic of the building; (b) “tabique” partition walls; (c) timber floor supported on the adulterated “frontal” walls or brick masonry; (d) brick masonry interior walls.

The “Gaioleiro” buildings (Figure 7a) were famous during the expansion of the city in the beginning of the 20<sup>th</sup> century. The quality of construction was very poor when

The facade walls were usually constituted by rubble stone masonry with lime mortar. The side walls were also in rubble stone masonry or brick masonry, but normally with constant thickness along the height. The wood trusses used in the interior walls of the “Gaiola Pombalina” were progressively adulterated and simplified, with the removal of the diagonal elements. The partition walls were in “tabique” (Figure 7b) or brick masonry (solid or hollow bricks) (Figure 7c)(Figure 7b).

The floors were composed by timber beams supported on the facades and covered by wooden planks (Figure 7d)(Figure 7c). The transverse deformation of

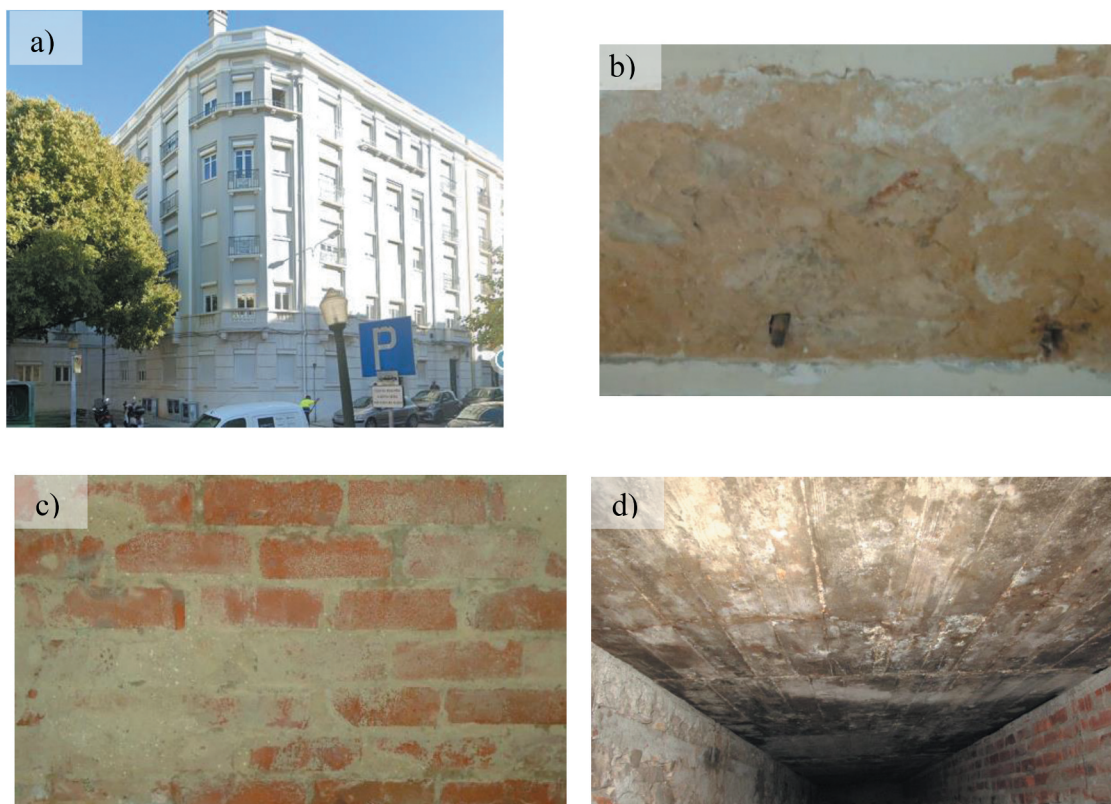
**Figure 8.** “Placa” typology: (a) aesthetic of the building; (b) rubble stone masonry wall; (c) brick masonry wall; (d) concrete slab simple supported on the masonry walls.

Finally, the “Placa” typology (Figure 8a) corresponds to a combination of masonry walls with RC slabs and is characterized by the introduction of the RC as a structural element. Most of these buildings were designed for lower class population, with small interior compartments. The main entrance is generally placed at the center of the building, typically providing access to two apartments per floor, through two-flight staircase.

The facade walls were usually in rubble stone masonry (Figure 8b) or brick masonry (Figure 8c) with hydraulic lime or cement mortar and often present a progressive decrease in thickness along the height. The side walls were made with the same material or concrete blocks, but usually with constant thickness along the height. The interior and partition walls were made with (solid or hollow) brick masonry or concrete blocks.

The typical wooden floors, presented in the previous typology, were gradually replaced by concrete slabs of poor concrete and one single reinforcement layer for positive bending moments (Figure 8d) (Figure 8b). The slabs were usually simple supported on the masonry walls without continuity. Later, reinforced concrete beams and columns were incorporated in the facades or in the interior partitions to overcome larger spans. The foundations were continuous and made with stone or brick masonry or concrete.

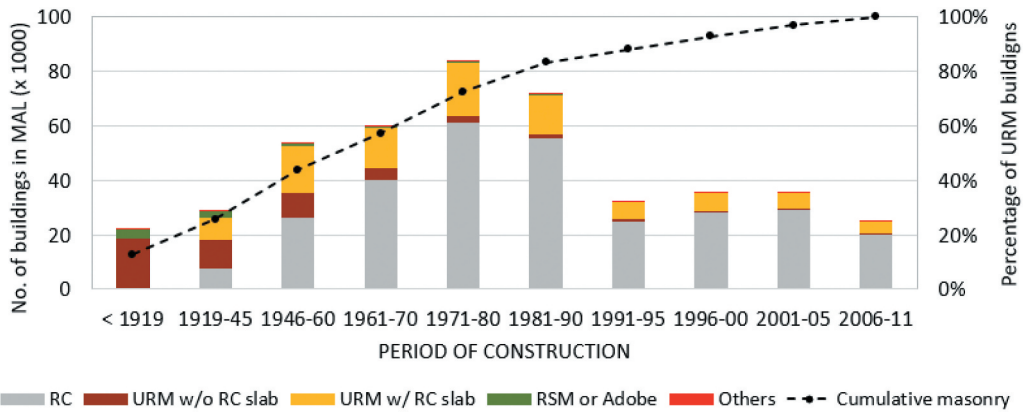
Figure 10. Building stock in MAL and evolution of URM buildings by period of construction up to 2011.

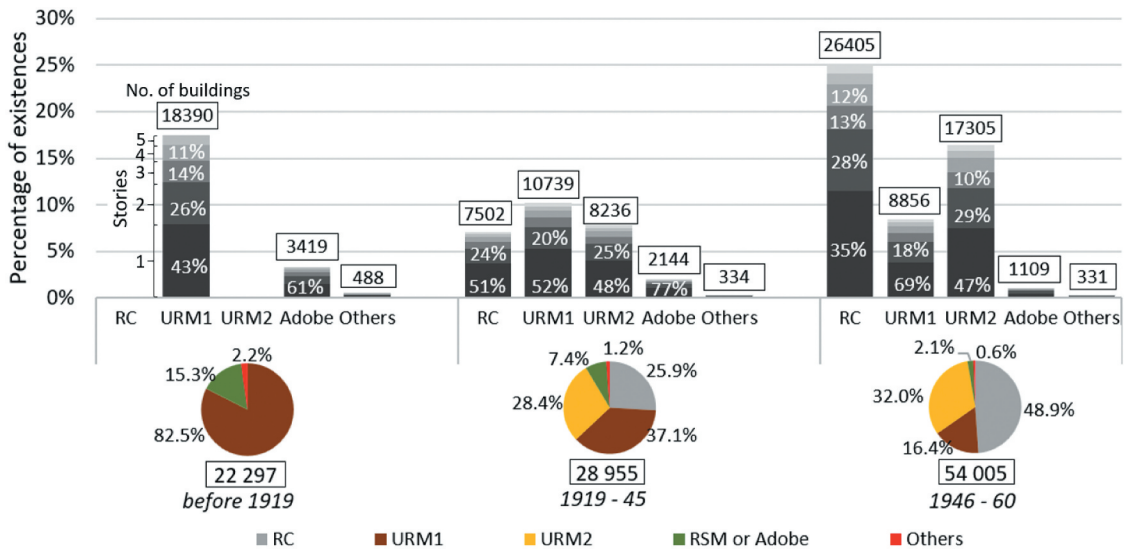
Figure 11. Disaggregation of the buildings in MAL up to 1960 by period of construction, typology, and number of floors.

The disaggregation of the building stock in the MAL in terms of period of construction (Figure 11), typology and number of floors was performed for three different periods up to 1960s. Before the decade of 1920, most of the housing stock corresponds to masonry buildings up to four stories without RC slabs (URM1). In the second

period (1919 to 1945), after the dissemination of the RC, it is notorious a decrease in the construction of URM1 typology and the appearance of masonry buildings with concrete slabs (URM2) and RC structures, mainly up to two stories. Note that a major part of the RC buildings built before the 1960s are masonry buildings confined by slender RC frames. In the last period (1945 to 1960), it was observed a clear boost in the construction, predominantly constituted by RC and URM2 buildings, with increasing number of floors, mostly up to four stories, influenced by the supply and demand increases in the real estate market.

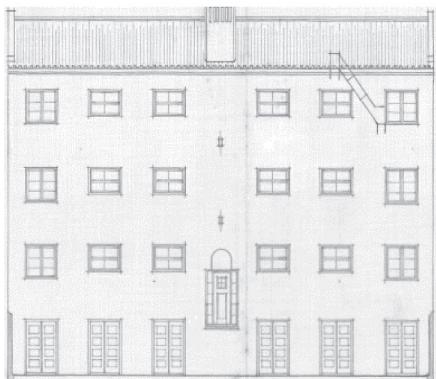
**Figure 13.** Example of data collection to characterize the population of old “Placa” and “Gaioleiro” masonry buildings.

The geometric characterization was based on the information available in detailed drawings from the original projects (blueprint) and collected in the municipal services. The data collection refers mainly to “Gaioleiro”

and “Placa” buildings built between 1900 and 1960 and up to five stories. Figure 13 presents some examples of the data collected from these typologies. The information available before this period is poor or absent. Furthermore, these are the most representative typologies in the MAL, since the others are mainly concentrated in downtown and require a more detailed analysis considering the advanced state of degradation and adulteration from the

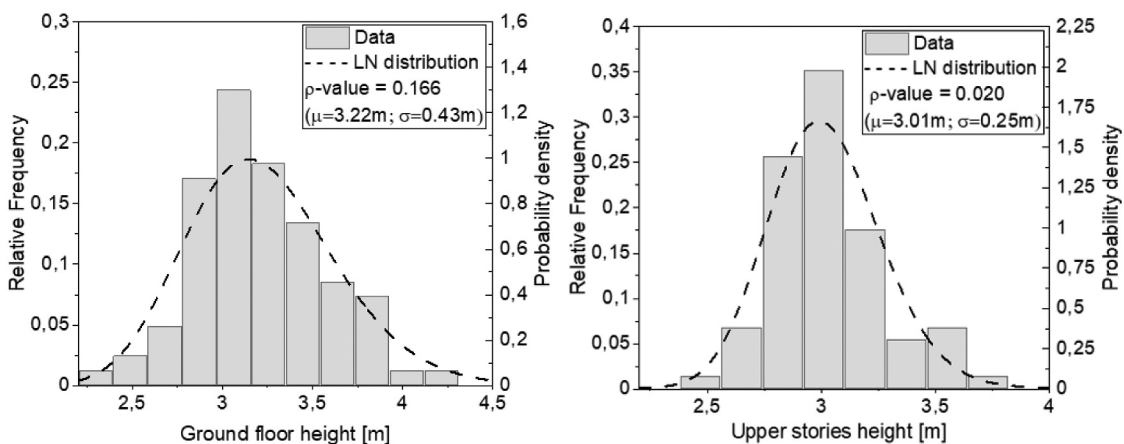
**Figure 16.** Building floor elevation: (a) ground floor height; (b) upper stories height.

The histogram for the ground floor and upper stories height is presented in Figure 16, showing that the ground floor height is relatively higher than in the

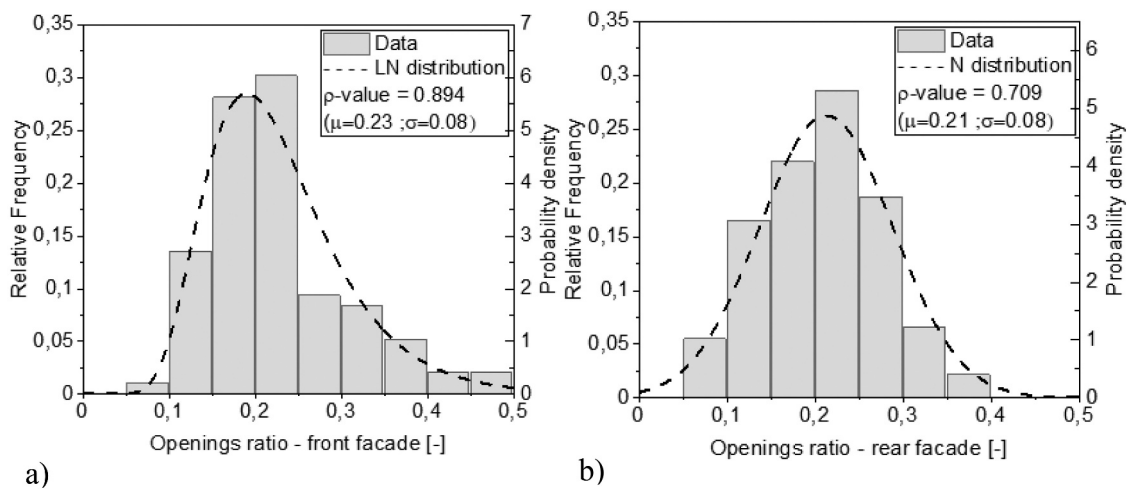
Figure 17. Opening ratio on upper floors: (a) front facade; (b) rear facade.

The number and type of openings (windows and doors) and respective dimensions were also collected for ground and upper floors. The values are relatively similar and summarized in Table 4. Figure 17 shows the openings ratio in the front and rear facade on the upper floors.

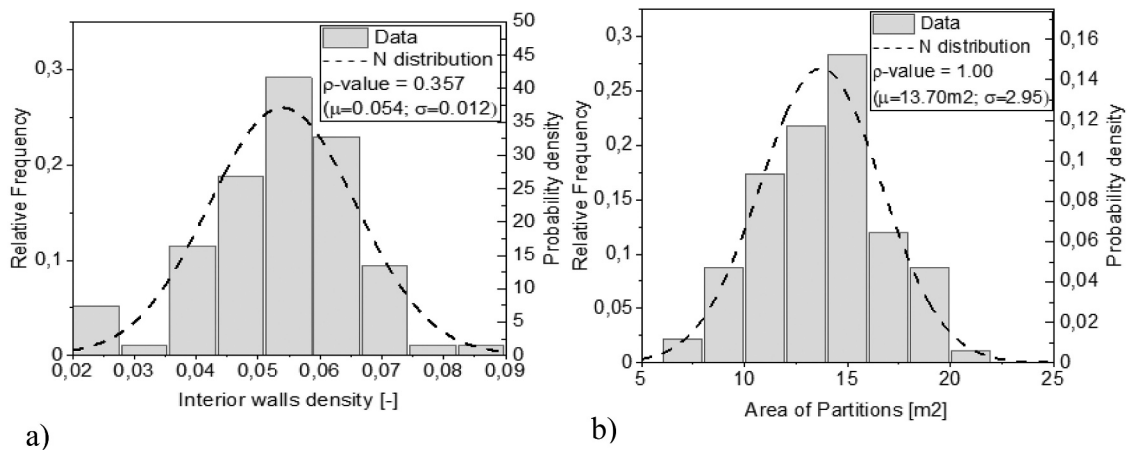
Figure 18. Interior wall characterization: (a) wall density, (b) area of partitions.

To define the distribution of interior walls, the respective density of walls and area of compartments were collected and shown in Figure 18.

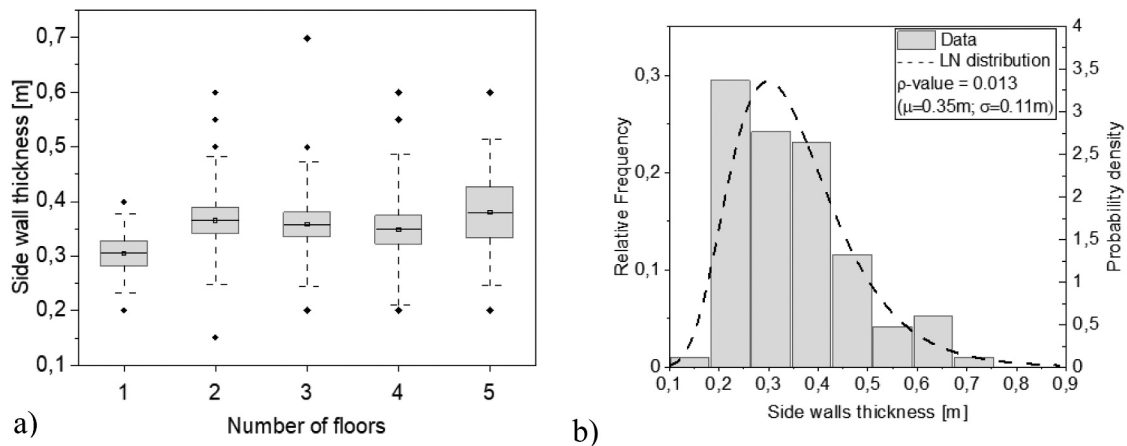
Figure 20. Lateral side wall thickness: (a) box plot by number of floors; (b) histogram with goodness-of-fit.

plot, with mean value and standard error of the mean represented in the box and one standard deviation by the whiskers with the values of the outliers for this bound. As can be seen in Figure 19a) and Figure 20a), for the facade and lateral side walls, respectively, the populations mean is not significantly different for

The histograms for the thickness at ground level are presented in Figure 19b) and Figure 20b), together with the fitted distribution. The goodness-of-fit of the LogNormal distribution is rejected for a significance level of 5% for both types of walls. These results reflect the huge variability of the materials and constructive methods employed in the facade walls. Referring to brick masonry is usually found between a single-leaf arrangement (0.23 m) and three brick-leaf arrangement (0.69 m). On the other hand, for stone masonry the thickness may vary according to the type and quality of material, reaching up 0.80 m for current buildings and minimum thickness of 0.40 m. For high-quality stone masonry (i.e., regular surface, uniform size, good arrangement and good mechanical properties, such as ashlar masonry and perpend stone) the thickness may be less.

The lateral side walls are usually thinner when compared to the facades. The thickness may vary between 0.20 m and 0.70 m (Figure 20b) and depends on the type of material (stone, brick masonry or concrete blocks).

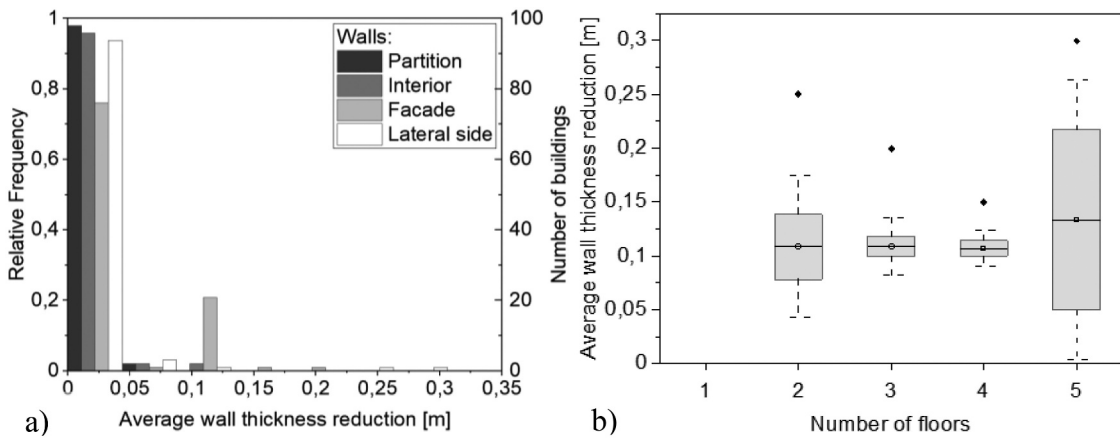
**Figure 22.** Mean wall thickness reduction: (a) histogram for different type of walls; (b) dispersion of the mean reduction per building height.

The reduction of the wall thickness along the height is evident in approximately 30% of the buildings analyzed, wherein most of the cases correspond to the facade walls, as seen in Figure 22a). According to Figure 22b), the mean wall reduction per floor is around 0.10 m, independently of the building height.

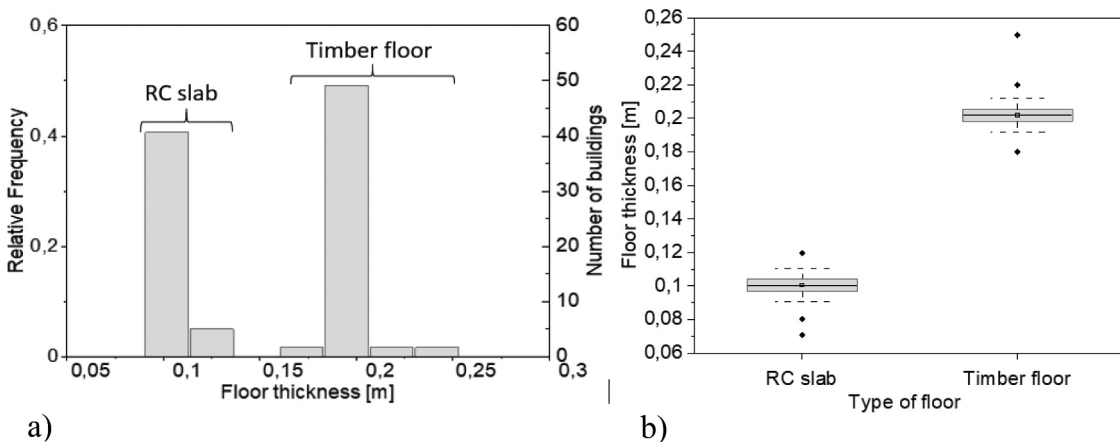
**Figure 23.** Floor thickness: (a) histogram for the different type of floor; (b) box plot with mean value and dispersion.

Regarding floor thickness, it is naturally dependent on the type of floor: for RC floor the majority has 0.10 m

and for timber floors the total thickness is around 0.20 m (Figure 23). According to the information collected, the timber floors are usually constituted by wood planks with 0.022 m of thickness, supported by timber beams with  $0.10 \times 0.20$  m,  $0.08 \times 0.16$  cm or  $0.07 \times 0.18$  cm spaced of 0.20 m to 0.40 m.
