Monitoring the mechanical behaviour of the weather vane-sculpture mounted atop Seville Cathedral's Giralda Tower

M. Solís*, A. Romero, P. Galvín

Key words: historical monument – structural health monitoring – damage detection

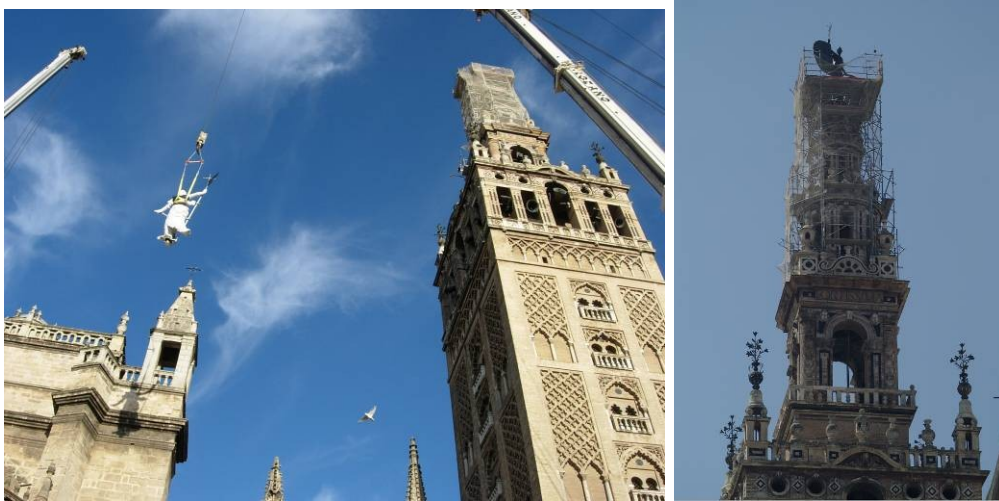
Figure 2. Mounting of the Giraldo atop the Giraldo Tower

Due to the deterioration of the Giraldo because of corrosion over its more than 400 years of history, it had to undergo of a thorough and meticulous restoration process from 1999 to 2005 [1] (Figure 1.), and in the meantime it was replaced with a replica. The restoration project culminated with its being mounted once again atop the Giraldo Tower (Figure 2.).

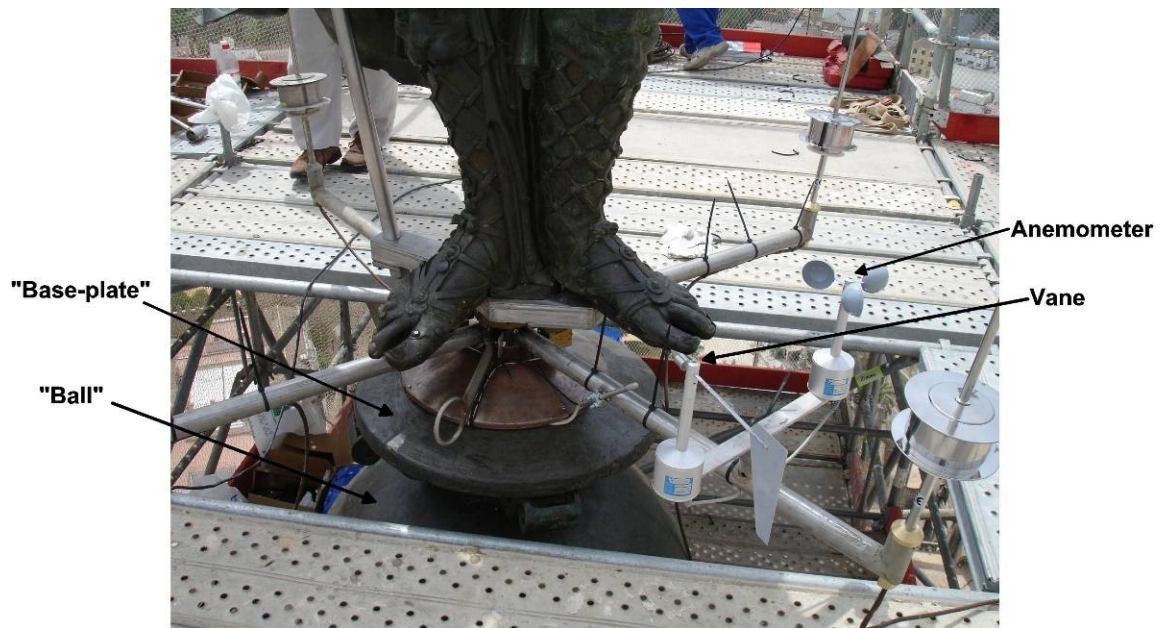
Figure 5. Sensors on the lightning rod support

The vane and anemometer sensors are installed on the lightning rod support installed under the Giraldillo and oriented towards the southeast. One of the reasons for choosing this location was to make them visually less conspicuous. For similar reasons, small-sized sensors were selected and were coated with a greyish matte finish.

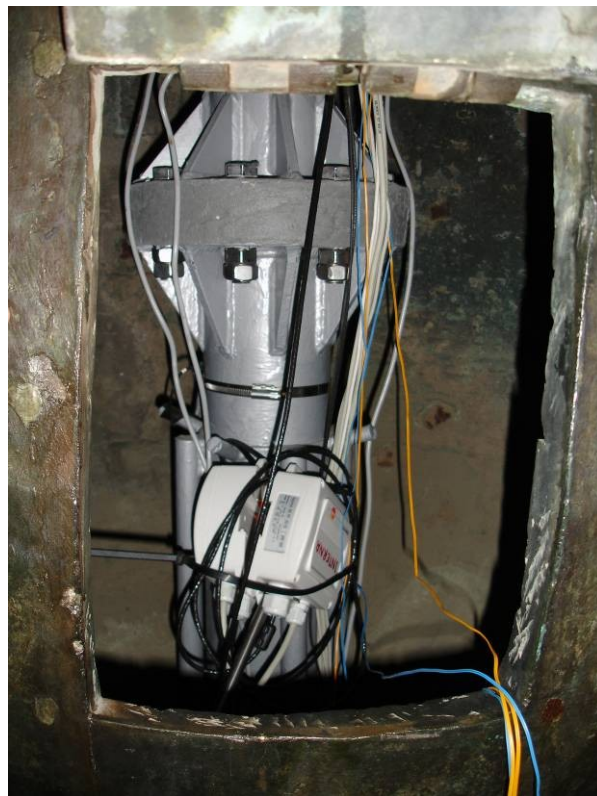
Figure 6. Mounting of sensors inside the "ball" (referred to as sections 1 and 2 in Figure 4.)

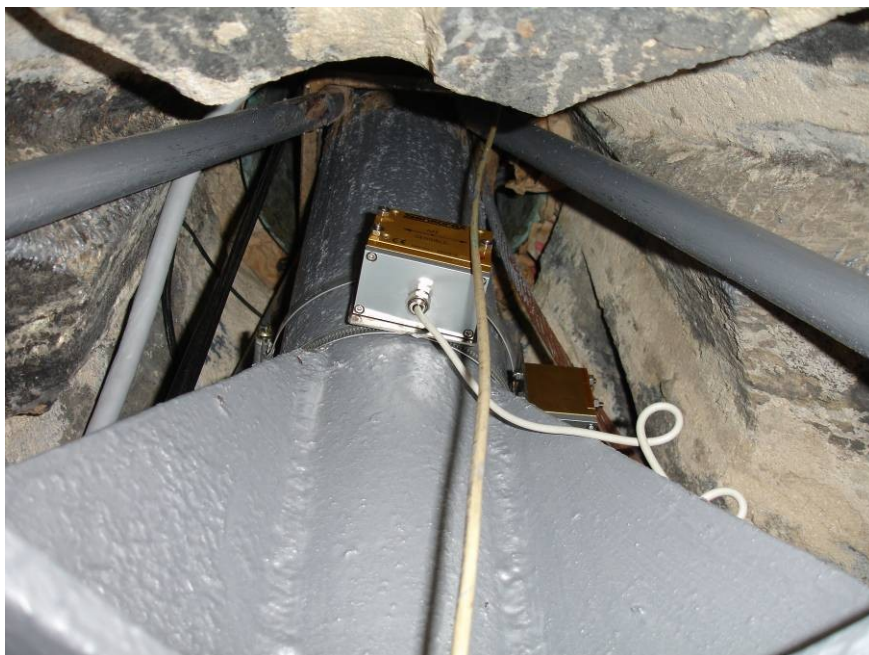
Figure 7. Mounting of inclinometers inside the dome of the Giralda Tower (referred to as section 0 in Figure 4.).

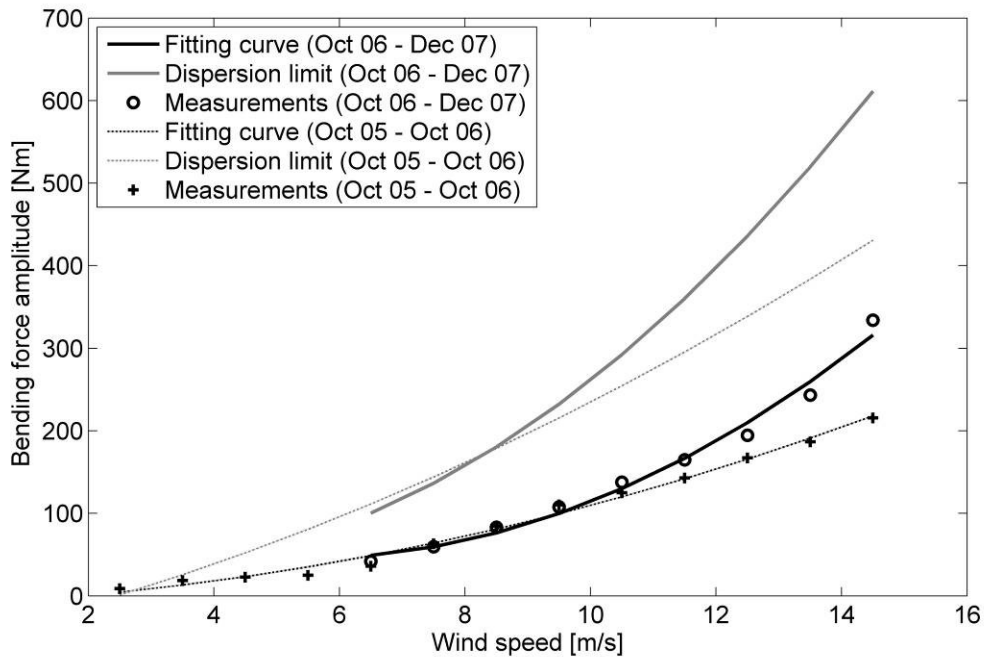
Figure 9. Correlation between the load cycle amplitude in the support shaft and wind speed for two different periods

Figure 9. shows the correlation between average wind speed and average amplitude of the resultant bending force for different wind speed intervals, obtained from auto-spectra of bending force data. For every record, the mean value of wind speed and the amplitude of the bending force—corresponding to the first natural frequency is obtained (forces corresponding to the first mode shape are dominant). Since these bending moment values are obtained from a spectral analysis, they are not influenced by any unbalance in the strain gage circuits.

Variance in the results obtained is relatively high due to the fact that in every record taken into consideration wind speed and direction may change significantly. Thus, Figure 9. shows - in addition to the parabolic fitting curve - a curve representing three times the standard deviation from the mean value for each velocity range.

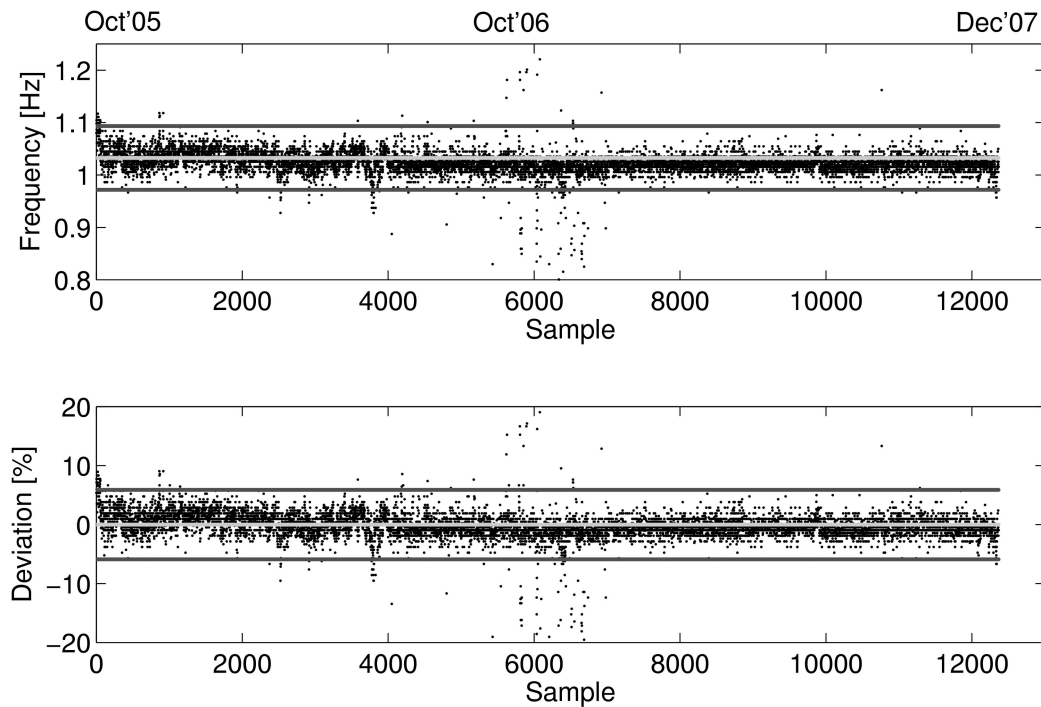
Figure 15. Fluctuations in the first natural frequency obtained for every analyzed recording

Figure 15. shows the variation of the first natural frequency observed in the structure during the period considered. It can be observed that there are no indications of loss of stiffness in the structure.

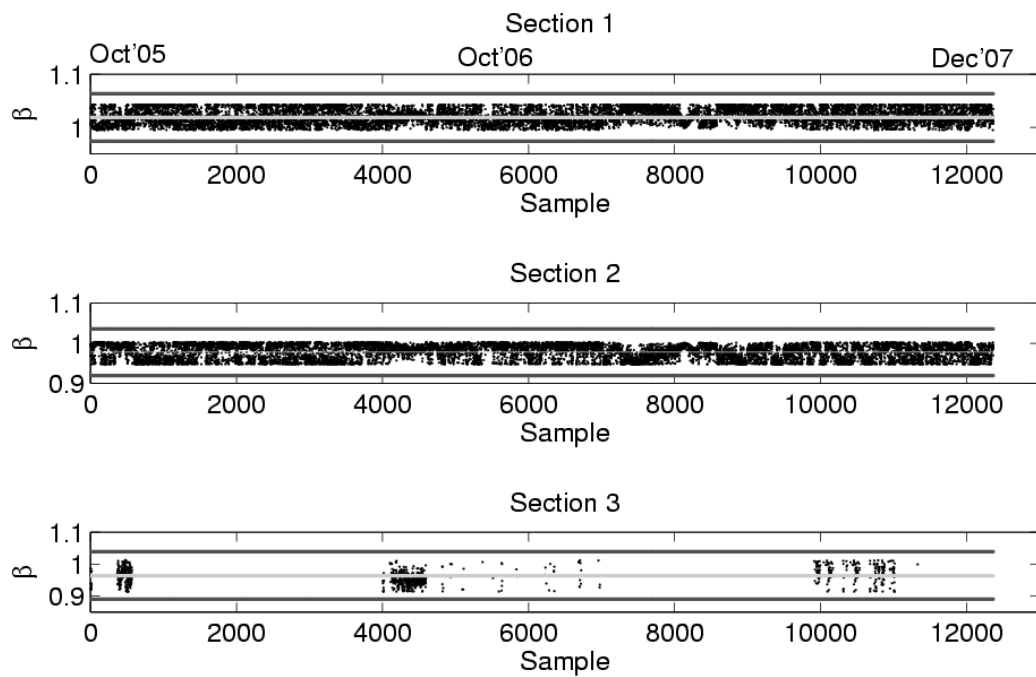
Figure 19. Evolution of changes in parameter β over time in the three sections equipped with accelerometers

Figure 18. and Figure 19. show mode curvature changes over time and the parameter β in the three sections equipped with accelerometers. As may be observed in these figures, there are many recordings for which no values are obtained for section 3. This is due to the fact that the accelerometers located at this section have not always worked properly so no information can be obtained for this section in some of the recordings.
