# Monitoring of Construction Over Soft CCR Deposits

## ABSTRACT

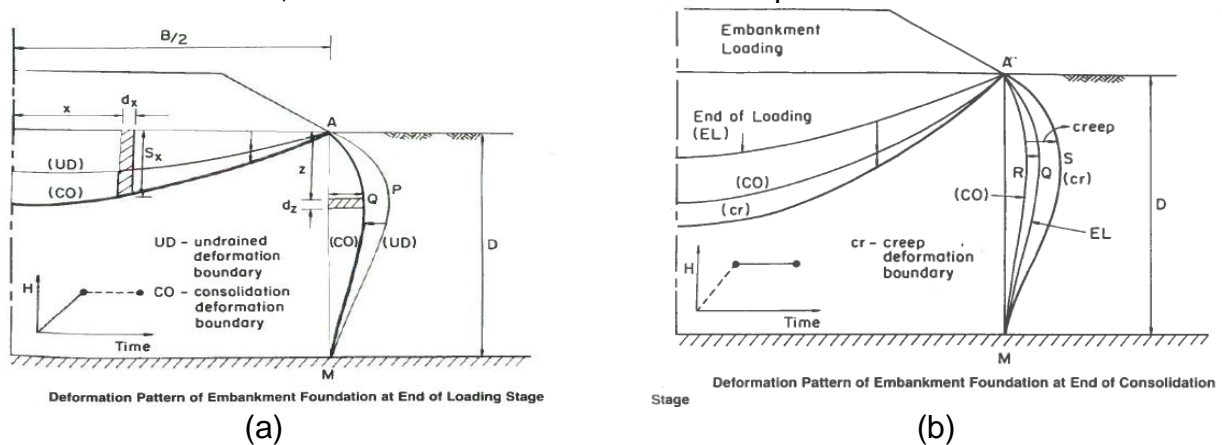
Figure 1. Deformation of Embankments on soft foundations (a) end of loading stage, (b) end of consolidation stage [adapted after Loganathan, N. et al. (1993) *Deformation Analysis of Embankments.*]

Loganathan, N. et al. (1993) pointed out that during loading and consolidation stages of an embankment considerable volume changes occur in the foundation soil, the magnitude of which depend on the load applied and the duration of consolidation. The volume changes, which occur vertically and laterally, are associated with settlement and lateral deformations of an embankment's foundation. Tavenas et al. (1979) summarized the results of a study of 21 embankments on soft soils. Ladd (1991) indicates that Tavenas et al. (1979) had demonstrated that correlations between horizontal displacements and vertical settlements can provide useful information regarding the relative importance of undrained versus drained deformations within embankment foundations. Ladd (1991) related some of the main points of Tavena et al. 1979 work indicating that the relationship between maximum horizontal displacement ( $h_m$ ) measured by inclinometers at the toe of the embankment, and the maximum settlement ( $s$ ) can be used to understand the behavior of the foundation material. Changes in the slope of  $h_m$  versus  $s$  observed during and after construction, and the shape of the horizontal displacement  $h_m$  versus  $s$  curves lead to the conclusions listed below. For ease of presentation, the  $h_m$  versus  $s$  slope is called the deformation ratio,  $DR = dh_m/ds$ .

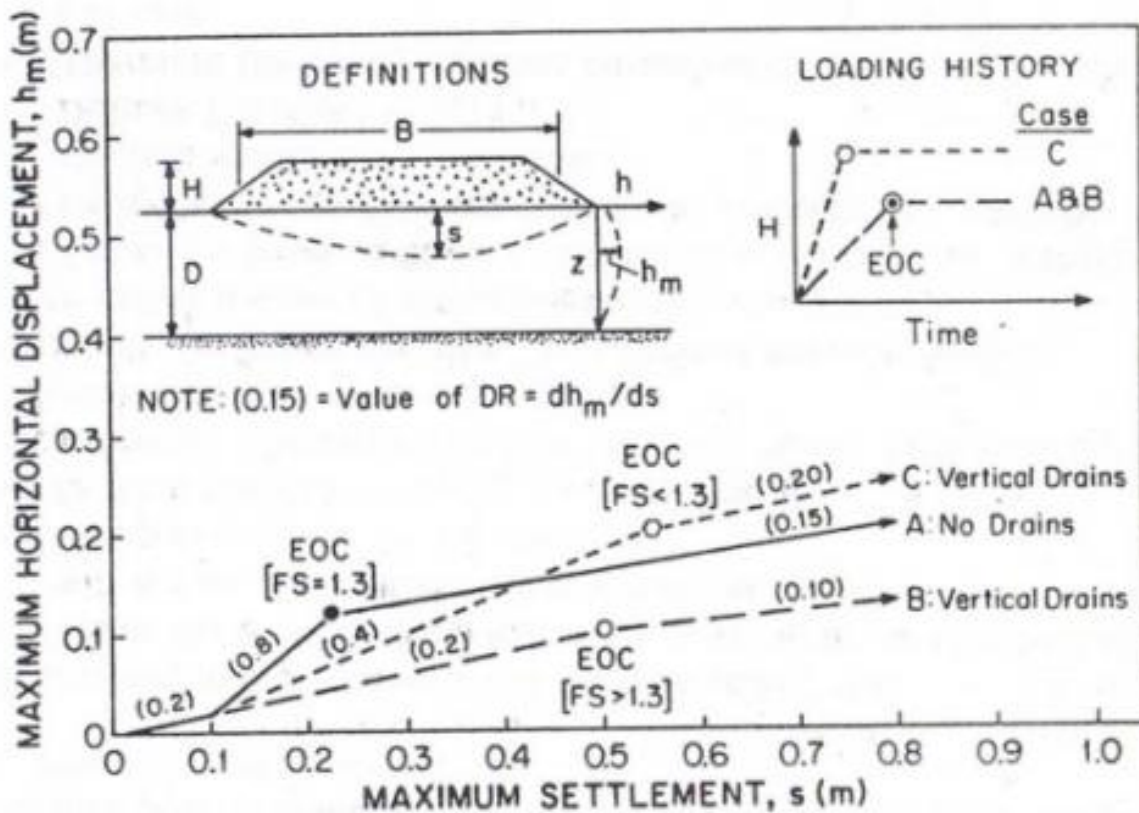
Figure 2. Schematic Relationship Between Maximum Horizontal Displacement and Maximum Settlement for Embankment Construction [adapted after Ladd. (1991) *Stability Evaluation During Staged Construction*]

The relationships presented in Figure 2 are an attempt to show the relationship between the horizontal displacement and the settlement for an over-consolidated foundation based on the Palavas site reported in Tavenas et al. (1979) and presented in Ladd (1991). Case A exhibits a partially drained ( $DR=0.2$ ) and undrained behavior ( $DR=0.8$ ) during fill placement, followed by consolidation having a deformation ratio ( $DR$ ) of 0.15. Case B has an identical loading history as Case A, but the vertical drains provide significant drainage during fill placement (much larger settlement, slightly smaller lateral displacement at the end of construction). More rapid consolidation also reduces  $DR$  after loading due to smaller effects of "undrained" creep.

In his 1991 Terzaghi Lecture, Ladd emphasized that significant variations from the schematic results presented in Figure 2 should be expected because the figure is based on limited specific field information for simple loading geometries, and the processes governing combined consolidation and creep behavior are not well understood, particularly with foundations having large zones of contained plastic flow. However, plots like Figure 2 are useful in monitoring the behavior of soft soil foundations.

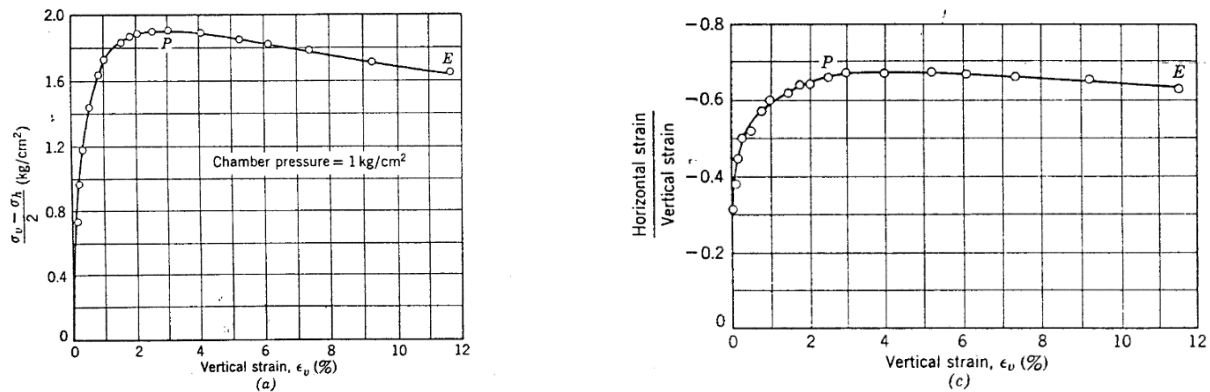
Figure 3. Results of a triaxial compression test on a well-graded calcareous sand. [adapted from Lambe and Whitman, Soil Mechanics, Figure 10.13(1969)]

The ratio of lateral and vertical deformations in a triaxial test with vertical loading indicate deformation ratios during the different phases of the test. During the initial phase of deformation, the deformation ratio is approximately constant, while the reorganization of the particles takes place. Values of the deformation ratio during this phase can be up to 0.2. When the deformations become large implying a failure, the deformation ratio would take values higher than 0.5. Results of a triaxial compression test are presented in Figure 3.

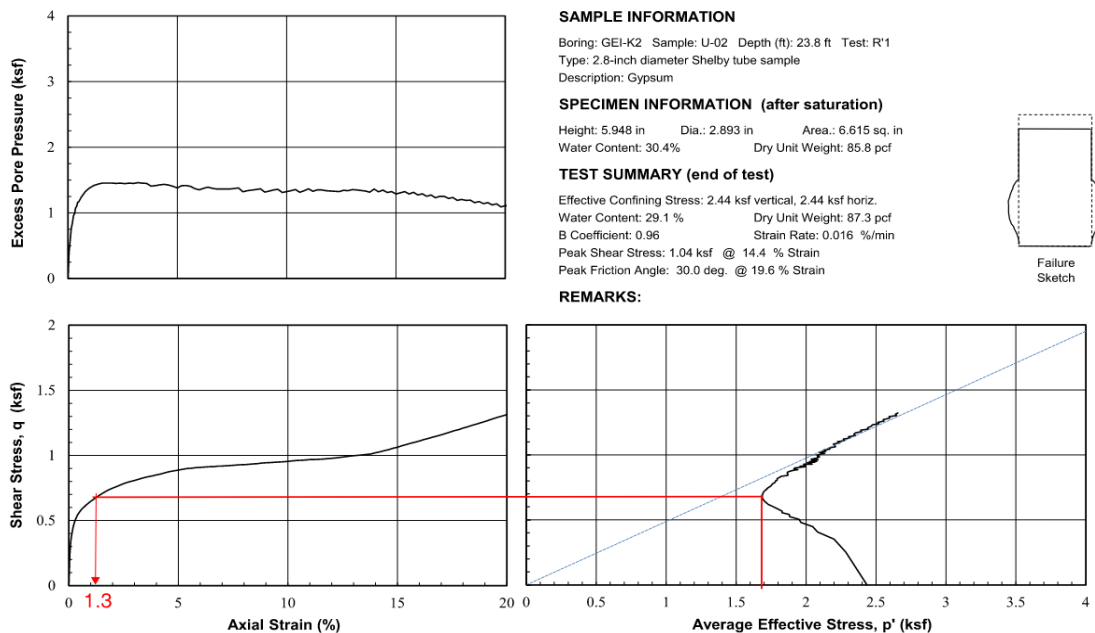
Figure 4. Results of a triaxial compression test on CCR materials

A consolidated undrained triaxial (CIU) test was performed on a tube sample of an identified low strength layer of gypsum from a boring at a CCR site. The specimen was isotopically consolidated to 1.6 times the estimated in situ vertical effective stress. The measured friction angle at maximum obliquity was 30 degrees. Results of the test are included in Figure 4. Figure 5 is a plot of strain ratio versus axial strain for this test.

CIU tests on CCR materials often exhibit compressive behavior followed by dilative behavior before reaching the ultimate strength. The point where the contractive behavior transforms to dilative behavior is called the phase transformation point. At this point the average effective stress  $p'$  from the test is the minimum. In the CIU test presented here, the phase transformation occurs at an axial strain of 1.3% which corresponds to a  $\epsilon_h/\epsilon_v$  ratio of around 0.54 as shown on Figures 4 and 5. Lambe and Whitman (1969) describe that when the deformations become large implying a failure, the strain ratio would take values higher than 0.5. Figure 5 exhibits inflection points at  $\epsilon_h/\epsilon_v$  ratios of 0.18 and 0.54 which further illustrates changes in behavior of the material at these points.

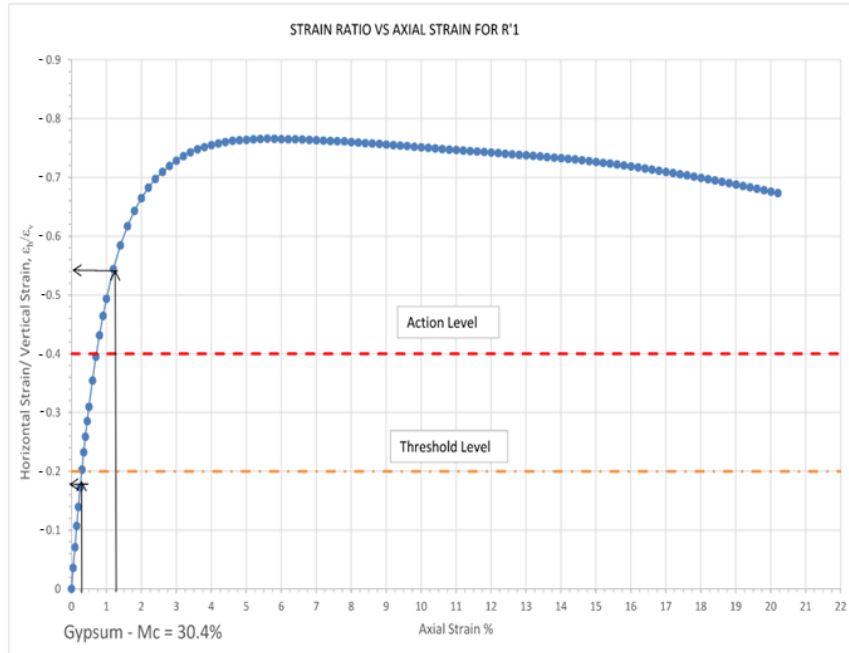
Figure 5. Values of the strain ratio based on results of a triaxial compression test on CCR materials

As described by Lambe and Whitman (1969), the initial stage, which is when straining is very small, extends to a strain of about 0.25%. During this initial phase of deformation, the values of the ratio are approximately constant while the reorganization of the particles is taking place. In the CIU test, the axial strain of around 0.25% corresponds to a  $\epsilon_h/\epsilon_v$  ratio of 0.18 as shown on Figure 5.

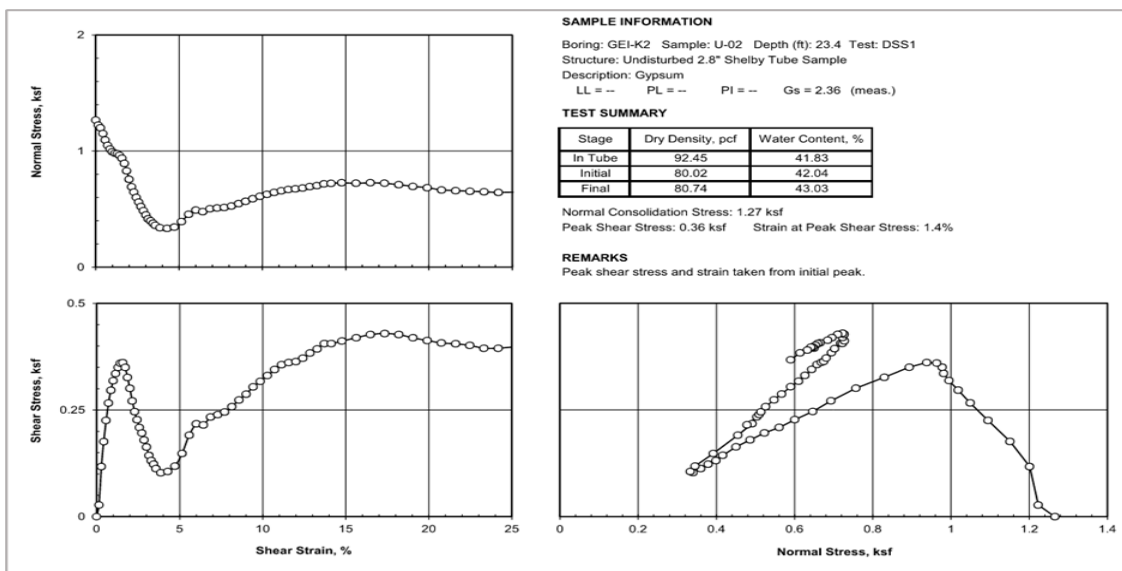
Figure 6. Typical results of a Direct Simple Shear test on CCR materials

Four direct Simple Shear Tests (DSS) were performed on tube samples of low strength gypsum from the same site as the CU' test above. The specimens were isotopically consolidated to 1 to 2 the estimated in situ vertical effective stress. In general, tests results exhibit contractive behavior of the material, with an initial peak strength and then a reduction to a residual strength as the strain continues. Figure 6 depicts typical results of DSS on CCR materials. Figure 7 shows a summary of results of the four tests.

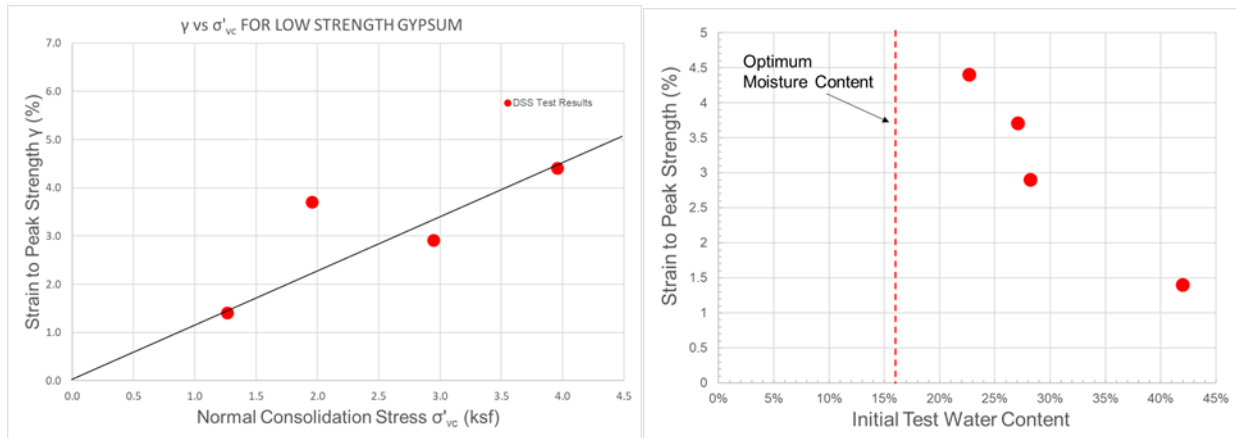
Figure 7. Summary of results from Direct Simple Shear tests on CCR materials

Furthermore, Figure 7 illustrates the relationship between moisture content of the material and the magnitude of shear strain necessary to reach peak shear strength. Centrifuge tests performed on fly-ash at a dense state and at a moisture content of appx. 4% above the optimum moisture content of the material revealed that upon opening of the gates of the sample holder, the fly ash exhibited a slope instability failure. Whereas a test performed on the same fly- ash at a loose state and at moisture content appx. above 16% of the optimum moisture content of the material revealed that upon opening of the gates of the same sample holder, the fly ash exhibited a sudden flow failure. EPRI (2021)

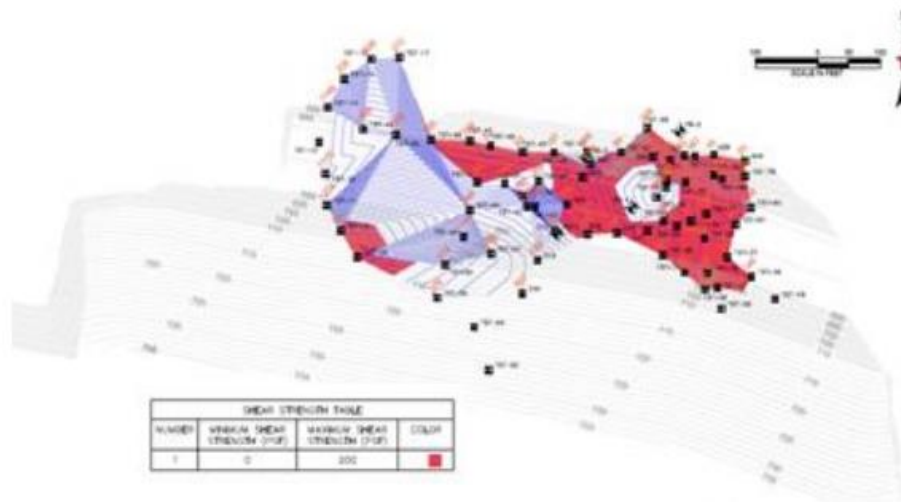
Figure 10. Subgrade strength under fill areas.

The proposed fill construction was subdivided into different areas based on the relative strength of fly ash subgrade as illustrated in Figure 10. The central and left placement areas revealed a relatively stronger subgrade (blue contours) than the right area, which revealed a subgrade strength of less than 200 psf. (red contours)

The horizontal deformation of the subgrade due to loading was monitored using six inclinometers located along the cross sections shown on Figure 10. SI- B1 (El. 671.8) at the toe and SI-B2 (El. 687.5) at the bench were located on the same alignment as SP-1, SP-2 and SP-3, along the central cross section of the slope. SI-C1 (El. 669.4) at the toe and SI-C2 (El. 686.07) at the bench slope are right of the central cross section, upstream of the dam. SI-D1 (El. 678.2) at the toe and SI-D2 (El. 687.4) at the bench are left of the central cross section of the loaded area. To determine if the fly ash subgrade exhibited a significant change in response to the loading, which may indicate a potential for failure, maximum settlement and lateral displacement were reviewed for the selected cross-sections.

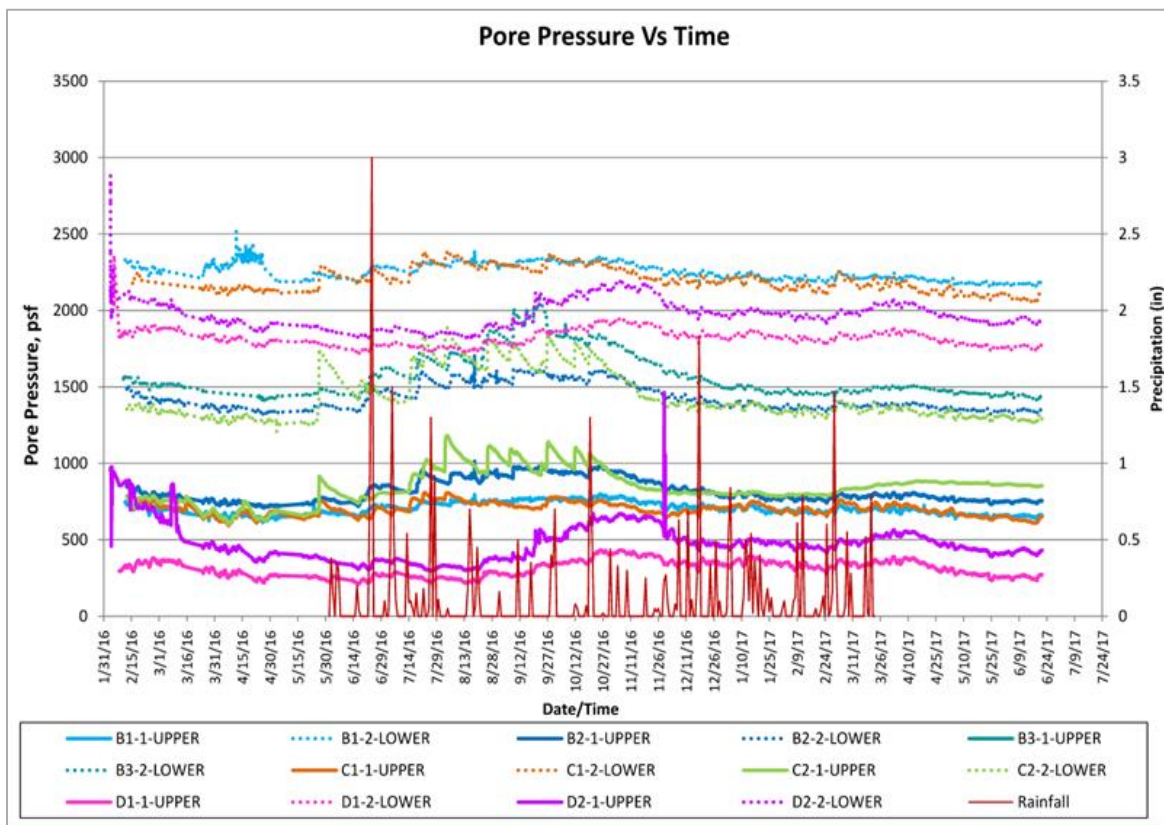
Figure 11. Variation of Pore Pressure with Time, including precipitation data.

The placement of fill on the fly ash subgrade led to the fly ash experiencing a buildup of excess pore pressure and subsequent dissipation of it as the fly ash particles took on the load, as illustrated in Figure 11. In general, the behavior of the pore pressure is affected by the rate of load application, the permeability of the fly ash mass, and the position of the water table, which in turn is affected by the precipitation and runoff into the area. Pore pressure was monitored using seven piezometer locations, each location containing two vibrating wire sensors located at two different depths within the saturated fly ash.

As shown on Figures 11 and 12, all piezometers recorded consistent trends in their behavior. None of the values determined indicate that the  $R_u$  levels of concern were reached during the period of construction to trigger a change of monitoring frequency or the stopping of construction.

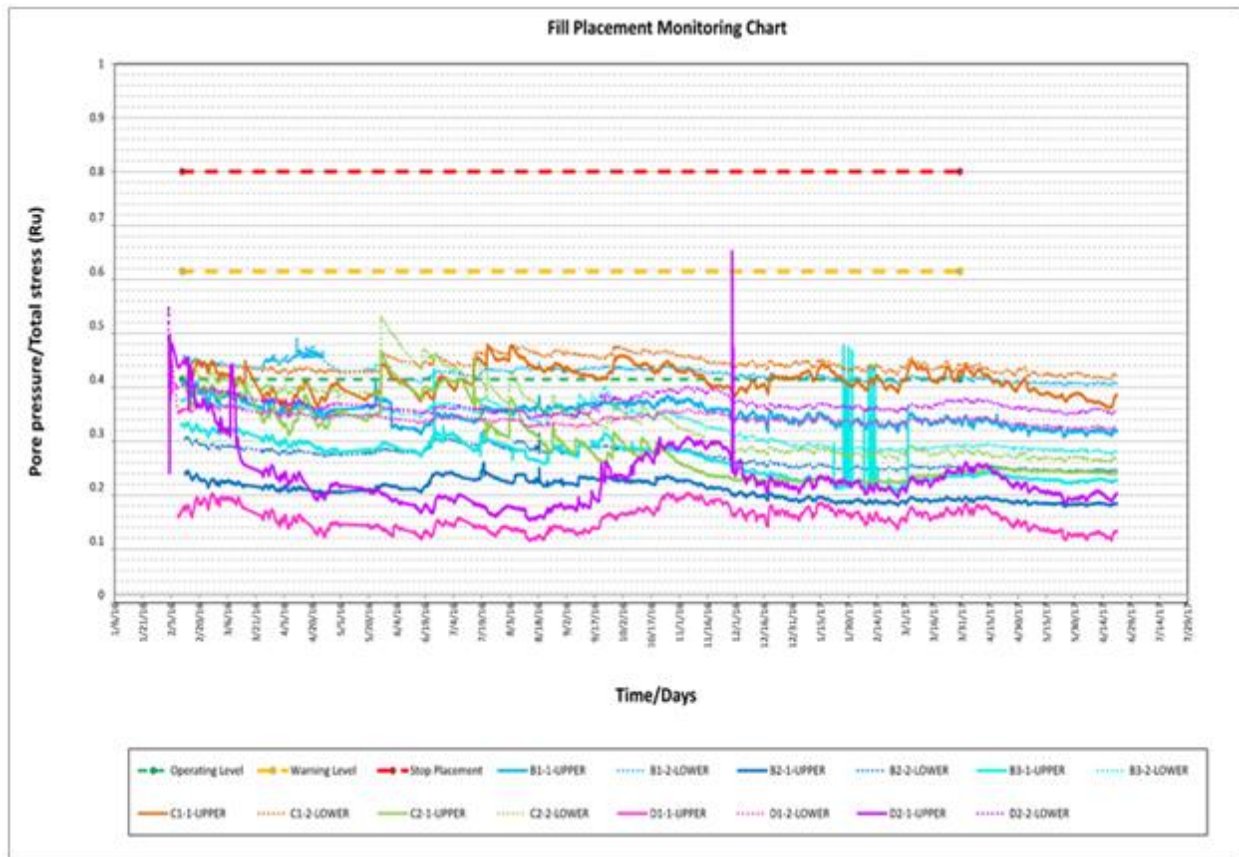
Figure 12. Variation of  $R_u$  with Time.

dimensional parameter  $R_u$  with time are shown below in Figure 12, where  $R_u = \Delta\mu/\Delta\sigma_v$  with  $\Delta\mu$  = change on pore pressure, and  $\Delta\sigma_v$  = change on applied stress.

$R_u$  thresholds for this project were established based on the work of Tavenas and Leroueil (1980) that presented a compilation of pore pressure observations available in the literature for the early stages of embankment construction. In their review, Tavenas and Leroueil (1980) determined that pore pressure response on initial loading was variable with  $R_u$  values ranging from 0.1 to 0.8, and the response after reaching the maximum threshold state was  $\approx 1.0$ . They also concluded that a value of  $R_u$  “of the order of 0.4 is significantly below the theoretical value corresponding to an undrained behavior.” On this basis, action thresholds were set for this construction at 0.4 and 0.6 as warning values leading to an increase in the frequency of recording and reviewing of the data. A value of 0.8 would lead to stopping all construction activities within the compromised loading area.

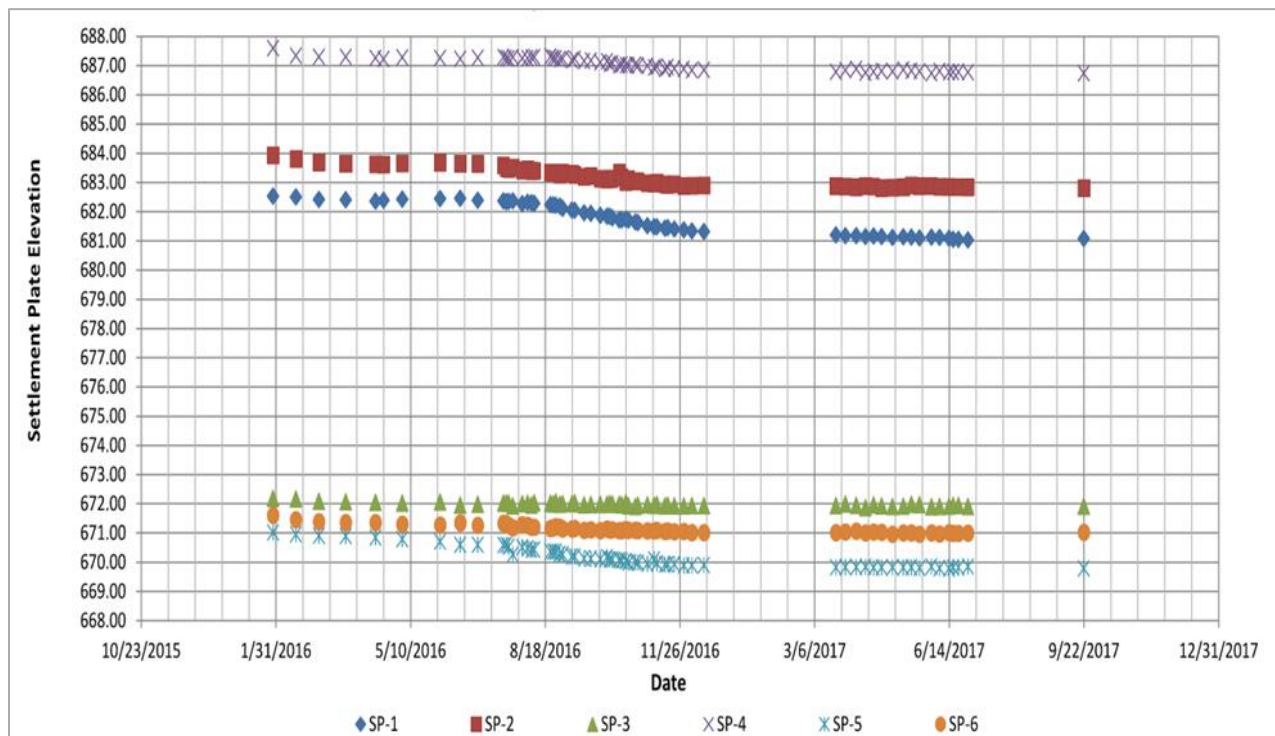
Figure 13. Overall movement of Settlement Plates over the monitoring Period.

The vertical deformation of the fly ash deposit was monitored using six settlement plates. Settlement plates were set at elevations near the fly ash subgrade but on top of the bridge layer. Settlement plates SP- 1 (El. 682.5), SP-2 (El. 684.0); SP-3 (El. 672.0) were located up the slope above the bench, at the bench, and at the toe along the central cross section of the loaded area, respectively. Settlement plate SP-4 (El. 687.6) was located at the bench of the slope left of the central cross section of the loaded area. Settlement plates SP-5 ( El. 671.0) and SP-6 (El. 671.5) where located on the bench of the slope right of the central cross section upstream of the dam. Overall settlement plate movements are shown on Figure 13.

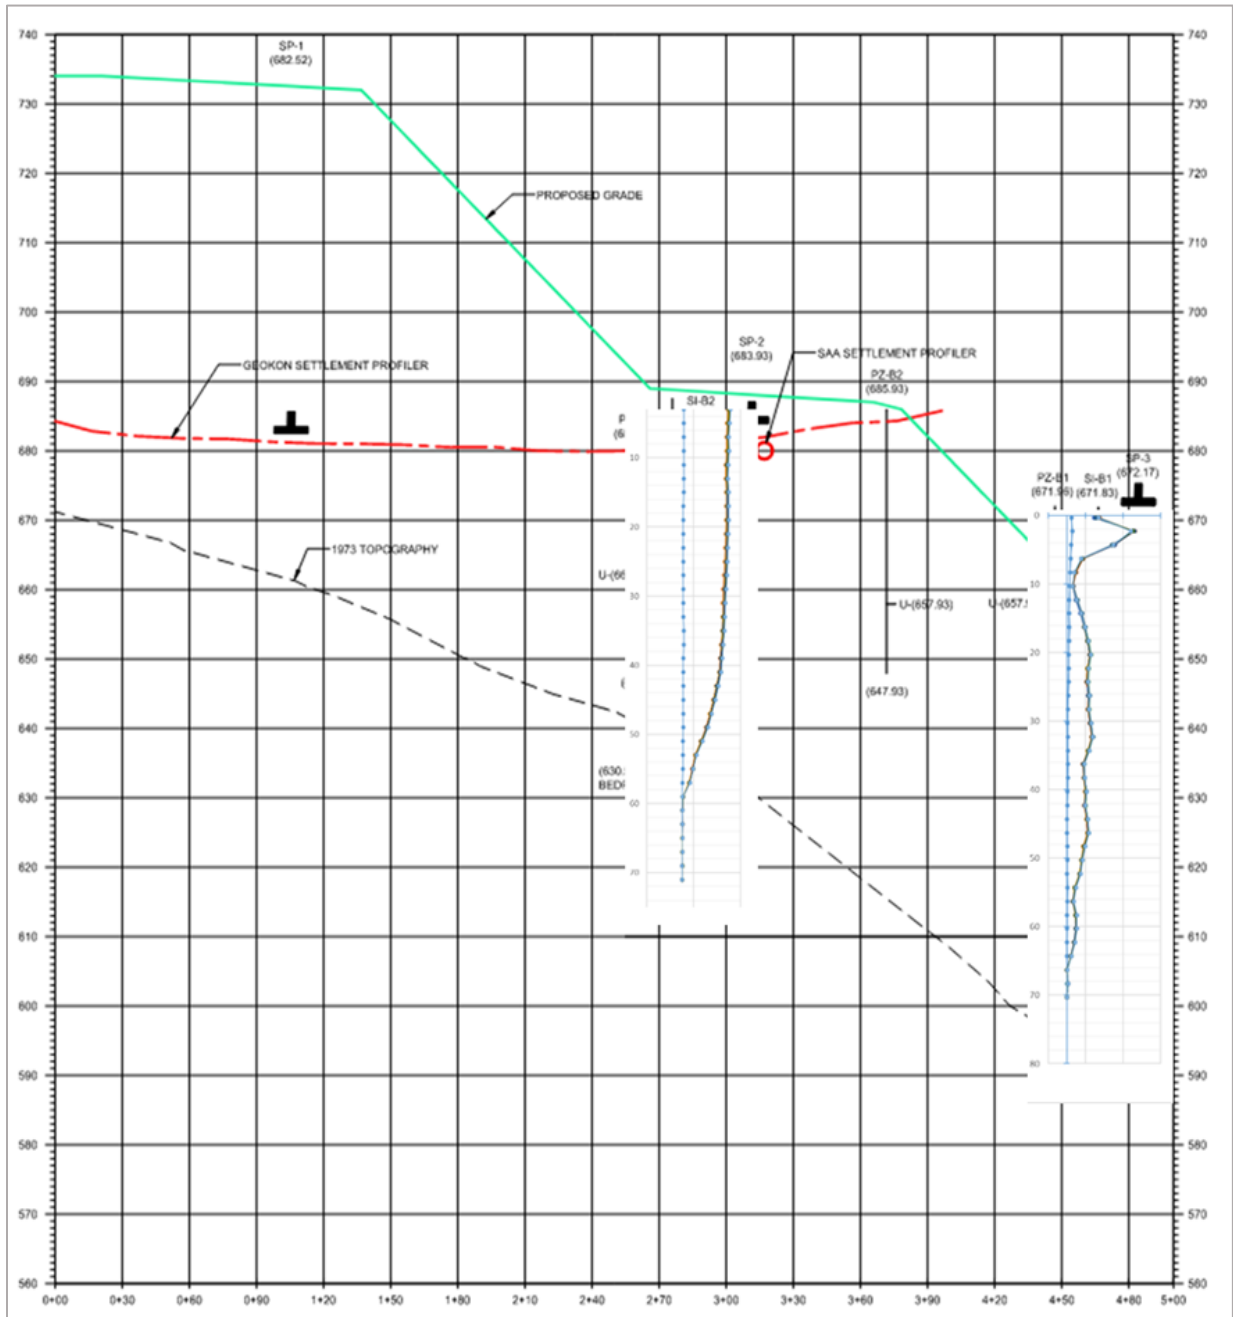
Figure 14. Central Cross Section of fill, depicting the location of settlement plates and inclinometer movements.

The central cross section geometry and instrumentation are shown on Figure 14. SP-1 was located to capture the settlement of the subgrade near the maximum loading condition. Settlement with time and settlement in response to fill placement are shown in Figure 15.

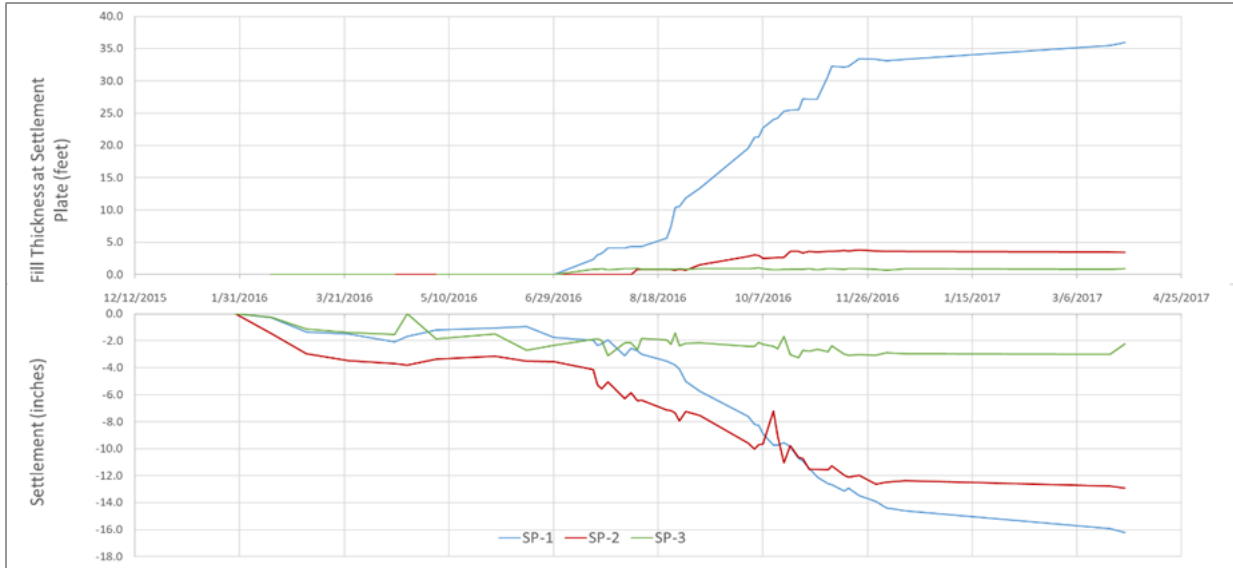
Figure 15. Fill thickness and Settlement Plate movement with time.

Settlement along the cross-section ranged from nearly 4 inches at the toe of the loaded area to nearly 18 inches at the location of SP-1, near the maximum load. Based on the shape of the settlement versus time plot, Figure 15, It should be noted that by the time of the final fill thickness was placed over SP-1, at least 90% of the consolidation settlement of the fly ash subgrade had occurred

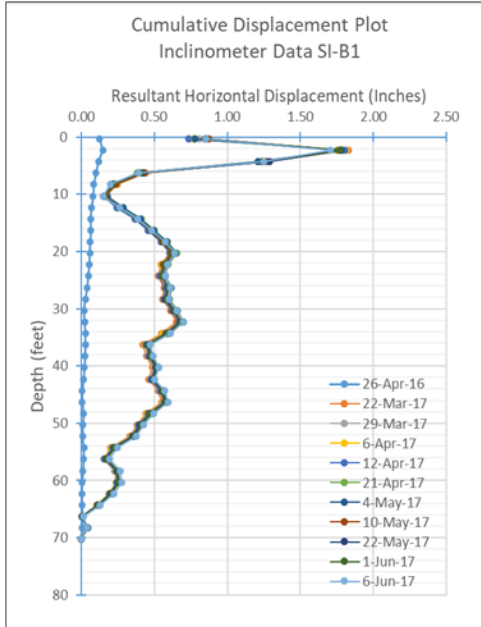
Figure 16. Horizontal Displacement with depth at **toe** of the embankment within this placement area.

recorded with settlement plates SP1 and SP2. Horizontal displacements are shown in Figures 16 and 17, and the variation of Horizontal displacement with fill height (load) is shown on Figure 18, The relationship between horizontal and vertical displacements is shown in 19.

At the toe of the slope, inclinometer SI-B1 recorded a maximum horizontal deformation of just above 1.3 inches near the surface of the fly ash reflecting the horizontal movement of the “mud wave” as the subgrade was loaded. Horizontal deformations of approximately 0.6 inch were recorded within the fly ash deposit between approximate depths of 20 to 45 feet below the ground surface. At the bench of the slope, inclinometer SI-B2 recorded horizontal deformations of about 2.2 to 1.8 inches between depths of 10 and 40 feet below the ground surface.

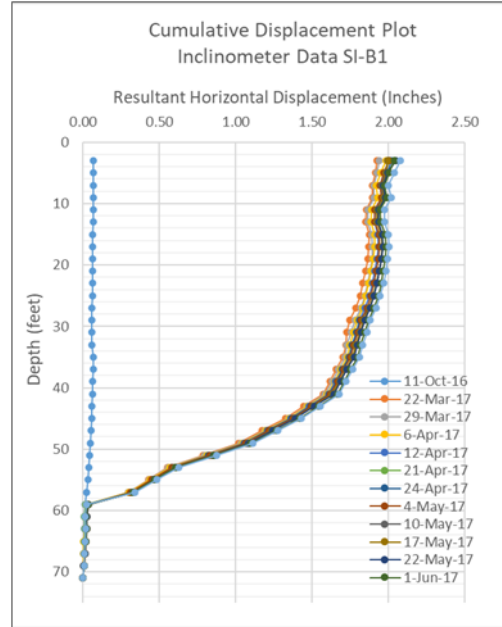
Figure 17. Horizontal Displacement with depth at the **bench** of the embankment within this placement area.

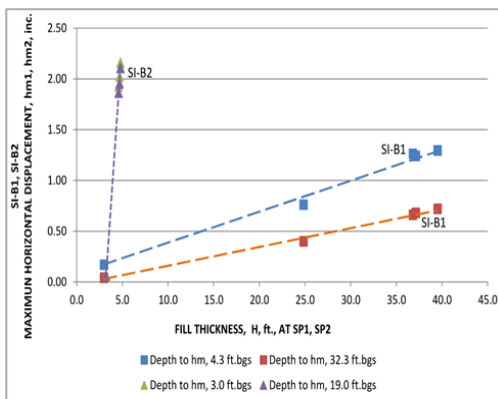
Figure 18. Variation of the Maximum Horizontal Displacement,  $h_m$ , with fill thickness above Settlement Plates in central area.

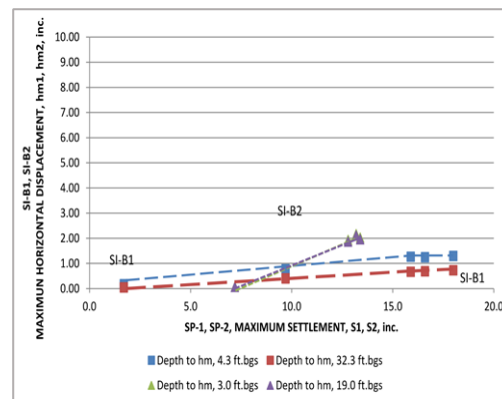
Figure 19. Relation between the Maximum Horizontal Displacement,  $h_m$ , and Maximum Settlement,  $s$ , in central area.

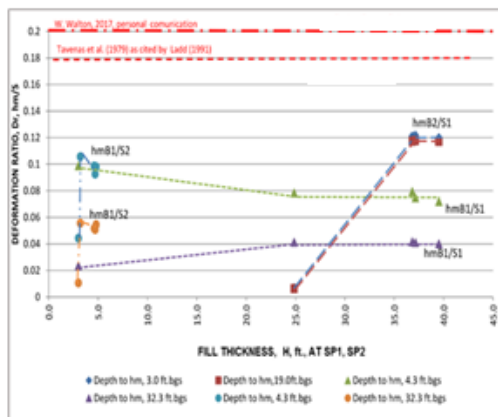
Figure 20. Deformation Ratio versus time within the central area.

that during the construction of the fill the deformation did not exceed the magnitude expected during consolidation, based on the values of the ratio being approximately constant. Deformation ratios versus time and fill thickness are shown in Figures 20 and 21.

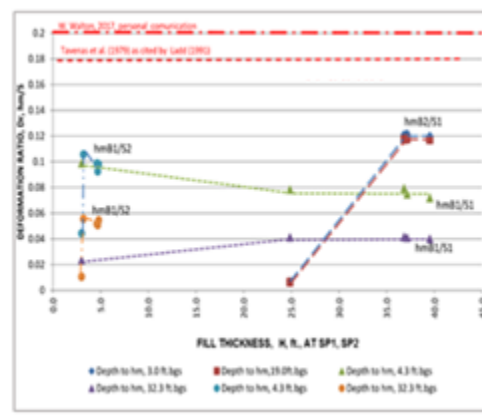
Figure 21. Deformation Ratio versus fill thickness (load) at the location of the settlement plates in central area.

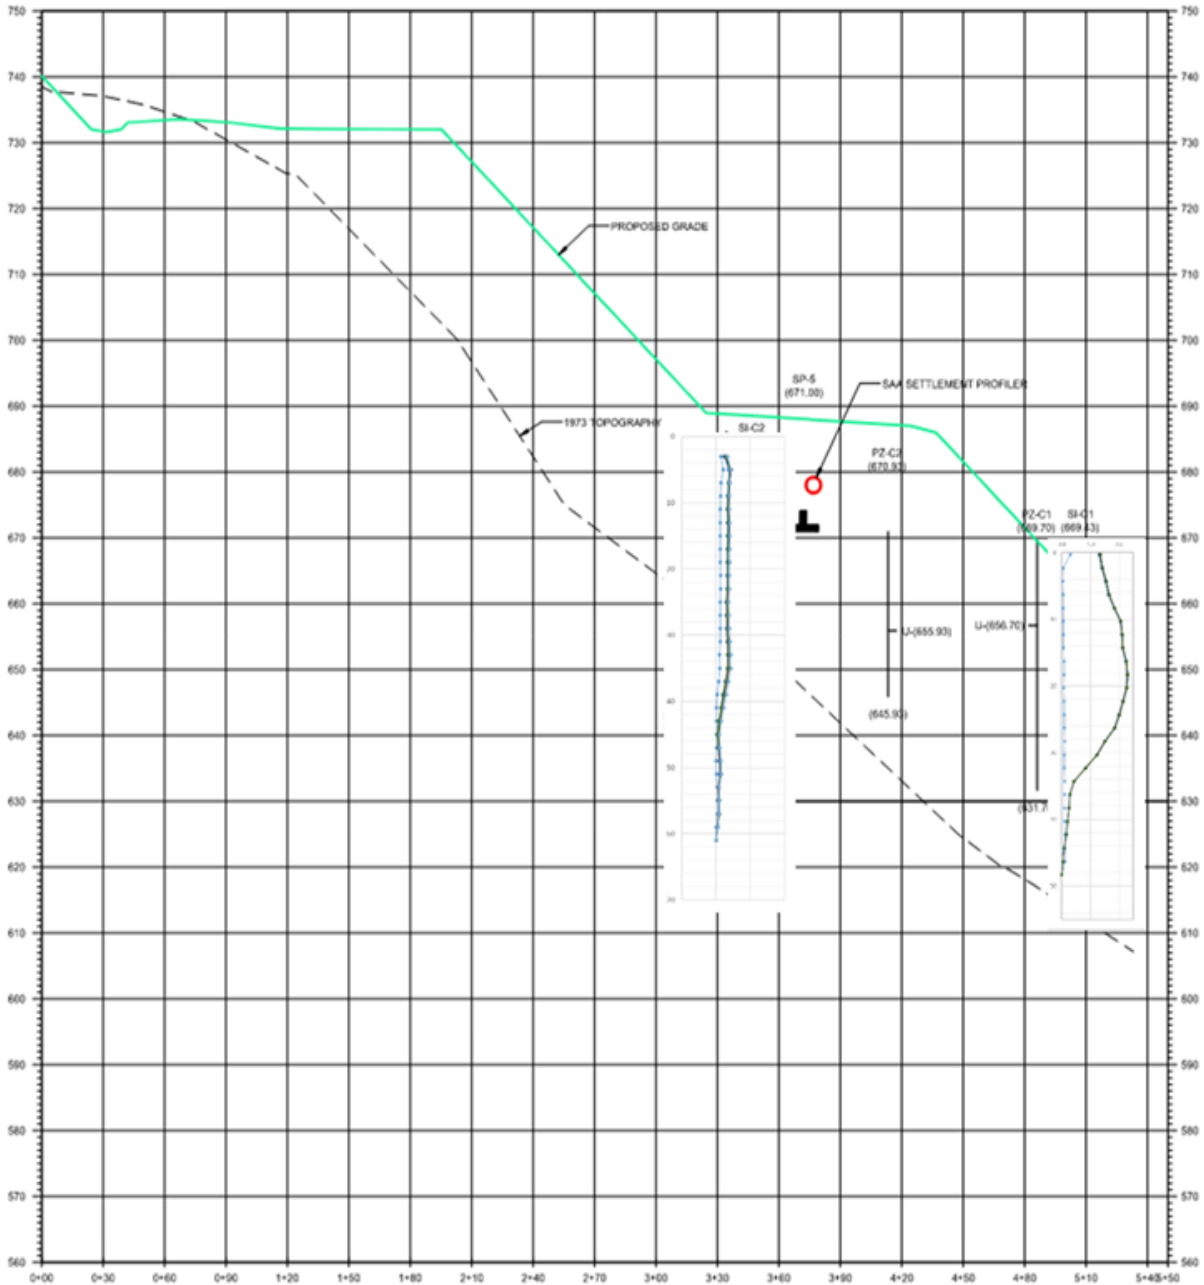
Figure 22. Section of placement area right of center, depicting the location of settlement plates and inclinometer movements.

Settlement plate SP-5 was located near the fly ash subgrade under the bench of the fill within the right area of the fill near the dam, SP-6 was located near the fly ash subgrade under the bench of the fill, but over the upstream slope of the existing dam. The location of these settlement plates in relation to the cross section of the fill slope, to the thickness of the fly ash deposit, and to other instrumentation is shown on Figure 22.

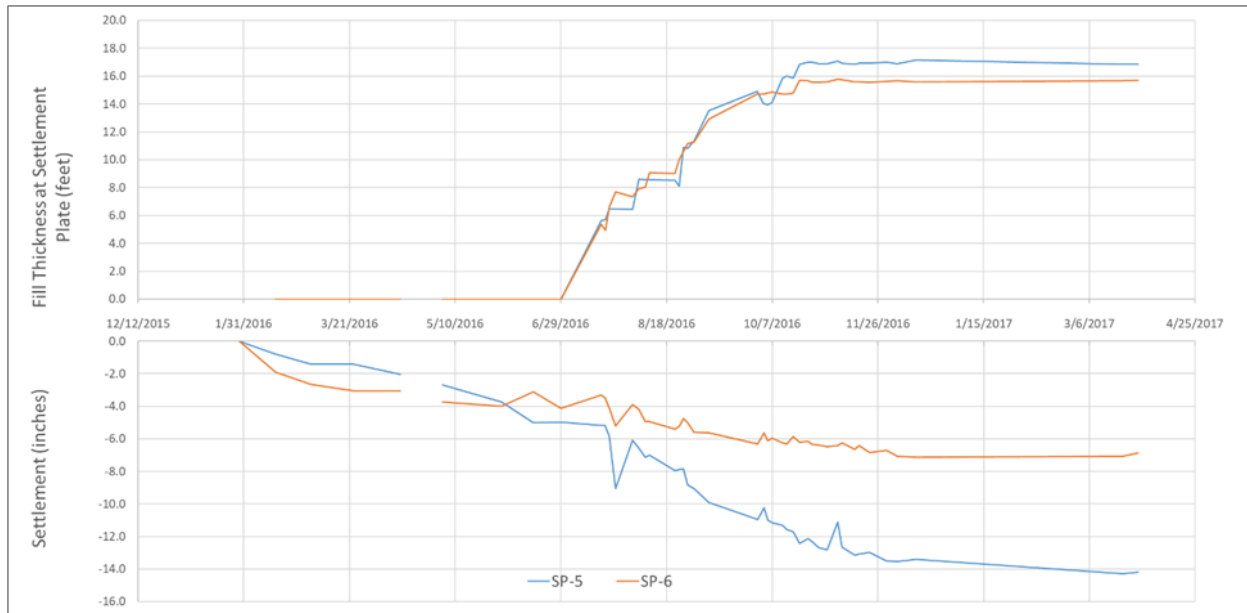
Figure 23. Fill Thickness and Settlement Plate movement with time.

Settlement within this fill area ranged from nearly 8 inches at SP-6 to over 14 inches at the location of SP-5. Settlement plate movement with time and in response to fill thickness are shown in Figure 23.

As depicted in Figure 23, by the time the final fill thickness was placed over SP-1 at least 90% of the consolidation settlement of the fly ash subgrade had occurred in this area of the subgrade. By the time the last set of readings within the scope of this monitoring effort was performed, approximately 3 months after the fill had reach its final elevation, a small additional settlement was recorded at SP-5, whereas no appreciable settlement was recorded at the location of SP-6.

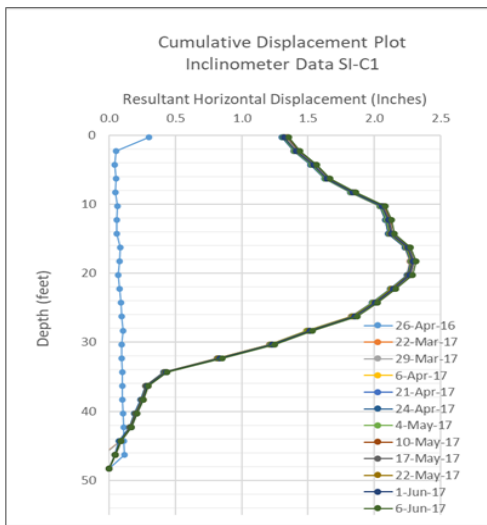
Figure 24. Horizontal Displacement with depth at **toe** of the embankment within the right area.

In inclinometer SI-C1, a maximum horizontal deformation of about 2.3 inches was recorded within the fly ash deposit at a depth of approximately 20 feet below the ground surface at the toe of the fill near the boundary of the subgrade improvement area, as shown on Figure 24. Horizontal deformations were recorded at two depths of interest below the fill's bench, in inclinometer SI-C2. A maximum horizontal deformation of about 0.43 inches was recorded at a depth of 6 feet below the ground surface and a horizontal deformation of approximately 0.48 inches was recorded at a depth of 35 feet below the ground surface, as shown on Figure 25.

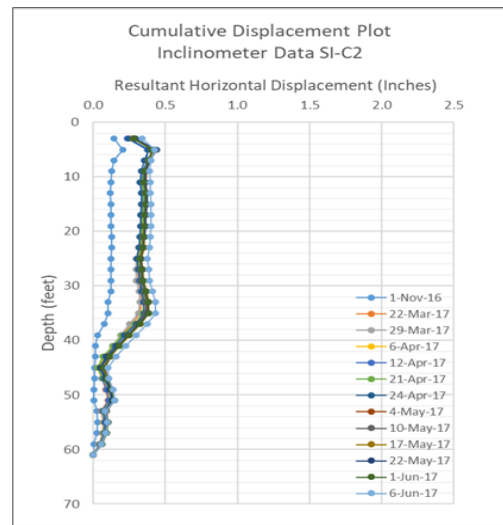
Figure 25. Horizontal Displacement with depth at the **bench** of the embankment in the right placement area.

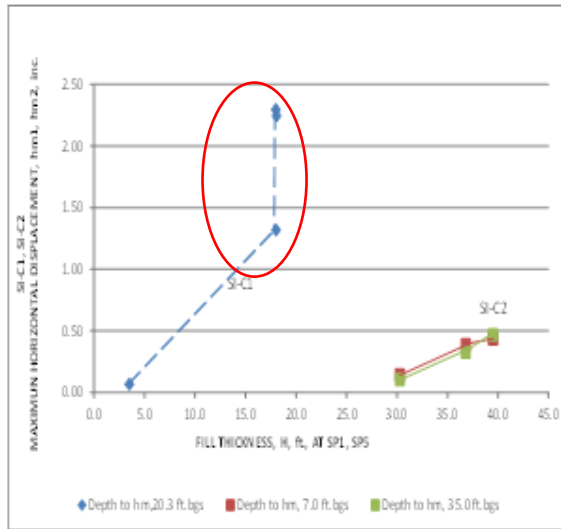
Figure 26. Variation of the Maximum Horizontal Displacement,  $h_m$ , with fill thickness above Settlement Plates in the right placement area.

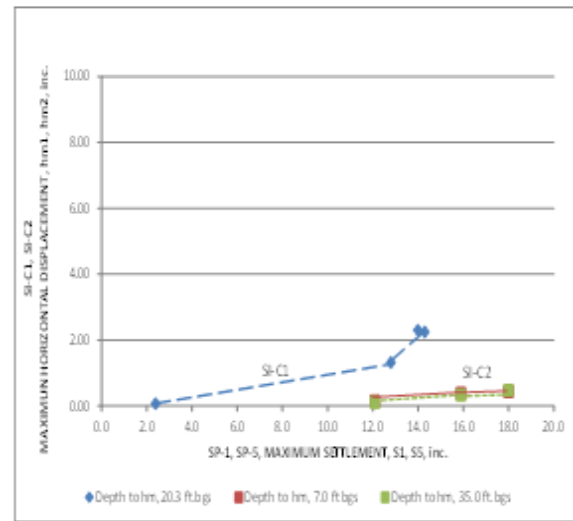
Figure 27. Relation between the Maximum Horizontal Displacement,  $h_m$ , and Maximum Settlement,  $s$ , in the right placement area.

Horizontal displacement versus time and fill thickness are shown in Figures 26 through 29. During the construction of the fill the deformation did not exceed the magnitude expected from the consolidation phase. The values of the ratio became approximately constant as the reorganization of the particles was taking place, as shown in Figure 28. However, as the height of the fill over SP5 reached its maximum elevation, the horizontal deformation observed in SI-C1 continued to increase indicating horizontal creep, as shown in Figure 26. While similar behavior is observed in the deformation ratio of SI-C1/ SP-5, in Figure 29, the magnitude of the ratio (less than 0.2) indicates that the movement is most likely associated with consolidation of the subgrade under the area improved to facilitate the placement of the bridge/capillary brake layer.

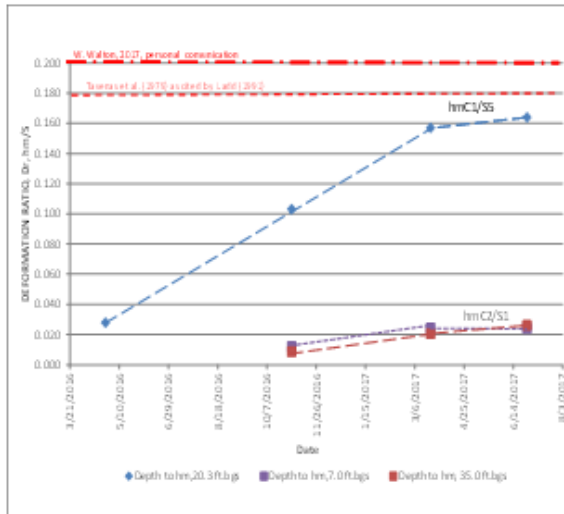
Figure 28. Deformation Ratio versus time in the right placement area.

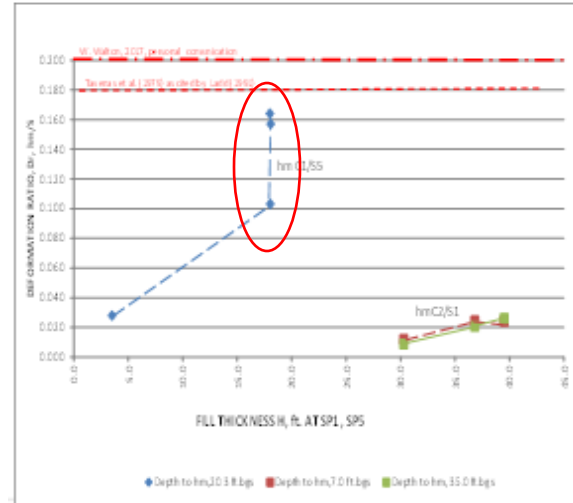
Figure 29. Deformation Ratio versus fill thickness (load) at the location of the settlement in the right placement area.

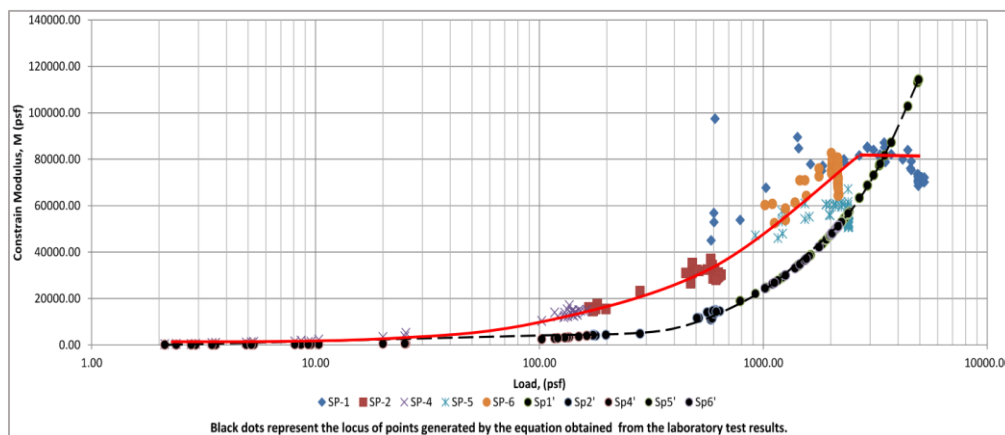
Figure 30, Comparison of values of M obtained in the laboratory and values of M back calculated based on actual vertical deformation observed during fill placement at the settlement plates.

It can be observed that the back calculated value of  $M$  (colored dots) was, in general, higher than the value determined in the laboratory for the same applied load, illustrating that the foundation material is stiffer, within the range of acting stresses, than anticipated. Thus, supporting the expectations that the drainage features of the facility would perform as intended in the design. However, the field values seem to reach a limiting value, which at this site is approximately 80,000 psf. The drop on value of  $M$ , experienced at the tail of the data, may be attributed to the estimating methodology used to determine the actual load at the location of the plate, meaning additional fill was placed to compensate for settlement which was not accounted for. This leads to an underestimate of vertical stress and therefore an underestimate of constraint modulus.

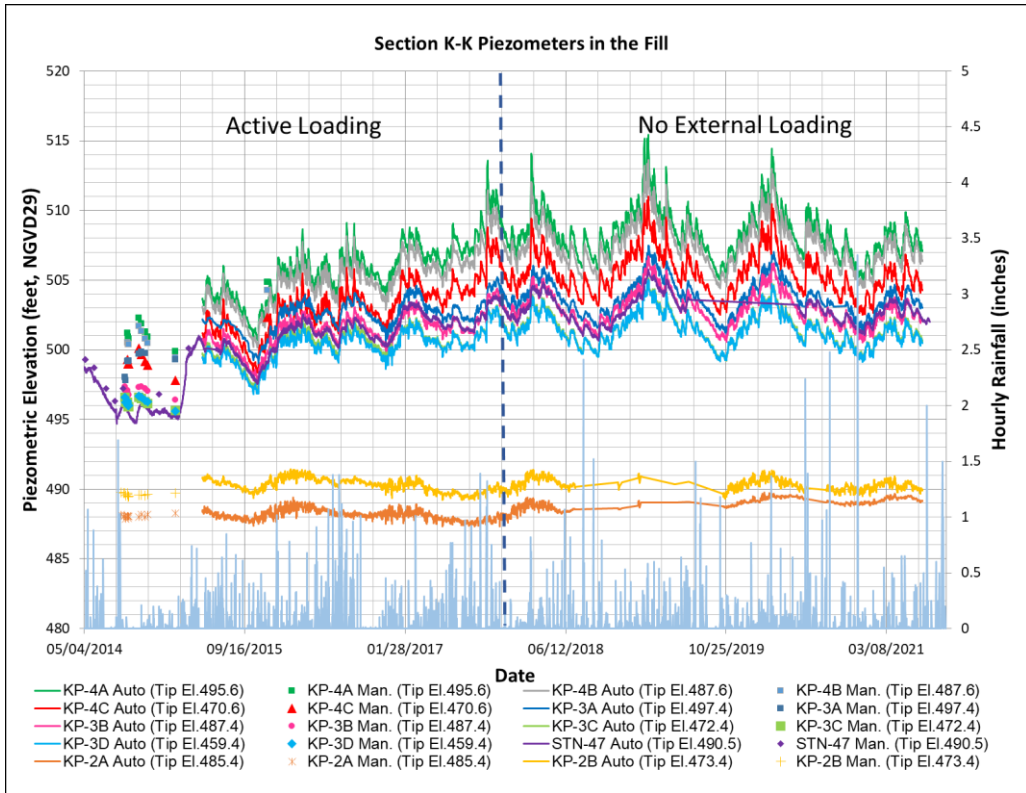
Figure 36. Phreatic water levels within CCR Stack in West Pond

The active instruments were used to evaluate movements at the stack and the associated loading mechanisms that could explain the movements. The height of the stack has not changed significantly since 2017. However, the water levels within the CCR stacks have fluctuated, as shown on Figures 36 and 37, and therefore effective vertical stresses acting on the weaker layers have also changed accordingly, causing a loading mechanism that has led to the displacements observed along the layers of interest.
