# Monitoring of Construction Over Soft CCR Deposits

## ABSTRACT

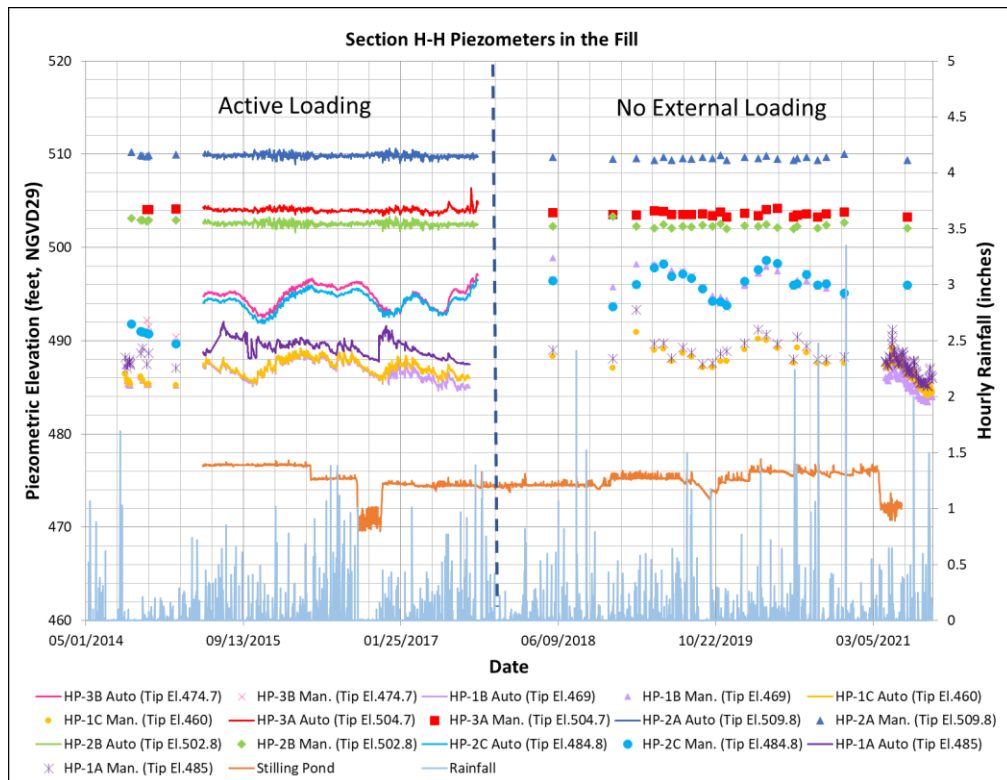
Figure 37. Phreatic water level within CCR Stack in East Pond

The active instruments were used to evaluate movements at the stack and the associated loading mechanisms that could explain the movements. The height of the stack has not changed significantly since 2017. However, the water levels within the CCR stacks have fluctuated, as shown on Figures 36 and 37, and therefore effective vertical stresses acting on the weaker layers have also changed accordingly, causing a loading mechanism that has led to the displacements observed along the layers of interest.

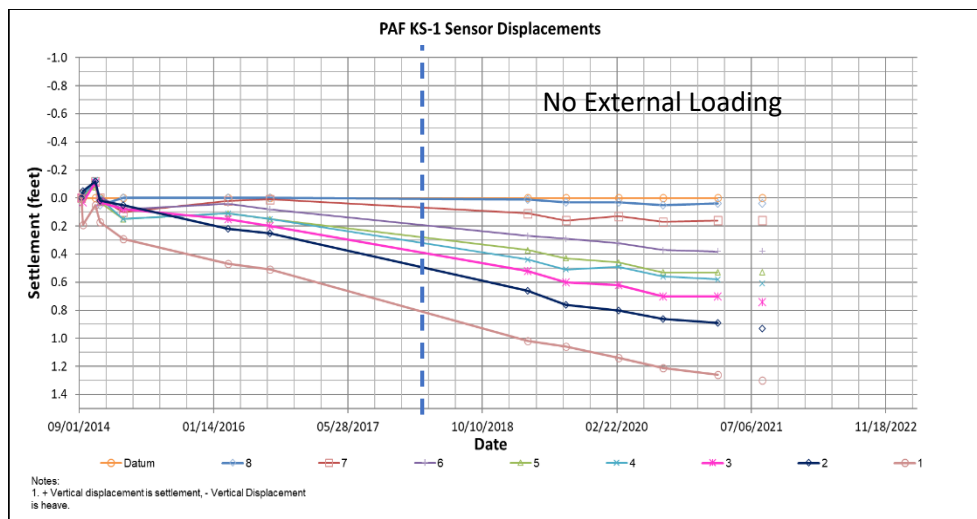
Figure 39. Record of vertical deformation at West Pond.

Figure 39 shows the vertical settlement recorded in the West Pond from 2014 until 2021. It should be noted that settlement continued after the end of 2017, even though there were not external loadings applied to the west pond stack.

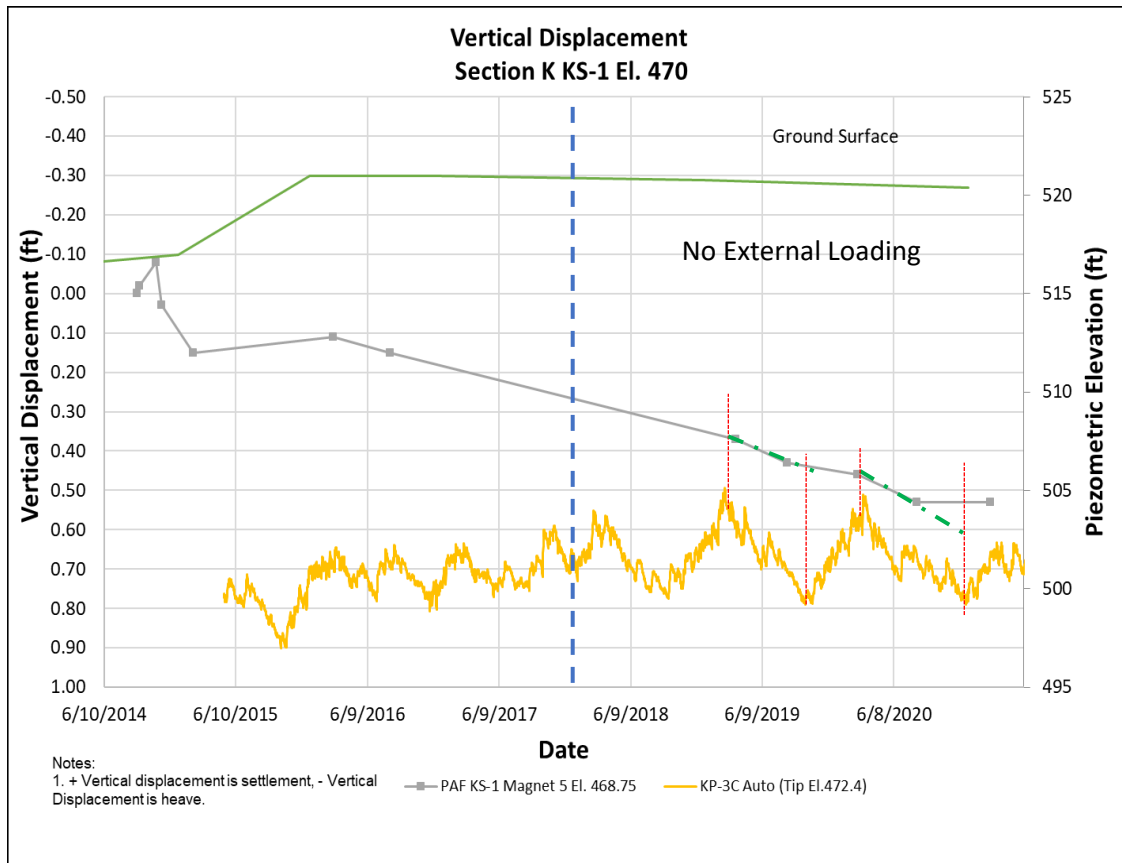
Figure 40. Cumulative vertical displacement and associated phreatic level at layer of interest, approximately elevation 470.

The Sondex KS-1 extensometer revealed an increase in vertical settlements at approximate El. 470 located in the identified lower strength zone, as shown in Figure 40. After the end of 2017, when active loading ceased, higher rates of vertical displacement were experienced during periods when lowering phreatic level trends (and therefore higher vertical effective stresses) occurred.

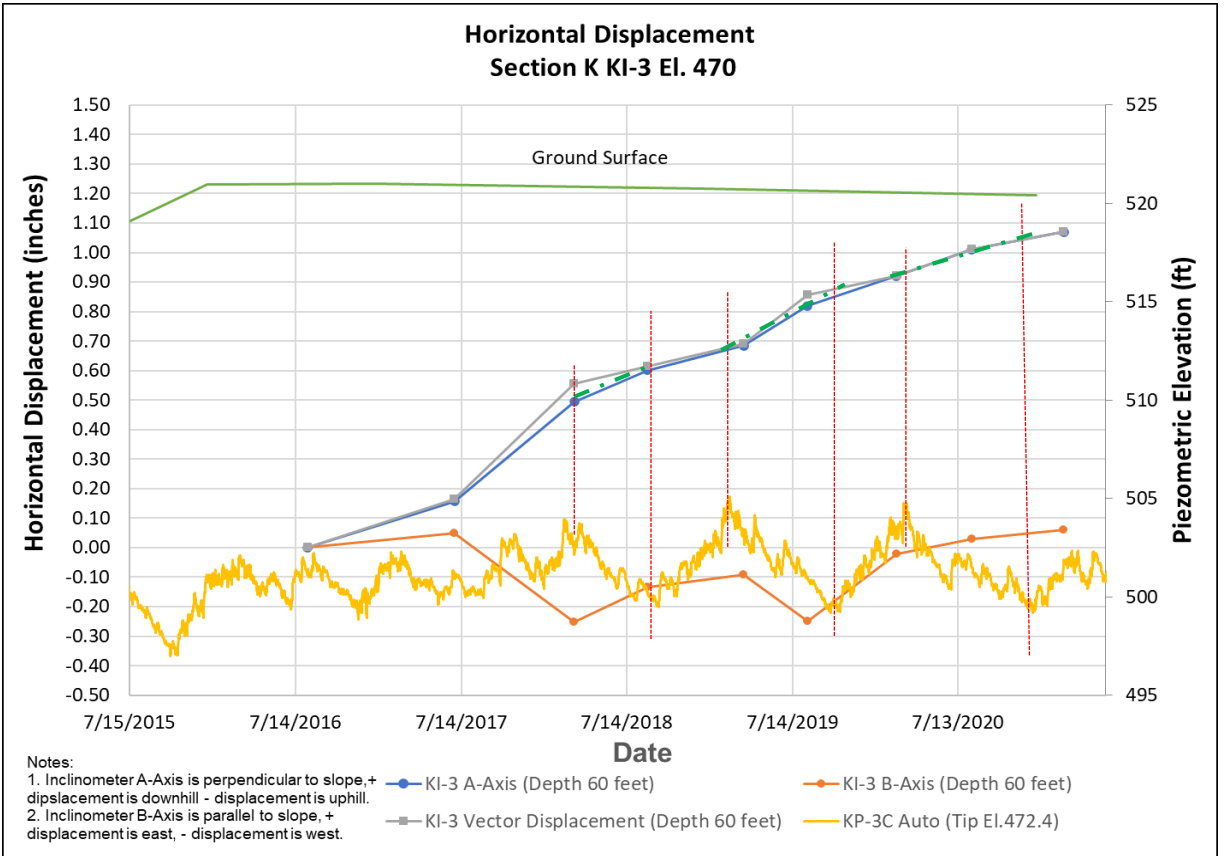
Figure 41. Cumulative horizontal displacement and associated phreatic level at layer of interest, approximately elevation 470.

The plots of horizontal and vertical displacements at El. 470 with pore water pressures from adjacent piezometer KP-3C show a trend of increasing movements in both horizontal and vertical directions when pore water pressures decrease, as shown in Figure 41. The decrease in pore water pressures causes an increase in effective stresses, providing the loading that results in additional settlement and lateral movement. After the end of 2017, when active loading ceased, higher rates of lateral displacement were experienced during periods when lowering phreatic level trends were being achieved.

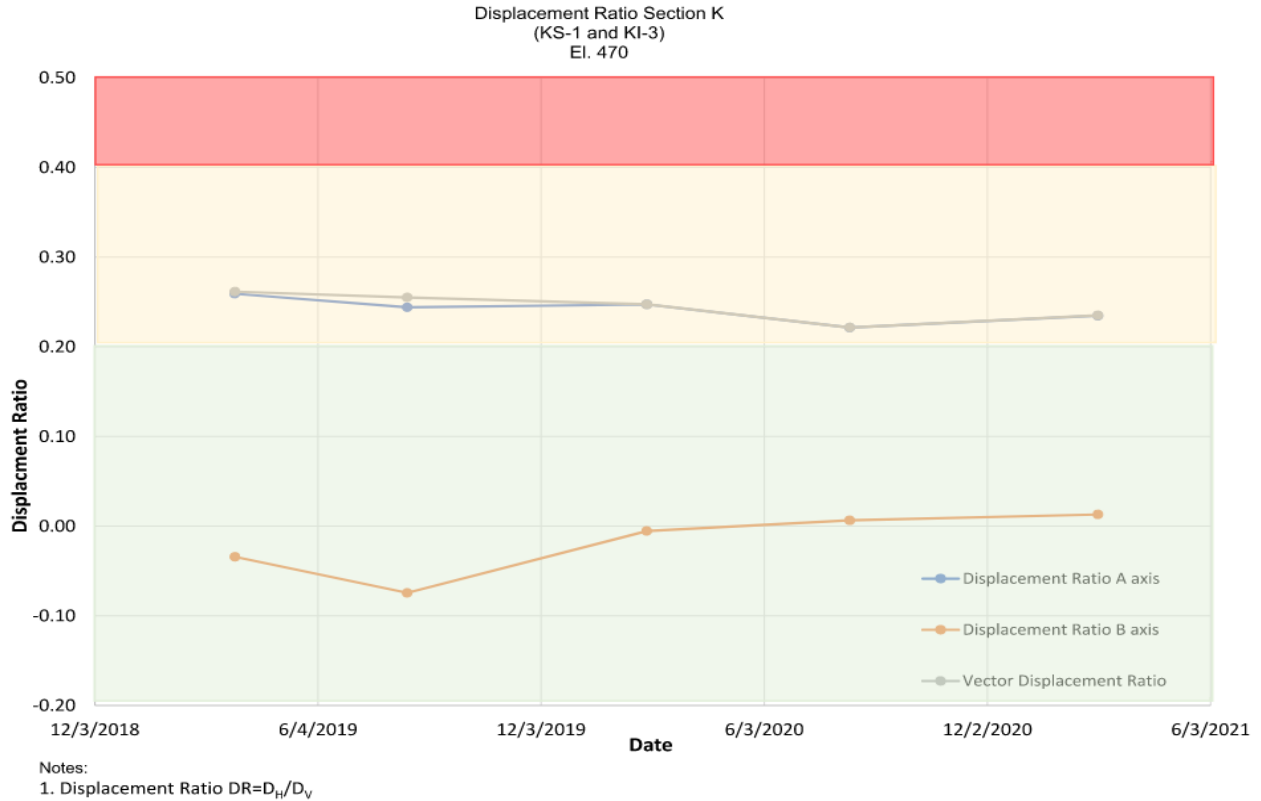
Figure 42. Displacement Ratio versus time at layer of interest, approximately elevation 470.

The maximum displacement ratio from 2019 to 2021 ranges from 0.22 to 0.26 and generally remains stable. Even though the displacement ratios are slightly above 0.2, they are relatively stable and do not appear to increase with time.

Soft foundations may experience long-term lateral displacements several times larger than what may be measured at the end of construction, and although the mechanisms causing this phenomenon are unclear, Ladd (1991) indicated that in his opinion an important causal factor of the continued shear distortions is “undrained” creep. To develop and understanding of the nature of movements at Section K-K’, the deformation ratio at El. 470 was calculated using lateral movements from readings of inclinometer KI-3 and vertical movement from readings of extensometer KS-1. A plot of displacement ratio versus time is shown in Figure 42. Displacement ratios in each direction as well as the resultant “vector” ratio are shown.

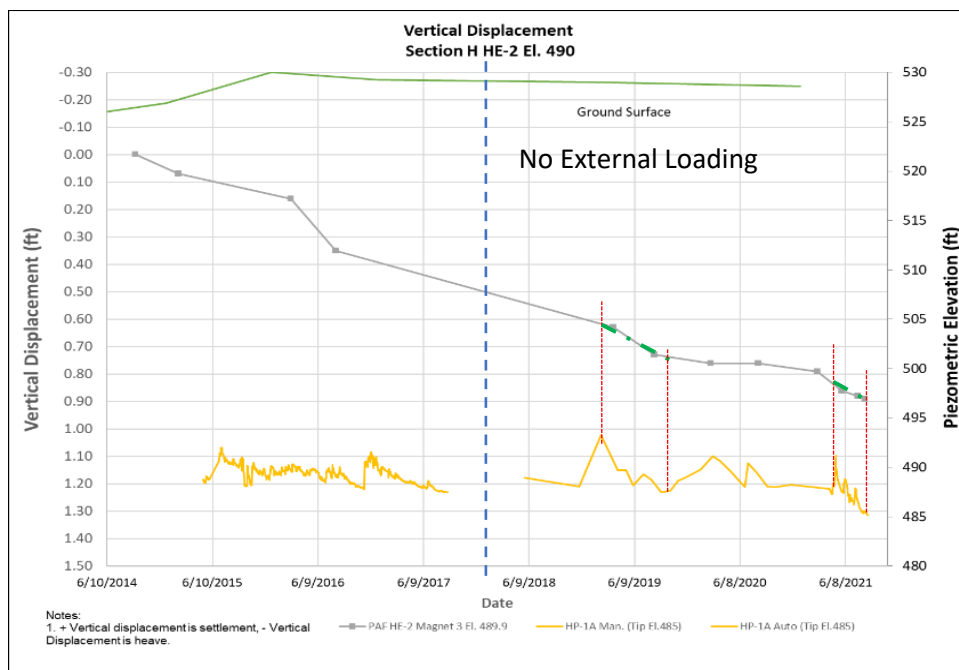
Figure 44. Vertical displacement at elevation 490.

A zone of lower strength material between El. 490 and El. 495 was identified at Section H-H. To evaluate movements at Section H-H the readings from extensometer HE-2 and HI-1 were compared. Inclinator HI-1 showed consistent movement from 2016 until the latest readings in 2021. From the cumulative displacement plot, two zones of large lateral displacement were identified. The first large displacement zone is located at a depth of 14 ft (El. 490), which corresponds to a lower-strength material zone at Section H-H. The second large displacement zone was located between depths of 24 and 40 ft (El. 480 and El. 466). Vertical displacements are plotted in Figures 46 and 47, and horizontal displacements are plotted in Figures 46 and 47. Water levels in corresponding piezometers are shown in all four figures.

The plots in Figures 44 through 47 reveal a trend of increasing movements in both horizontal and vertical directions when pore water pressures decrease. The decrease in pore water pressures cause an increase in effective stresses in the soil, which results in additional settlement and lateral movement. Deformation ratios at El. 490 and El. 470 were determined using lateral movement at depth, from readings of inclinometer HI-1, and vertical movement, from readings of HE-2. The deformation Ratios are plotted in Figures 48 and 49.

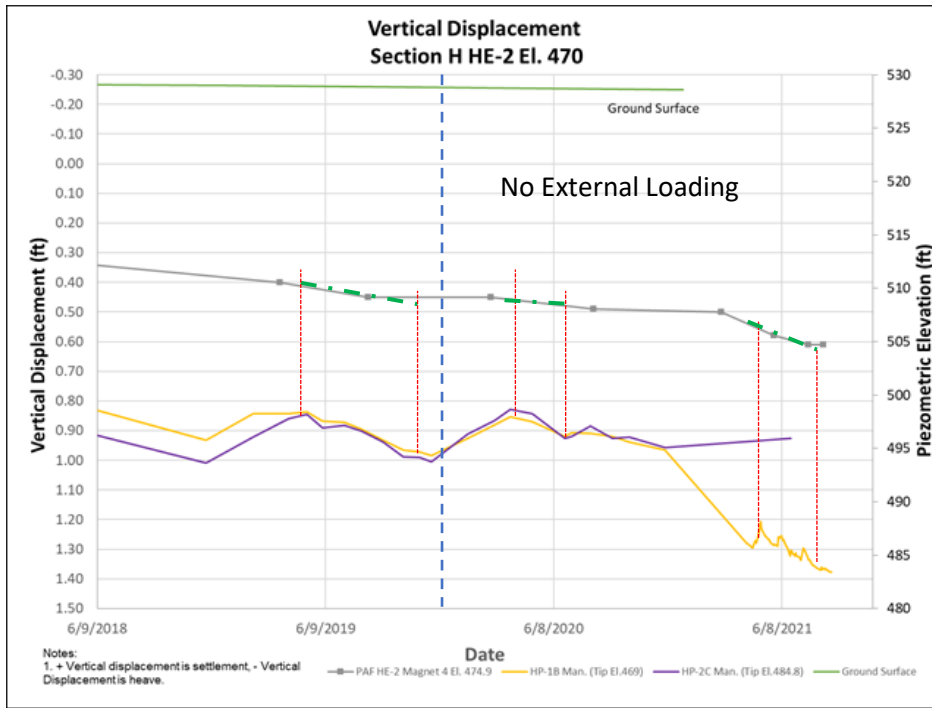
Figure 45. Vertical displacement at elevation 470.

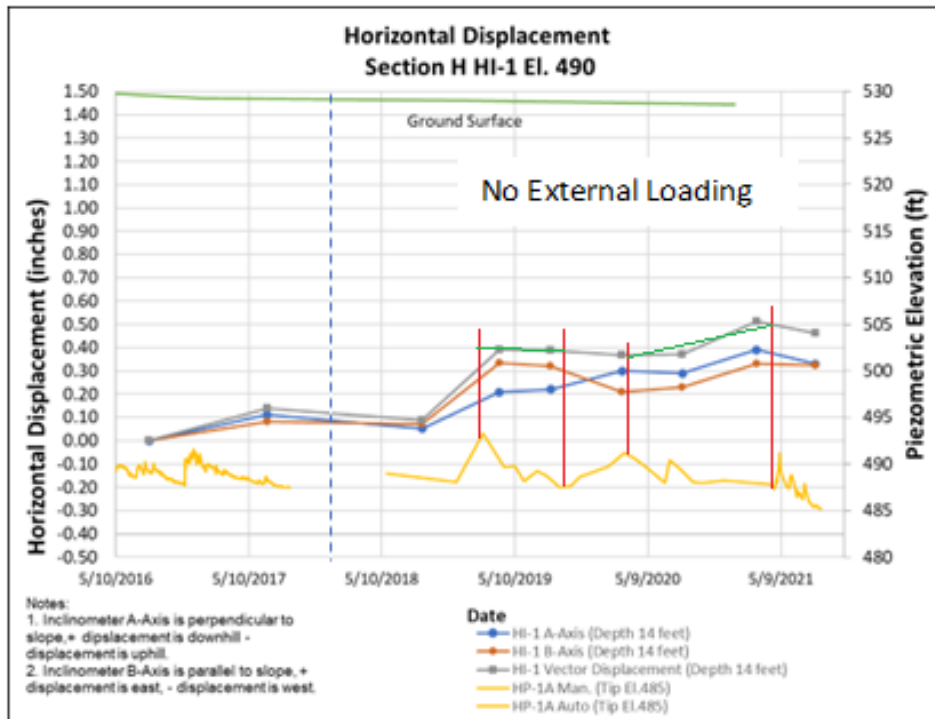
Figure 46. Horizontal displacement at elevation 490

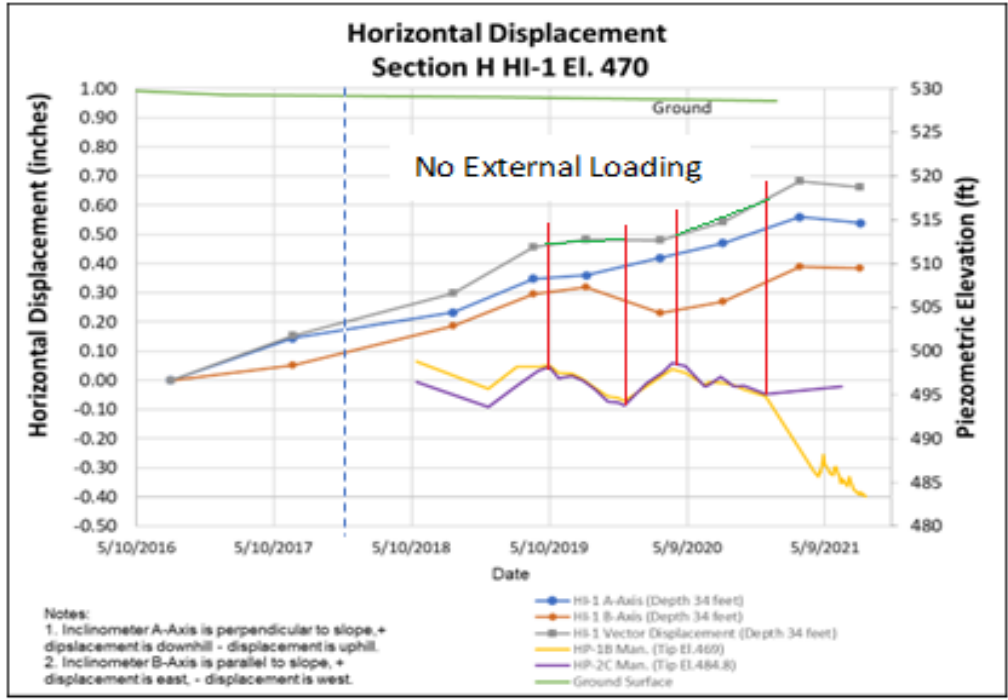
Figure 47. Horizontal displacement at elevation 470

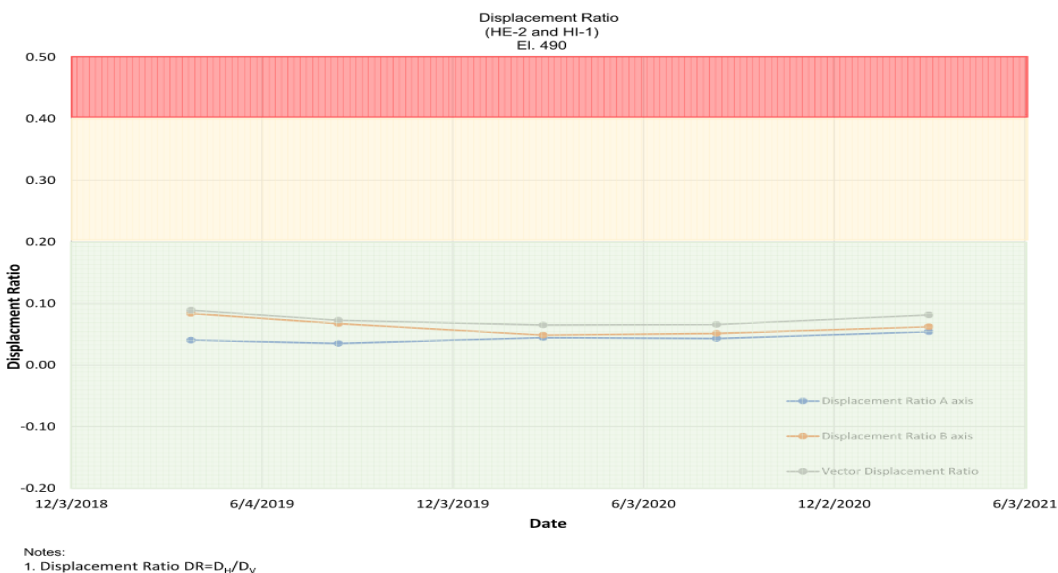
Figure 48. Displacement Ratio at Elevation 490.

At El. 490 the displacement ratio remained at low levels, ranging from 0.06 and 0.09. At El. 470 the displacement ratio ranged between 0.16 and 0.2, and generally remains stable. The maximum displacement is equal to 0.2, which indicates consolidation behavior of the stack. However, an increasing trend in displacement ratio was observed when plotting the last set of readings of these instruments.

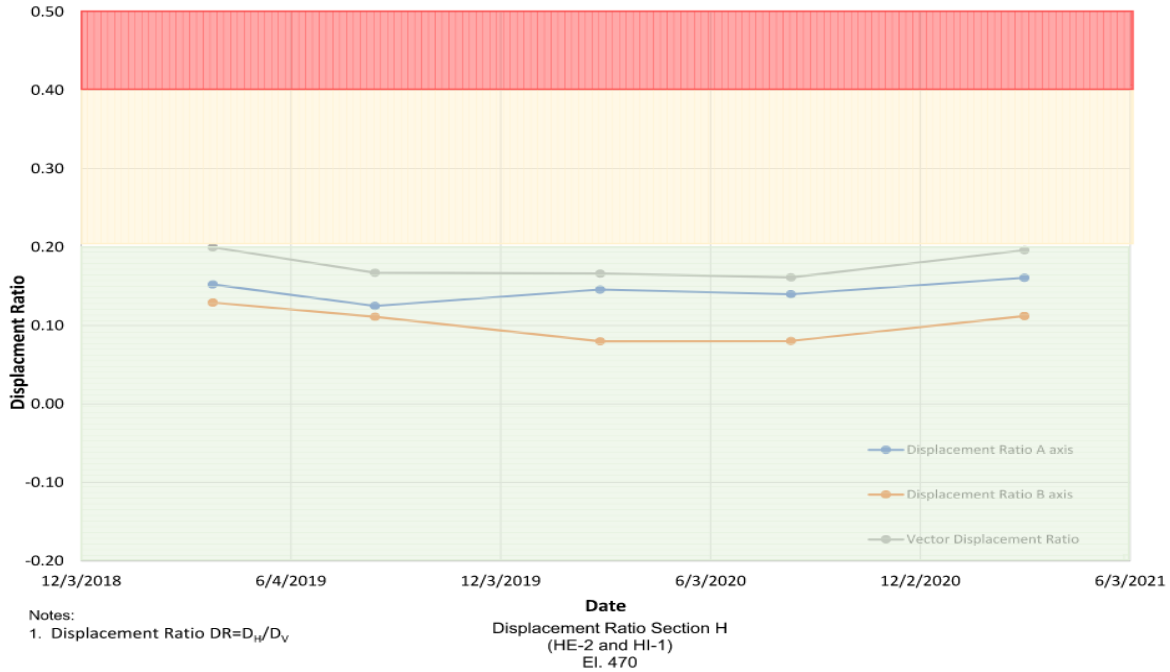
Figure 49. Displacement Ratio at Elevation 470

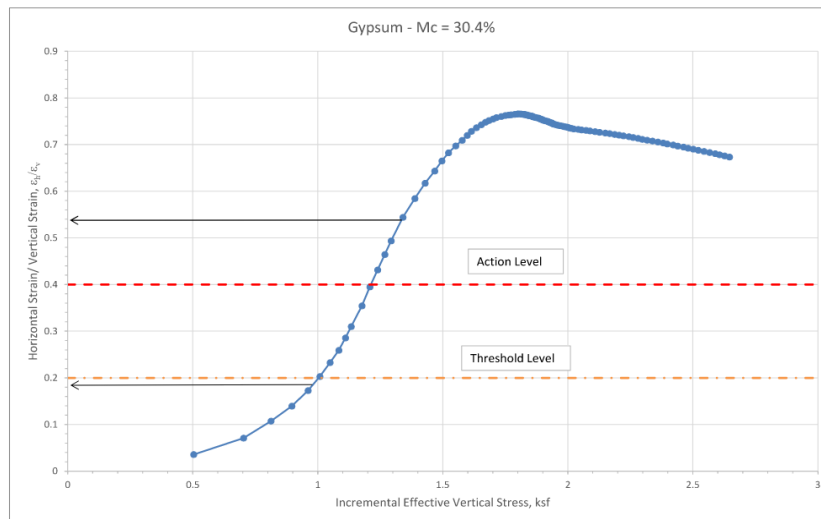
Figure 50. Deformation Ratio vs effective vertical stress during Triaxial CU' test.

Closing of facilities general results in preventing or limiting infiltration of water and therefore a lowering of the phreatic level overtime. As the phreatic level drops over time, the effective stress on layers of interest will increase. To determine if these increases are resulting on detrimental behavior to the facility or to its appurtenances, one may compare the field deformation behavior of the weak CCR deposits with the behavior of the material observed in laboratory tests. A plot of the values of the deformation ratio versus incremental effective vertical stress from a triaxial test, shown in Figure 50, can be used to guide the understanding of the movements as the facility's long-term behavior is monitored.
