JOINT TRANSPORTATION RESEARCH PROGRAM

INDIANA DEPARTMENT OF TRANSPORTATION
AND PURDUE UNIVERSITY

Large Culvert Inspection Procedures: Guidelines for INDOT

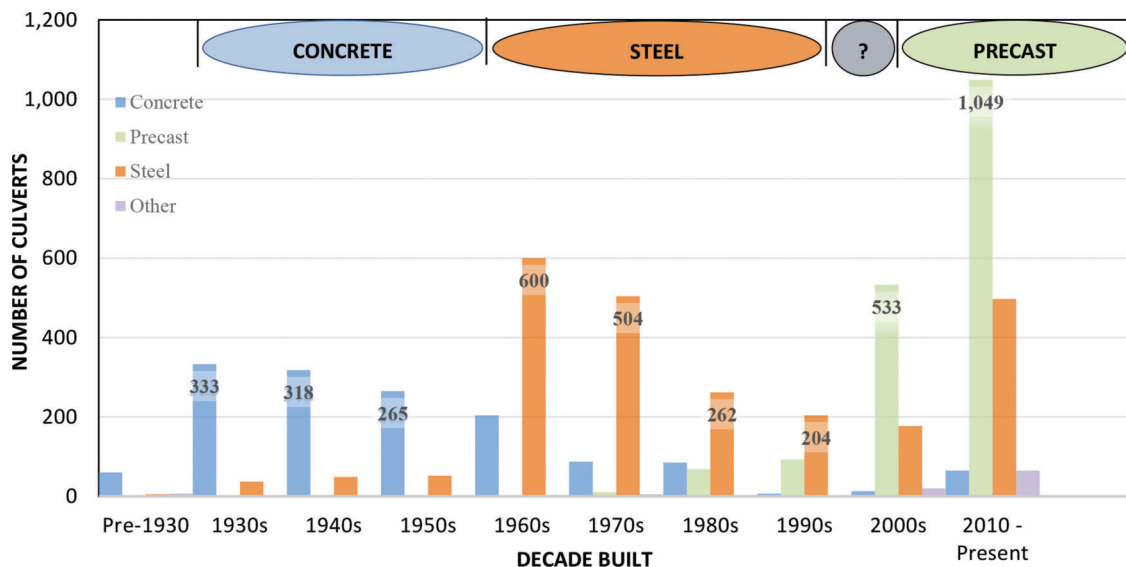
Figure 5.1 Dominant large culvert material by decade.

Using the estimated age data described in Section 4.3, the culvert inventory is presented in Figure 5.1 based on the decade in which each culvert was built, with the data further broken down based on material type. Distinct periods during which a certain material was dominant for the construction of large culverts are evident in the figure. Of the large culverts for which the estimated year-built is available, concrete was the dominant material for culverts built from the 1930s through the 1950s. From the 1960s through the 1980s, steel was the dominant material, mainly in the form of metal pipes. From 2000 to the present day, the use of precast concrete has become the most popular material. The information for culverts built in the 1990s suggests that steel was the dominant material, but due to the low volume of data available for this decade, historical year-built data for culverts constructed during this time may be missing from the large culvert inventory. Overall, the trends presented in Figure 5.1 provide one potential reason why metal pipes comprised 66.4% of the population of culverts for which repair work was performed during the period from January 2016 to April 2021 (see Section 5.1.1). Overall, the historical data in Figure 5.1 are expected to be useful to asset engineers in understanding the relative age of the culvert inventory based on material type.

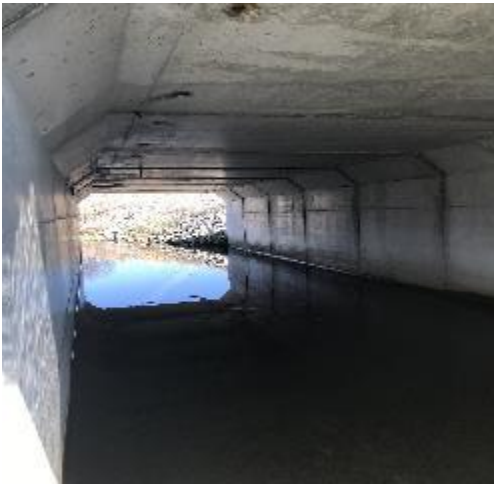
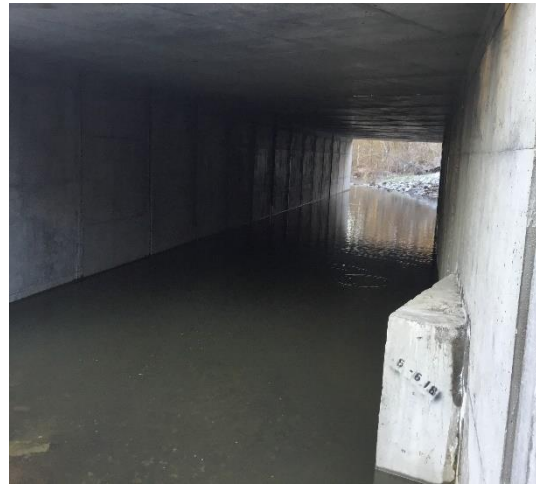
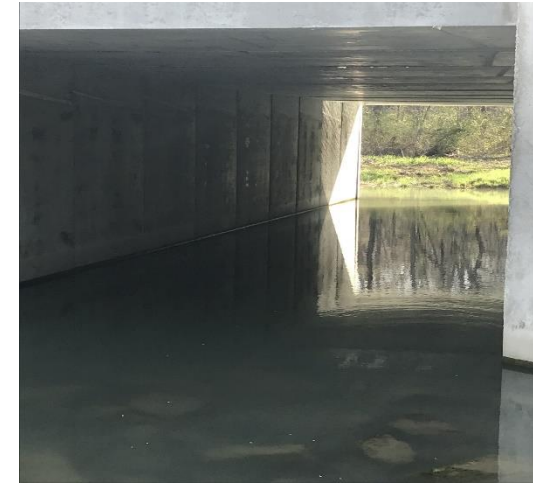
CONCRETE - 9

9 EXCELLENT NEW CONDITION ISOLATED DAMAGE FROM INSTALLATION MAY BE PRESENT.

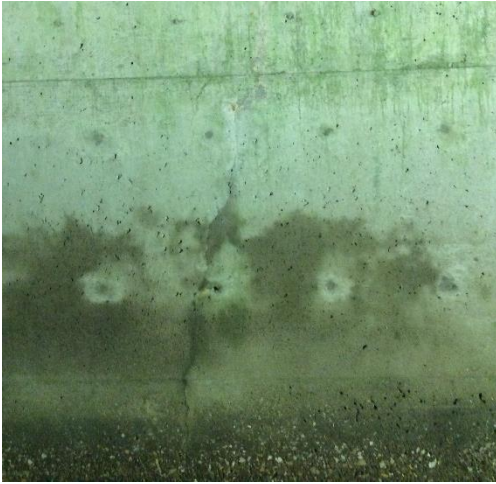
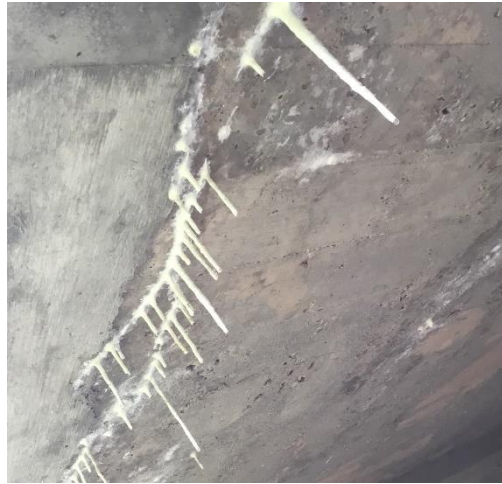
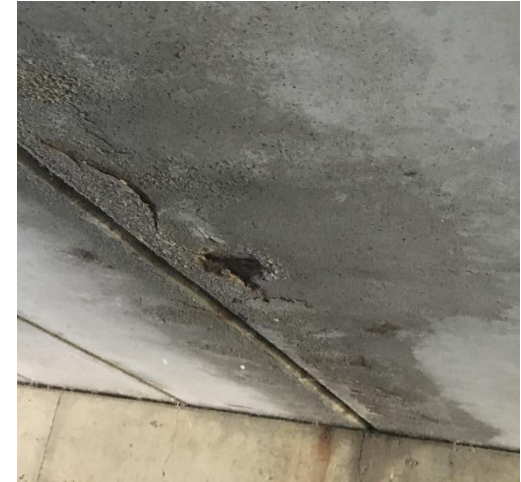
CONCRETE - 6

6 SATISFACTORY CRACK WIDTHS LESS THAN 0.0625 IN. EFFLORESCENCE AND/OR MINOR LEAKAGE WITHOUT RUST STAINING PRESENT. SPACING OF CRACKS TRANSVERSE TO TRAFFIC 3 FT OR GREATER. SCALING/ABRASION LESS THAN 0.25-IN. DEEP COVERING LESS THAN 20% OF SURFACE AREA. TOTAL DELAMINATED AND SPALLED AREAS LESS THAN 5% OF SURFACE AREA. INDIVIDUAL SPALLS ARE LESS THAN 6 IN. IN DIAMETER AND LESS THAN 1-IN. DEEP.

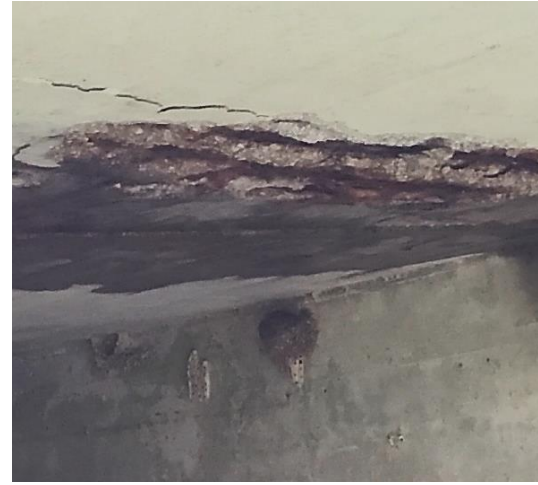
CONCRETE - 4

4 POOR EXTENSIVE CRACKING WITH CRACK WIDTHS GREATER THAN 0.125 IN. SPACING OF CRACKS TRANSVERSE TO TRAFFIC BETWEEN 1 FT AND 3 FT. SCALING/ABRASION GREATER THAN 0.5-IN. DEEP COVERING LESS THAN 50% OF SURFACE AREA. TOTAL DELAMINATED AND SPALLED AREAS LESS THAN 25% OF SURFACE AREA. SPALLING HAS EXPOSED CORRODED REINFORCING STEEL.

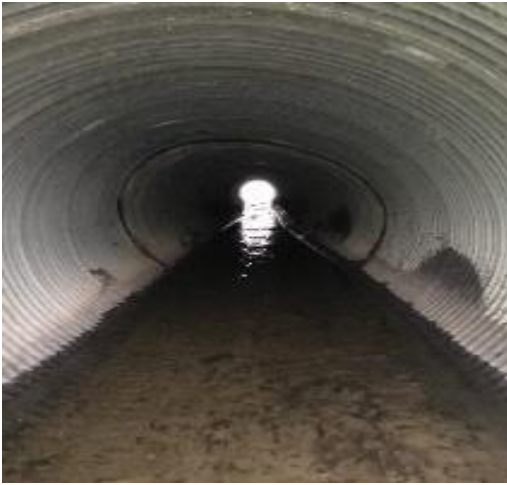
Photo 1

6 SATISFACTORY PROTECTION GONE ALONG INVERT. LAYERS OF RUST THROUGHOUT. MODERATE SECTION LOSS LESS THAN 6 IN.²/FT² OR 4% OF INVERT AREA. CULVERT RETAINS SMOOTH CURVATURE BUT NON-SYMMETRICAL SHAPE. MEASURED VERTICAL DEFORMATIONS RESULTING IN LESS THAN 5% LOSS OF ORIGINAL DIAMETER.

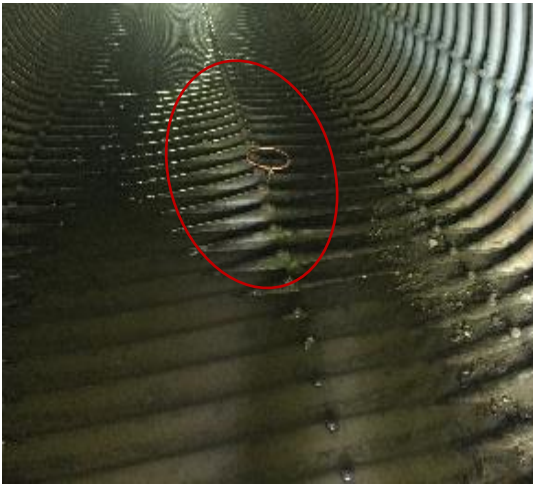
Photo 1

5 FAIR HEAVY RUST AND SCALING THROUGHOUT. HEAVY SECTION LOSS: LESS THAN 15 IN.²/FT² OR 10% OF INVERT AREA. TOP HALF OF CULVERT RETAINS SMOOTH CURVATURE. MINOR BULGES OR FLATTENING PRESENT IN BOTTOM OF PIPE. MEASURED VERTICAL DEFORMATIONS RESULTING IN LESS THAN 10% LOSS OF ORIGINAL DIAMETER.

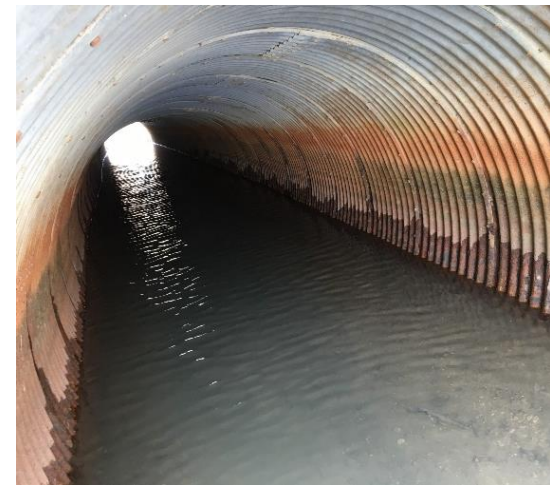
Photo 3

Photo 3: Heavy rust is observed throughout pipe structure.

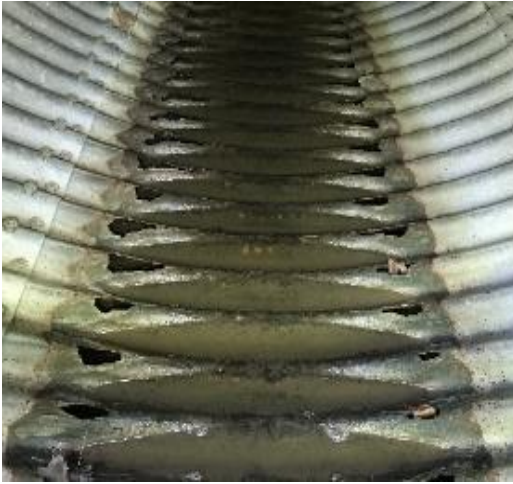
Photo 1

4 POOR EXTENSIVE RUST AND SCALING THROUGHOUT. MINOR PERFORATIONS/HOLES THROUGHOUT INVERT. MINOR PERFORATION/HOLE AREA LESS THAN 30 IN.²/FT² OR 20% OF INVERT AREA.. CULVERT HAS SHARP POINTS OR TURNS PRESENT ALONG CURVATURE DUE TO FLATTENING. MEASURED VERTICAL DEFORMATIONS RESULTING IN LESS THAN 15% LOSS OF ORIGINAL DIAMETER. IMPACT DAMAGE RESULTING IN LOCALIZED DENTS WITH WALL PENETRATION BUT NO SIGNS OF SOIL INFILTRATION.

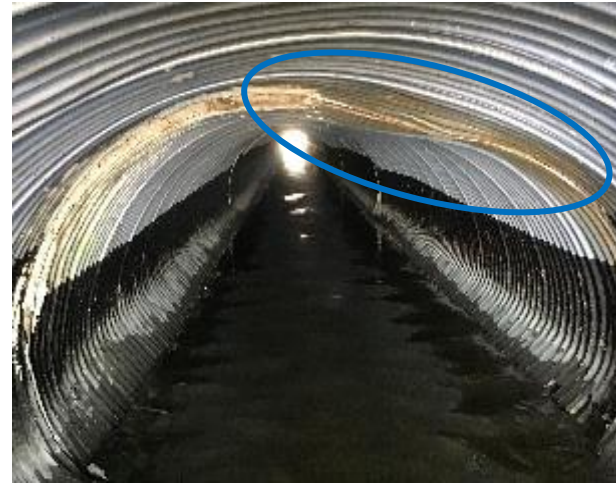
Photo 2

3 SERIOUS EXTENSIVE RUST AND SCALING THROUGHOUT. MODERATE PERFORATIONS/HOLES LESS THAN 36 IN.²/FT² OR 25% OF INVERT AREA. CULVERT HAS EXTREME DISTORTION IN ONE SECTION OF PIPE. LOCAL AREAS OF REVERSED CURVATURE MAY BE PRESENT. MEASURED VERTICAL DEFORMATIONS RESULTING IN GREATER THAN 15% LOSS OF ORIGINAL DIAMETER.

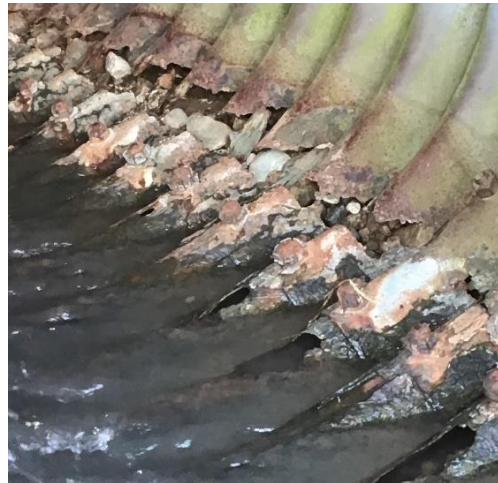
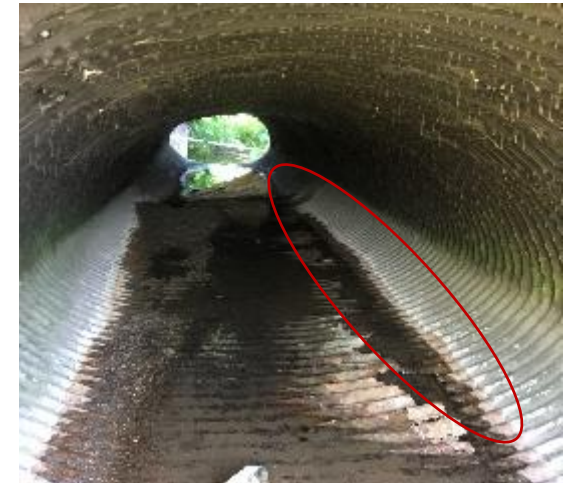
2 CRITICAL MAJOR PERFORATIONS/HOLES GREATER THAN 36 IN.²/FT² OR GREATER THAN 25% OF INVERT AREA. CULVERT HAS EXTREME DISTORTION IN MULTIPLE SECTIONS OF PIPE. IMPACT DAMAGE RESULTING IN LOCALIZED DENTS WITH WALL PENETRATION ALLOWING SOIL ENVELOPE TO INFILTRATE PIPE.
