Environmentally assisted cracking of a single crystal nickel-based superalloy

K. Dawson^a, F. Duarte-Martinez^b, S. Gray^b, J. Nicholls^b, G. Gibson^c, J. Leggett^c and G. J. Tatlock^a

^aDepartment of Mechanical, Materials and Aerospace Engineering, University of Liverpool, Liverpool, UK; ^bDepartment of Surface Engineering and Precision Institute, Cranfield University, Cranfield, UK; ^cRolls Royce Plc, Derby, UK

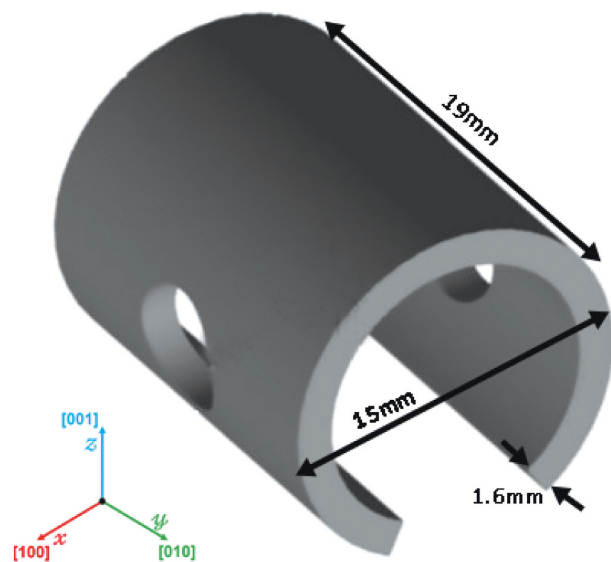
Figure 1. Schematic representation of a c-ring test piece with orientation reference (image adapted from Brooking et al. [7]).

C-ring test pieces were machined from single crystal cast bars of an alloy with a composition matching Cannon Muskegon's CMSX-4® Ni-based superalloy (Table 1). Test pieces were produced with a <001> crystallographic orientation aligned approximately parallel to the cylinder long axis (Figure 1). A load was applied by means of adjusting a bolt which passed through a pair of holes, drilled through the centre of the c-ring, perpendicular to its long axis. A full description, detailing the stress calculations of similar c-ring test pieces, is presented by Brooking, et al. [7]. Test pieces were subject to a maximum constant stress of approximately 700MPa and pre-coated with a NaCl/water solution before being exposed to a flowing 50ppm SO₂ in air environment at a temperature of 550°C.

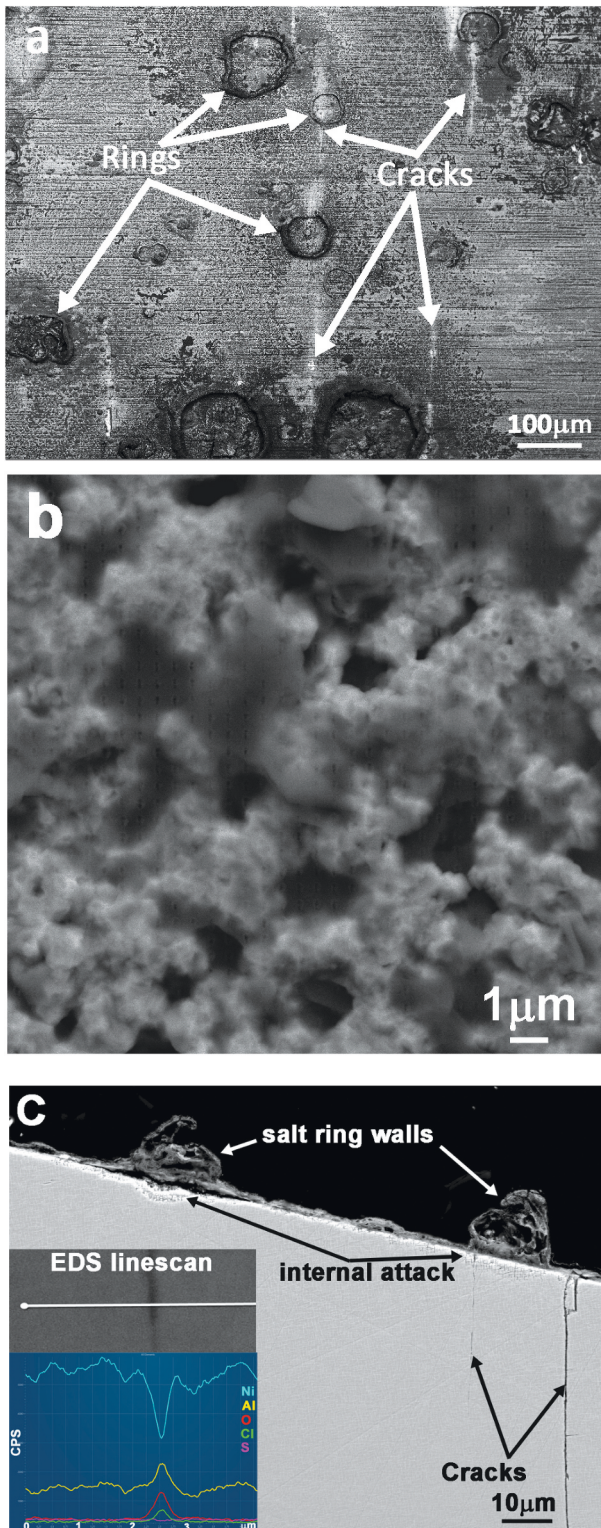
Figure 2. (a) SEM image showing parallel cracks (bright lines) emanating from salt-ring features on the surface of a CMSX-4 c-ring test piece, (b) low-z beam sensitive amorphous material in porous nickel oxide and (c) cracks in substrate beneath a cross sectioned salt ring, with EDS line-scan inset showing enhanced O, Cl and Al concentrations in a crack (2 hours testing at 550°C).

Scanning electron micrographs of c-ring specimens exposed cracks running parallel to the c-ring long axis (Figure 2(a)). After only 10 minutes, occasional cracks were observed, some approaching 200 μm in length. Following tests of 2 hours, cracks were more numerous and their lengths much greater (>0.5 mm) than were observed in the 10-minute exposure sample. EDS chemical analysis of c-ring surfaces revealed a nickel rich oxide layer interspersed with circular corrosion product features (previously salt rings) and relatively dark (low-z) areas of porous oxide surrounding the salt rings. EDS and high-resolution SEM images demonstrated that the lower-z regions surrounding the circular features were dual phase, made up of porous nickel oxide, the pores containing a beam sensitive material (Figure 2(b)) enriched in Na, S and O, probably Na₂SO₄. When analysed from the surface, the oxide scale formed over sub-scale cracks, was most often enriched in aluminium, although on occasion, titanium and tantalum-rich scales were formed above cracks.

Cracks were observed on the surface of both the 10 minute and 2-hour exposure test pieces located near the c-ring apex. When viewed in cross section (Figure 2(c)), straight cracks could be seen following, approximately, the [001] direction. Crack initiation occurred in locations where salt spray droplets had previously dried and in the surrounding regions of

two-phase voluminous surface corrosion products. The inset EDS line-scan presented in Figure 2(b), demonstrates the enhanced oxygen, chlorine and aluminium concentrations measured in a crack formed in

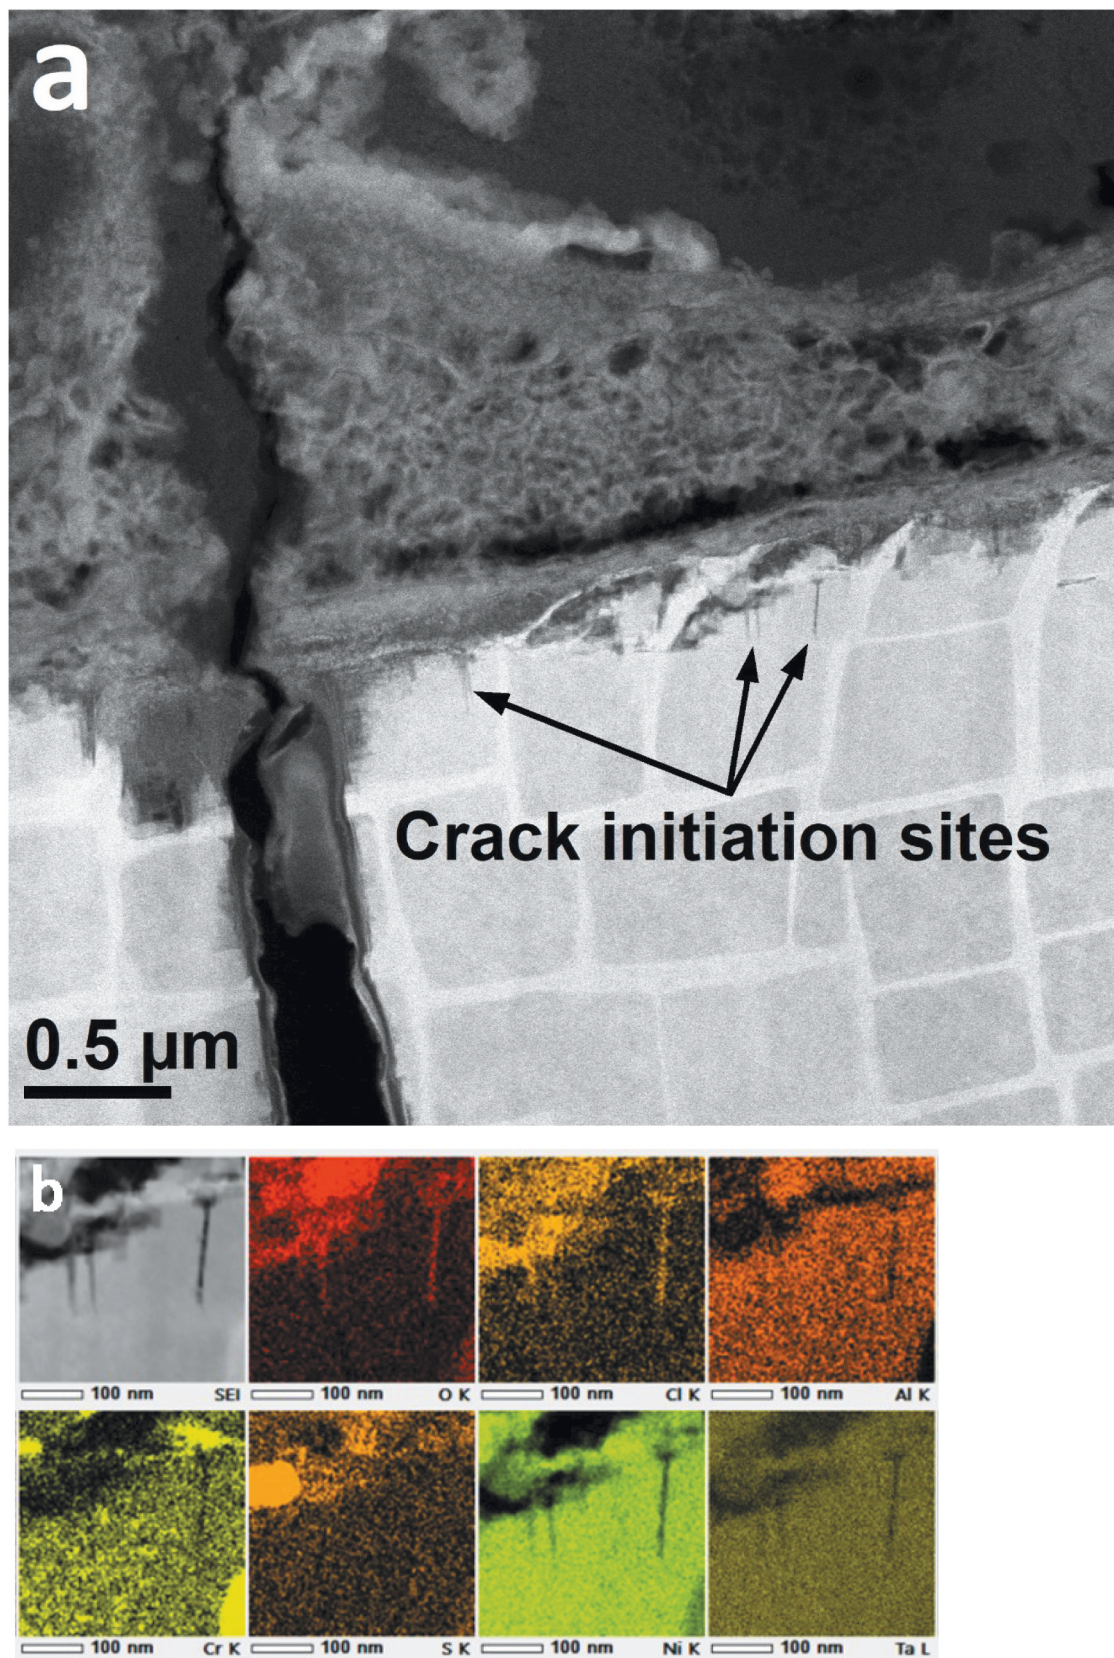
Figure 3. (a) HAADF-STEM image showing a primary crack, several crack embryos and a voluminous surface corrosion product, and (b) EDS maps of a γ' precipitate, including surface corrosion and crack embryos.

Thin lamellae specimens were FIB sectioned from the mid-point of cracks observed on the surface of the 10-minute exposure c-ring sample. All primary cracks were propagated on the (100) plane, passing through γ' precipitates. Several short (<200 nm) cracks were measured, adjacent to the most significant primary cracks (Figure 3(a)). These smaller cracks, <10 nm in width, also propagated on the (100) plane and each was nucleated and terminated within a single γ' precipitate. EDS measurements revealed oxygen and chlorine in these diminutive cracks but although sulphur was detected at the crack opening, it could not be confirmed within the cracks themselves (Figure 3(b)).

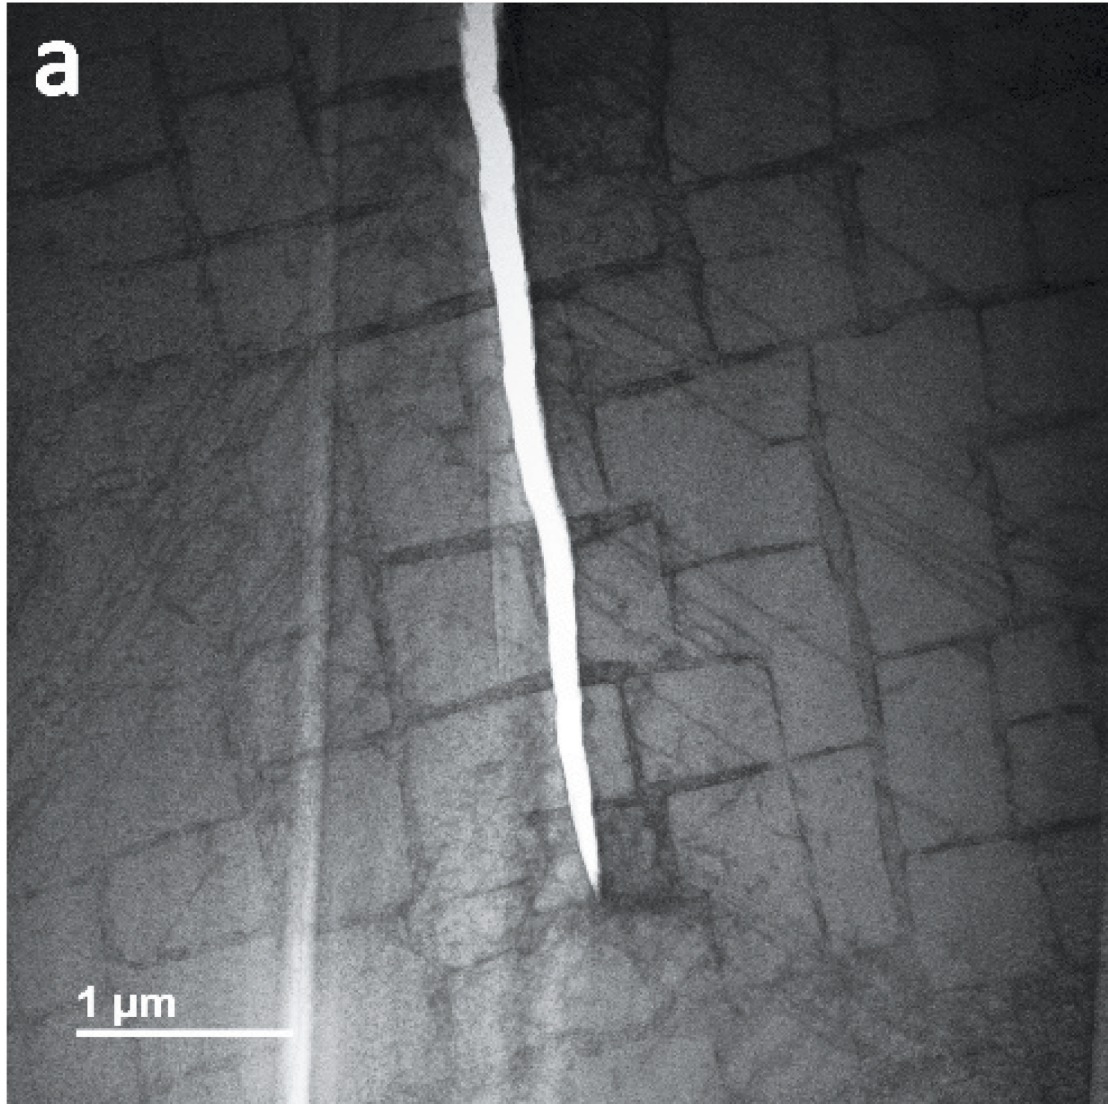
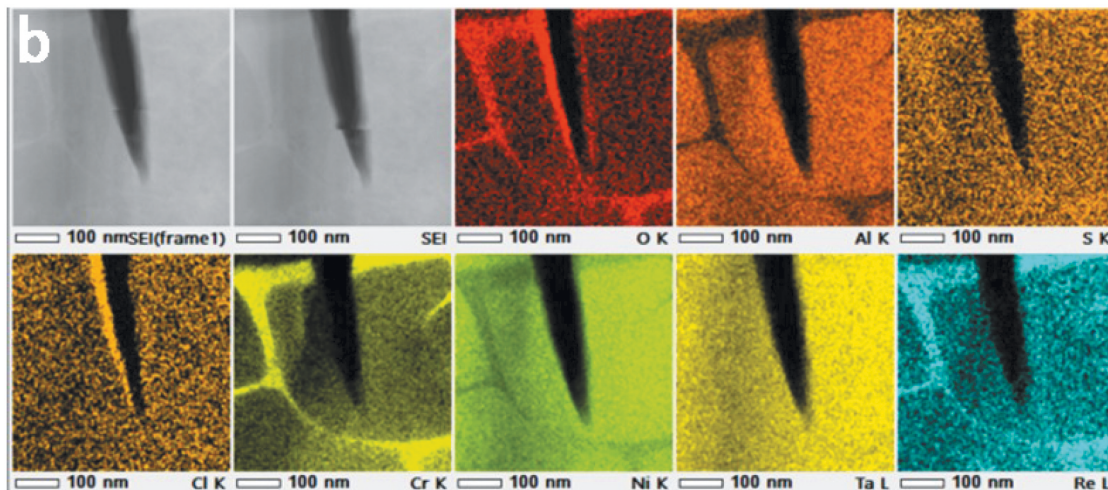
Figure 4. (a) BF-STEM image showing a primary crack tip in a 10-minute exposure CMSX-4 c-ring and (b) the accompanying EDS maps revealing element distributions at the crack tip.

at greater depths into the crack (Figure 4). In addition to the NiO layer, a thin film of amorphous material, containing O-Cl-S, was observed between the outer NiO and crack surface. Within these amorphous channels, strands of sulphur rich, high-z, crystalline material were detected, often only a few nm thick.

Analysis of primary crack tips (Figure 4(a)) revealed numerous $\langle 011 \rangle$ traces of $\{111\}$ type stacking faults in the γ' precipitates adjacent to the crack. Dislocation densities were greatest in the γ matrix and a high density of dislocations was seen at the crack tip, although it is possible that the tip was in

EDS analysis at the absolute crack tip (Figure 4(b)) revealed a thin film of oxygen and chlorine-enriched material; sulphur was not detected at the crack tip. On this occasion, it is possible that less O and Cl was

apparent on the right hand edge of the crack, due to detector shadowing. However, clearly, Cl and O were detected at the tip of a 20 μm deep crack, at a point approximately midway along the crack length, beneath salt deposit features, after 10 minutes testing. At this stage, there was no evidence of crystalline NiO growth at the crack front but a film of amorphous Cl-O rich material was evident.

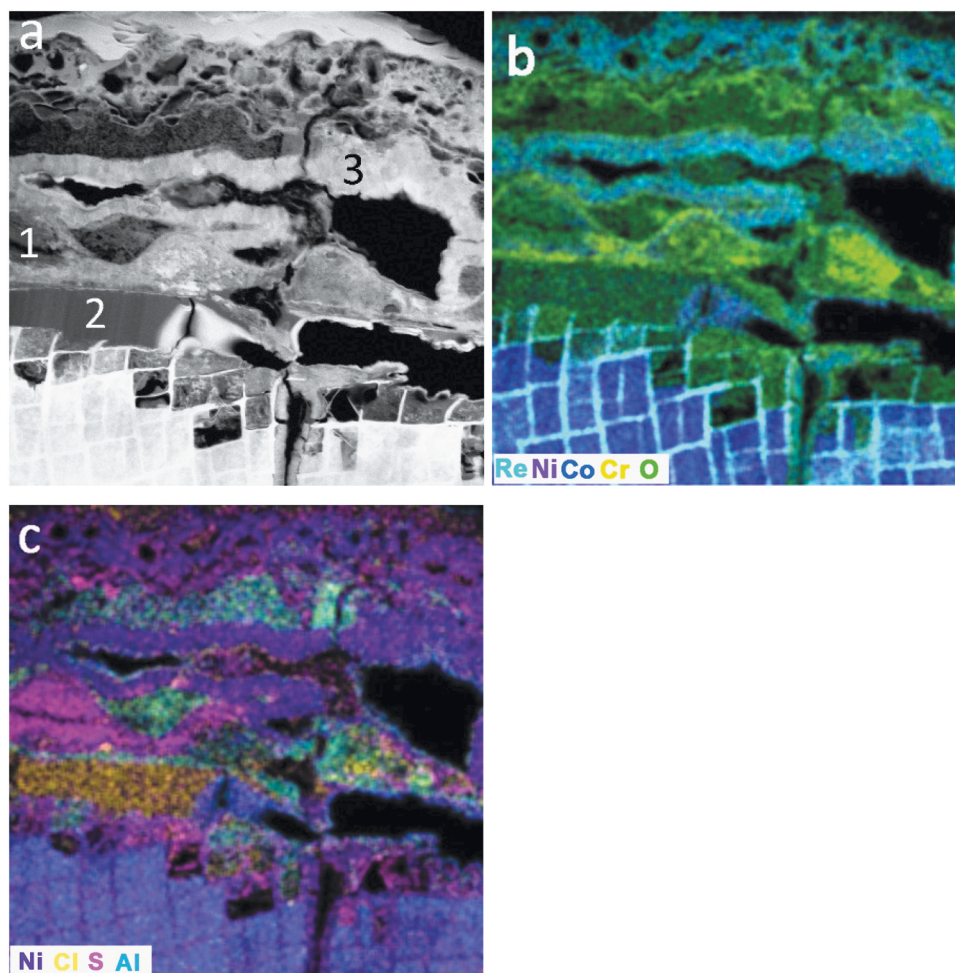
Figure 6. (a) HAADF STEM image (Table 2 EDS locations indicated), EDS composite maps (b) & (c) showing the complex nature of the corrosion products in a prior salt ring wall and the preferential attack of γ' . (2-hour exposure).

The complex chemistry and morphology of salt-ring wall corrosion is presented in Figure 6(a-c). There were similarities between broad-front and salt-ring regions of attack, layers of porous convoluted, and dense polycrystalline NiO (Table 2, region 3) were observed. Oxygen was detected throughout the surface scale and within the corroded areas of the alloy (Figure 6(b)). In contrast to the areas displaying broad front alloy attack, beneath the salt ring wall, γ' was preferentially attacked; chlorine, oxygen and sulphur were all detected in this region. Both sulphur and chlorine were present in discrete regions of the salt ring wall (Figure 6(c)), in beam-sensitive phases that appeared to be amorphous and each was detected

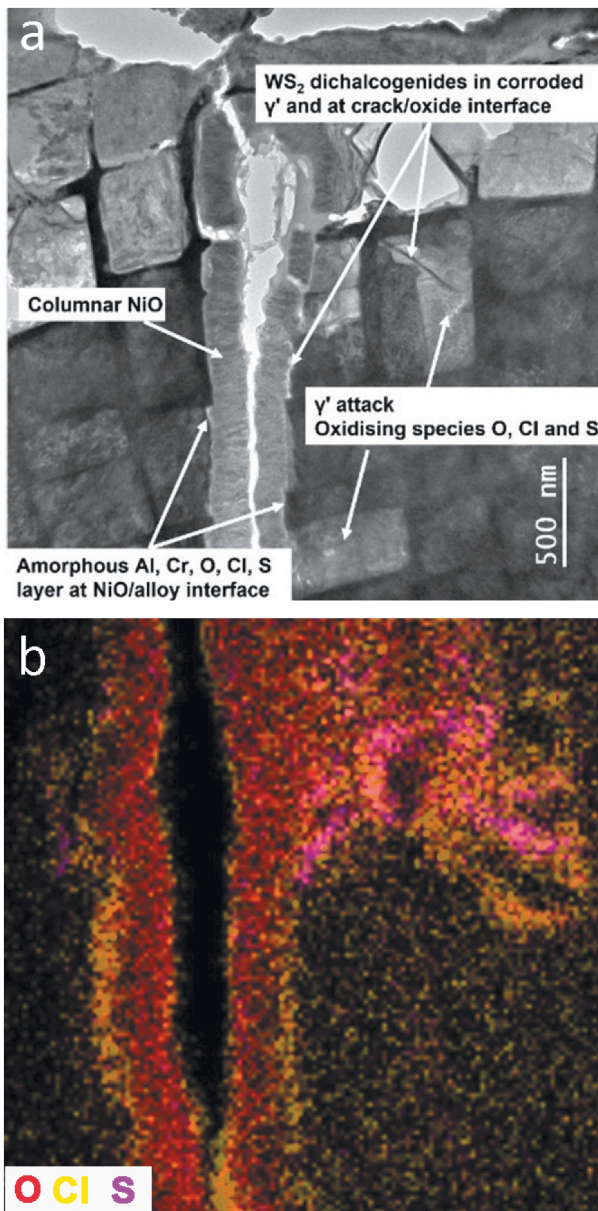
Figure 7. (a) BF-STEM image revealing a crack and the associated features and (b) the distribution of oxidising species and their relative locations.

Regions of aluminium oxide, enriched in chlorine and tantalum, and areas of chromium oxide, also enriched in chlorine were observed at the crack opening. A columnar, polycrystalline nickel oxide core, down the centre of the crack, was formed by the growth of NiO layers on the opposing crack surfaces (Figure 7(a)). However, a low-z amorphous layer was observed at the interface between the nickel oxide layer and the alloy-crack surface. Due to its diminutive size and stray EDS signal from surrounding material, it was not possible to determine the precise composition of the narrow low-z interface layer but oxygen and chlorine were routinely detected; sulphur was also detected in this interface layer and in adjacent regions of γ' corrosion (Figure 7(b)).

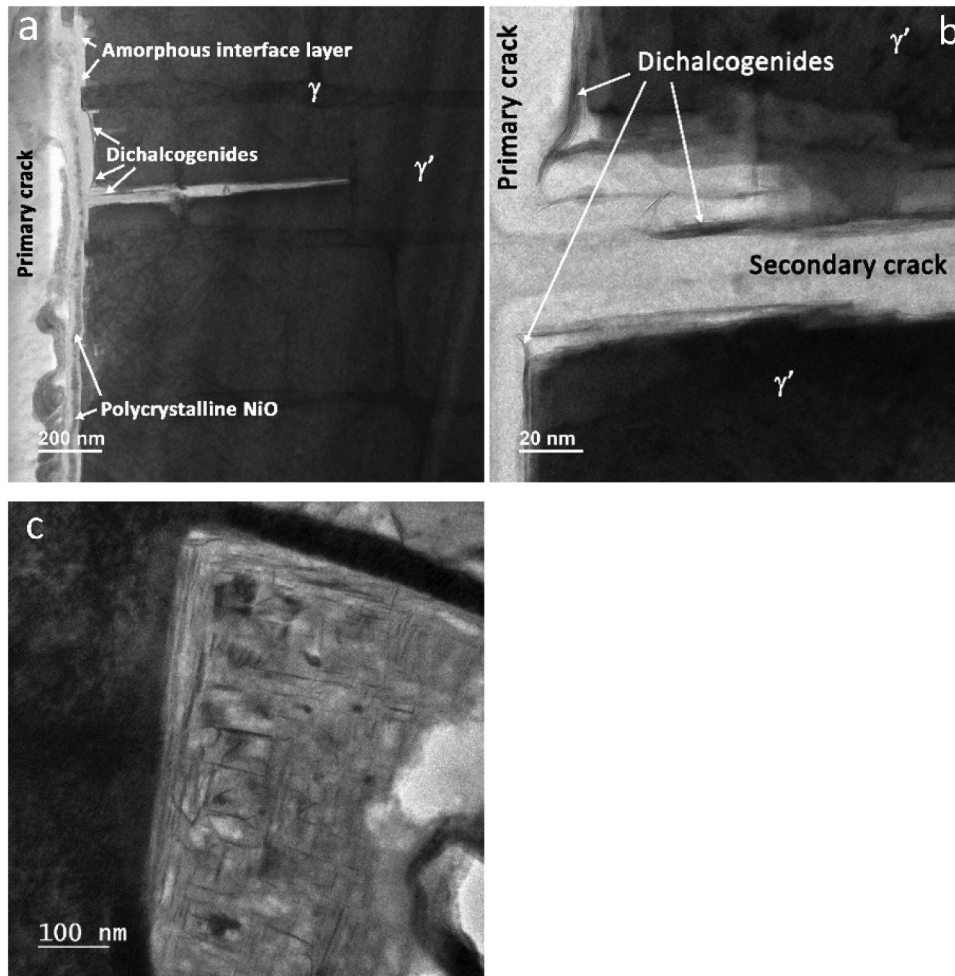
Figure 8. (a) BF-STEM image features common to primary and secondary cracks, (b) expanded BF-STEM view of a, and (c), BF-TEM image showing orthogonal arrays of MS_2 films in a corroded γ' precipitate (a & b 10 minute test and c, 2 hour exposure).

High-resolution imaging revealed fine strands of layered material directly adjacent to surfaces of corroding γ' material, situated within the amorphous interface layer between the columnar NiO and cracked alloy surfaces (Figure 8). The majority of these features were only a few nm in width but often greater than 100 nm in length (Figure 8(b)). Strands of high-z material were observed lining the surfaces of primary cracks, small secondary cracks and within corroded γ' precipitates (Figure 8(c)). EDS analysis indicated the layered structures were rich in sulphur and tungsten. Atomic resolution HAADF-STEM and BF-S/TEM lattice resolution images suggest that the crystal structure was consistent with a dichalcogenide phase (Figure 9). Large numbers of dichalcogenide features were also observed at the γ/γ' interface, where previous work has demonstrated an enrichment of tungsten [8]. Orthogonal arrays of dichalcogenide films, aligned with the alloy $\langle 001 \rangle$ directions, were also prevalent in corroded γ' material.

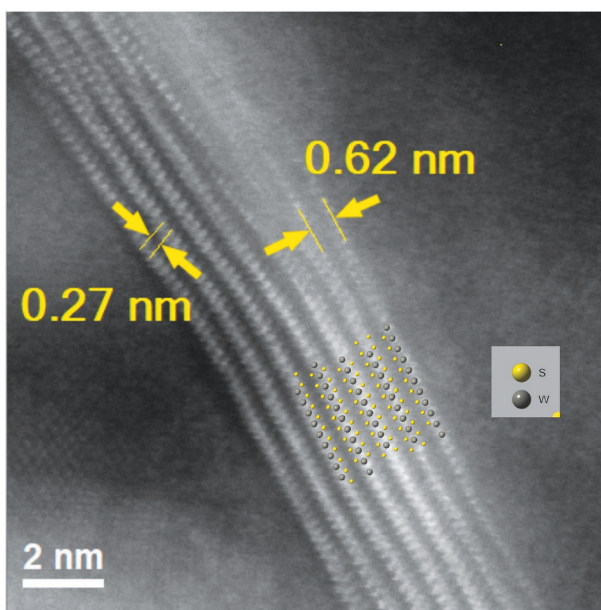
Figure 9. HAADF STEM image revealing the atomic structure of a dichalcogenide strand, with UVW [110] R3m:H model structure overlaid (COD 9012102).
