Fireside performance of different coatings in biomass power plant

ABSTRACT

The energy sector will need to employ novel strategies to reduce greenhouse gas emissions, such as the increase of steam temperatures/pressures or the use of low carbon fuels (i.e. biomass). Both cause heat exchanger materials' degradation issues, due to the formation of more/different corrosive deposits, which requires the use of expensive nickel-based materials or coatings. This paper focuses on the behaviour of three different coatings (HVOF NiCrFeSi, laser clad FeCrAl and Laser Clad NiCrFeSi) deposited on TP347HFG, at 700°C (up to 1000 h exposure). Tests were performed using the 'deposit recoat' method (KCl deposit) in simulated biomass combustion environments. Cross-sections were analysed using dimensional metrology, to determine distributions of metal loss and internal damage. Intergranular damage and pits were identified using SEM/EDX. A 'diffusion cell' behaviour was observed, which led to depletion of alloying elements from the coating and consequent increase in damage. The results suggested a severe degradation of all coatings.

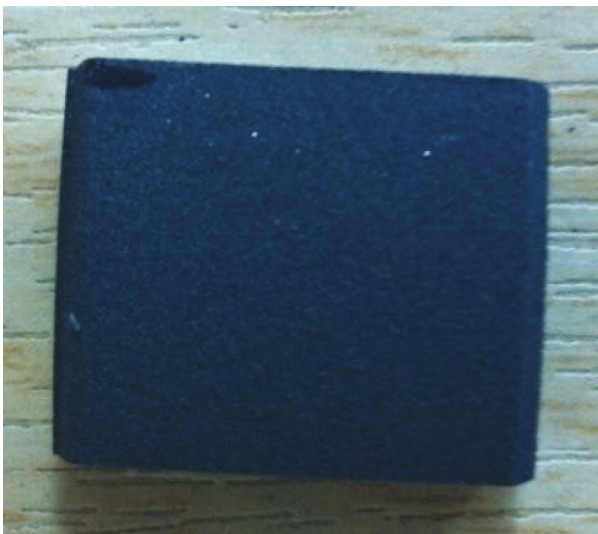
Figure 1. Examples of tube segments used for corrosion exposures, the samples are about 15 mm x 15 mm, with 4 mm thickness.

which were subsequently cut into specimens (Figure 1). The typical dimensions of specimens were ~15 mm long and wide with a ~4 mm wall thickness.

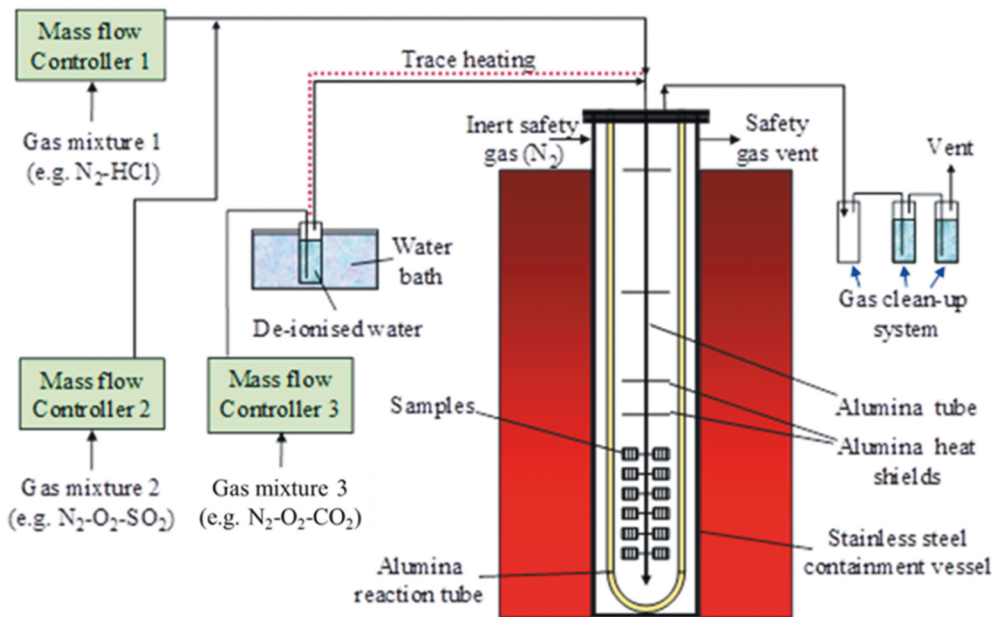
Figure 2. Rig layout for fireside corrosion tests [20].

Fireside corrosion tests were carried out in alumina-lined, controlled-atmosphere, vertical tube furnaces (Figure 2) for 1000 h exposure, in cycles of 200 h, using the deposit recoat technique [19,20]. Samples were accommodated in alumina crucibles. Samples were cleaned with acetone and then IPA in an ultrasonic bath for 10 minutes each prior to exposure. Dimensional metrology was carried out on the clean samples using a digital micrometre (resolution of 1 μm) before exposure. The deposit was applied with a brush paint to give coverage of ~20 mg/cm² of dried deposit (deposit composition 100% KCl). This was done to simulate the deposit formation following biomass firing, however the exact exposure conditions were chosen to accelerate the fireside corrosion processes. The acceleration of the fireside corrosion processes has been done using higher fluxes. The application of the deposit was repeated every cycle. Sample weight was measured before and after every

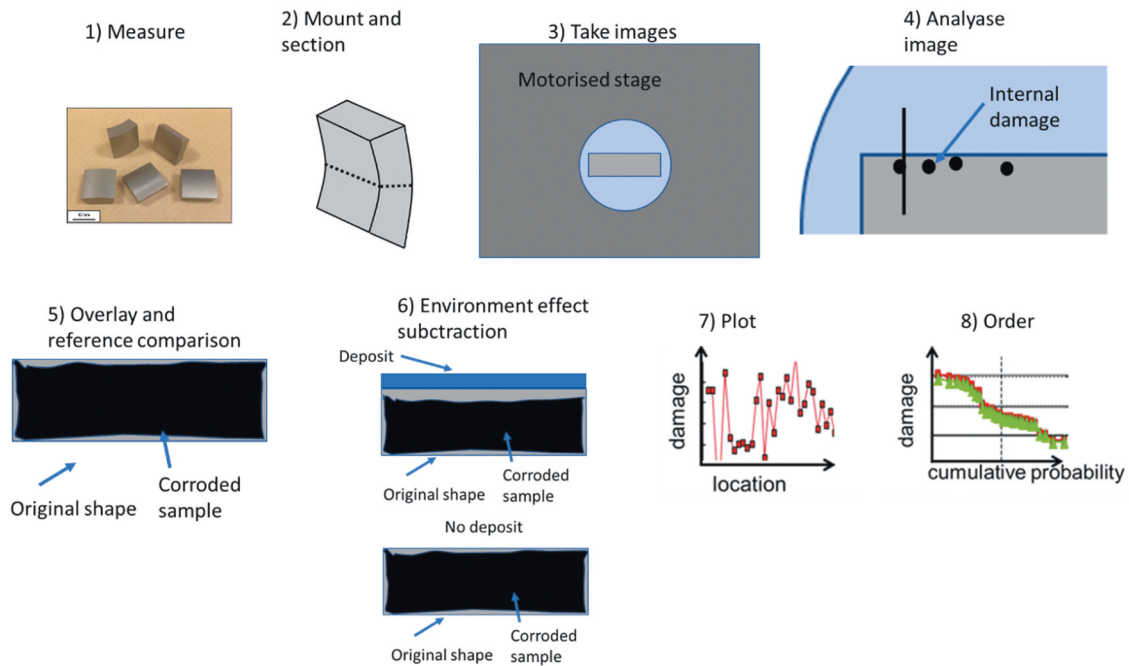
Figure 3. Schematic representation of the dimensional metrology process. The process consists of several steps 1) measurement of samples prior to exposure, 2) mount the samples in resin, 3) image of samples' perimeter, 4) select points at metal's surface and for internal damage, 5) comparison with pre-exposure measurements and reference samples, 6) subtraction of the environment effect by comparison to a sample without deposit, 7) plot of the resulting change in metal against location and 8) re-order of the data based on cumulative probability.

Dimensional metrology was used to generate the statistical distributions of coating corrosion damage data for each exposed sample [29–31]. A microscope was used to collect images around the cross-sections. The images were then measured with an image analyser to collect x-y coordinates of the remaining coating. The data were compared to the pre-exposure metrology data collected to determine the coating performance. The cumulative probability curves were obtained by ordering the data before plotting. A schematic diagram of the process is given in Figure 3.

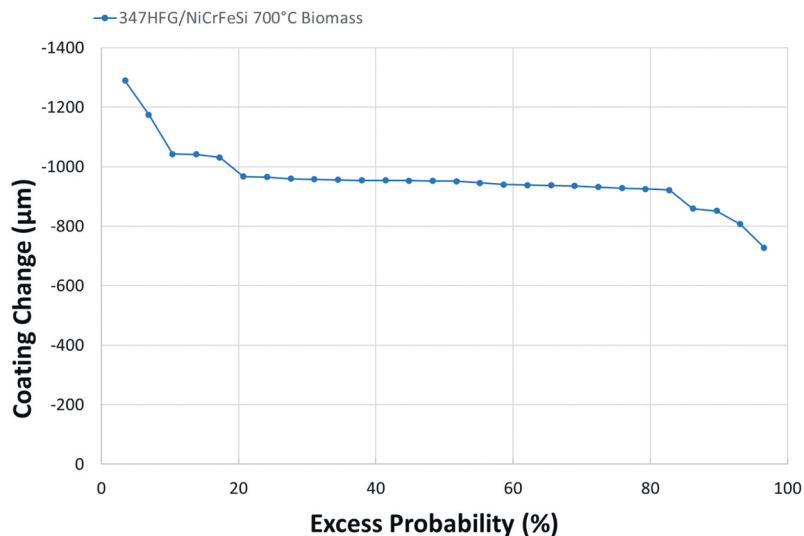
Figure 4. Cumulative distribution of coating change for NiCrFeSi deposited through laser clad after 1000 h exposure.

The results of this work are presented in this section. The first part will present results for the dimensional changes of the samples. Typical dimensional changes are presented in Figure 4, which shows different types of behaviour. On the right hand side of the graph (above 80% probability), there is a ‘steep’ section of slope indicating areas with the lowest coating loss; areas that have undergone slower corrosion than the average. In these regions, there are small portions of the coating that have damage of as low as about $-700\ \mu\text{m}$.

The majority of the chart (from about 80% to about 20%) shows a second section that is almost parallel to the X-axis of the graph, with a coating change of approximately $-950\ \mu\text{m}$. This type of behaviour is typical of ‘uniform’ damage around the sample; approximately 60% of the surface has this extent of coating loss.

The last (left hand) section of the graph, from about 20% down, shows another steep variation towards higher damage. This type of behaviour is typical of localised damage. Analysing these data points more

In summary, there is a probability of about 97% that the coating will lose $-700\ \mu\text{m}$ or more under these conditions over 1000 hours exposure. The median change observed for this coating (NiCrFeSi deposited via laser clad) corresponds to $-950\ \mu\text{m}$, which is more than half of the original coating thickness. The graph also shows that almost 60% of the sample shows this amount of change. Looking at the highest damage, observed for a small part of the sample’s surface (about 2–3%), virtually no coating is left on the surface (a loss of about $-1300\ \mu\text{m}$).

The cumulative probability plot shown in Figure 4 shows only the data for one of the coatings (NiCrFeSi deposited with laser clad). This is because, using optical microscopy, it was not possible to distinguish between substrate and coating for the samples NiCrFeSi HVOF and FeCrAl. The samples were prepared from tube sections, with only one, the top side, coated. This makes it difficult to extract dimensional data from the samples. The complete loss of coating is highlighted by the images in Figure 5. From left to right, the figure

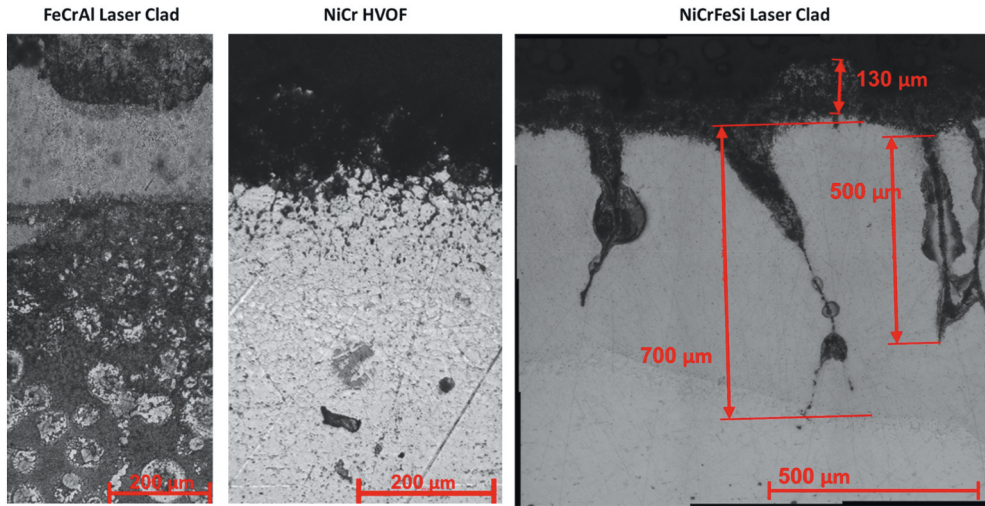
Figure 5. Optical micrographs of the three different coatings after 1000h exposures.

shows three different alloys/coating combinations, FeCrAl laser clad, NiCrFeSi HVOF and NiCrFeSi laser clad, respectively. As can be seen from the optical micrographs, three different microstructures were observed. In the first two images from the left (FeCrAl Laser Clad and NiCrFeSi HVOF, respectively) it is not possible to clearly differentiate the coating microstructure, or an interface between coating and base alloy. In the image on the right hand side (NiCrFeSi laser clad), on the contrary, an interface can be seen, highlighting the presence of the coating on the base alloy. From this figure, it can also be seen that the NiCrFeSi laser clad

shows signs of pitting type of corrosion; this is in line with observations from dimensional metrology (Figure 4). Furthermore, a porous area can be seen on the top surface of the coating, this should correspond to a scale/deposit layer.

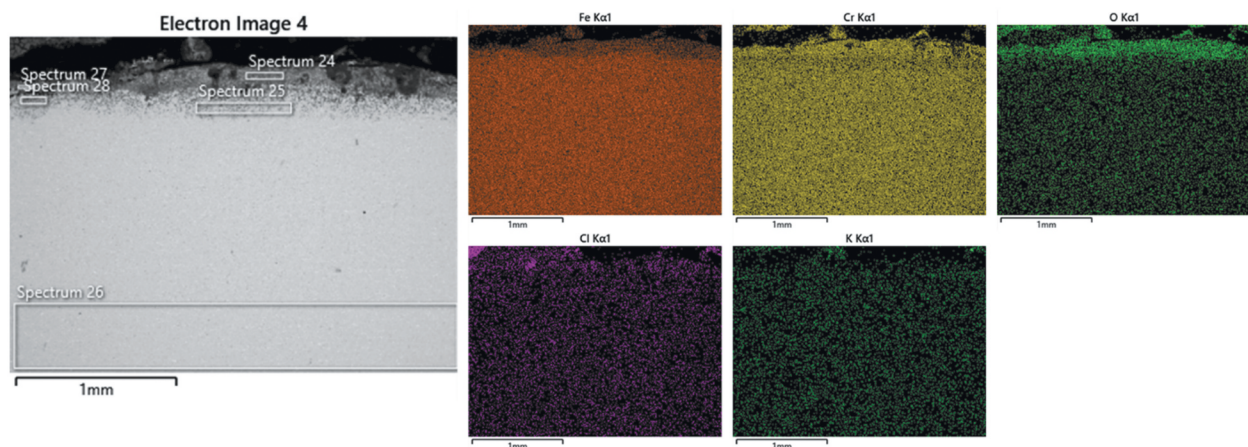
**Figure 7.** SEM micrograph with EDS maps of NiCrFeSi HVOF coating after 1000h exposure.

The metal surface has also been analysed (Figure 7). As it can be seen from the EDS maps, there is the presence of Cl-rich particles at the interface, suggesting the migration of some of the Cl from the deposit to the metal surface. This is not coupled with the diffusion of K, confirming the dissociation of the KCl deposit observed in the scale/deposit layer (Figure 6 and Table 4). At the same time, it can note an

The features observed in the elemental maps are confirmed by the spectra collected (Table 5). It seems that the presence of K is negligible at the metal surface. It also highlights some depletion of Cr below the surface (Spectrum 25, Table 5), in respect to the amount in the bulk alloy (Spectrum 26 Table 5). This region corresponds to an internal corrosion attack.

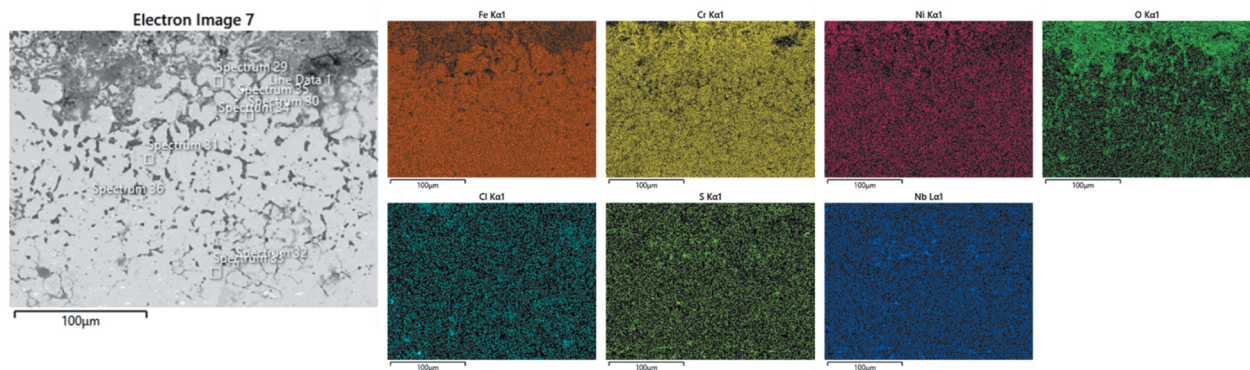
**Figure 8.** SEM micrograph with EDS maps of NiCrFeSi HVOF coating after 1000h exposure at higher magnification.

Looking closer at the internal corrosion area (Figure 8) it can be seen how this is characterised by a grain boundary type of attack. From the EDS maps in Figure 8 it can be seen how this internal corrosion area is characterised by a depletion of Fe at the grain boundaries, where an oxide is formed. Some traces of Cl and S appear to be present below the metal surface. The grain boundaries attack is responsible for a ‘diffusion cell’ type of behaviour, which has been reported already in the literature for coatings [41].

Table 6 reports the elemental composition of the spectra collected at several locations of Figure 8. Spectra 34 and 35 reports the composition of the corrosion products around the grain boundaries. It can be seen by the spectra that those areas are depleted in Fe, while maintaining the same amount of Cr and higher O and Cl content. This could suggest the formation of Cr-rich oxide, which could stop the diffusion of alloying elements from the bulk of the alloy to the surface. This could translate into the lack of Cr available to form

a protective oxide. Spectra 29, 30 report the composition of different grains close to the metal surface, which are either fully enclosed in the corrosion product or not fully enclosed in the corrosion product, respectively. From these values, it can be seen how the Cr content of the fully enclosed grain is lower than that of the rest of the alloy (16 wt% and 18 wt% respectively). This is in agreement with the idea that corrosion products stop Cr diffusion from the alloy, leaving the grain below the metal surface depleted in Cr.

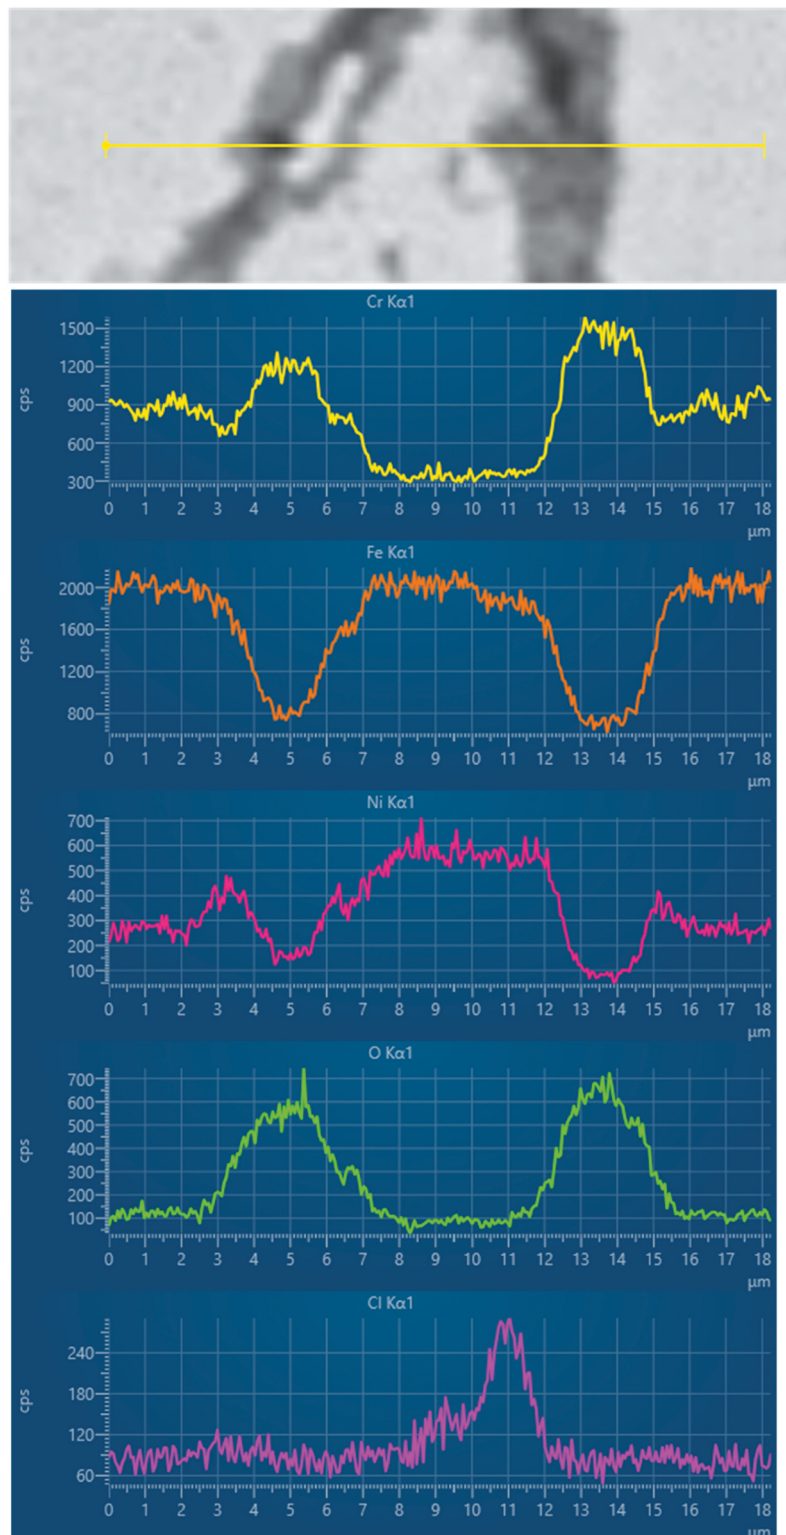
**Figure 9.** EDS line scans from location in Figure 8.

Figure 9 shows the line scans collected from Figure 8. It can be seen how the line intersects two different corrosion products along the grain boundaries, and how in these areas there is an increase in Cr content, together with O. The concentration of the two elements then falls inside the grain. Opposite behaviour has been observed for Fe.

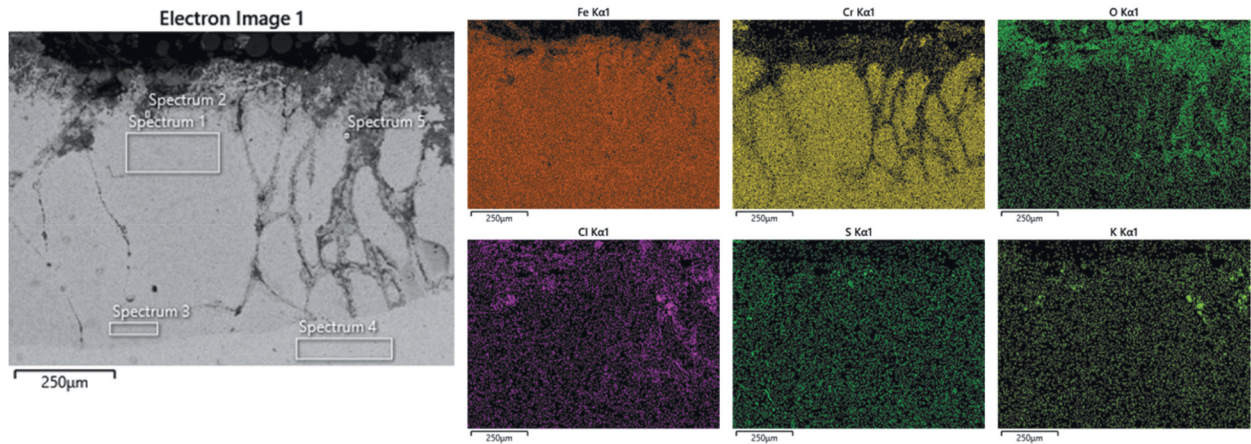
**Figure 10.** SEM micrographs with EDS maps of NiCrFeSi deposited through laser clad after 1000 h exposure.

Figure 10 shows the SEM micrograph and EDS maps for the other Ni-based coating, the NiCrFeSi deposited through laser clad. The micrograph confirms what has been seen from the metal change distribution and the optical images (Figures 4 and 5) with coating still present on the surface of the alloy. The maps show depletion of Cr from the corroded areas and no evidence of a protective Cr-rich oxide on the surface of the material. On the contrary, it seems that the formation of Fe-rich oxide has been formed on the coating surface and in the internal corrosion areas. The presence of Cl has been observed in these areas as well. This could suggest that Cl could react with Fe to form an Fe-Cl complex, which could then form Fe-rich oxides

Table 7 reports the elemental composition of the spectra collected from Figure 10. Spectra 1 and 3 report the composition of the coating close to the

surface and close to the metal, respectively. From the data, it can be seen that, apart from some trace of Cl and K near the surface, no major difference was recorded. Spectra 2 and 5 report the composition of corrosion products on the metal surface and internal corrosion, respectively. It can be seen how the spectra taken inside one of the pits (Spectrum 5) presents a high concentration of K and Cl (about 20 wt% for both), lower than on the coating surface (Spectrum 4).

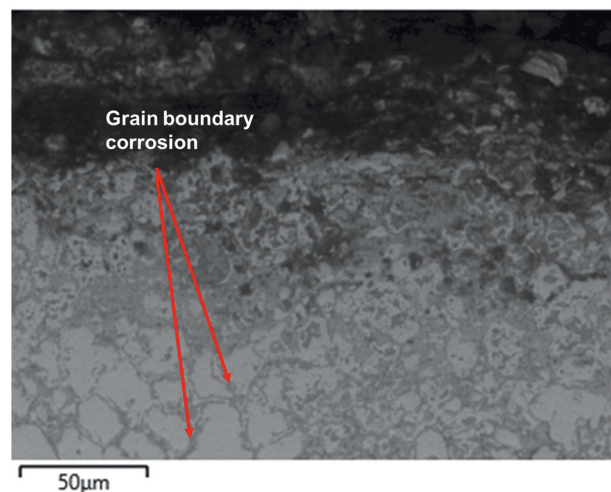
**Figure 13.** SEM micrograph of FeCrAl deposited through laser clad.

The internal corrosion area seems to show signs of intergranular attack, as shown from Figure 13. This is in line with what has been observed in Figures 8 and 11, showing internal grain boundary attacks, which could lead to a ‘diffusion cell’ type of behaviour, which could enhance the corrosion attack.
