# Crack Detection in an Aluminium Oxide Grinding Wheel by Impact Hammer Tests

Lee, Y.; Turcic, D.; Danks, D.; Wern, C. Crack Detection in an Aluminium Oxide Grinding Wheel by Impact Hammer Tests. *Computation* 2023, 11, 47. <https://doi.org/10.3390/computation11030047>

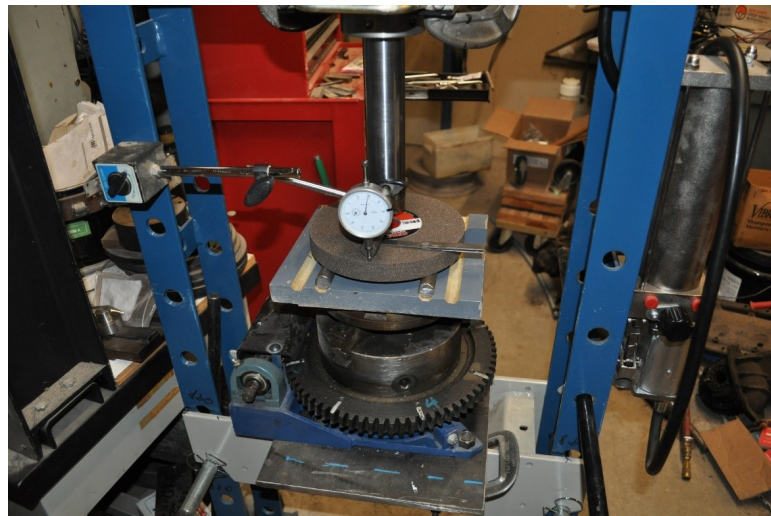
The grinding wheels were cracked, as shown in Figure 2, using a three-point bend fixture in a 20 ton hydraulic load frame.

The load and deflection were monitored with a pressure gauge on the load frame hydraulic cylinder and a dial indicator on the wheel directly adjacent to the loading point. The loading points were 203 mm long by 19 mm diameter steel bars. The outer load points were 178 mm apart and the centre loading point was midway, 89 mm, between the two outer bars. The cracked wheels were glued either with 25 mm of glue radially or glued completely, as shown in Figure 3, so that we could determine the effect of the amount of glued surface in the vibrational response of the grinding wheel during impact hammer testing. In this study, a water-curing single part glue was used to bond the grinding wheel segments since it can bond the vitrified grinding wheels. After applying the glue, mechanical steel clamps were used to hold the wheels until the glue was set.

**Figure 2.** Three-point bending fixture to crack the grinding wheels.

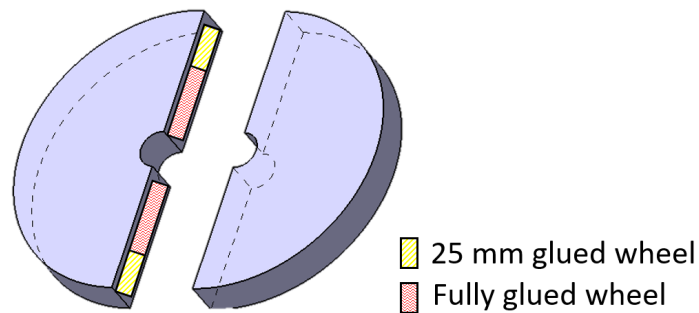
**Figure 3.** Glued segments of the grinding wheel.

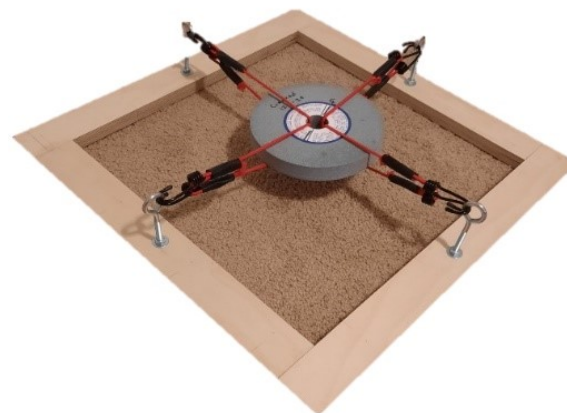
Following OSHA’s recommendation, ring testing is performed on all the tested wheels to determine if there was a difference in the audible ring tone. As shown in Figure 4, grinding wheels were suspended in the air, and then the audible ring test was performed using a screwdriver handle by gently tapping the grinding wheel to note the sound made by the handle.

**Figure 4.** Test fixture to suspend the grinding wheel.

The grinding wheels were held on a fixture, as shown in Figure 4, suspending the wheel in the air to allow impact hammer testing with an impact hammer and three accelerometers

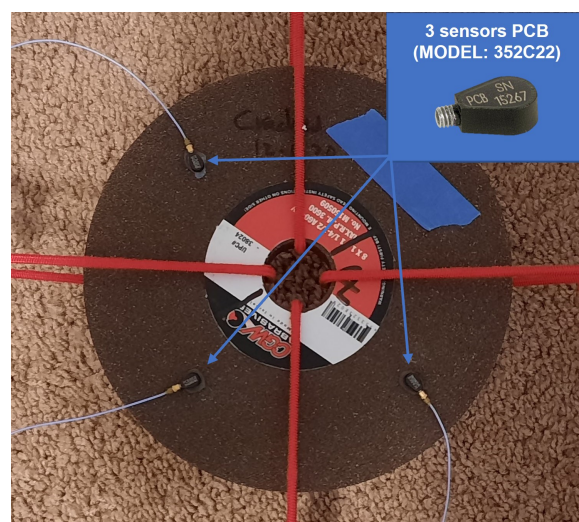
Figure 5 shows the placements of the accelerometers, and the wheel's cracked direction is indicated by the black line drawn along the 1st and 3rd quadrants. The accelerometers were located on the 2nd, 3rd, and 4th quadrants, and 15 taps were made on each quadrant using the impulse hammer. To improve the consistency and reliability of the test, a total of 60 taps were made for each grinding wheel. The measurement direction of the accelerometer is along the direction of the cable shown in Figure 5.

**Figure 5.** Measurement setup for impact hammer testing.

placed around the wheel. The uniaxial accelerometers were placed on three different quadrants of the grinding wheel while taps were made around the wheel. The impact hammer test was performed using the PCB Piezotronics impulse hammer model 086c03 (with a mass of 100 g). The accelerometers were PCB Piezotronic (model 352C22) with a sensitivity of 10 mV/g, and a frequency range between 0.5 and 10,000 Hz. The accelerometer signals were conditioned using a PCB amplifier model 482A16. The accelerometers and impulse hammer signals were sampled with a RIGOL oscilloscope (MSO5074) at 1 MHz.

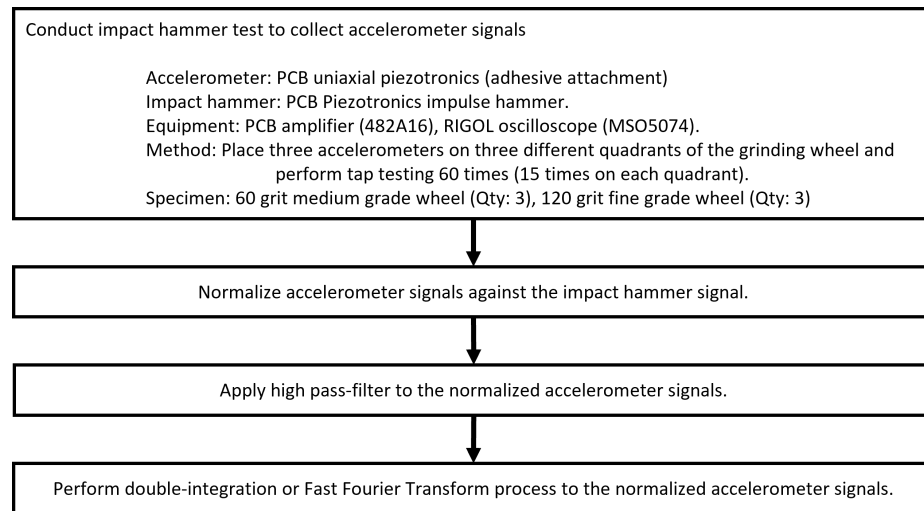
Figure 6 shows how the signals were collected and processed. The accelerometer signals were normalized against the impact hammer signal, using MATLAB R2021a software, since the impact energy of the hammer may not be the same during testing. The normalized signals were then filtered with a high-pass filter of 0.5 Hz to match the operating range of 0.5 to 10,000 Hz of the accelerometer [14]. To obtain the displacement at the accelerometer location,  $s(T)$ , double integration of the measured acceleration,  $a(t)$ , was conducted using the integration time step of  $10^{-6}$  seconds (the sampling frequency of accelerometers is 1 MHz) and it can be written as [15]:

**Figure 6.** Accelerometer signal processing procedure.

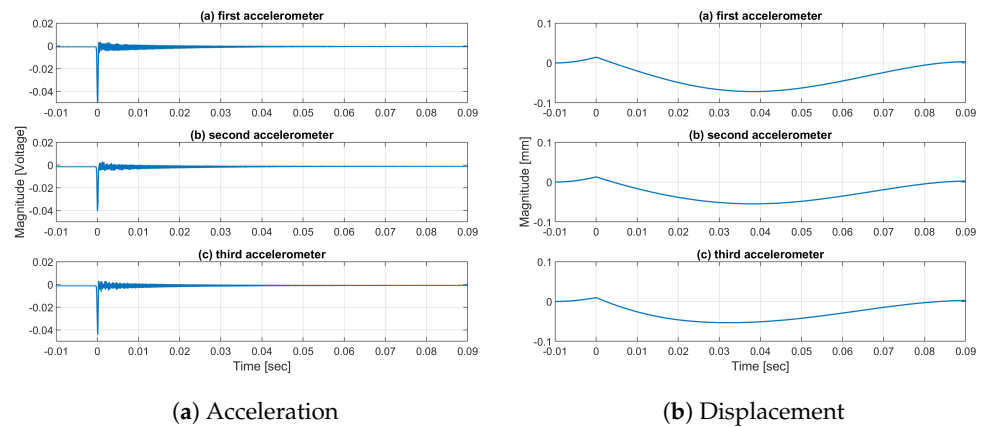
Similar acceleration and displacement for the 120-grit grinding wheels are shown in Figures 10–12. Figure 10 shows the acceleration and computed displacement for the new wheel, while Figures 11 and 12 show wheels that were fully glued and 25 mm glued.

**Figure 11.** Typical acceleration and displacement results of the fully glued 120 grit wheel.

Table 3 shows the compiled displacement for the 120-grit wheels. It was observed that the 120-grit wheels behaved like the 60-grit wheels, where the new wheel had greater stiffness and lower displacement, while the 25 mm glue wheel had the lowest stiffness and correspondingly highest displacement. The 120-grit wheels behaved like the 60-grit wheels where the new wheel had the bounce back phenomenon where the broken wheel’s displacement was in the impact direction.
