## **Crack monitoring in historical masonry with distributed strain and acoustic emission sensing techniques.**

Verstrynge, E., De Wilder, K., Drougkas, A., Voet, E., Van Balen, K., Wevers, M. (2018). Crack monitoring in historical masonry with distributed strain and acoustic emission sensing techniques. *Construction and Building Materials*, 162, 898-907. doi: 10.1016/j.conbuildmat.2018.01.103

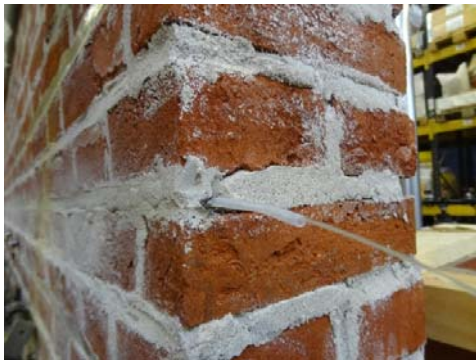
Figure 1: Ends of the optical fibre (pig tails) at the entrance point in the mortar joint

The optical fibre was equipped with five FBG sensors, which were installed with a base length of 0.8 m or 0.55 m for strain monitoring. At one end of the wall, the optical fibre was bent to enable coverage of two horizontal joints with just one fibre and to increase the robustness of the monitoring system in case of fibre rupture, as the optical fibre can be interrogated from both ends. After installation, only the ends of the optical fibre (pigtailed) remained visible as a connection point towards the laser and acquisition system, see [Figure 1](#).

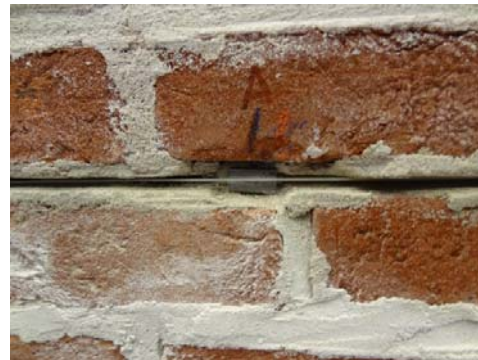
Figure 2: Anchor point and optical fibre in the mortar joint before repointing

installation procedure of the optical fibre sensor was chosen, based on the results of a preliminary test program, which indicated a very low and unreliable adhesion between fibre and mortar. It was therefore opted to fix the optical fibre to small anchors with a depth of 10 cm which were installed on predefined locations in the mortar joints, see [Figure 2](#). The installation process of the optical fibre thus included following subsequent steps: removal of the pointing mortar in two horizontal joints; installation of anchors in drilled holes having 0.8 or 0.55 m between two anchors; fixation of the optical fibre on the anchors with adhesive; repointing of the joint with similar mortar as applied for the original joint; hardening of the fresh mortar joint during 30 days before testing.

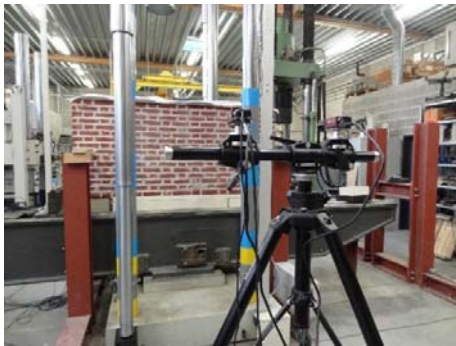
Figure 3: setup of two camera's for DIC measurements

In the reported study, the area in the middle of the masonry test wall was investigated using a stereovision DIC system, see Figure 3. The zone under investigation, also referred to as the area of interest (AOI), measures approximately 1100 mm by 900 mm (Figure 4). The DIC system consists of two CCD 8-bit cameras with lenses having a focal length equal to 12 mm mounted on a tripod. The cameras are located at a perpendicular distance of approximately 2.2 m from the test specimen. The image acquisition rate of each camera is equal to 2 Hz with an exposure time of 20 ms. All images of the two cameras are transferred to a desktop computer and synchronized with the analogue data (applied force and stroke) of the hydraulic press.

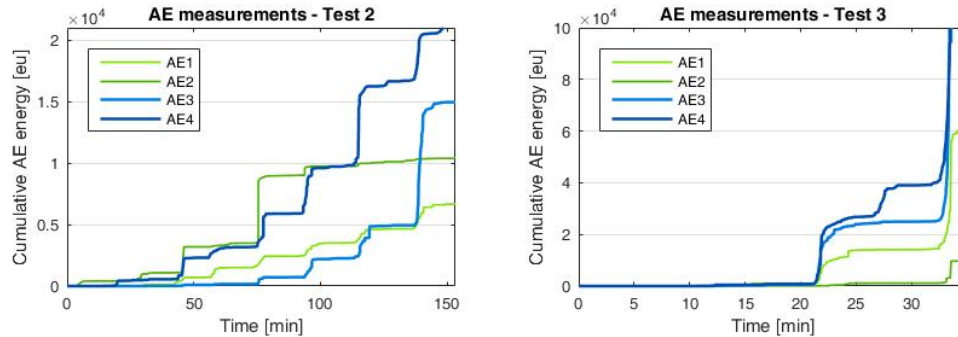
Figure 9: Cumulative AE energy measured by each of the four AE-PZT sensors, test 2 (left) and test 3 (right)

AE-PZT sensor 2 and 4, both located near the tension zone at the bottom of the wall clearly detect a higher AE energy level from the start of test 2 (Figure 9). Halfway through test 2, when the micro cracking localizes near sensor 4, the AE activity detected by sensor 2 falls back. In the last load step of test 2, it is likely that micro cracking has reached AE sensor 3 as an increase in AE energy is detected. However, this is not confirmed by the measurements of the AE-FOS. In test 3, it is clear that the asymmetric macro crack is located near AE sensor 4, as this sensor detects the highest AE energy during loading, but also during unloading, which indicates friction in the existing cracks. At the final cycle, AE sensor 3 detects the highest amount of AE events (max. values are not shown). At this point, the AE-FOS detects a major increase in AE activity, just before rupture of the fibre (Figure 10). The limited (vertical) range of the AE-FOS in masonry hindered an accurate detection of AE activity by this sensor at an earlier stage during the test.

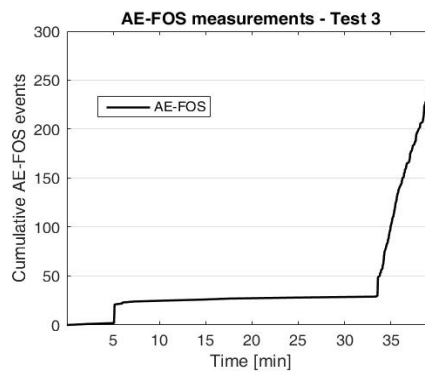
Figure 10: Cumulative number of AE events detected by the optical fibre (AE-FOS) during test 3
