Skin-stringer separation in post-buckling of butt-joint stiffened thermoplastic composite panels

K.S. van Dooren^a, B.H.A.H. Tijs^{b,a}, J.E.A. Waleson^b, C. Bisagni^{a,*}

^a Delft University of Technology, Faculty of Aerospace Engineering, Delft, The Netherlands

^b Fokker/GKN Aerospace, Papendrecht, The Netherlands

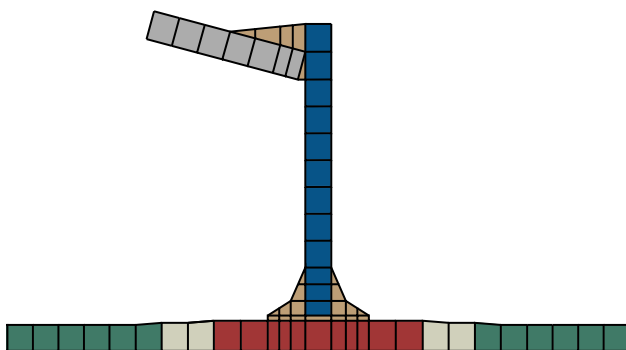
Fig. 6. FE mesh of the stringer cross-section.

The modelling approach makes use of shared nodes to connect the different sections, as shown in the stringer cross-section in Fig. 6. Shared nodes instead of ties shows better computational efficiency and more consistent mesh convergence. The interface between the filler and the skin of the middle stringer is partially bonded by a contact pair definition with VCCT. This area, which is the length of the stringer between the potting, is 445.3 mm long and 9.7 mm wide and has an initial damage of approximately 70 mm in the middle. It is assumed that the pre-crack is present only between the filler and the skin, and that it also only grows in this interface. The possible crack growth into the filler is neglected to lower the complexity of the model. This assumption is based on failure behaviour seen during internal tests by GKN Fokker and three point bending tests by Baran et al. [25]. It is chosen to use VCCT as it shows good results for a relatively coarse mesh [11,30,33], needed for large structures as in this work, which was also shown by Bertolini et al. [7] in a direct comparison between VCCT and CZM. Furthermore, VCCT requires a pre-crack, and this requirement is automatically fulfilled due to the initial damage in the skin-stringer interface.

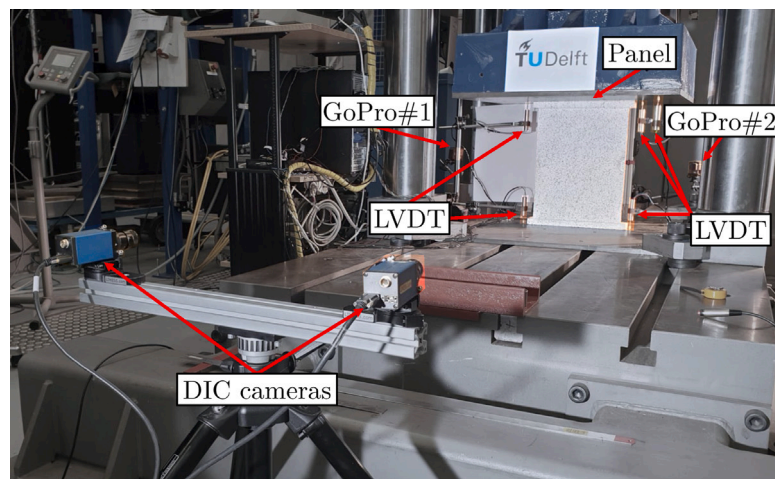
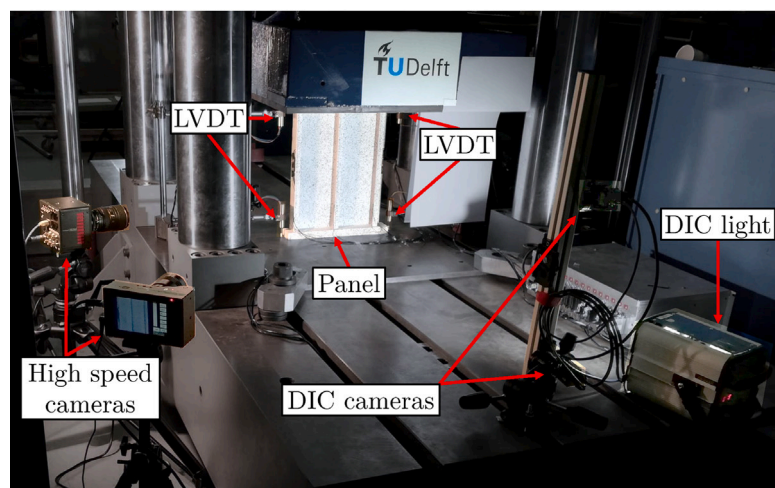
(a)

(b)

Fig. 9. Test setup: (a) skin-side; (b) stringer-side.

The experimental test setup is shown from the skin-side and stringer-side of the panel in Fig. 9. The panel is placed between the base and the compression plate of the test machine, after which a low preload of 0.5 kN is applied to keep the panel in place. The tests are performed at a loading rate of 0.1 mm/min until final failure of

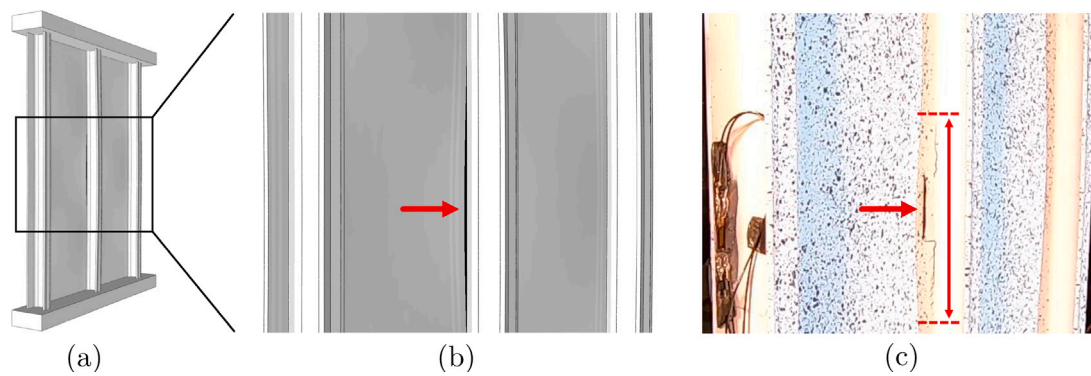
Fig. 15. Crack opening seen from left side of panel 1 at 156 kN: (a) full view of panel; (b) close-up FE; (c) close-up camera footage with visual separation length marked in red.

As panel 1 and panel 2 show very similar behaviour, only camera footage of panel 1 is here reported. At 156 kN, approximately between buckling and final failure, crack opening can be well distinguished, as shown in Fig. 15. The crack has opened and grown, with more crack

growth in downwards direction compared to upwards direction. The cap-side of panel 1 is shown Fig. 15(c). The opposite side of panel 1, corresponding to the side of the stringer without cap, is shown in Fig. 16, where no crack opening can be seen. The one-sided crack opening is due to the buckling shape, where the outwards half-wave on the cap-side opens the crack, while the inwards half-wave on the opposite side of the cap tends to close it.

shown in Figs. 15(a–b) and 16(a–b) for the cap and the opposite side, respectively, for a comparison with the camera footage.

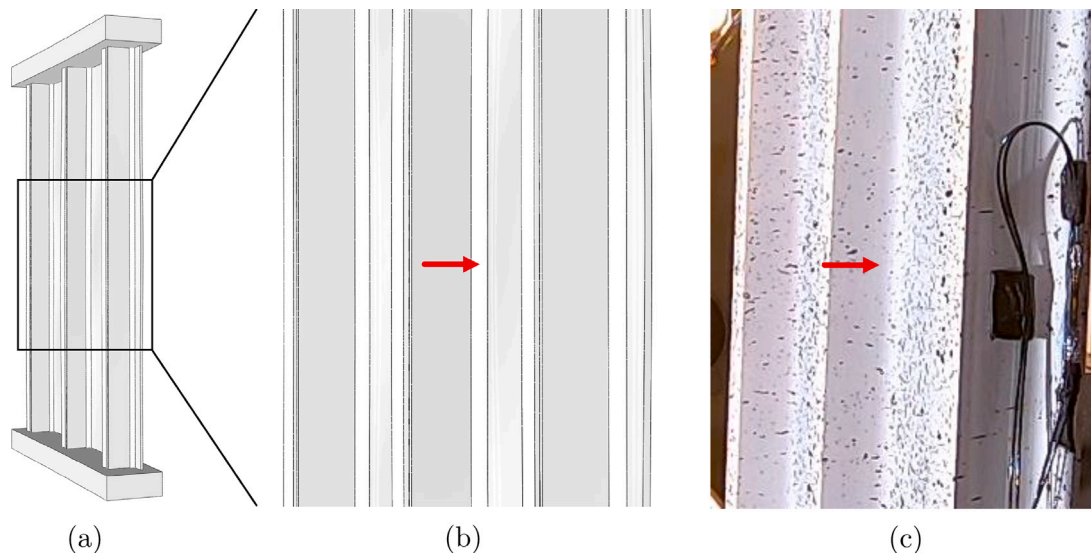
Fig. 16. Closed crack seen from right side of panel 1 at 156 kN: (a) full view of panel; (b) close-up FE; (c) close-up camera footage.

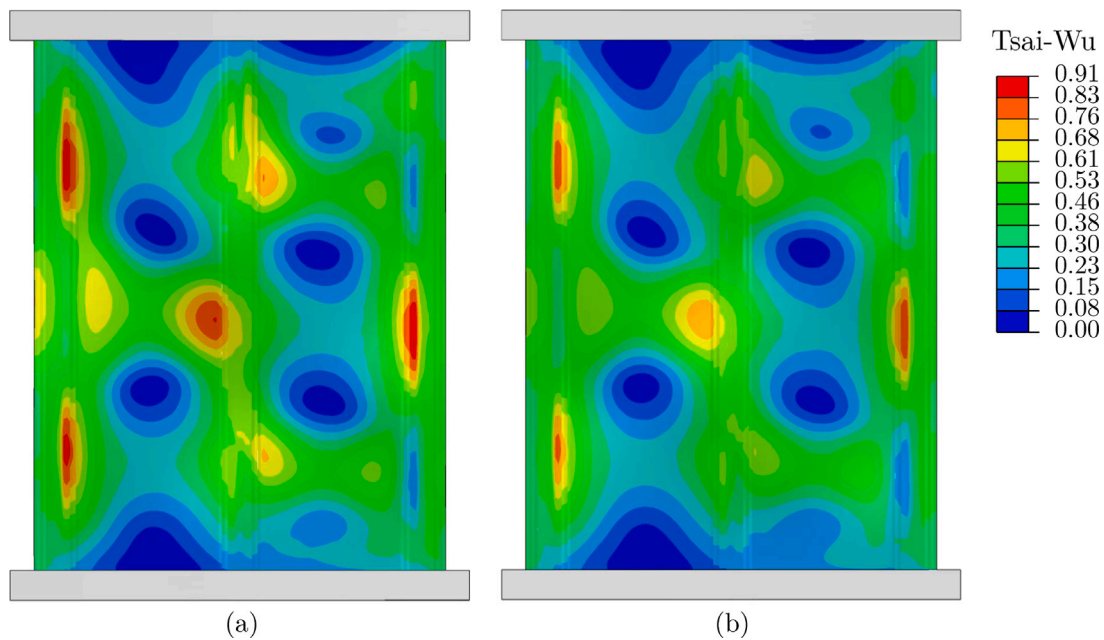
Fig. 19. Tsai-Wu failure criterion of the skin bottom zero ply from the numerical prediction at maximum load: (a) panel 1; (b) panel 2.

critical ply according to the Tsai-Wu criterion is the bottom zero ply in the skin, for which the contour plots of both panels are shown in Fig. 19. It can be noted that the most critical locations are underneath the outer stringers, approximately coinciding with the longitudinal location of outwards half-waves of each corresponding bay.

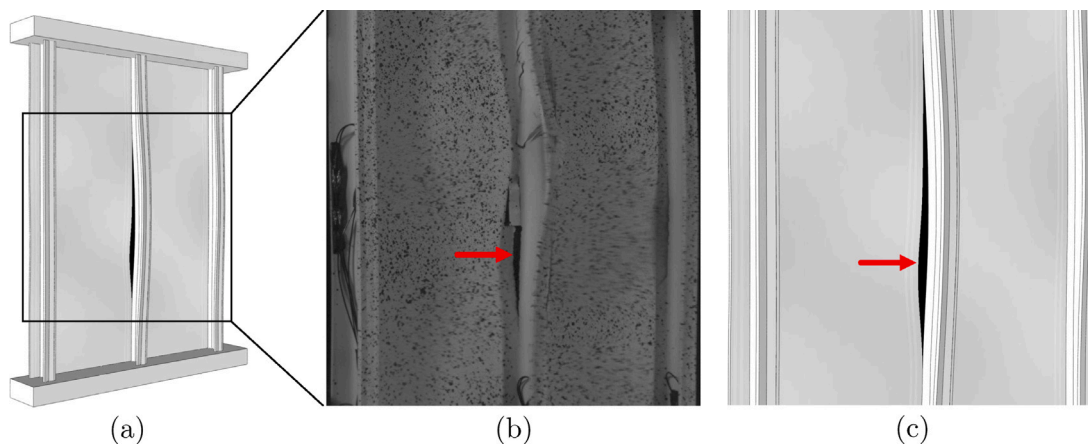
Fig. 20. Crack opening of panel 1 during final failure: (a) full view of panel; (b) high speed camera; (c) close-up FE.

The final failure mode is captured by two high speed cameras. The area that is recorded by high speed camera 1 is shown on the FE model in Fig. 20(a). A frame of the 3000 fps high speed footage of panel 1 is shown in Fig. 20(b). It highlights the behaviour during separation of the middle stringer. The crack in the butt-joint grows in downwards

direction and a tunnel forms between two outwards buckling half-waves. Due to the separation of the stringer from the skin, the cap and the web of the stringer also start to show failure, and consequently load carrying capabilities are lost. The numerical prediction of the final failure of the panel is shown in Fig. 20(c). The analysis also reveals crack growth in downwards direction, with a tunnel between two outwards buckling half-waves, similarly to the failure behaviour seen in the tests.

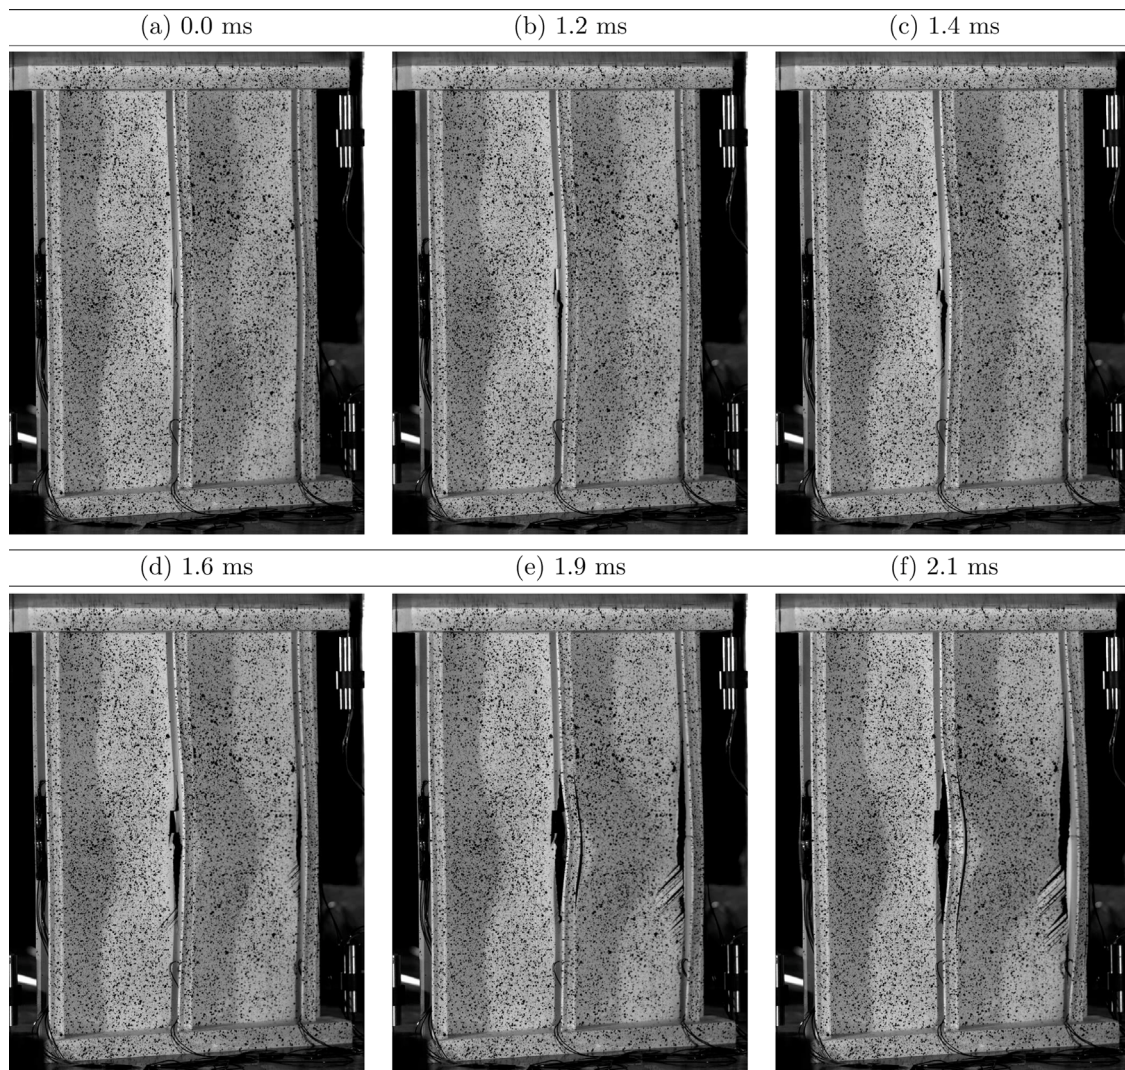
Fig. 21. Sequence of final failure of panel 2 captured by high speed camera: (a) crack opening of middle stringer; (b) crack propagation of middle stringer; (c) separation of right stringer; (d) separation of middle cap; (e) failure of middle cap; (f) separation of left stringer and separation of right cap.

The sequence of the final failure over the full length of panel 2 is captured by the second high speed camera at 10,000 fps, as shown in Fig. 21. Final failure starts with the crack opening (a). Then the crack grows between the web of the middle stringer and the skin (b), after which the separation between the web of the right stringer and the skin occurs (c). This is followed by the separation between cap and web of the middle stringer (d) and failure of the middle cap (e). Then, the web of the left stringer starts to separate from the skin simultaneously with the separation between cap and web of the right stringer (f). This sequence occurs within 2.1 ms, and shows that the skin-stringer separation is the critical failure mode leading to the final failure of the panel.
