Further investigations into alloy induced acidic fluxing

Gas turbine materials often feature precipitates containing refractory metals to enhance their mechanical strength. This can make them susceptible to alloy-induced acidic fluxing whereby refractory elements increase the acidity of salt deposits. It is not clear to what degree degradation around alloy precipitates is caused by alloy-induced hot corrosion mechanisms, or the inability to develop a protective scale where precipitates are located. The effect of alloy-induced hot corrosion was isolated from the disruption of the protective-scale formation by adding particles of molybdenum to the 80/20 (Na/K)₂SO₄ deposit for a 'deposit re-coat' style hot corrosion test. The resulting morphologies were compared to samples exposed without the addition of molybdenum. Morphology changes were investigated using scanning electron microscopy with energy-dispersive X-ray mapping. Results show a mix of sulphidation and pitting. The effects of molybdenum additions appear more severe for MarM 509 compared to PWA 1483.

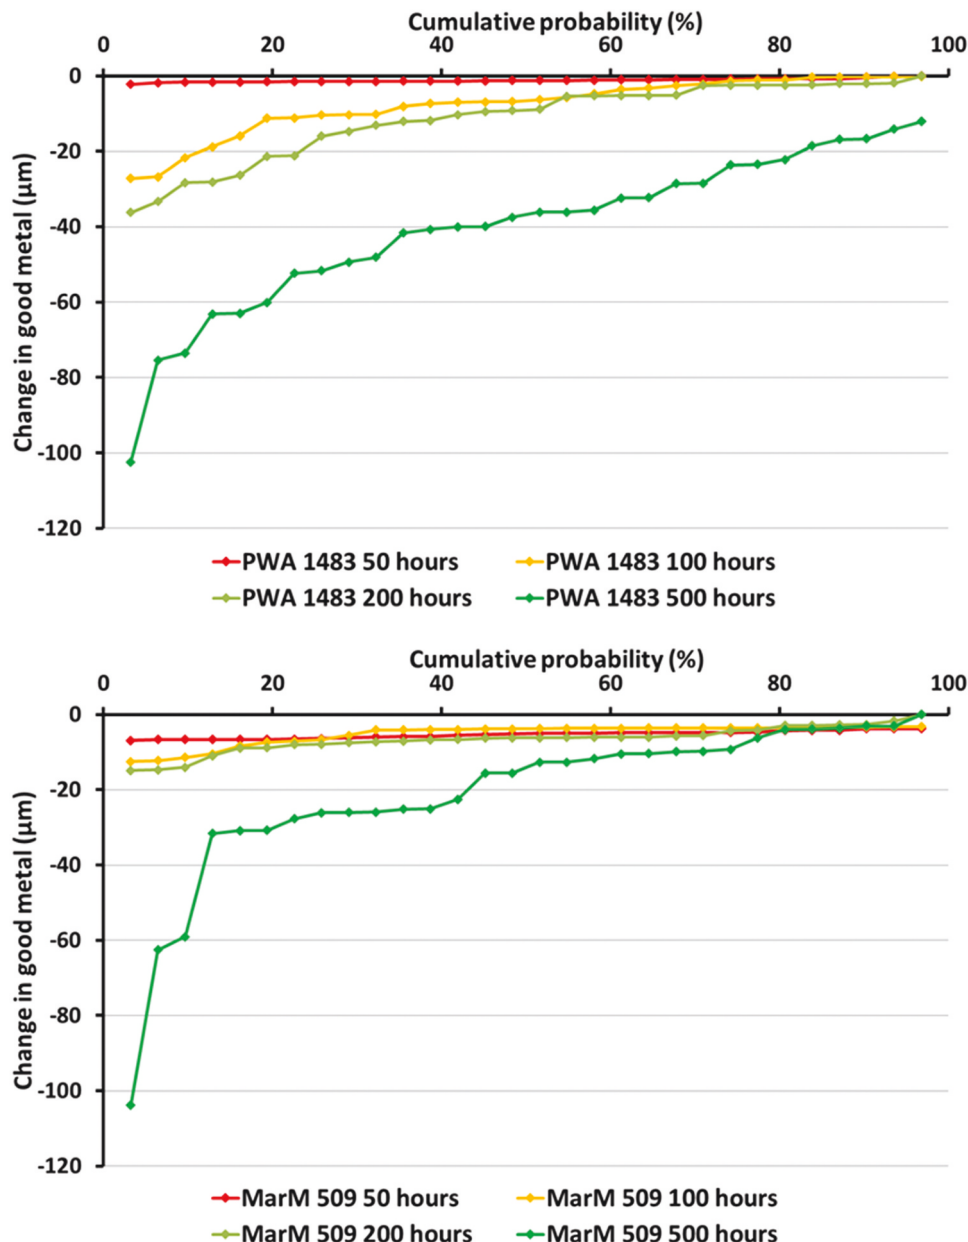
Figure 3. Cumulative probability of change in good metal plots for PWA 1483 (top) and MarM 509 (bottom). Exposure carried out at 700 °C in an air atmosphere with 300 ppm SO₂. The deposit flux was 1.5 μg/cm²/h of 80/20 (Na/K)₂SO₄ modified with additions of 1.5 μg/cm²/h of Mo.

Cumulative probability curves for change in good metal are presented in Figure 3. Both PWA 1483 and MarM 509 exhibit negligible change in good metal after 50 h of exposure indicating that, at this time, they have remained in the incubation stage of hot corrosion. After 100 h of exposure approximately 55% of PWA 1483 and 15% MarM 509 show a greater degree of change in good metal. These proportions are similar after 200 h of exposure but with a greater degree of metal loss (up to $10 \mu\text{m}$) where corrosion is occurring. After 500 h, the whole of PWA 1483 has entered into propagation while only 80% of

MarM 509 has done so over the same period. While a similar change in good metal (approximately 103 μm) is observed for both alloys at their lowest levels of probability (representing the deepest pits), the distribution of damage is more localised for MarM 509 while PWA 1483 has a more even distribution.

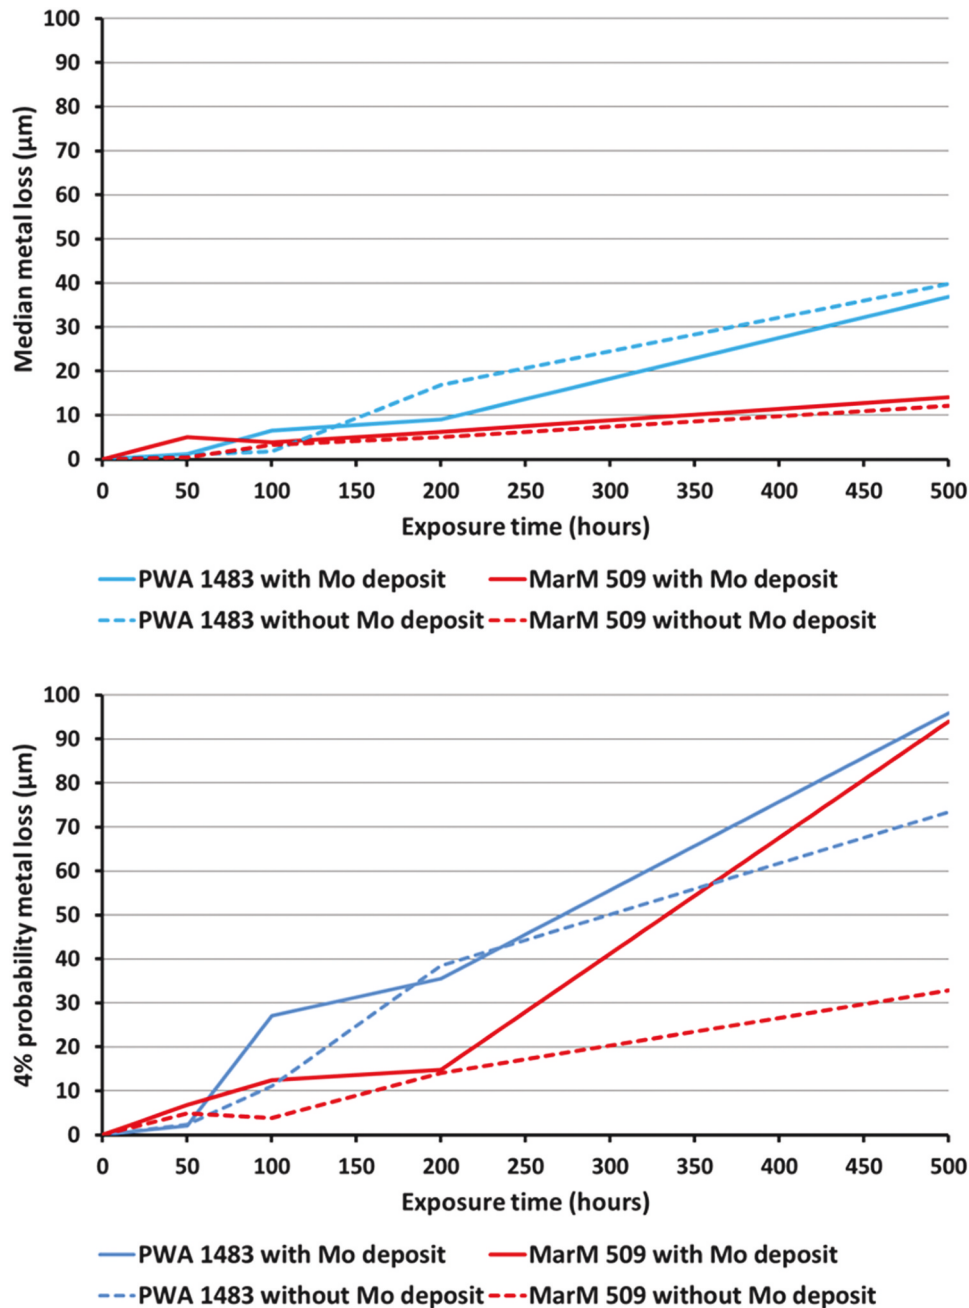
Figure 4. Median (top) and 4% (bottom) probability of metal loss exceedance plots. Exposure carried out at 700 °C in an air atmosphere with 300 ppm SO₂. The deposit flux was 1.5 µg/cm²/h of 80/20 (Na/K)₂SO₄ either modified with 1.5 µg/cm²/h of molybdenum or unmodified [8].

Median and 4% probability of good metal loss were used to compare the current exposures using the Mo modified deposit with previous work [8] using the same test parameters but an unmodified deposit. These data are presented in Figure 4. Median values give an average indication of corrosion damage, whereas the 4% probability data indicate the severity of corrosion pits.

Little difference between the Mo modified and unmodified deposits can be seen at the median value for all tested exposure times. However, differences are seen at the 4% probability of good metal loss. The greatest difference between the Mo modified and unmodified deposits is seen after 500 h of exposure

at the 4% probability. These were an extra 22 µm for PWA 1483 and 61 µm for MarM 509.
