HIGH VELOCITY IMPACT ON TEXTILE REINFORCED COMPOSITES

Warnet L., Akkerman R., Ravensberg M.
 [Warnet L.]: l.warnet@utwente.nl
 University of Twente, the Netherlands

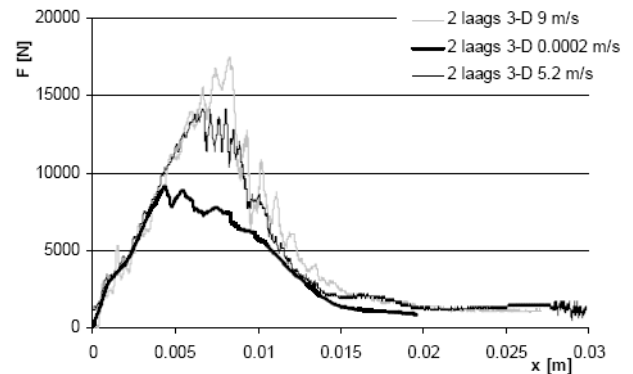
Fig. 4. Typical force – deflection diagrams at different velocities for the two layers 3D structure.

At low impact velocities (9m/s – 480J), the maximum force and the absorbed energy both increase compared to the quasi-static test results. Also the total damage area increases.

At high velocity (110m/s – 600J) again the total amount of damage seems to increase. The damage also goes beyond the clamping diameter, showing the limitation of the clamping technique and diameter.
