# Secondary Structures on the Friction Surface of Diamond-like Coating

**Keywords:** diamond-like coatings; friction; steel ball; surface; SEM methods; secondary structures

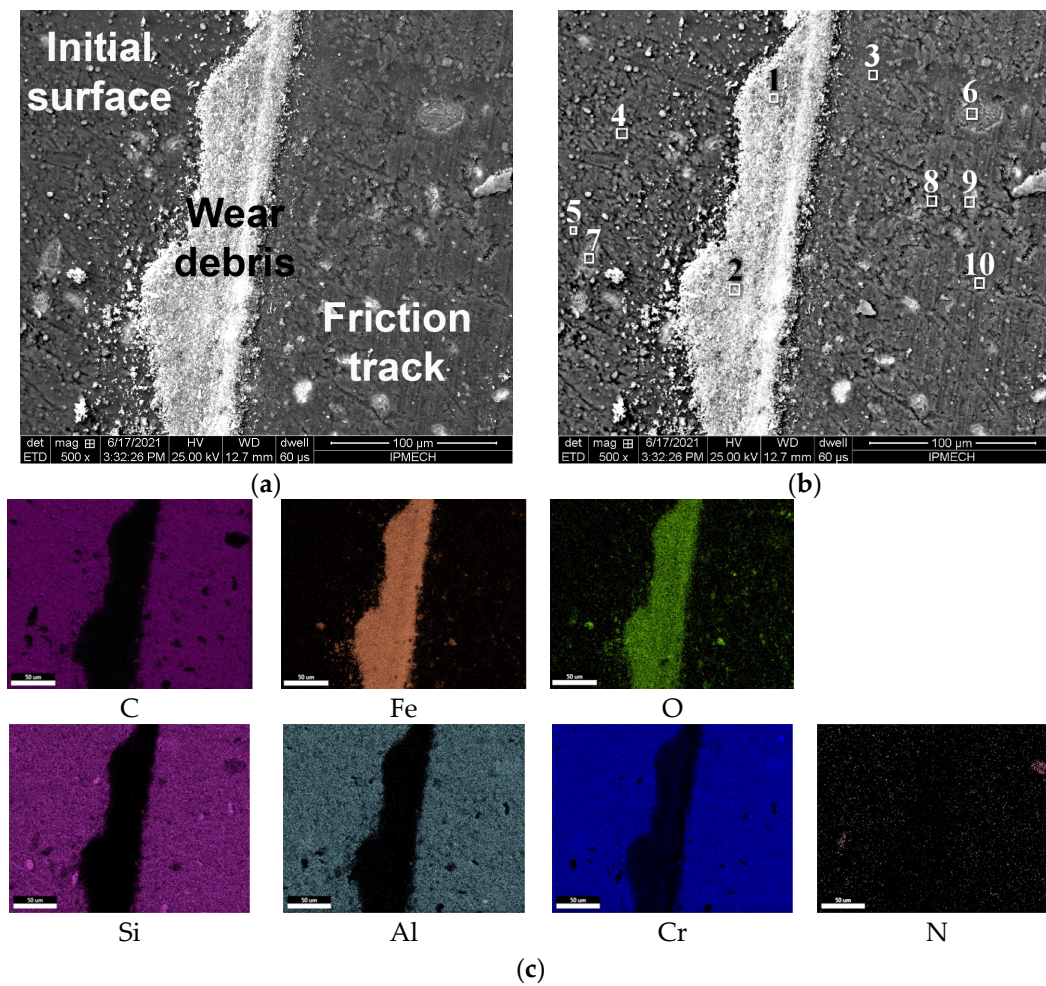
The image of the sample surface at the boundary of the upper edge of the friction track (area 1) and element distribution maps is shown in Figure 3, and the elemental composition of the characteristic zones is in Table 2. A graphical representation of the results, as done,

**Figure 3.** Image of the sample surface in area 1 at the boundary of the friction track: (a)—characteristic zones, (b)—zones of X-ray spectral analysis, (c)—maps of the distribution of chemical elements.

Figure 3a shows the zones that most clearly differ in composition and topography—the edge of the friction track, a strip of a relatively dense layer of wear particles, and the initial surface of the coating. It should be taken into account that SEM gives the content of elements

Figure 3 shows that the zones mentioned above differ significantly in topography. The friction track is smoother than the original surface and has risks in the direction of friction. It could be seen that on both surfaces there are defects in the form of pits of various shapes and sizes; moreover, the number of defects on the friction track was greater, and the defects themselves were larger. The wear particle zone is a light band consisting of many compact groups of small particles. The strip zone near the friction track is smoother compared to more distant zones.

The element distribution maps (Figure 3c) confirm that the wear strip consists mainly of iron oxides and was depleted in carbon and elements from the nitrated sublayer.

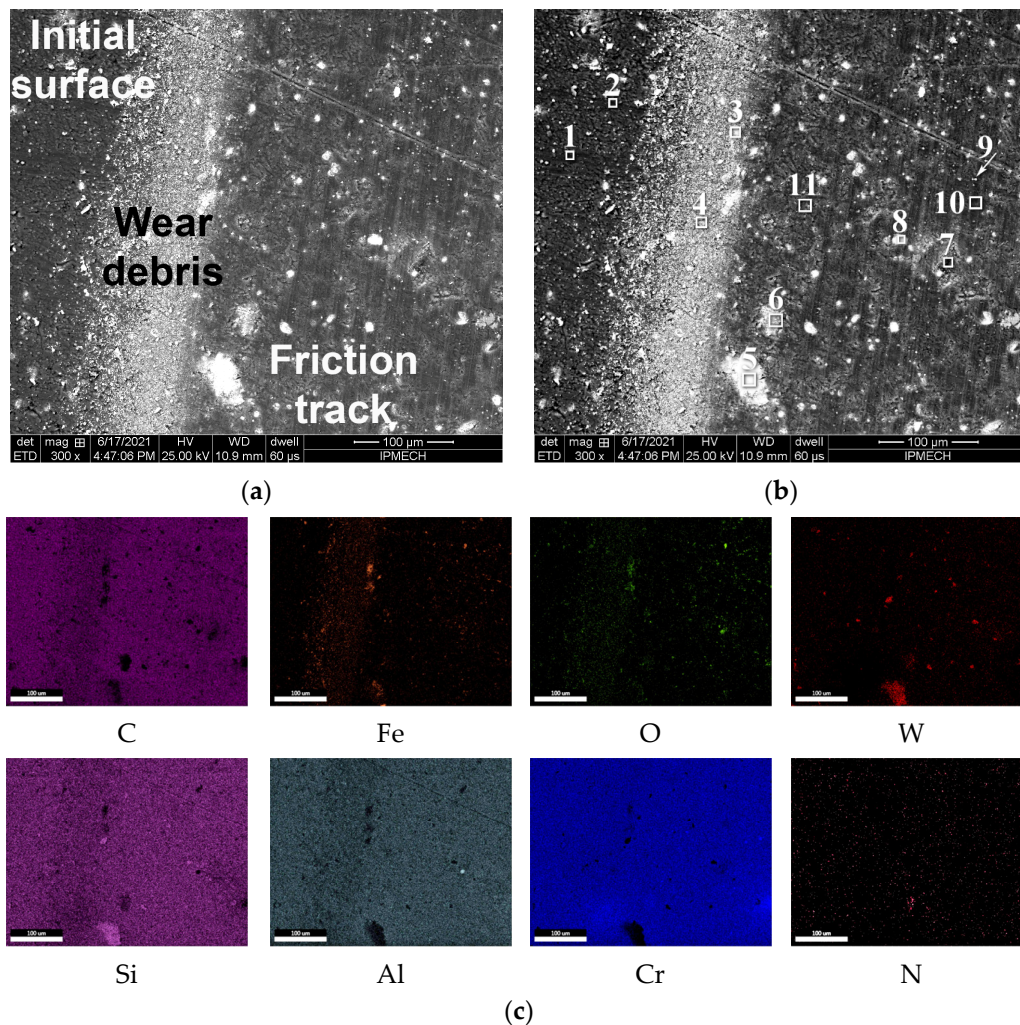
There was no dense layer of wear particles at the boundary of the friction track, but there were separate particles of different sizes (Figure 4).

**Figure 4.** Image of the sample surface in area 2 at the boundary of the friction track: (a)—characteristic zones, (b)—zones of X-ray spectral analysis, (c)—maps of the distribution of chemical elements.

According to the element distribution maps (Figure 4c), the wear particle strip contains iron, oxygen, and carbon. The oxygen content was less than in the wear strip in Figure 3. Iron oxides are located on the friction track and in the strip of wear products. The appearance of pits was noted on the friction trace. They have a high content of silicon and tungsten or aluminum and nitrogen. It depends on what is at the bottom of the pit; a nitrided sublayer or a substrate based on tungsten carbide. The tungsten carbide bottom pit contains steel ball wear particles (iron).
