Mevisse, F & Meo, M 2022, 'Creep detection of Hastelloy X material for gas turbine components with nonlinear ultrasonic frequency modulation', *Materials Characterization*, vol. 191, 112099.  
<https://doi.org/10.1016/j.matchar.2022.112099>

# **Creep detection of Hastelloy X material for gas turbine components with nonlinear ultrasonic frequency modulation**

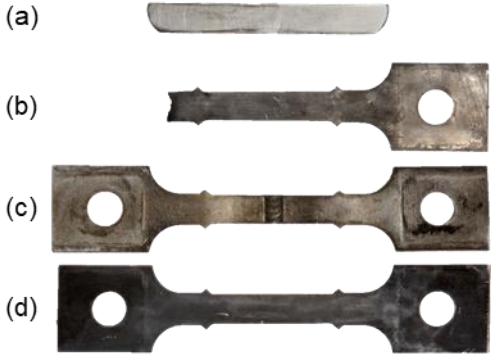
The samples had dimensions of  $2 \times 30 \times 150$  mm. Figure 1a illustrates the unloaded reference sample from the same batch, which was used for comparison. All creep samples had measuring tips that were used for continuous strain measurement during the creep tests. Sample CR2-1 was

broken after 3250 h and loaded with 70 MPa and 750 °C (Figure 1b), and a strain of 6.3% was achieved. Sample CR2-2 (Figure 1c) was loaded with identical parameters but was welded at the middle to assess the influence of the weld seam on the creep behaviour. Sample CR3 was loaded with 35 MPa and 800 °C for 5850 h (Figure 1d), and a strain of 1% was reached before the test was stopped.

**Figure 1.** Creep specimens: (a) CR1; (b) CR2-1; (c) CR2-2; (d) CR3.

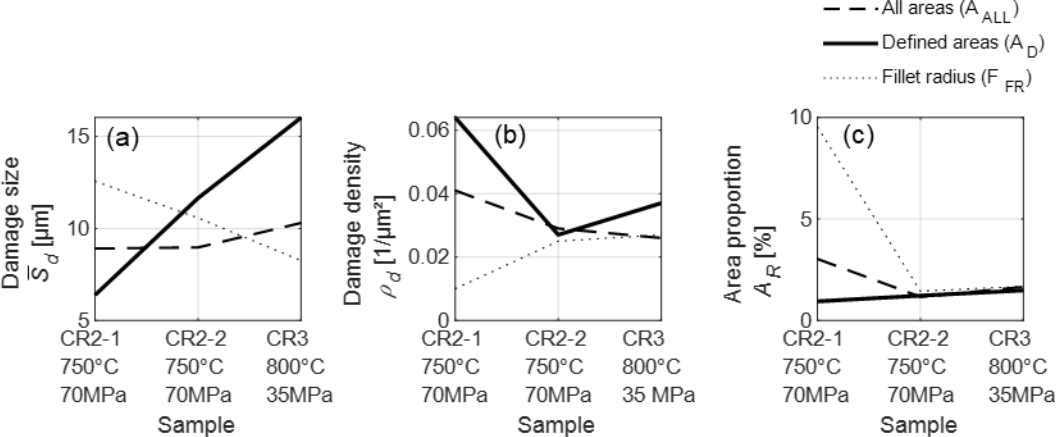
From the images, the mean values of the damage sizes ( $\bar{s}_d$ ) of individual samples were first determined (Figure 10a) and found to vary from 2.5 to 19.3  $\mu\text{m}$ . In general, damage size is considered a good indicator for determining the current creep phase. Pores form first at the grain boundaries, which then combine to form microcracks and then progress to larger failures. With all values ( $A_{ALL}$ ) considered, CR2-1 and CR2-2 show almost identical damage sizes, with the CR3 sample exhibiting the largest flaws. With the defined areas ( $A_D$ ), the welded CR2-2 sample was found to have significantly larger pores than those of the broken CR2-1 sample. This was also demonstrated in the scanning electron microscopy images, wherein the pores in the edge area have already combined to form microcracks (Figure 6). Sample CR3 clearly showed the largest flaws, and sample CR2-1 had the largest damage in the transition radii.

Damage density (Figure 10b) describes the number of defects in an evaluated area and is calculated as  $\rho_d = \frac{n_d}{A_0}$ , where  $A_0$  is the total evaluated area and  $n_d$  is the total number of damage points in the evaluation area. If several pores connect to form microcracks, this results in larger damage and a reduced damage density, hence further increasing the formation of pores in other positions. With all areas ( $A_{ALL}$ ) and defined areas ( $A_D$ ) considered, CR2-1 provided the highest density as a result of the influence of the break point of the sample. However, with only the transition radii considered, sample CR3 had the highest values.

In an area-based evaluation, the values are provided as percentages (Figure 10c). Sample CR2-1 exhibited peak values when all the values and the values at the transition radii were considered:  $A_R = \frac{A_{\Sigma d} \cdot 100}{A_0}$ , where  $A_{\Sigma d}$  is the total area of damage. With the defined areas ( $A_D$ )

considered, the values increased steadily from sample CR2-1 to sample CR3. This sample was loaded the longest, for a total of 5850 h.

Figure 10. Metallurgical evaluation: (a) damage size; (b) damage density; (c) area proportion.

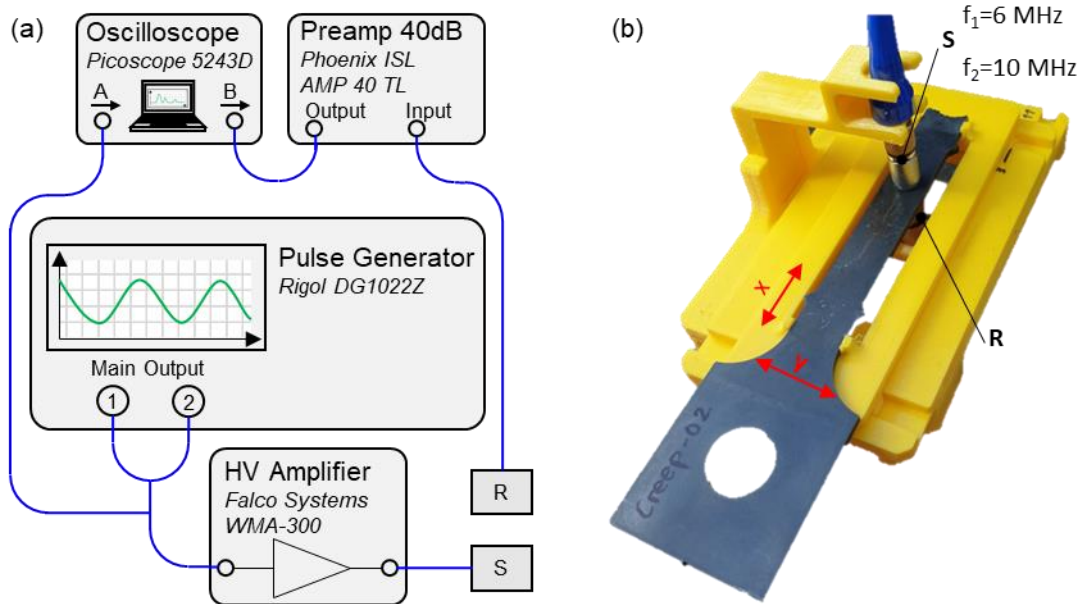
In this study, a Rigol DG1022Z pulse generator was used to generate the frequencies. Two frequencies (i.e.  $f_1 = 6$  MHz,  $f_2 = 10$  MHz) were sent over two channels to a Falco WMA-300 amplifier and amplified with an output voltage of 150 V. The signals were sent to the sample by Sensor S, and the longitudinal waves were received on the other side with Sensor R and amplified with a Phoenix ISL 40 dB amplifier. Olympus V129-sm contact transducers were used for this application. The measurement data were then sent to an oscilloscope for further processing. A total of 100 pulses were sent, and their mean values were considered. This not only allowed avoiding wave reflections but also increased the probability of passing small flaws. The wave propagation due to the reduced wall thicknesses of the deformed components was examined without any influence [25]. In the additively manufactured specimen-clamping and positioning device shown in Figure 19b, the sample can be moved around two axes with a constant sensor position.

**Figure 19.** Experimental setup: (a) overview; (b) sensor attachment to a sample.
