## MANAGEMENT OF 20TH CENTURY HYDROELECTRIC PLANTS AS INDUSTRIAL HERITAGE

**KEY WORDS:** Hydroelectric Plant, Gravity Dam, Architectural Conservation, Planned Conservation, Preventive Measures

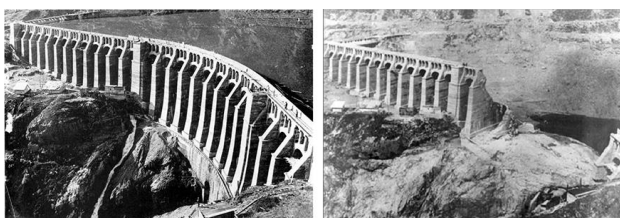
Figure 1. Gleno Dam before and after the collapse (Luino et. al., 2014)

Gleno Hydroelectric Plant, with an installed capacity of 3.7 MW, was constructed on Gleno Creek in Italy between 1916 and 1923. The initial project of the dam was designed as a concrete gravity dam, but after the construction of the foundations for the concrete gravity dam, with a change of plans, a multiple-arch concrete dam was constructed with a height of 43 meters, and a length of 200 meters. The change in the type of dam and the use of poor materials and techniques in the construction caused the failure of the dam flooding the settlements of Bueggio, Dezzo, Azzone, Colere and Corna di Darfo, killing at least 356 people on December 1, 1923 (Figure 1). The failure of Gleno Dam accelerated the studies on dam safety in Italy in the 20th century. The failed dam of Gleno still constitutes the subject of scientific studies testing the methods for dam safety. Pilotti et. al., in their study on the Gleno Dam, reconstructed the event by recovering a great deal of information that can be used for modelling purposes. Since topography surveys of the site were not available for the area before 1923 –and the flood has severely changed the previous topography- they had to reproduce the bathymetry by means of a 5 x 5 digital elevation model (DEM) based on historical documents and they prepared a two-dimensional (2D) shallow water simulation describing the dynamics of the reservoir emptying and a one-dimensional (1D) modelling of the dam break wave propagation, with a first-order finite volume numerical scheme (Pilotti et. al., 2011). The remains of the failed dam are still at the site open to the interest of the public. Besides, in memory of the disaster, a collection of documents, photographs and testimonies of the industrialization in 1920s is exhibited at the “Gleno Exhibition Space.”

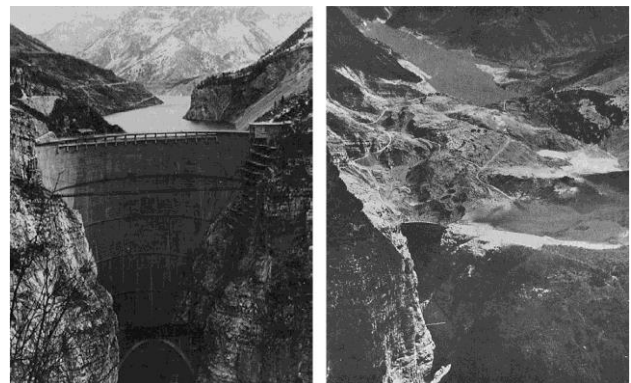
Figure 2. Vajont Dam before and after the landslide (Runout, 2000)

Vajont Dam, a concrete arch dam constructed on Vajont River between 1957 and 1959, was a structure with a height of 262 meters, a length ranging between 27 meters (at the base) – 191 meters (at the top) and thickness of 22.11 meters (at the base) – 2.4 meters (at the top). It was designed by Carlo Semenza and constructed by Società Adriatica di Elettricità ("SADE", or "EDIS") (English: Adriatic Energy Corporation). In 1962, the dam was nationalized to be run by ENEL as part of the Italian Ministry for Public Works. However, three years after the filling of the basin, on October 9, 1963 a landslide occurred at the site destroying Longarone, causing about 2000 casualties and complete devastation. The extraordinary aspect of the Vajont case is that: it is not exactly a dam failure, as the structure of the

concrete dam still remains intact at the site. The dam did not collapse, but huge masses of earth and rocks fell into the reservoir as a result of a landslide upstream, and the water in the reservoir overtopped the dam causing the disaster (Figure 2).

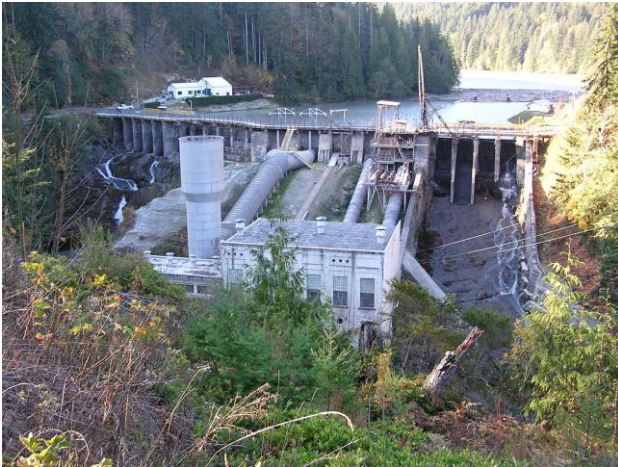
Figure 3. Elwha Dam before removal (Ward, 2005)

Elwha Dam, on the Elwha River in the United States, was constructed by L. L. Summers of Chicago between 1911 and 1914. The 33 meter high embankment consisted of a 120 foot long concrete gravity central section flanked by concrete multiple-buttress spillway and intake sections. During the construction, in 1912, a leakage occurred; the dam and the powerhouse with the generating units and the switchboard was severely damaged. However, the top part of the dam was still intact after the leakage, like a bridge wedged between the walls of the canyon. In reconstructing the dam, excavated materials from the walls of the canyon were placed as a heavy rock-fill above, below and beneath the dam. By December 1914, the construction of the dam was completed after the reconstruction. The installed capacity of the plant was 14.8 MW with 4,800 hp Wellman Seaver Morgan Francis type, double runner turbines. The powerhouse was a two-storey concrete building resting on a bedrock and structurally supported by reinforced concrete columns faced with curtain walls. The generating units were on

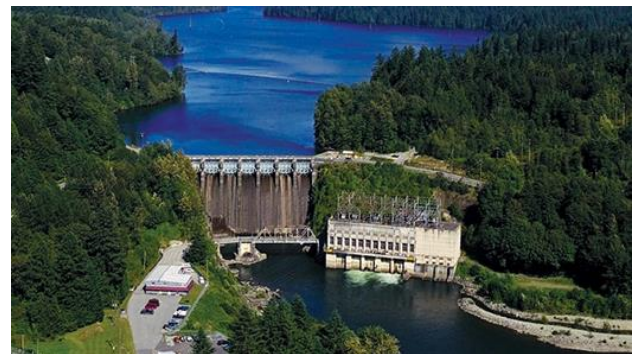
Figure 4. Ruskin Hydroelectric Plant (BCHydro, 2019)

Ruskin Dam on State River in Canada is a concrete gravity dam inaugurated in November 1930 (Figure 4). It is 59.4 meters in height and 110 meters in length. The installed capacity of the hydroelectric plant is 105 MW with an annual generation of 374 GWh using three 35 MW turbines of Francis type. The powerhouse is an Art-Deco building immediately adjacent on the river's eastern bank. Hydro-works in the valley was initiated by Western Canada Power Company, but after the provincial government took over the BC Electric Company, the facility has become the property of BC Hydro.

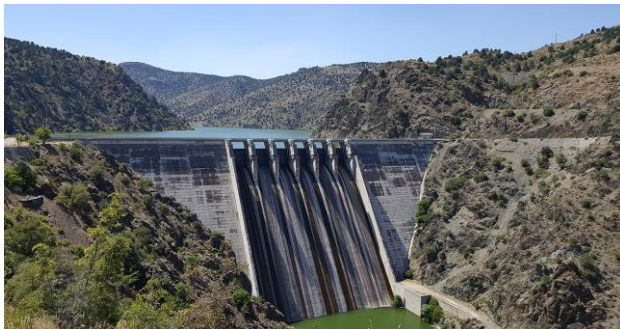
Figure 5. Saryiar Dam

Saryiar Hydroelectric Plant was constructed in 1956 on Sakarya River in Turkey. The dam is a concrete gravity dam with a height of 90 meters and a length of 554 meters (Figure 5). The installed capacity of the plant is 160 MW with an annual generation of 400 GWh using four 40 MW Francis type turbines (Figures 6-7).

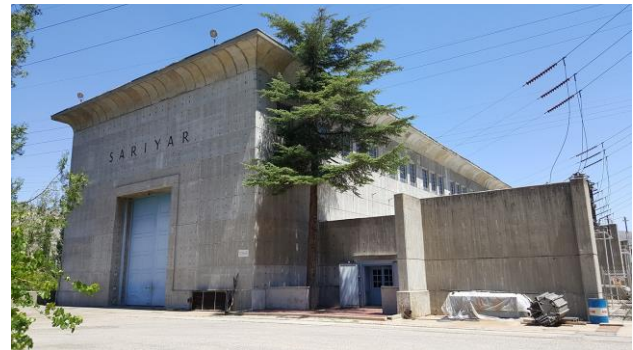
Figure 6. Saryiar Powerhouse

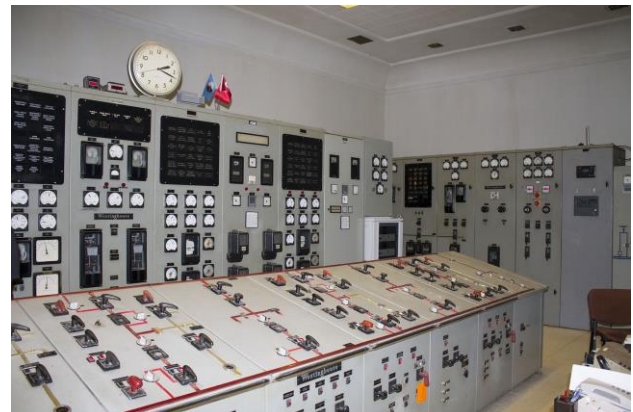
Figure 6. Saryiar Hydroelectric Plant, control room

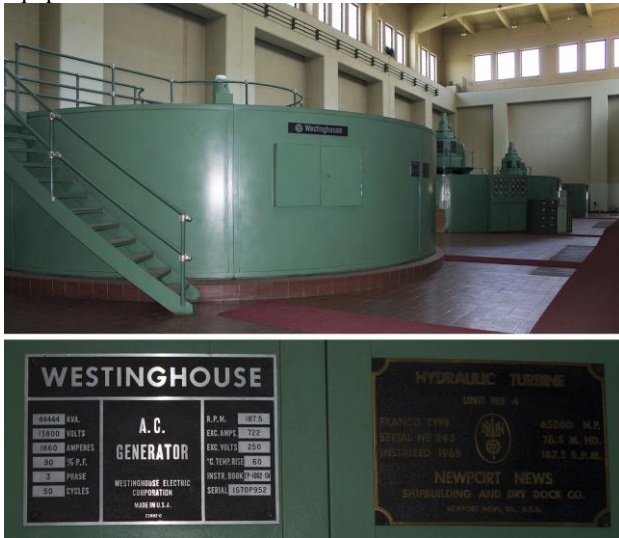
Figure 7. Saryyar Hydroelectric Plant, turbines
