## Computed Tomography analysis of damage in composites subjected to impact loading

V. Crupi, G. Epasto, E. Guglielmino

**ABSTRACT.** The composites, used in the transportation engineering, include different classes with a wide range of materials and properties within each type.

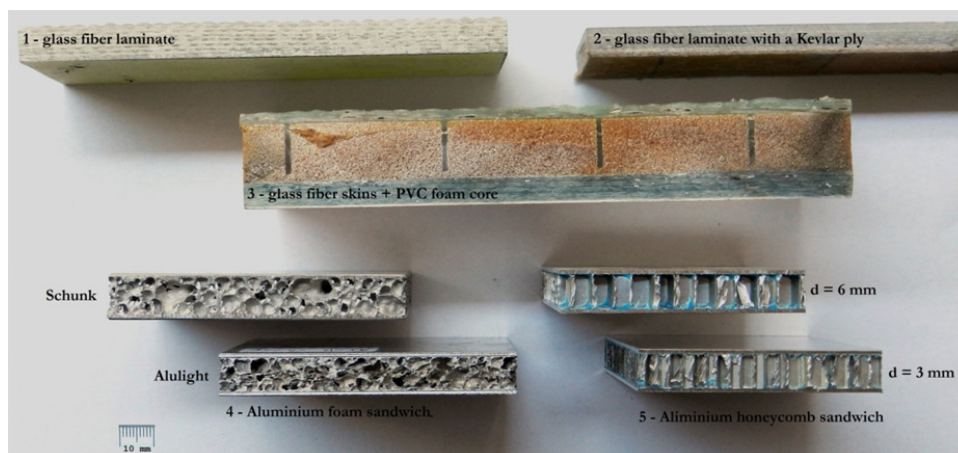
In this paper, the following different typologies of composites have been investigated (Fig 1): laminated composites, PVC foam core sandwiches, aluminium foam sandwiches (*AFS*) and aluminium honeycomb sandwiches.

Figure 1: Investigated composite materials.

The polymeric sandwiches consist of a PVC foam core and two GFRP (glass-fibre reinforced plastic) laminated skins. The measured total density is about  $0.68 \text{ g/cm}^3$ . The PVC foam core has a density of  $0.075 \text{ g/cm}^3$  and a thickness of about 15 mm, while the average thickness is 3 mm for the upper skin and 7 mm for the lower one.

One of the two investigated laminates is made of alternated fibre-glass MAT and GFRP  $[0^\circ/90^\circ]$  biaxial layers and has a thickness of about 10 mm, the other one has an additional  $[0^\circ/90^\circ]$  Kevlar reinforced layer and two GFRP  $[\pm 45^\circ]$  biaxial layers and a thickness of about 9 mm.

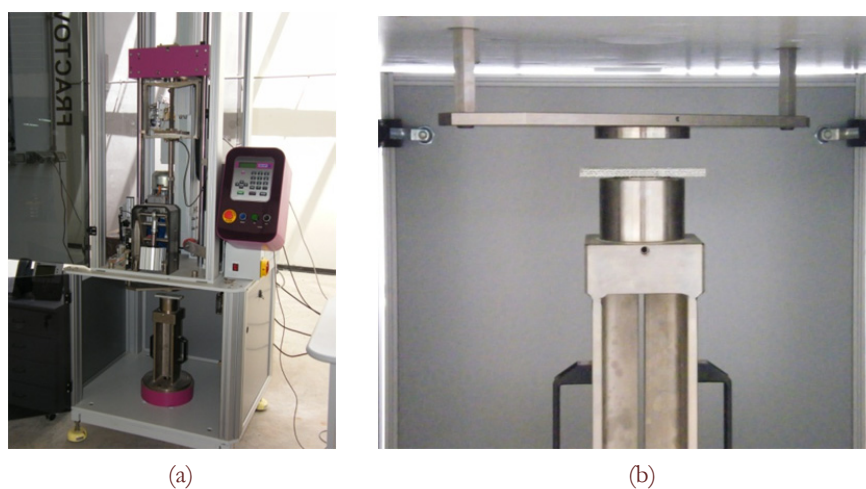
Low-velocity impact tests were performed using a *CEAST Fractovis Plus* drop-weight impact test machine (Fig. 2). The instrumented impactor, having a hemispherical tip with diameter of 20 mm, hit the centre of the specimens.

The tests were conducted on the different typologies of composites with an impactor mass of about 7 kg. The drop height was adjusted to generate different level of initial impact energies (from 56 to 284 J), each with a corresponding impact velocity (from 4 to 9 m/s). The specimens were clamped by a rigid metallic plate with a diameter of 40 mm, as shown in Fig. 2, without crushing the sample.

Figure 2: a) Drop-weight impact test machine; b) Clamping system.

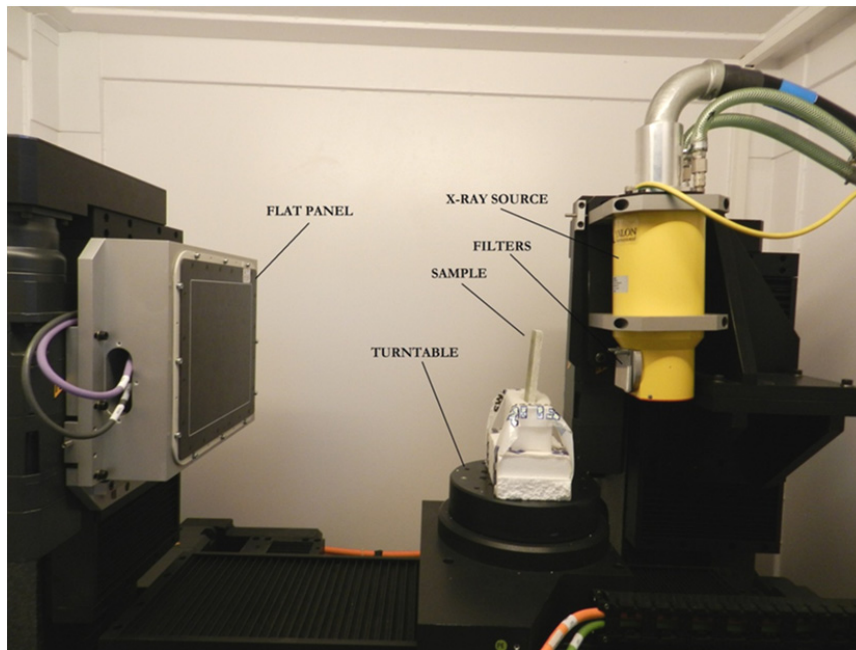
The impact damage of the composites, undetectable by a visual inspection, was analyzed by the *Y.CT Vario focus* X-ray computed tomography system (Fig. 3). This unit is equipped with an X-ray source having maximum voltage and current of 225 kV and 7.1 mA, respectively, depending on the focal spot size that can be chosen among these values: 250  $\mu\text{m}$ , 300  $\mu\text{m}$ , 500  $\mu\text{m}$  and 800  $\mu\text{m}$ . The detector system is a flat panel with a resolution of 1920 x 1536 pixels. The scans, reported in this paper, were conducted with 250  $\mu\text{m}$  focus and X-rays were set at a voltage of 210 kV and at a current of about 1.1 mA. Different filters (Al, Cu and Sn filters) were used depending on the sample. It is worth noting that the source-detector and the source-sample distances are critical in determining the magnification of the sample and, thus, the resolution of the scan: the closer the sample was to the source and the further away from the detector, the higher the magnification. A conical X-ray beam scanned the sample, which was rotated at increments of  $0.5^\circ/\text{s}$  for each rotation

step. This procedure was then repeated until a full rotation of  $360^\circ$  was achieved, and a total of 1440 projections were then obtained to be used in the 3D profile generation. The sizes of the voxels and images were  $0.033 \div 0.050$  mm and  $2048 \times 2048$  pixels respectively. The integration time was chosen equal to 500 ms. It is important to underline that this NDT technique doesn't require to cut and polish the samples for carrying out the X-ray measurements. This allows a significant savings of time and the investigation of the internal damage without perturbing the impacted specimen.

The system, based on a variable focal-spot size technology, creates the cross-sectional images of three-dimensional objects using X-rays. A volumetric representation of the item to be inspected is obtained as a result of the CT. Both the material inner and outer structures and the geometric dimensions of the item to be inspected are recognizable.

Figure 3: Y.CT Vario cone-beam X-ray tomography system.

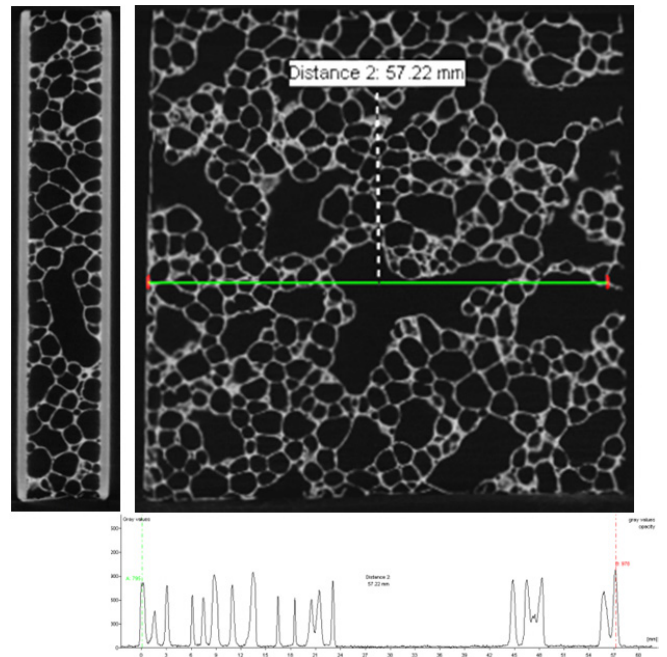
The investigation of the aluminium foams by means of CT is very useful to check their quality in terms of porosity distribution, that influence the mechanical properties of the foams. Fig. 5 shows the CT reconstruction of an *AFS Schunk* panel; the tomogram allows the investigation of the foam porosity and the localization and quantification of the pores by checking the grey levels intensity. Because of the non homogeneity of the *AFS* panels, it is strongly necessary to check the sample before carrying out the impact test and to discard defective samples, as the one shown in Fig. 5.

Figure 5: CT analysis of an *AFS Schunk* panel.

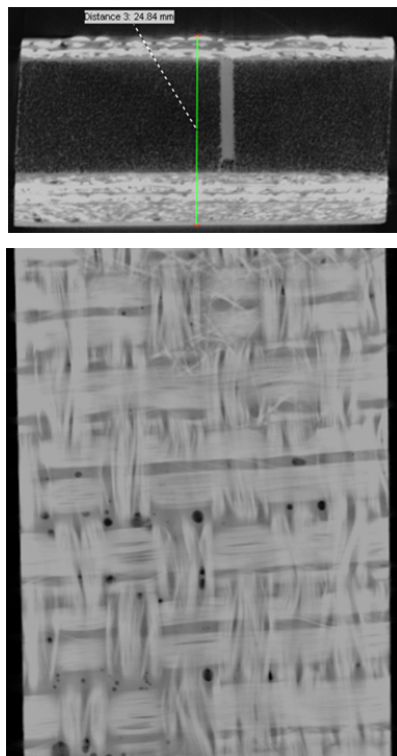
CT analyses allowed, also, the investigation of a polymeric sandwich with glass-fibre reinforced skins and foam core for quality control of flaws and for the evaluation of thickness and geometric properties of core and skin layers (Fig. 6).

Figure 6: CT analysis of a polymeric sandwich composite.

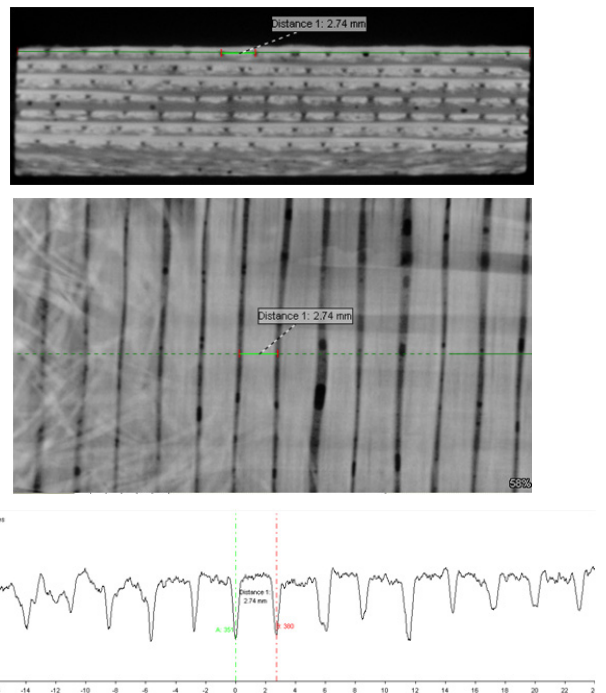
The thickness and the typology of each laminate layer can be evaluated by CT, the dimensions of a biaxial ply of a GFRP laminated composite, obtained by checking the greyscale levels, are shown in Fig. 7.

Figure 7: CT analysis of a laminated composite.

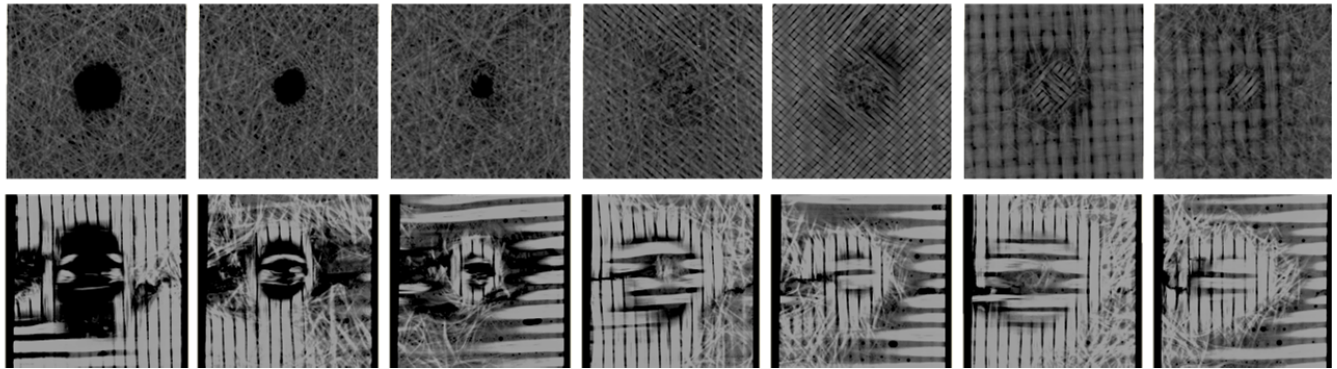
The impact damage mechanisms of composites with Kevlar fiber layers are distinctly different from those of GFRP. X-ray CT images of two laminated specimens subjected to 126 J impact energy are shown in Fig. 8. In particular, the images show a comparison between a fiber-glass laminated composite (upper images of Fig. 8) and a hybrid Kevlar/fiber-glass

laminated composite (lower images of Fig. 8). The cross-sectional images of the impact-damaged area were taken in the frontal through-thickness direction of the specimen, considering a distance between two slices of about 0.4 mm. Only the most representative slices of the two damaged specimens are shown in Fig. 8.

Figure 8: Tomograms of laminated specimens impacted at energy of 126 J.

In the hybrid Kevlar/fiber-glass laminate the impact damage mechanism is dominated by failure of mat and biaxial fiberglass layers, whereas  $[0^\circ/90^\circ]$  Kevlar layer, positioned near the bottom face, don't fail completely, but show out-of-plane deformation. That is confirmed by the tomogram of the middle section of an impacted laminate after a test at  $v = 8$  m/s, shown in Fig. 9, where shear cracks are also observed.

Fig. 10 shows that damage mechanism of a GFRP laminate after the impact at 6 m/s is characterized by delamination and fiber/matrix debonding. Three major damages can be found through the thickness: broken fibers, delaminations and transverse matrix cracks (Figs. 8 and 11). As described by Abrate [4], the damage process is initiated by matrix cracks which then induce delaminations, that is the debonding between adjacent laminas. Shear cracks, positioned at an angle from the midsurface, were observed in the tomogram of Fig. 11a relative to the middle section of impacted panel, confirming the important contribute of the shear stresses. In the low-velocity impact tests, the matrix cracks appeared in the first layer impacted because of the high, localized contact stresses and damage propagated through the thickness towards the bottom face, resulting in a pine tree pattern [4, 12] as shown in Fig. 11a. Large delamination damage occurs at the back face and progressively becomes smaller toward the impact face (Fig. 11b). The matrix cracking and fiber breakage were easily detected by a visual inspection as the near surface matrix cracking manifested itself in a stress-whitened or discolored patch, as reported in literature [14]. The longitudinal matrix interlaminar cracks below the impacted surface and the presence of delaminations at the bottom of the specimen can be noted in the tomograms of Fig. 11 relative to different transverse sections of the impacted specimens.

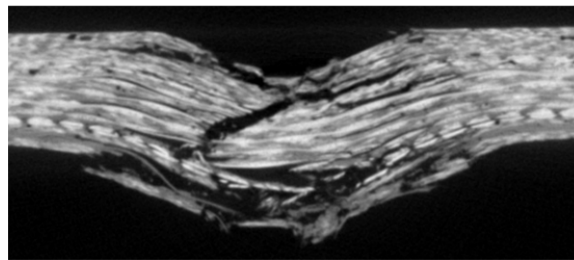
Figure 9: Tomogram of an hybrid Kevlar/fiber-glass laminate after the impact ( $v = 8$  m/s).

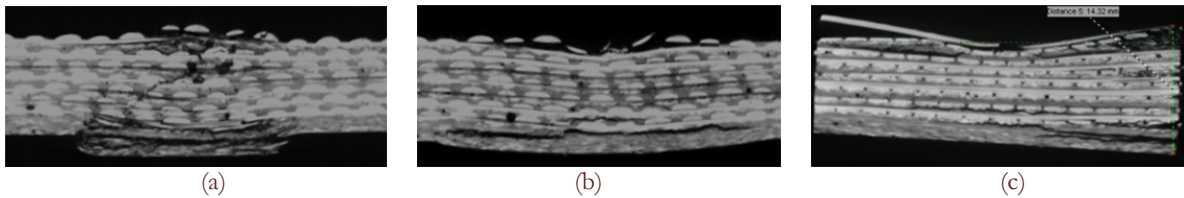
Figure 11: Tomograms of a GFRP laminated panel after the impact ( $v = 6$  m/s).

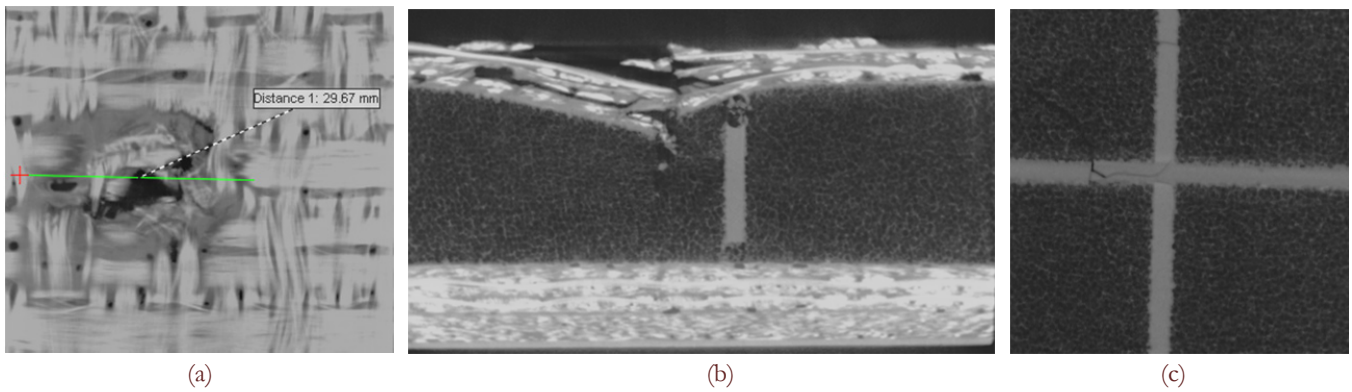
The CT investigations of the impacted polymeric sandwiches allow a better understanding of their failure mode, which is characterized by the rapid crushing of the PVC core (Figs. 12 - 14). Careful observation of the failure sequences in these specimens at various impact energies showed that the failure was produced by the formation of matrix cracks in the central region of the skin under the impactor (Fig. 12) and, for tests at higher impact energy, the cracks propagated along

Figure 12: Tomographic images of the damaged GFRP-PVC foam core panel after the impact ( $v = 4$  m/s).

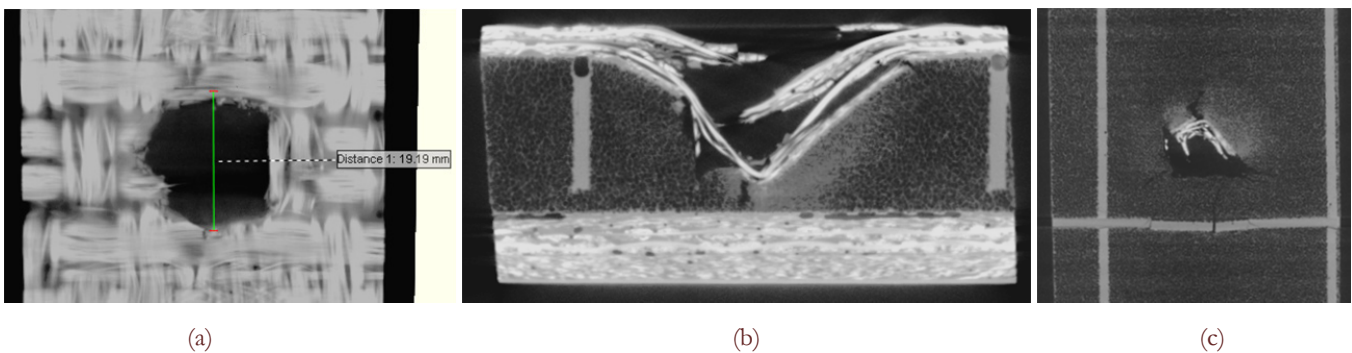
the adhesive/face interface, which resulted in core fracture (Fig. 13), failure of vertical reinforcements and delamination of the lower skin, as shown in Fig. 14.

Figure 13: Tomographic images of the damaged GFRP-PVC foam core panel after the impact ( $v = 6$  m/s).

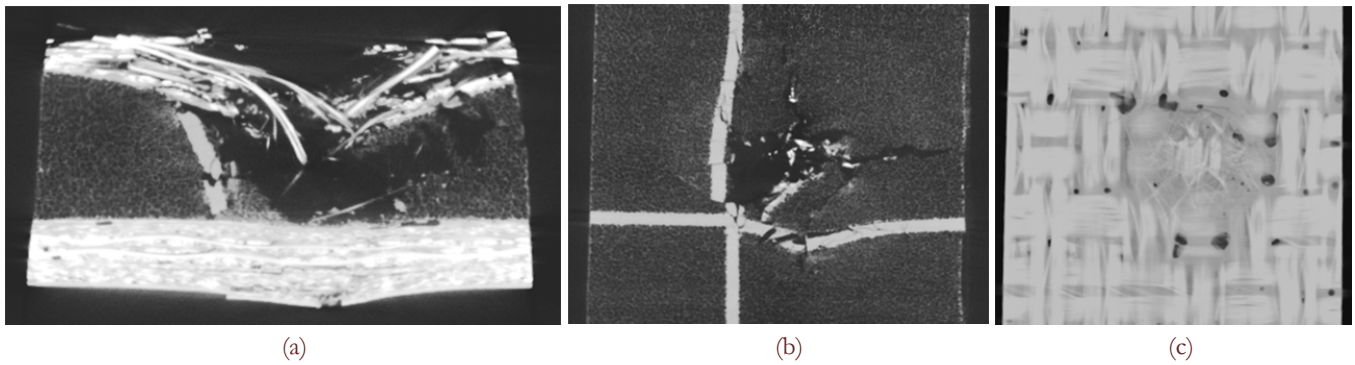
Figure 14: Tomograms of GFRP-PVC foam core panel after the impact ( $v = 7$  m/s); the ply in (c) is on the lower skin of the sample.

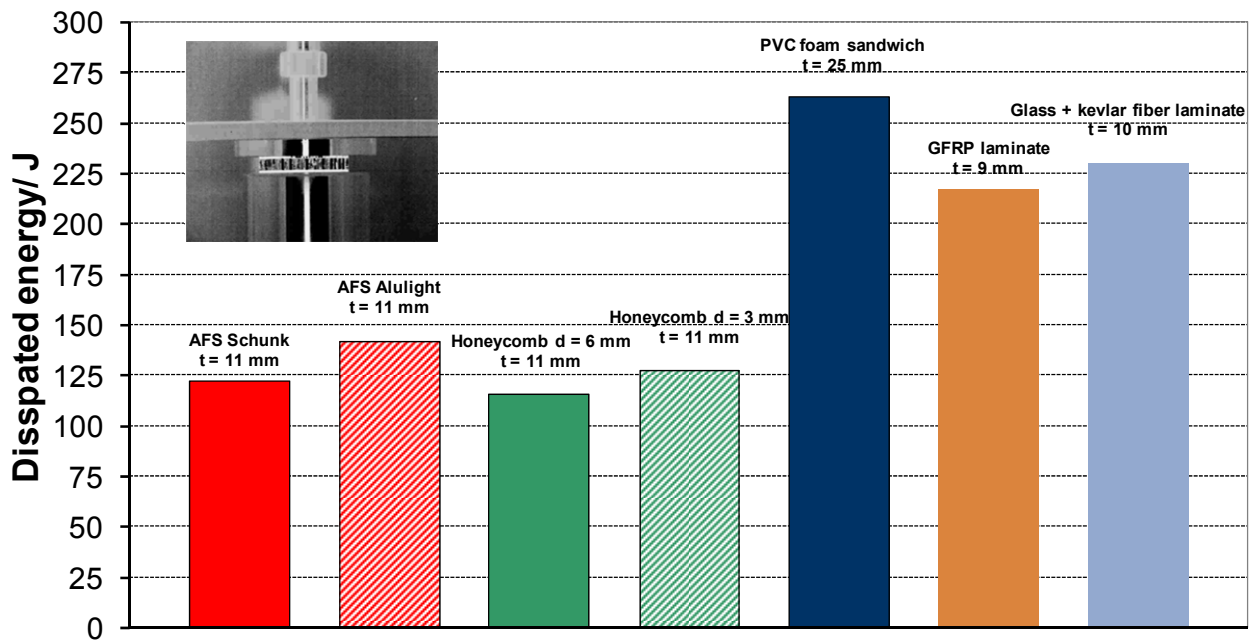
The values of energy required to produce the complete failure of the investigated composites are reported in Fig. 18.

Figure 18: Energy required to produce complete failure of the investigated composites.
