An Experimental and Numerical Investigation to Characterize an Aerospace Composite Material with Open-Hole Using Non-Destructive Techniques

Abstract: In this study, the open-hole quasi-static tensile and fatigue loading behavior of a multidirectional CFRP thick laminate, representative of laminates used in the aerospace industry, is studied. Non-destructive techniques such as infrared thermographic (IRT) and digital image correlation (DIC) are used to analyze the behavior of this material. We aim at characterizing the influence of the manufacturing defects and the stress concentrator through the temperature variation and strain distribution during fatigue and quasi-static tests. On the one hand, the fatigue specimens were tested in two main perpendicular directions of the laminate. The results revealed that manufacturing defects such as fiber waviness can have a major impact than open-hole stress concentrator on raising the material temperature and causing fracture. In addition, the number of plies with fibers oriented in the load direction can drastically reduce the temperature increment in the laminate. On the other hand, the quasi-static tensile tests showed that the strain dis

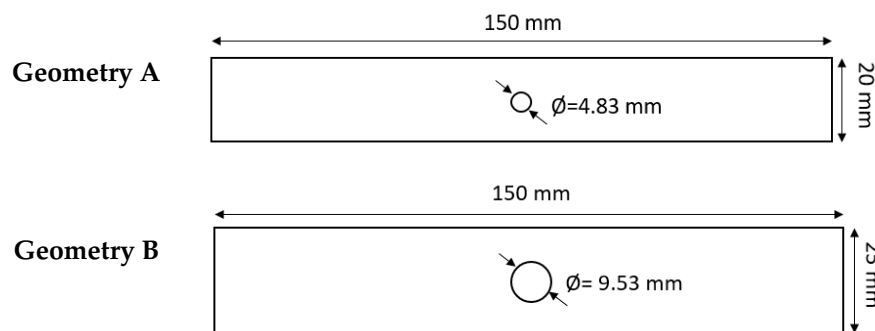
Two different geometries are used in the study, depicted in Figure 1. Samples of these geometries were prepared for both the longitudinal and transverse direction of the original laminate plate material. The hole and the external perimeter were cut using an abrasive waterjet cutting technique.

Figure 1. Geometries of the CFRP specimens. Samples of each geometry were cut considering both the longitudinal and transverse directions of the original laminate plate.

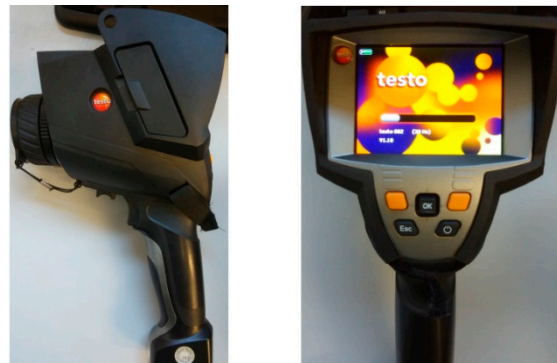
For this analysis, all tests were conducted at room temperature. During fatigue testing, infrared images of the samples surfaces were acquired using an IR camera (Testo 882, Titisee-Neustadt, Germany) to measure the variation of the specimen surface temperature. This camera is shown in Figure 2. The IR camera pixel resolution of 320×240 and the temperature sensitivity of 50 mK was sufficient to monitor the temperature variation accurately.

Figure 2. IR camera Testo 882 to measure surface temperature variation used during fatigue tests.

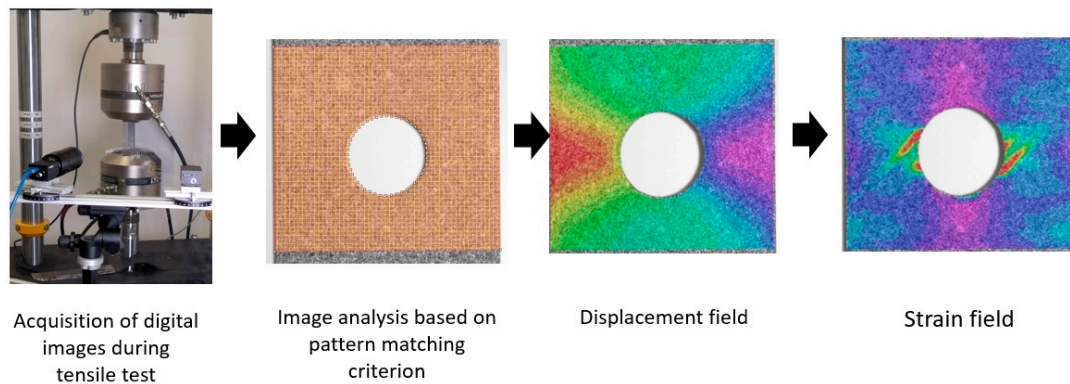
application process is shown in Figure 4. As can be seen, the DIC technique enables the detection of strain concentration zones in the analyzed structures, and it is also possible to identify the regions where cracking is initiated.

Figure 4. Scheme of digital image correlation (DIC) procedure.

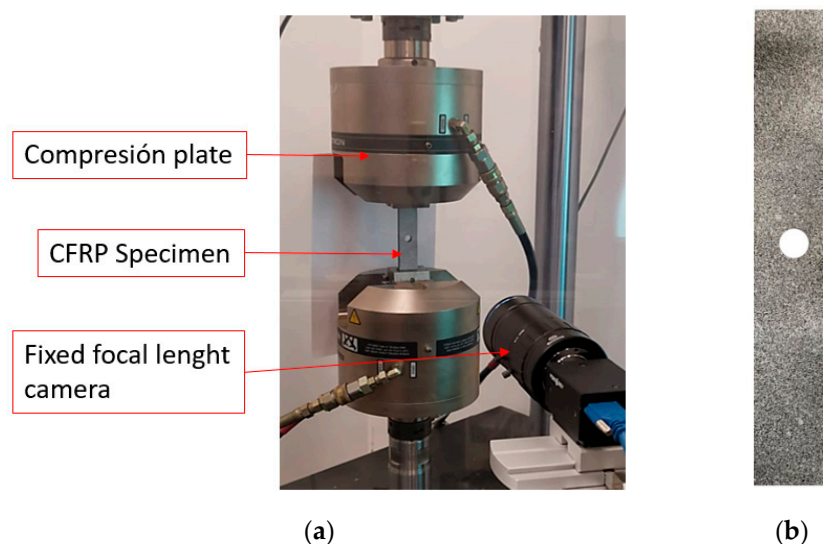
Images were taken with a high resolution fixed focal lens (HF7518V-2, Myutron, Tokyo, Japan) and extension rings of 10 mm (focal length of 65 mm). In order to apply DIC, the upper layer surface of the specimen was speckled using randomly distributed black and white spray paints to increase contrast, as shown in Figure 5b. Moreover, the quality of the pattern was inspected using VIC-2D Digital Image Correlation software (v.6.0.2 Correlated Solutions Inc., Irmo, SC, USA) to verify optimum speckle pattern on the surface of the specimens. A perpendicular relative position between camera and specimen was ensured to acquire images and to avoid out-of-plane displacements during testing, as shown in Figure 5a. All tests were performed under displacement control mode with quasi-static conditions, and an applied displacement rate of 2 mm/min following the D5766/D5766M standard [68]. The force-displacement response data were registered. No pre-load was applied, and all tests were continued until the global failure of the specimens.

Figure 5. (a) Experimental testing and imaging set-up; (b) tensile specimen with speckled pattern.

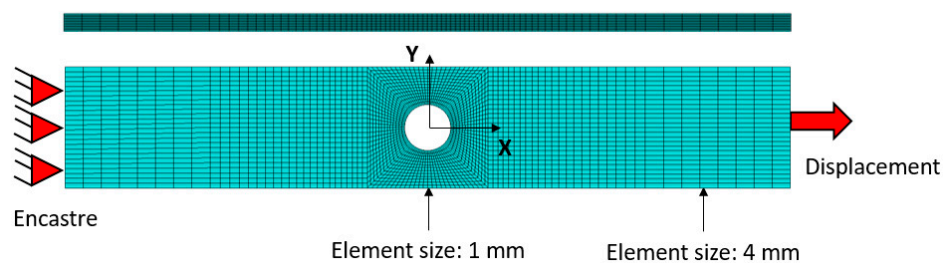
Finite element models of each configuration were developed using ABAQUS/Standard code, aimed at simulating the quasi-static tests described previously. Each model reproduces the multidirectional carbon fiber component described earlier. The laminate is implemented with 3D solid elements C3D8R (8 node-linear brick, reduced integration and hourglass control), with a size of 1 mm close to the hole zone and 4 mm far from this area. One element per ply is defined through the thickness. The symmetry plane in the stacking sequence is considered, hence only half of the laminate is defined (27 plies) to save computational time. The displacement of the workpiece is restricted at one side and a fixed velocity of 2 mm/min is applied to the opposite side simulating the same experimental conditions. All the layers are tied. The scheme of the full model, including boundary conditions, is presented in Figure 6.

Figure 6. Representation of the finite element model generated considering the test conditions. A high level of discretization was defined at the stress concentration region.

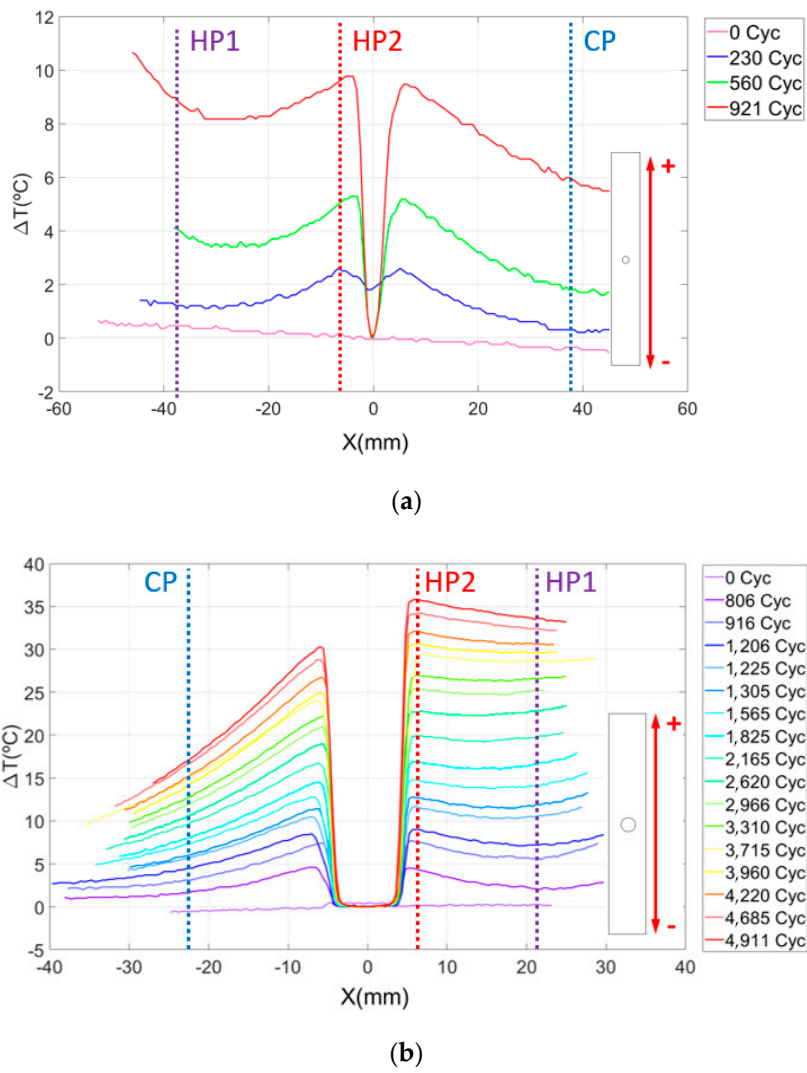
The results of the thermographic analysis in CFRP specimens with-open hole are now presented. Figure 8 presents a plot of the evolution of the temperature increment in the longitudinal middle section of the specimen cut in the direction of the fibers at 0° as a function of the number of load cycles. The variation in the temperature in the Y axis is calculated as $T_{(x)} - T_0$ where $T_{(x)}$ is the temperature of the material at x distance from the center of the hole in a vertical direction and T_0 is the initial temperature of the specimen. This expression defines the temperature origin at the hole and is used as an indicator of damage progression.

Figure 8. Evolution of the surface temperature variation as a function of the number of load cycles in specimens cut at longitudinal direction for (a) geometry A and (b) geometry B.

The second phenomenon is related to the fact that the variation of the temperature at one side of the specimen increases faster with the number of cycles than at the other side. This can be clearly observed in Figures 8 and 9. This thermoelastic response breaks the temperature symmetry along the material characteristic for a low number of cycles, resulting in a non-symmetric thermoelastic response unexpected in simple uniaxial tension. We hypothesize that it is probably caused by the fiber waviness of the laminate. Fractured specimens observed under optical microscope revealed that the breakage of the material is affected by these manufacturing defects. Thus, fracture is located near the area with important ply misalignment, as observed in Figure 9b.

To quantify the influence that both stress raisers (open hole and fiber waviness) have on the material temperature distribution under fatigue conditions, Tables 1 and 2 show the absolute temperature of the surface material at points close to the stress concentrators, named Hot Points, and the temperature in an area far from both critical points, named the Cold Point. These points have been marked with a line in Figure 8 as HP1 and HP2 and CP, respectively.

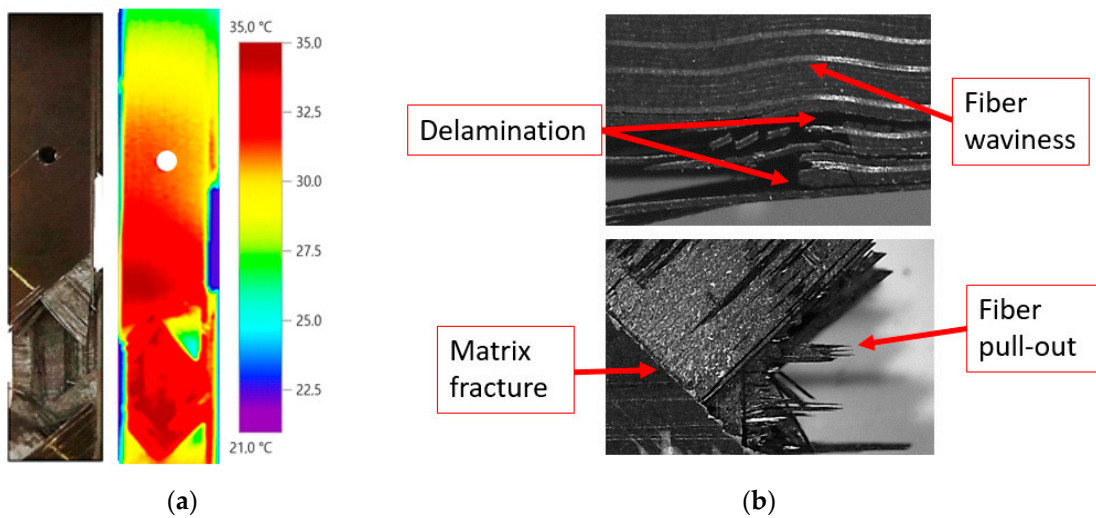
Figure 9. (a) Specimen temperature at breakage time for geometry A and (b) failure mechanisms observed under optical microscope after breakage.

After analysis of the results, it is observed that waviness produces an area of higher temperature where failure occurs. The combination of the local undulation with the stress raiser due to the hole leads to a more critical condition than at the opposite side. For the case shown in Figure 9a, the load was around 85% of the static strength, causing the breakage close to the area with manufacturing defect, as mentioned. For the geometry B, the load was around 70% of the static strength, causing a delamination less severe in the fiber waviness area as shown in Figure 10b. In this case, the fracture was located through the hole (see Figure 10a). The difference between the two specimens was also observed in Figure 8. In these plots, the maximum temperature is reached in the area where final catastrophic failure was located.

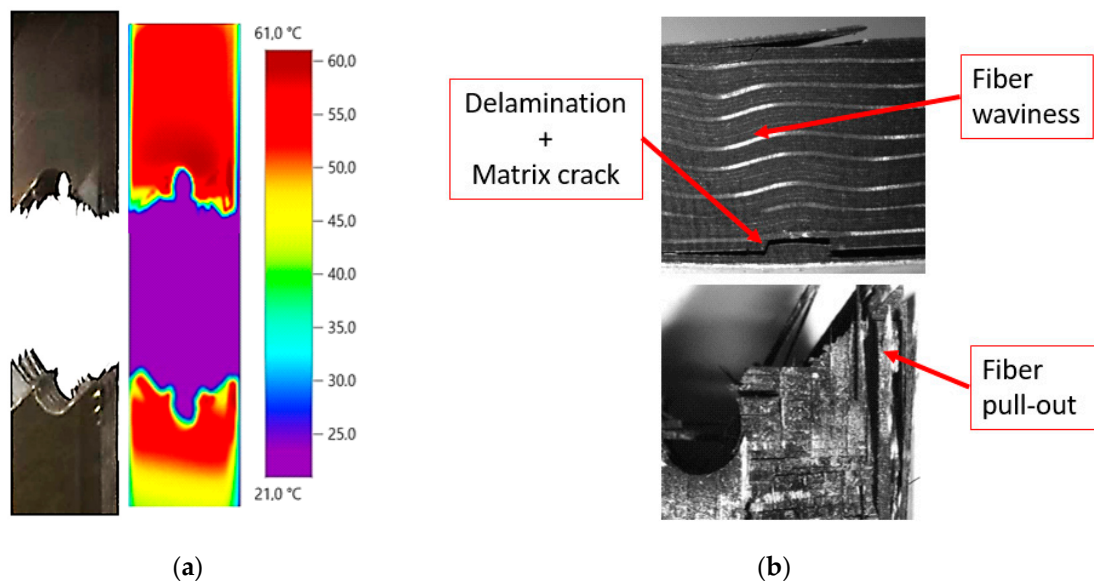
Figure 10. (a) Specimen temperature at breakage time for geometry B and (b) failure mechanisms observed under optical microscope after breakage.

On the one hand, the fiber waviness (HP1) raises the laminate surface temperature by 41% and 95% before breaking for geometries A and B, respectively. On the other hand, the surface temperature around the hole (HP2) increases by 35% and 111% for the same geometries. This means that the damage pattern of the material is also characterized by a greater temperature gradient at these regions, as shown in Figures 9 and 10. In the cold area, the surface temperature value increases only by 27% and 32% for geometries A and B, which points out the clear influence of the waviness and hole on temperature variation, due to the high stresses detected. In this area, minor damage was observed at the microscope.

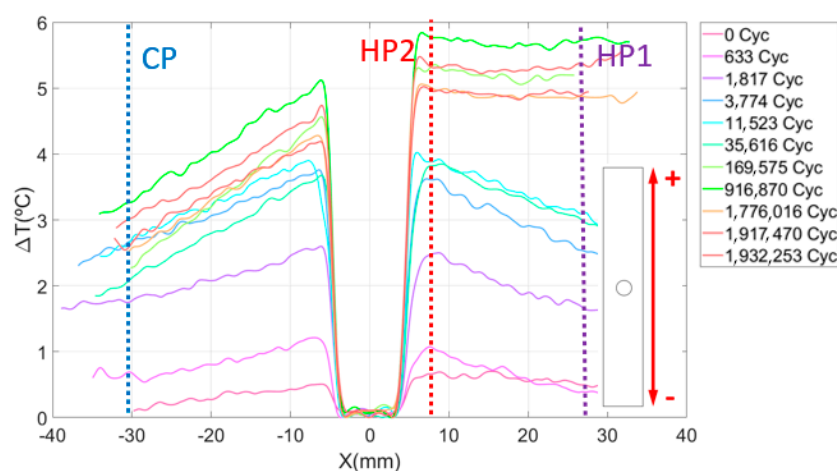
For the specimens cut in perpendicular direction to the plies at 0° , the damage initiation and progression scheme was similar to the previous samples. The results for these configurations are presented in Figure 11. In this case, none of the tests reached breakage because the number of plies oriented in the load direction is greater than the number of plies oriented at 0° , which increases the laminate resistance. For the same reason, the surface temperature increment is lower than the one detected in the previous specimens cut in longitudinal direction to the plate. In both cases, the load amplitude was kept, and the cycle limit was fixed at 2,000,000. Nonetheless, it is easy to identify the areas where the specimen presents defects because the surface temperature starts to increase faster than in other laminate areas. In addition, we can see that, by increasing the number of plies oriented in the traction direction, the presence of damage caused by waviness is delayed with the number of cycles.

Figure 11. Evolution of the surface temperature variation as function of the number of load cycles in specimens cut at transversal direction for (a) geometry A and (b) geometry B.

Tables 3 and 4 show the surface temperature of the specimens measured for the Hot and Cold control points. In this case, increments of 35.7% and 40.9% were observed for the fiber waviness defect and 26% and 23% for the open hole. For both cases, the temperature around the open hole is slightly higher at the beginning of the test. However, when the number of cycles increases, the temperature in the HP2 exceeds the temperature of the HP1 until the end of the test. This is probably an indicator of the failure initiation due to a fiber waviness [74]. Measured temperature at the cold point increases only by 19.8% and 23% for geometries A and B, respectively.

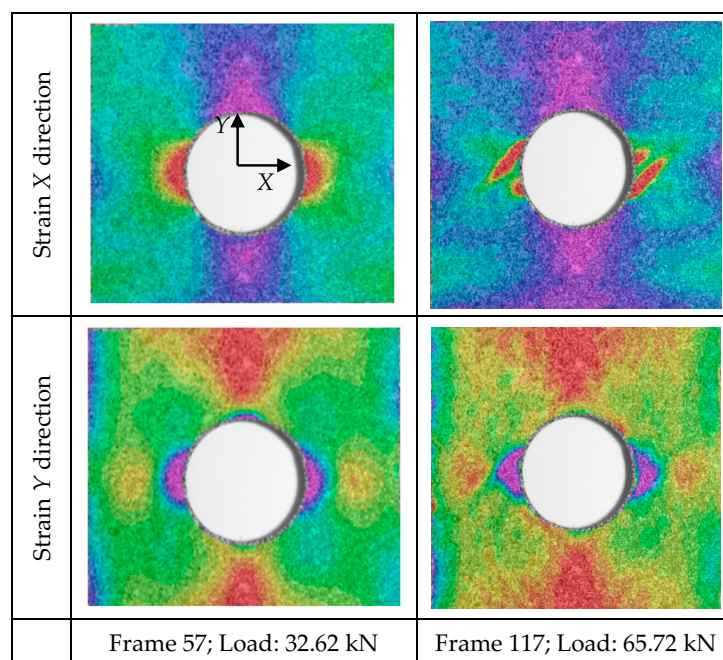
Results from the quasi-static tensile test, analyzed through the application of Digital Image Correlation, are discussed in this section. Figure 12 presents the engineering strain distribution in X and Y directions for different load steps of the test for a specimen of geometry B. The DIC technique clearly detects the strain distribution due to the stress raiser during testing. Moreover, it predicts the highly strained areas where fracture is prone to develop; see for example the inclined highly strained distribution surrounding the hole in Figure 12 (top right).

Figure 12. Strain distribution in X and Y directions for two different load steps.

Under small loads, the strain distribution around the open hole exhibited a pattern similar to the common pattern of an isotropic sample. As load increases, this pattern is modified because surface cracks appear (visually observed) in the open-hole region and increases the engineering strain in this area. The damage evolution observed in Figure 12 involves matrix splitting in the $+45^\circ$ ply, propagating from the hole edge at the location where the fiber direction is tangential to the hole. This damage pattern is also observed in similar studies with thin laminates [28,36].

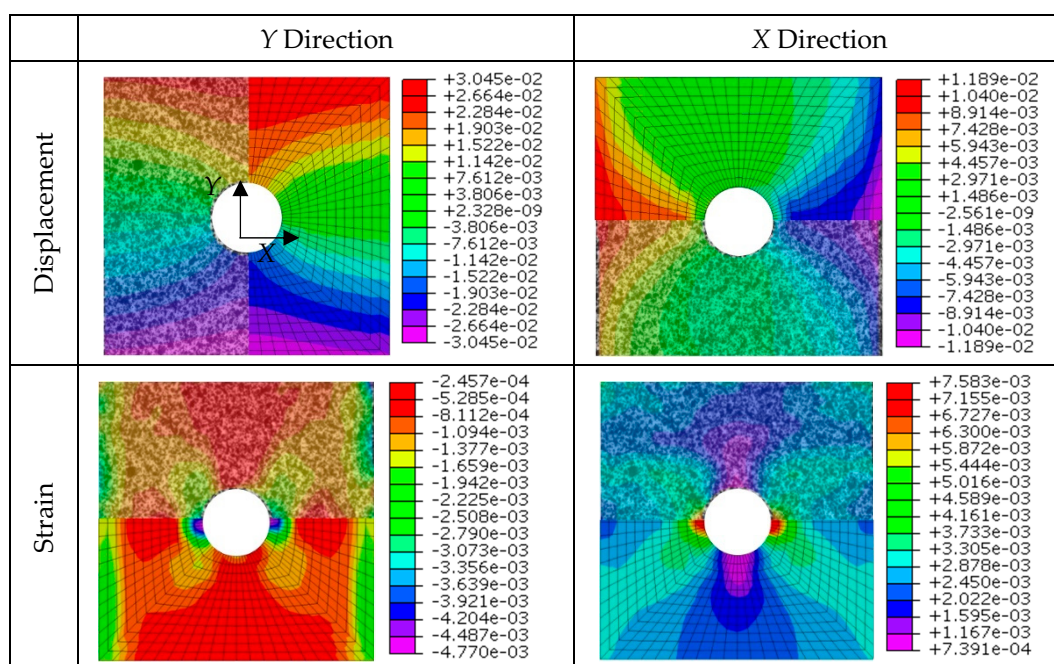
On the other hand, two finite element models that reproduce the static tensile testing were developed. They were validated against the experimental predictions of DIC technique. Specifically, both the displacement and strain fields have been compared for geometry A (Figure 13) and geometry B (Figure 14) configurations. It can be observed that the distribution of the field is very similar for both cases and in both directions, which validates the numerical models developed and points out the effectiveness of DIC technique for surface displacement analysis.

Figure 13. Comparison of displacement and strain fields between DIC estimation and numerical prediction for geometry A.

The model predicts the displacement value with an error of 4.2%, which is acceptable. The results of the maximum and minimum displacement values obtained are presented in the following Tables 5 and 6 for geometries A and B, respectively. Results are shown for three different instants from the start of the test. The minimum and maximum strain values have also been compared, obtaining similar results for the instants shown in Tables 7 and 8.

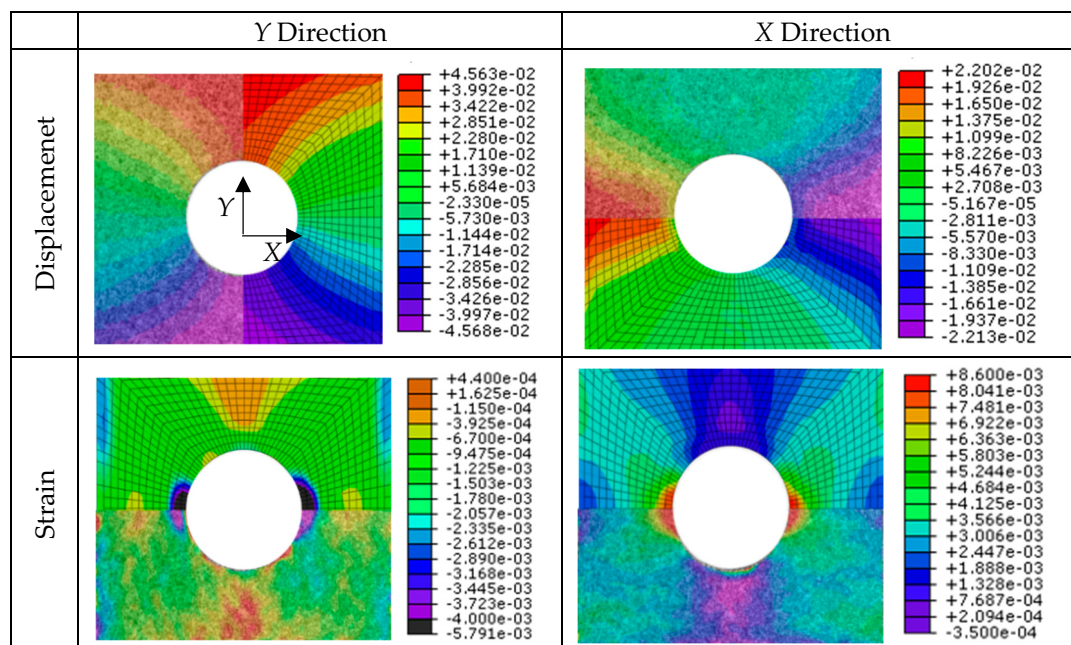
**Figure 14.** Comparison of displacement and strain field between DIC estimation and numerical prediction for geometry B.

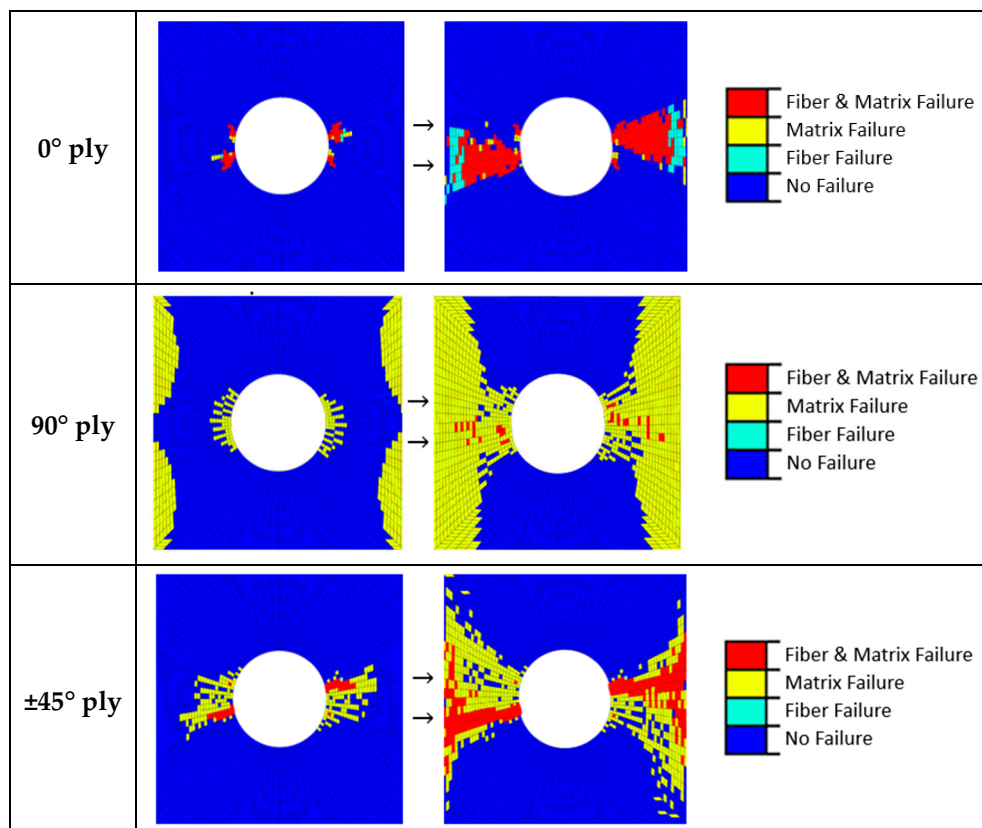
Finally, a damage study with the numerical model was carried out. Figure 15 presents the damage evolution for plies of the laminate oriented at 0° , 90° and 45° . The damage is induced with increasing the displacement in one side of the specimen. Plies at 0° are oriented in the loading direction. For this case, a combined fiber-matrix failure starts at the hole and propagates perpendicular to the loading

direction towards the border of the laminate. This damage accumulation strongly reduces the stress concentration introduced by the hole, and the fiber failure occurs in the simulation (see Figure 15; top).

For the plies not oriented in the load direction, the majority of the damage comprises the matrix cracking of the 90° plies. In this case, fibers do not undergo traction conditions and the matrix around the hole and the free edges suffer isolated damage (see Figure 15; middle). There is also some matrix cracking in the $\pm 45^\circ$ directions and some fiber failure. These plies initiate the matrix cracking. As the load is further increased, the damage grows across the width of the specimen from the hole in a “zone of influence”, bounded by $\pm 45^\circ$ (see Figure 15; bottom). Finally, a catastrophic failure happens. The sequence of damage events are similar to previous static models [52].

Figure 15. Failure patterns for different oriented plies of the CFRP laminate.
