Vibration Bending Fatigue Analysis of Additively Repaired Ti-6Al-4V Airfoil Blades

A thesis submitted in partial fulfillment of the
requirements for the degree of
Master of Science in Mechanical Engineering

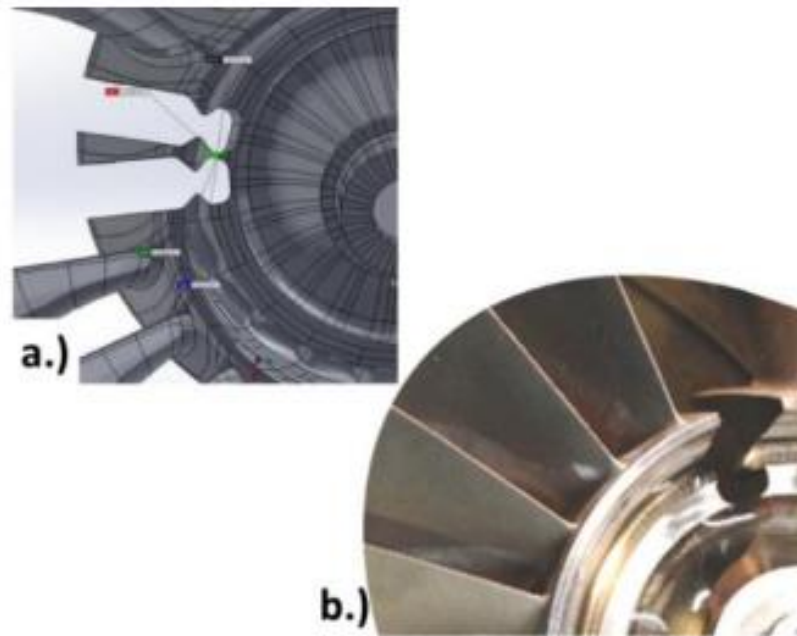
Figure 1: IBR examples with blades being attached to the hub as one large part. [1]

Modern jet engine rotors, referred to as blisks or Integrally Bladed Rotors (IBRs), have attached blades. These rotors get the designation of IBR since the blades are attached to the hub of the rotor as one solid piece of material, as shown in Figure 1. During operation in an engine, these rotors are spinning and vibrating at high frequency ranges, causing the blades to sometimes encounter multiple modes of bending. Each mode of vibration has an associated resonant frequency. This frequency is representative of the number of vibrations per second required for the blade to bend at each mode. There is an increased stress and strain that occurs when the blades vibrate at the resonant frequency that a given blade may have for the different modes of vibration. The blades on these blisks eventually experience failure, such as cracking, due to the high stress that is endured over long periods of use. When a blade becomes damaged, either a repair or replacement is required, but traditional rotor repair can take significant amount of time depending on the complexity of the damage and the number of parts that are experiencing the same type of problems.

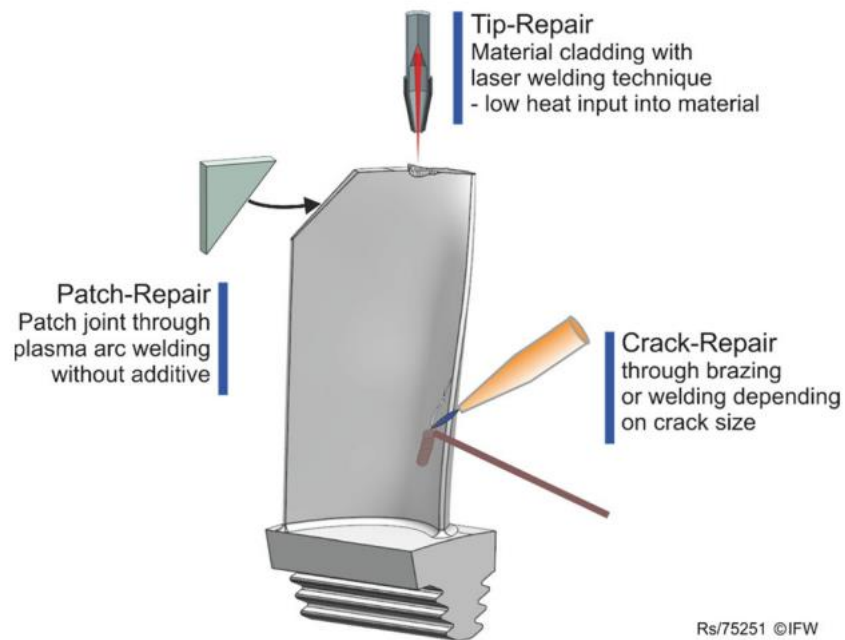
Figure 2: Examples of the current types of repairs that can be done for IBRs [2]

much strain as other regions may be. Currently, repairs for these low-stress regions include tip repairs using material cladding with a laser welding technique, crack repairs using either brazing or welding depending on the size of the crack, and patch repairs that weld chunks of material onto the blade in areas where the blade may have been removed. These types of repairs can be seen in Figure 2.

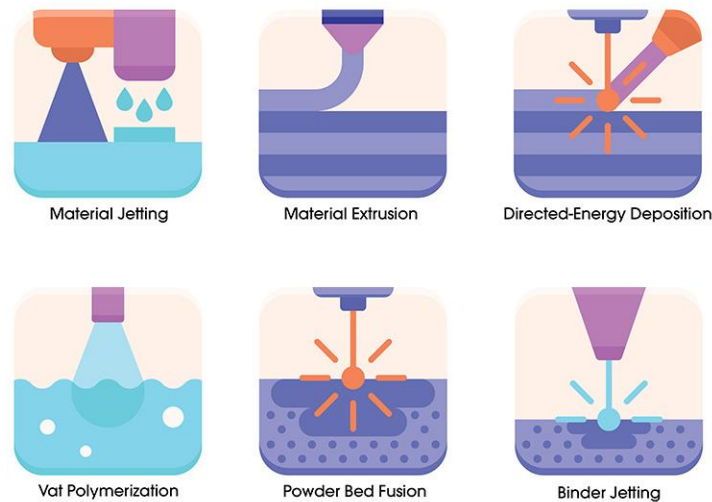
Figure 3: the different types of AM that are common today. [4]

Additive manufacturing (AM), also known as 3D printing, is a form of manufacturing that builds on a substrate in layers of material that are added one at a time. This manufacturing process has many different types and forms, as shown in Figure 3. There are six main types of AM: material jetting, material extrusion, direct energy deposition, vat polymerization, powder bed fusion, and binder jetting. Most forms of AM fall into one of these main category types. The goal of each of these AM techniques is to create a part by adding material to form a model. The blueprint for building an AM part comes from a 3D geometry file that can be made in many different types of computer aided

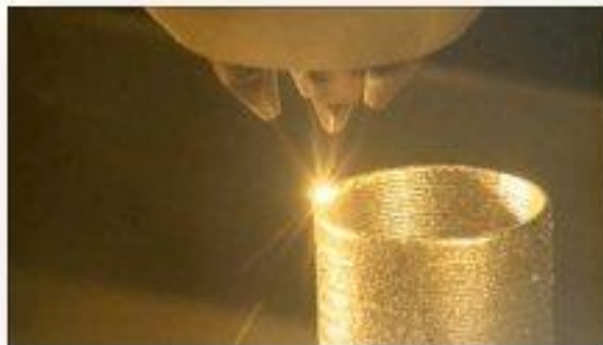
Figure 4: Directed energy deposition using blown powder as the feed source for the metal alloy. [11]

The purpose of this project was to find a process that will work for this type of repair and analyze the ability for it to be used safely and consistently. The technique that was chosen to complete blade repairs is commonly referred to as directed energy deposition (DED), but is similar to brazing, electron beam welding, wire and arc AM, and laser engineered net shaping (LENS™) [10-13] This process feeds metal alloy powder into a laser path that is then melted onto the component in layers [14-15]. These layers can fill large gaps in a component to complete a repair if the area is accessible to the laser [10]. DED processing parameters involve adjusting the feed rate of the metal alloy, as well as the speed the laser moves, and the power of the laser being used to melt the material. Small changes to any of these parameters can have significant impact on the quality of the final build. Figure 4 shows an image of what a powder fed DED process looks like during the building process.

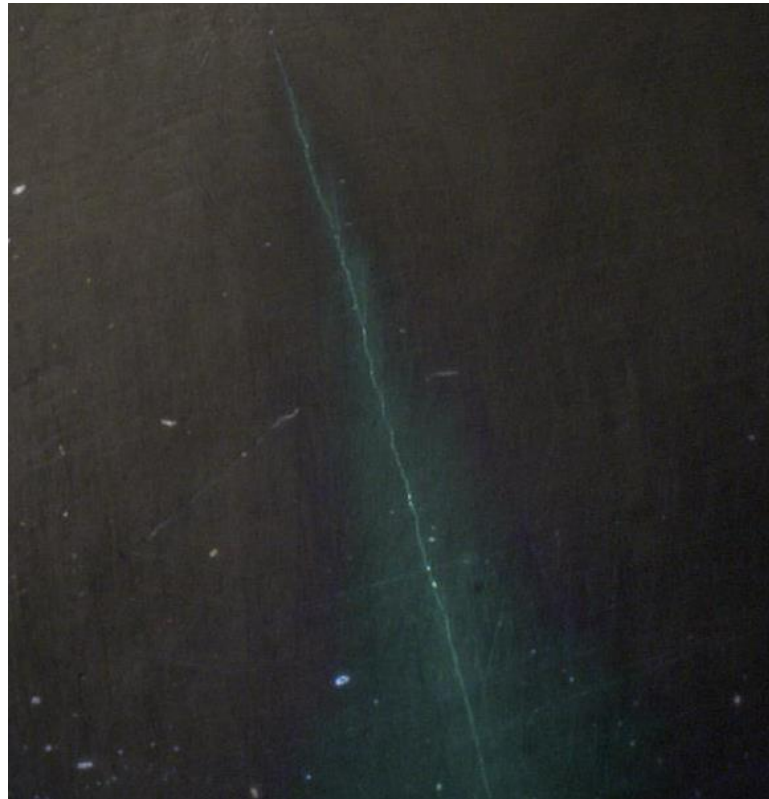
Figure 6: Crack found using FPI on a vibration fatigue specimen

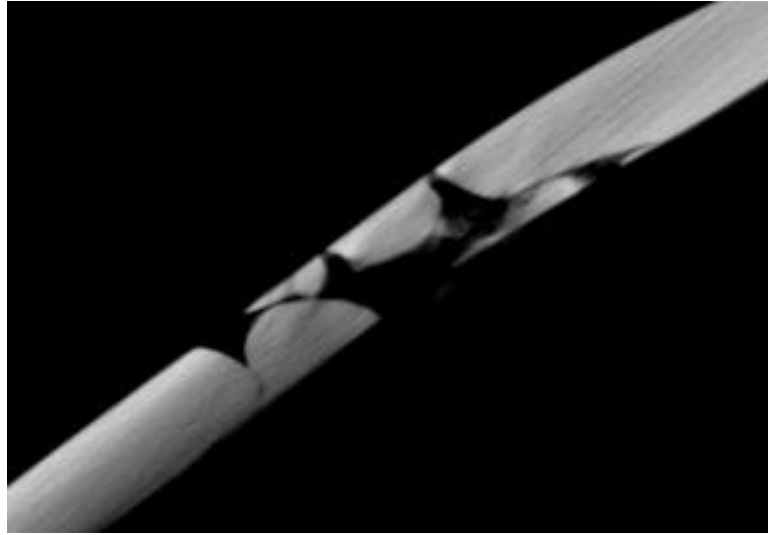
Figure 7: Large lack of fusion pore found in an image generated using CT scanning

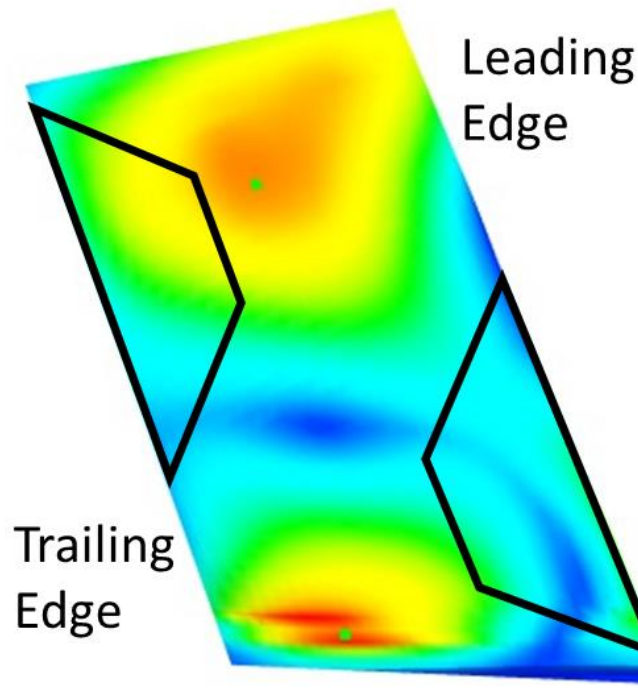
Figure 8: A maximum principal strain plot for mode two bending that shows the areas in which the repairs were made. The black trapezoid shapes outline the areas that were removed from the blades before the repair process began.

The blades that were repaired for this project were retired after being used in the field for multiple years, with some of the blades accruing several thousand cycles of use. To begin the repair process, a portion of the blade was removed to simulate the removal of a damaged portion of the blade [1]. This was done by removing trapezoid-shaped sections from the blade on the trailing edge and the leading edge that were near, but not in, high stress locations, similar to the shapes shown in Figure 8. Once these sections were removed using wire electrical discharge machining (EDM), the blades were repaired using a DED process to fill in the removed sections. In this type of process, the laser moved parallel to the edge while Ti-6Al-4V metal alloy powder or wire was deposited into the path of the laser to create layers of deposited material that moved from the inside to the outer portion of the blade. The blade was stress relieved following the AM repair.

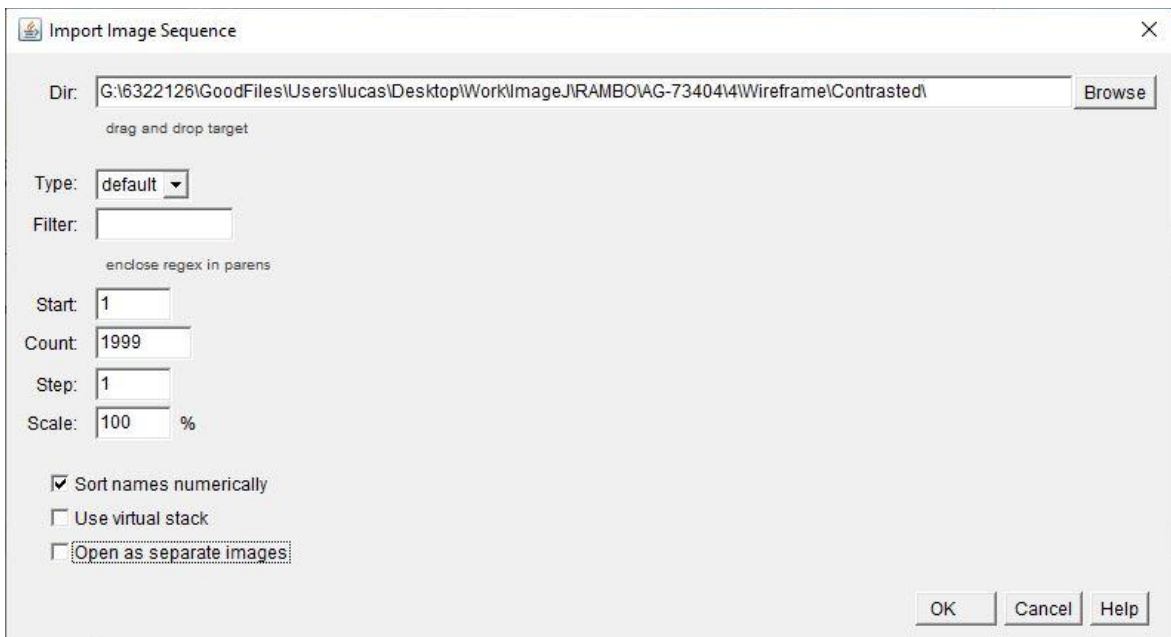
Figure 9: Import Image Sequence pop-up window in ImageJ

as a hyper stack, and open as separate images. The scans were always sorted numerically due to the order of the images being crucial to the processing steps. A virtual stack is helpful because it opens much faster, but it is limited in terms of the processing steps that can be completed, so this was typically avoided. Opening as separate images for this project had no benefits whatsoever. The OK button at the bottom of the window was selected once the desired selections were made.

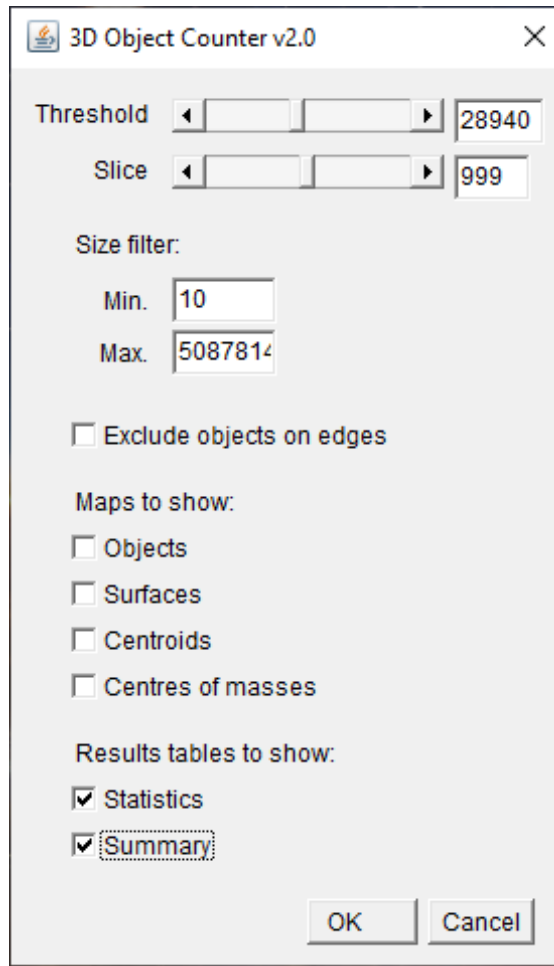
Figure 13: 3D Object Counter tool pop-up window from ImageJ

The final step for image processing using ImageJ was to complete a 3D measurement of the pores in the CT scan. Measuring the pores in 3D was completed using the 3D object counter feature in the software. First, the types of measurement that were going to be made had to be selected, like the first set of measurements from above. Selections were made by choosing analyze in the tool bar, then 3D OC options, and choosing which things should be measured in the process. The measurement feature was found in the analyze section of the tool bar, then selecting 3D object counter. This selection opened the 3D Object Counter pop-up window shown in Figure 13. Completing this measurement also produced a window with results that could be saved as an excel file, with all the measurements including the z-direction of the stack. This means the measurements spanned across multiple images at a time, not restricted to just one slice from the stack of the CT scan. Doing this allows for some interesting calculations to be done with the

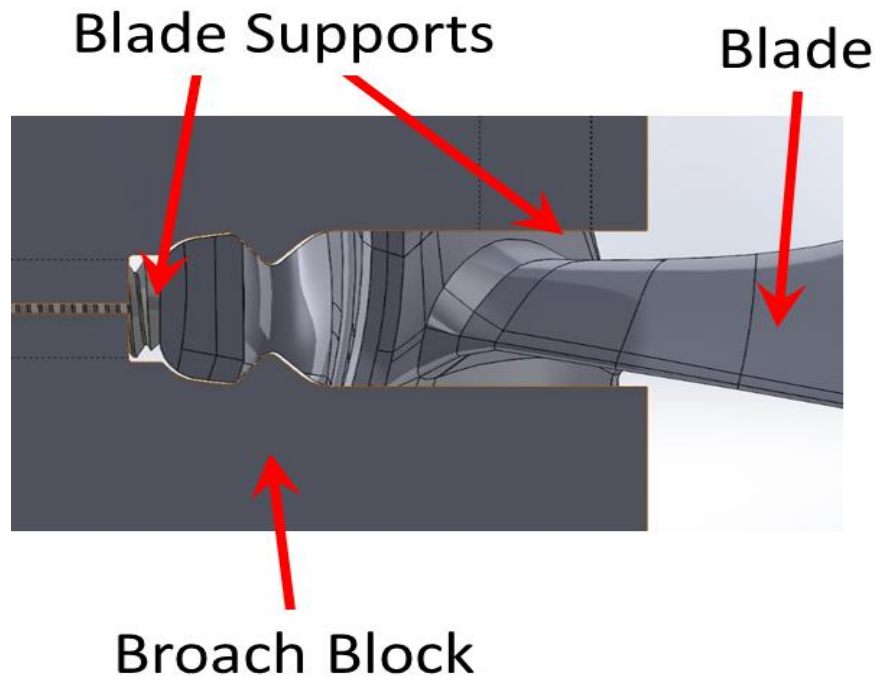
Figure 14: Broach block set up used for testing the fatigue life of the repaired blades

The method used for testing a jet engine blade in application relevant loading was to attach it to a hydraulic shaker and vibrate it at the mode two resonant frequency to create a large strain, and thus, a large stress that caused failure. To do this, the blade was inserted into a custom broach block, shown in Figure 14, that was tightened to 120 foot-pounds. The broach block was then bolted down onto the top of the Unholtz-Dickie Electrodynamic Shaker System, as shown in Figure 15. Properly securing this apparatus was very important because any movement of the blade in the broach block system could have resulted in inaccurate test results. The sensitive nature of the vibration fatigue testing requires a high level of precision and minimizing the unnecessary movement of the specimen is a large part of keeping the test accurate. This method has been used in application relevant loading for previous work with similar configurations [34, 35].

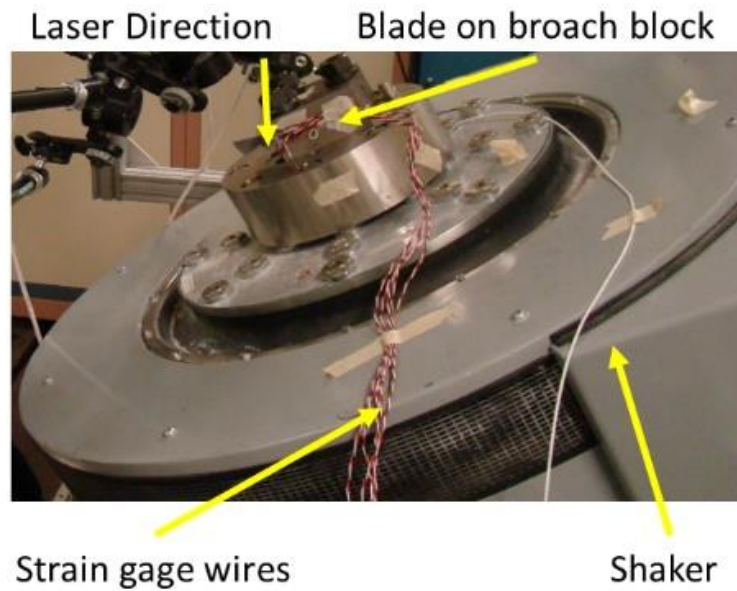
Figure 15: Testing Apparatus set up of broach block and blade on the Hydraulic Shaker

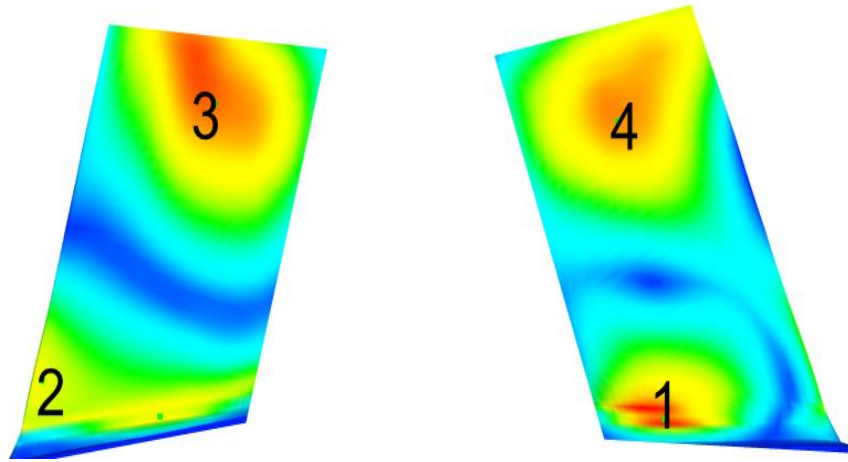
Figure 16: Maximum principal strain plot from FEA of a blade in mode 2 bending that highlight the top four area of highest strain

Using the FEA strain locations and the preliminary baseline testing, a typical failure location was found. All of the non-repaired blades that were fatigue tested on the shaker set up failed at the root, shown by the number one displayed on Figure 16. This is the highest strain, and therefore the highest stress, that the blades experienced on the shaker when vibrating in the mode two bending shape. The other three regions are also area of high strain but given as a percentage of the maximum from area one. Location three is the second highest strain on the blade at 98.2% of the maximum value. The fourth location is next with 94.4% of the strain at location one, and the least of these locations being 76.9% of the maximum strain at location two. Making the cuts and repairs near, but not in, the two highest strain locations was the goal to push the limits of the repair processes and find out what the limitations really were. This also allowed for larger pores to be created without causing a huge drop in mechanical performance due to the location of the pores not being in the highest strain area of the blade.

The typical failure point on this type of blade occurs at the root, near the trailing edge where a fillet occurs that transitions from the airfoil to the base of the blade. This failure point is expected because the maximum stress being located at this location for this type of blade testing based on the FEA results. Figure 16 shows the stress contour plot of the blade after an FEA analysis that simulated the shaker testing where the blade is clamped at the base and vibrated at the frequency that targets the second mode of bending. Figure 16 shows two regions of high stress for this mode shape, one as described before at the root, and one in the center of the blade that is closer to the tip. The region in the center is a result of the second node line where almost no displacement occurs due to the mode two bending shape. This node line causes increased stress as a result of low displacement in that region, but the stress is not larger than the max stress location at the root. The AM repairs were completed near this second location of high stress at the center of the blade to

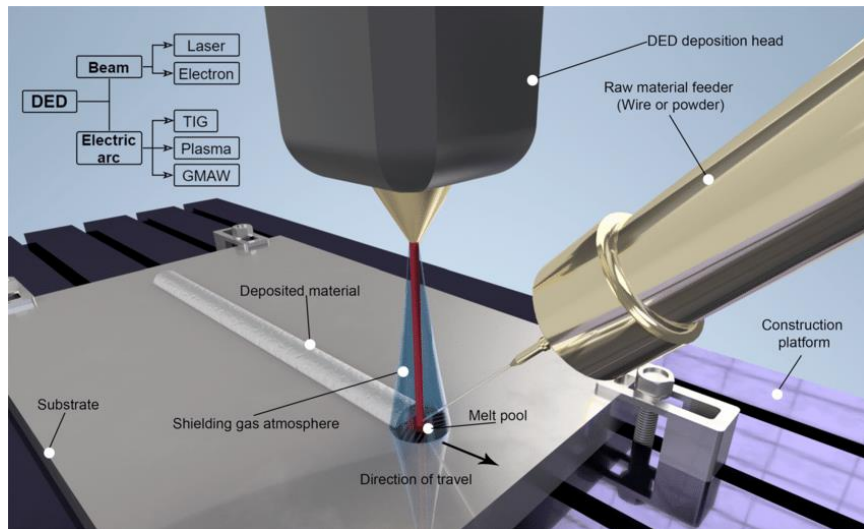
Figure 17: General procedure diagram for the wire DED process [24]

There was a total of eleven blades that were repaired using the Wire DED process. These repairs began once the correct section had been removed from each blade. All wire DED repairs were completed on blades that had been removed from the IBR. Figure 17 shows a general diagram of how the material was added to the blades during this process. The blade was secured in place beneath the deposition head in the proper area needed for the Ti-6Al-4V wire feed to reach the surface. This wire feed was heated to allow for easier melting and deposition onto the blade. Once the wire contacted the blade surface, the 6 kW laser melted it into the gap of the blade in layers that started on the interior of the blade and moved out to the edge. The heat required to complete this process could not be contained solely to the repair area. This created a heat affected zone (HAZ) around the repair and in the base material of the blade. This boundary and heat affected zone is known for creating large defects because this is where the deposition must “turn around” and move along the repair in the opposite direction. Since the deposition could not be exactly precise on

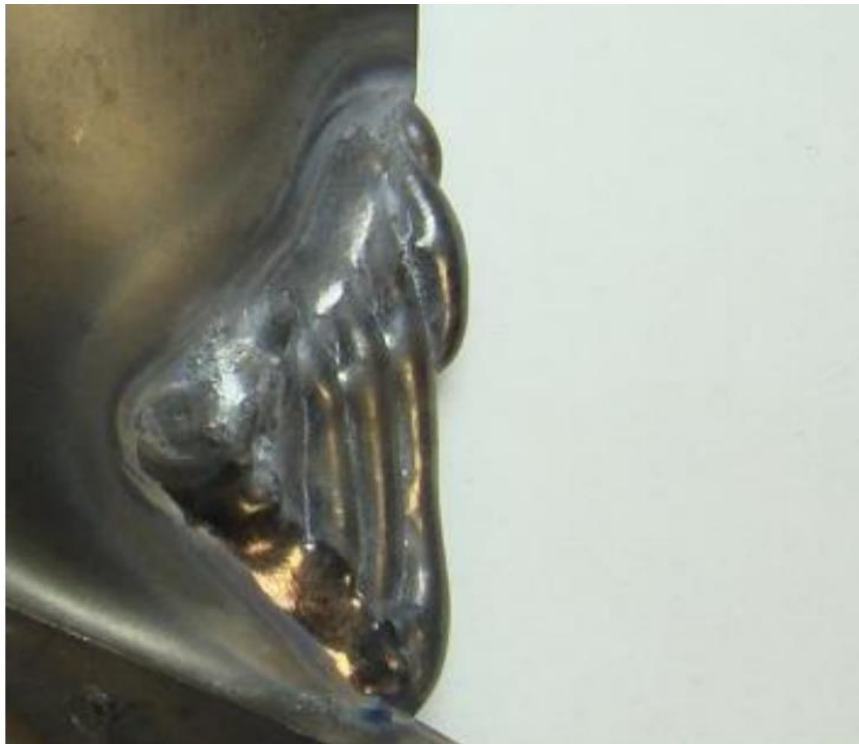
Figure 18: Final result of a wire DED process repair deposit before it was polished back to nominal geometry

matching the thickness and geometry of the blade being repaired, the deposited area was thicker than the blade, as shown in Figure 18.

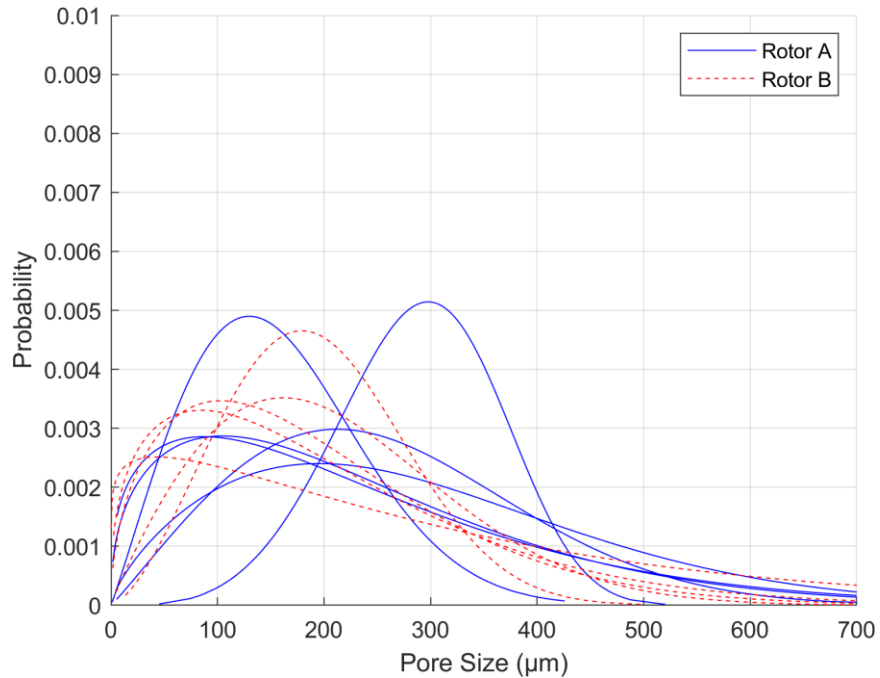
Figure 19: Probability density function for pore diameters of each wire DED repair from Rotors A and B

Figure 19 shows the probability distribution function (PDF) of the pore sizes among all the wire DED repairs, blue being repairs from rotor A and red being rotor B repairs. This graph represents the probability of a pore being created versus the size that pore could be, given in μm . The area under the curve for each of the repairs represents the total probability of a pore being created up to a specific size. The peak of the curve represents the most probable pore size for each repair. A sharper peak at a lower value of pore size is better since this indicates an overall smaller range of pore sizes being found in that repair. Although peak at a lower value is more ideal, it is important to remember that there is still a 50% chance of a pore being created that is larger than this peak value. Using this type of graph, it is easy to see the inconsistency of the wire DED process. Both the probability and the pore size start at zero on the graph, but the curves continue to span a pore size of over 700 μm . The span of the curve is representative of the range of sizes that was measured in each of the repairs. The larger the span of the curve along the x-axis, the larger the pores were for that given repair. The maximum size along the x-axis of this graph was cut off at

700 μm to focus on the peaks of the curves in the smaller size ranges, but these curves do continue onwards past the end of the graph shown here.

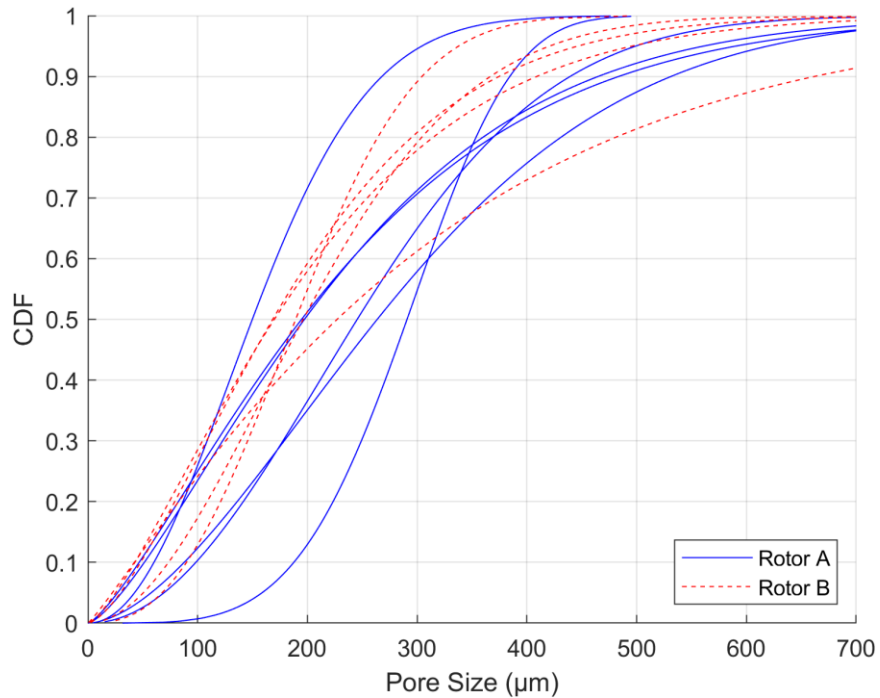
The next graph that was used to show the consistency of the repairs is the cumulative distribution function (CDF), shown in Figure 20. This graph shows curves that give the probability of a pore being created that are equal to or less than the size given by the x-axis. For example, going up from the 200 μm size will intersect the curve at a given value on the y-axis. This is representative of the probability that a pore will be created in that repair process that is 200 μm or less. The top of the curve approaches a value of one close to the maximum pore size found in each repair, confirming that the probability of a pore being created that is less than or equal to the maximum size is 100%. Like in Figure 19 that shows the PDF, some of the CDF curves continue off the chart past the 700 μm size. This is due to the maximum pore size for some of the blades being larger than this

size. Consistency is shown in a CDF when the curves end around the same pore size. This is not the case for the wire DED as many of the curves span a much larger range than the ones that are shown here.

Figure 20: Cumulative Distribution Function for pore diameters of each wire DED repair from Rotors A and B

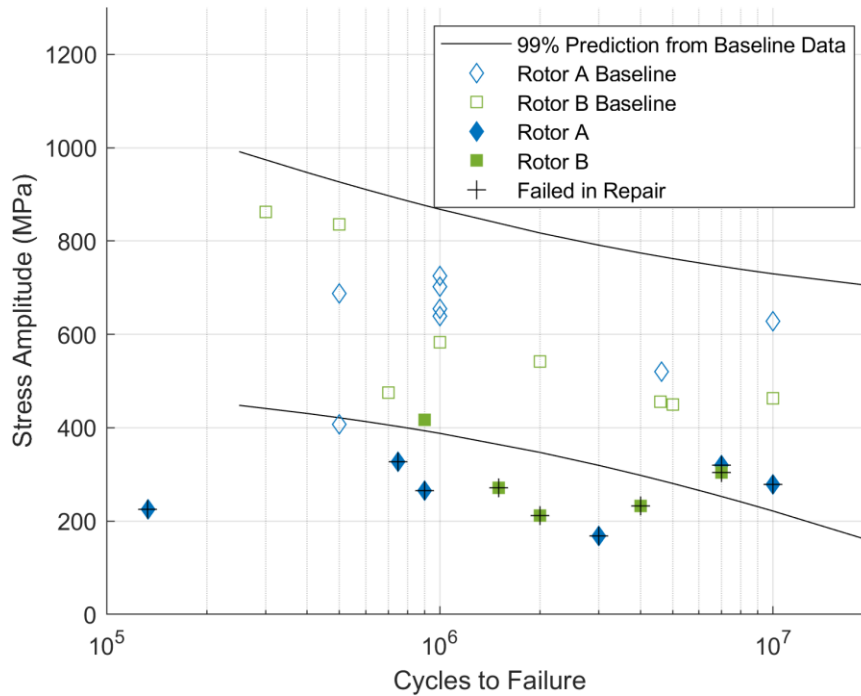
Conducting vibrational fatigue testing on the blades produced results for the failure strain and number of cycles to failure. The strain was converted into stress and used to create Figure 22, which is a stress versus number of cycles to failure. The stress value that was used here was determined by taking the strain from the strain gage that was placed at the root of the blade, then converting that strain to stress using the young's modulus. This means the failure stress that was used for every blade in this graph is the stress from the root of the blade, not the stress at the location of the crack formation. As shown in the plot, all but one of the wire DED repairs failed in the deposited material, away from the typical base material failure location at the root. Failures inside the repair material are marked on the plot with a plus sign over the original marker. The hollow markers represent the baseline blade testing data, with the blue diamonds showing rotor A and the green squares showing rotor B results. The filled in versions of these markers give the results for the repaired blades that were fatigue tested. The solid black lines on the plot give 99% prediction bounds that were generated using the baseline data of the non-repaired blades.

Figure 22: Stress versus Number of Cycles to Failure from vibration fatigue testing for each individual wire DED repair in Rotors A and B

Due to the type of step test that is conducted in the vibration fatigue testing procedure, there is a specific number of cycles required per step of the test. However, these steps do not begin immediately. There is a number of preliminary steps that are required to get the shaker up to the required speed for the first step to run smoothly. One of the wire DED repairs did not make it to this first step due to an incorrect estimation of the failure strain. This data point is shown on the far left near the bottom of the plot, very much outside the range of the 99% prediction data. Along with this data point, there are six other blades that failed outside of the prediction interval. This is simply because the failure stress was too low for the given number of cycles to failure to be inside of the range. Ideally, the repaired blades would fall into this prediction interval to prove that the repairs were a successful alternative to normal baselined data. With only four of the wire DED repairs

being inside of this prediction area, and three of those four failing in the deposited material, these blade repairs would be classified as unsuccessful.

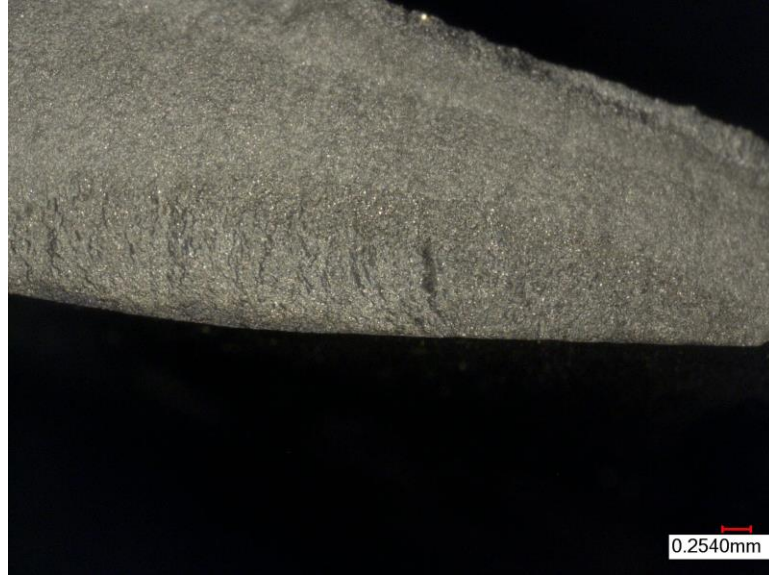
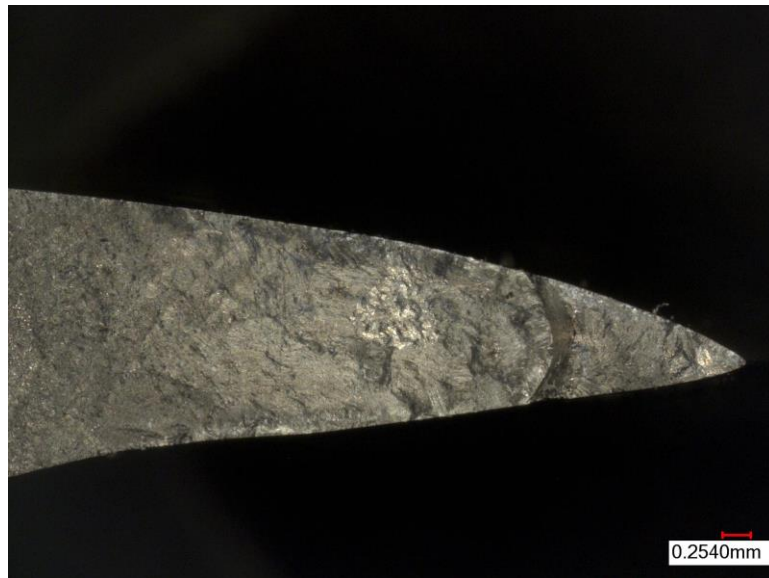
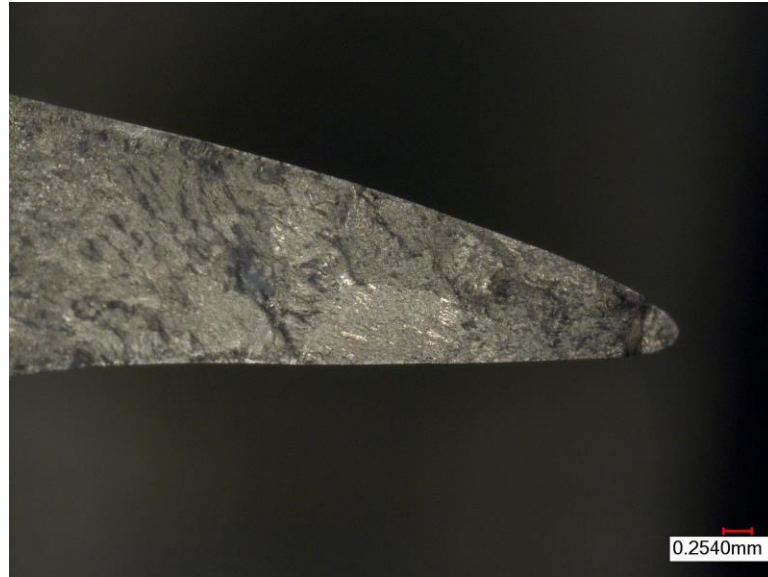
After the testing was completed on each of the blades, the crack was fully propagated, and the blades were separated to expose the fracture surface. These fracture surfaces are shown below as Figure 23. Analyzing these fracture surfaces helps to give more insight into the reason that these failures occur. The images shown in Figure 23 are similar to all the fracture surfaces that were analyzed from all the wire DED repairs. The first fracture surface here is blade B-2 which is the only wire DED blade that failed in the typical failure locations and in the base material. This fracture surface shows striations that point towards a crack initiating at the surface along the bottom of the image. The next image is the fracture surface from blade A-5. On the right side of the image is a large lack of fusion defect that caused the initiation of failure for this blade. This was the largest pore found in the entire repair as it spans the full thickness of the blade, from suction side to pressure side. The final fracture surface of Figure 23 is from blade A-11. Similar to blade A-5, there is a lack of fusion pore across the thickness of the blade closer to the leading edge. This was most likely the cause of fracture initiation as well, which can be confirmed by the small number of striations that are pointing towards this region throughout the rest of the image.

Figure 23: Fracture surfaces from wire DED repairs in blades a.) B-2 b.) A-5 and c.) A-11

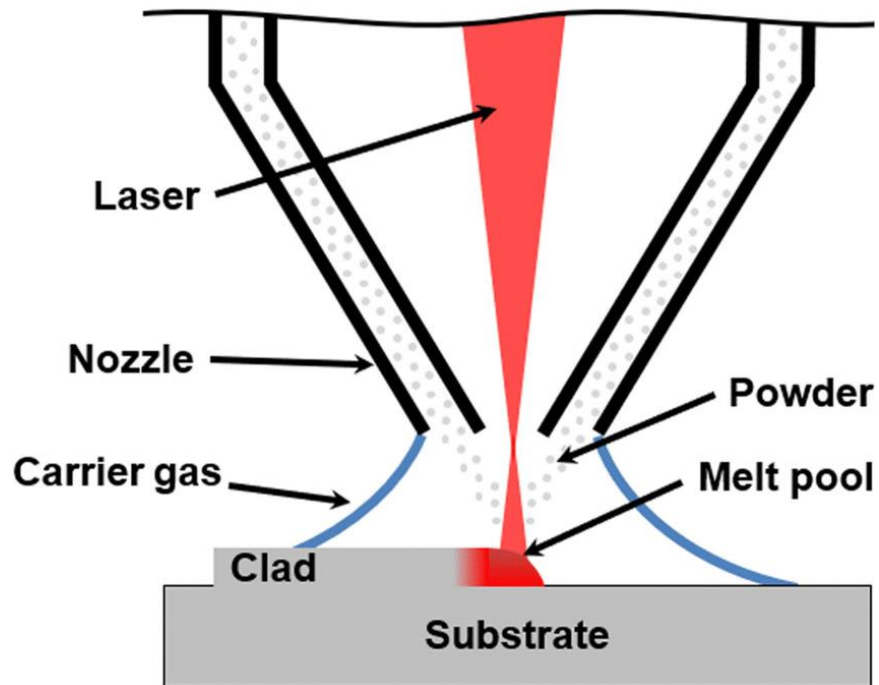
Similar to the wire DED process, the LBP-DED process melts Ti-6Al-4V alloy material to the surface of a component using a 1kW fiber laser. Both the laser and powder feeder move along the surface of the part to simultaneously blow powder into the specified area and melt the particles to the surface. This process can be generally described using Figure 24. The diagram shows the orientation of the laser and powder feeder, along with the formation of the material on the substrate. The process is run in an argon controlled chamber to prevent oxidation issues from occurring during the build. During the melting process, the laser was pulsing rapidly to prevent the part from overheating. Leaving the laser on the entire time could have caused the part to become overheated and created unwanted changes to the surrounding base material microstructure. This was avoided by using the pulsing technique with the laser.

Figure 24: Diagram of the general procedure for a LBP-DED process [25]

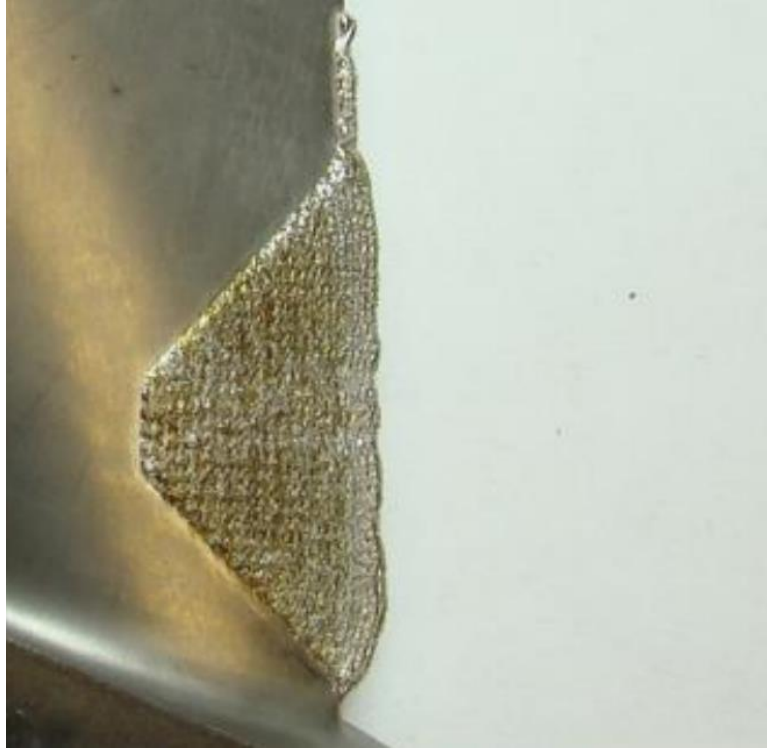
For the blade repairs, this system started at the inner most portion of the removed section and worked outwards, blowing powder into the gap, and adding one layer at a time. These layers were purposefully built larger than the blade to fill as much of the removed portion as possible, then the repaired area was hand polished back to nominal geometry afterwards. An example of the final deposit from a leading edge repair can be seen in Figure 25.

Figure 25: Final product of an LBP-DED repair deposit on an IBR blade before being polished back to nominal geometry

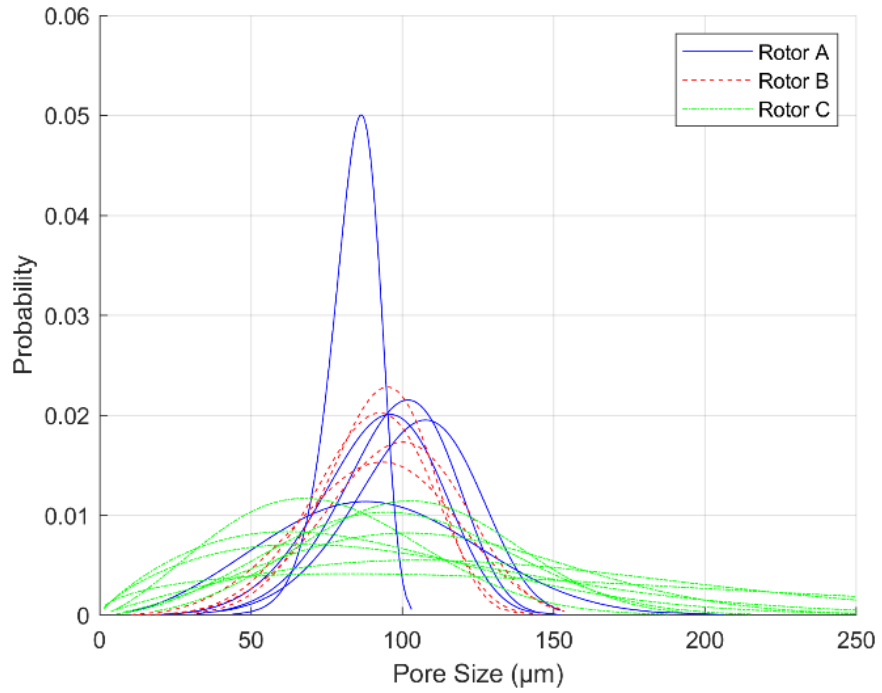
The one exception from rotor A that has the large spike on the graph is due to an extremely small number of pores that were found in the repair section of blade A-5, also seen in Table 3. Rotor C blades are shown by the curves that are flatter and wider due to the different repair procedure. This rotor has larger maximum pores and more pores overall, resulting in an overall larger range of pore sizes. This conclusion can also be made when looking at the CDF graph, which shows the probability of a pore being smaller than a given value. The lines on this graph appear to approach a value of one on the y-axis when the pores reach the maximum size for each individual repair, meaning there is a very high probability that a pore will be less than that size. It should be noted that these larger pores that were found in rotor C were found near the repair line. These lack-of-fusion pores were

created in the repair when the laser would have to turn around at the edge of the repair section.

Figure 26: Probability density function for pore diameters of each individual LBP-DED repair from Rotors A, B, and C

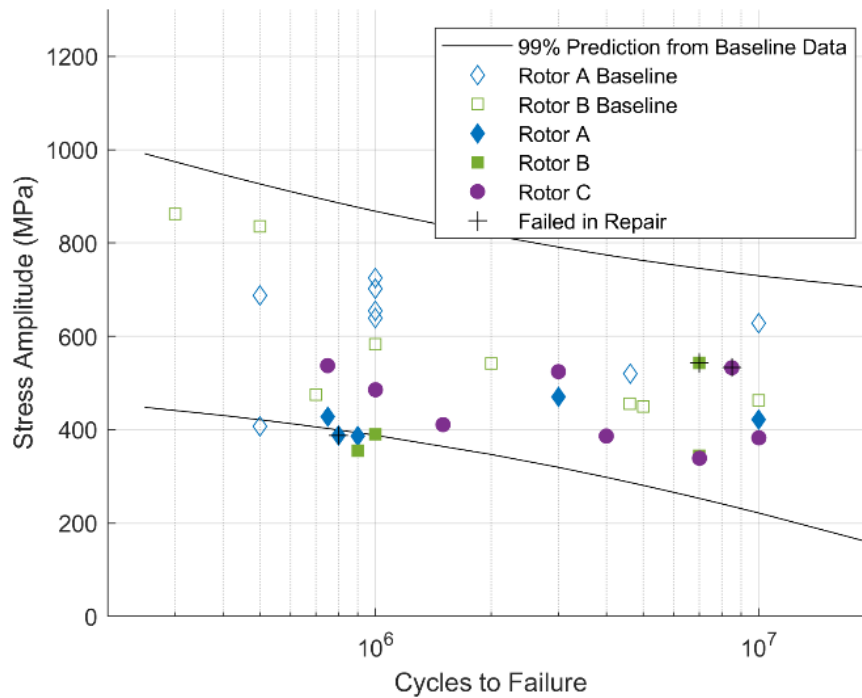
To establish a baseline, a group of 16 blades with no repairs were tested with the vibration bending set up to determine the expected life from blades that have not been altered since operating in the field. From these baseline blades, it was determined that the typical failure point on this type of blade occurred at the root, near the trailing edge where a fillet occurs that transitions from the airfoil to the base of the blade. Figure 29 represents the results from the tests for the stress versus cycles to failure for all the blown powder repairs and baseline data and the solid black line is a 99% prediction interval that was created from baseline data that was collected when testing engine blades from the same rotors that had not been repaired via DED. The repaired blades that were tested are shown for rotor A and B in the blue and purple markers. The repair data is still mostly within the range of the 99% prediction interval that was created using baseline data. Of the three repairs that ended up outside of the prediction, only blade A-5 failed in the repaired section. There were two blades that failed in the base material of the blade but outside of the range of the prediction interval. This is expected to be due to the condition of the blades when received before any work had been done for this project since there was previous use for each of these rotors in engines.

Figure 29: Stress versus Number of Cycles to Failure from vibration fatigue testing for each individual blade in Rotors A, B, and C.

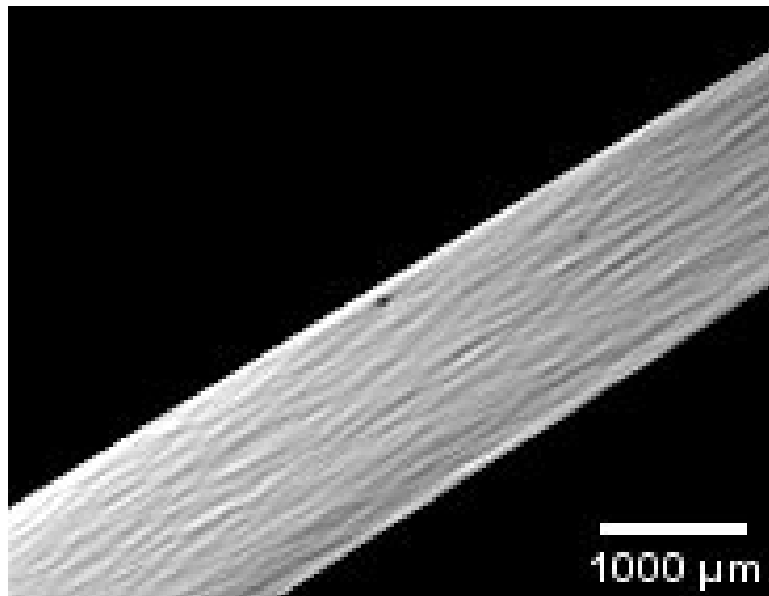
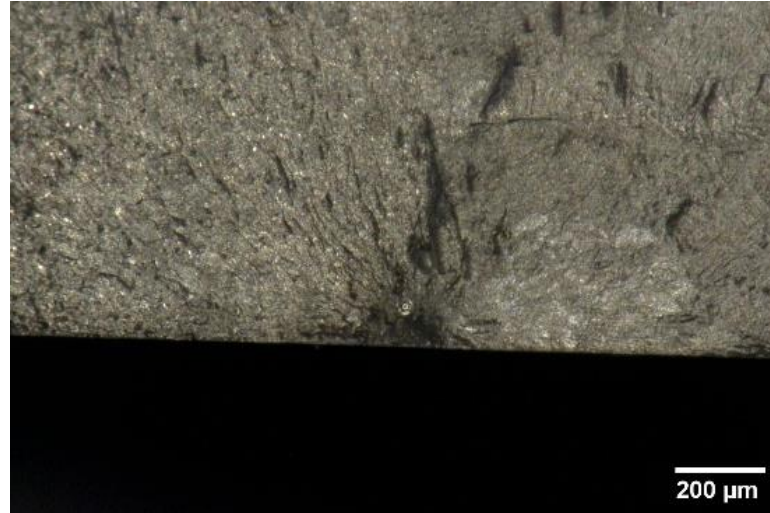
Of the three deposited material failures, A-19, B-13 and C-21, the only fracture surface where a pore was found in the initiation site of the failure was blade B-3. There were no pores that were visible at the initiation site on the fracture surface of blades A-19 or C-21 using both an optical and a scanning electron microscope, but there was one small pore at the initiation site of the fracture surface for blade B-13. This was found to be a gas pore with a diameter of approximately 41 μm . Figure 30 shows both the CT scan image and the image taken using an optical microscope of the pore found at the initiation site. This is interesting because the initiation point at a 41 μm pore was not expected when there was a 120 μm pore also in the same repair, therefore further investigation was required and is discussed in the following sections.

Figure 30: Initiation pore for blade B-3 in a) a CT scan and b) an optical microscope image.

The initiation point for blade B-3 was found to be a small pore using fractography on an optical microscope, as shown in Figure 30. The pore was measured on the fracture surface to be 41 μm in diameter. This was confirmed by locating and measuring the pore in the CT images. Since the voxel size of the CT scan was only 28 μm , this pore was very hard to detect on the CT scan as it only appeared to be about 1 to 1 1/2 pixels in size. Figure 30 shows the images from the CT scan and the optical microscope of the initiation pore. A pore of this size is surprising to see as initiation point in a repair section of a blade with other pores being found in the same repair that were found to be three times the size of this one. To further explain why this small pore caused failure, SIF values were considered.

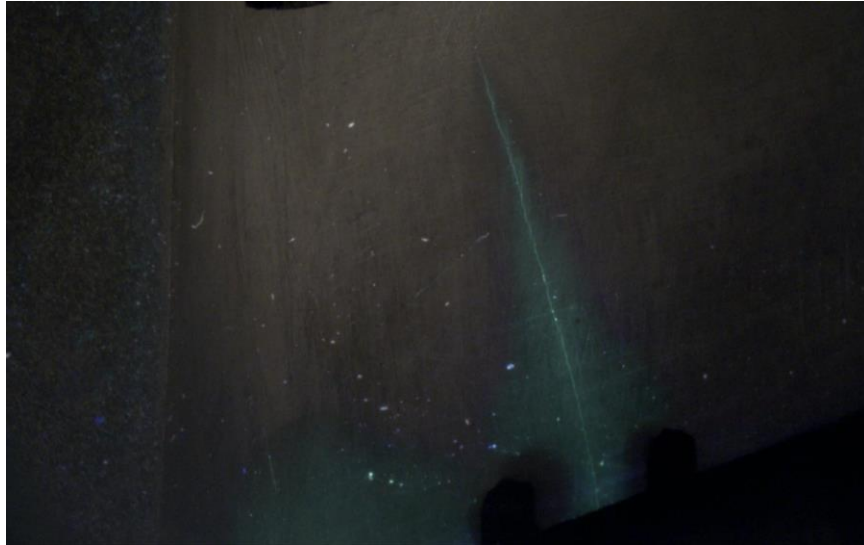
The premature failure that is shown in the table for blade A-19, this being the only blade that failed outside of the 99% prediction interval created using the baseline material, is most likely due to a combination of the surface condition after being hand polished to nominal geometry and previous duty cycles, as mentioned previously. The fracture surface for this blade was damaged during the testing procedure and in attempt to separate the blade for fracture analysis to the point where an initiation point could not be fully determined. However, this crack does appear very close to the base of the blade and spans both the deposited material and the base material. Figure 31 shows this crack from blade A-19 in relation to the base of the blade. Although the fracture surface of this blade does have the striation marks that are typically associated with pointing towards the point of initiation, this blade does not have one point that can be determined. The crack did occur near the base, which would have been at the very bottom of the repair, meaning a majority of this crack was spread through the base material. There is a chance that the crack initiated in the base material and spread to the leading edge as shown in the image.

Figure 31: Crack in blade A-19 that spreads from LE to base material of blade outside of the repair

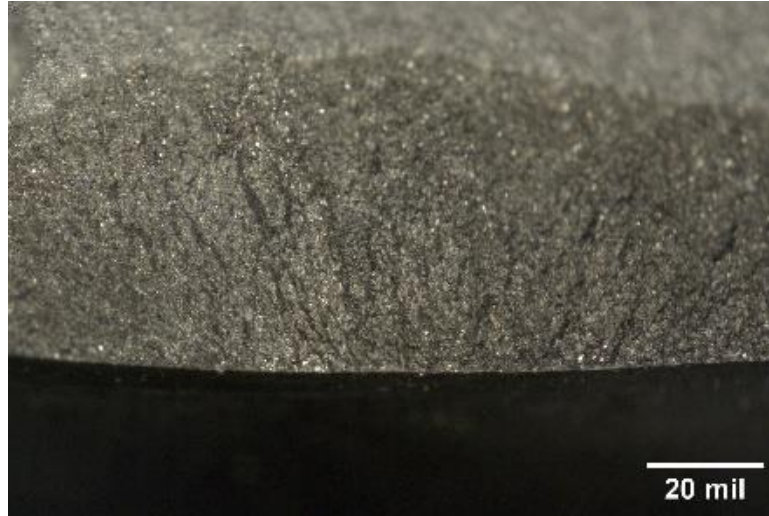
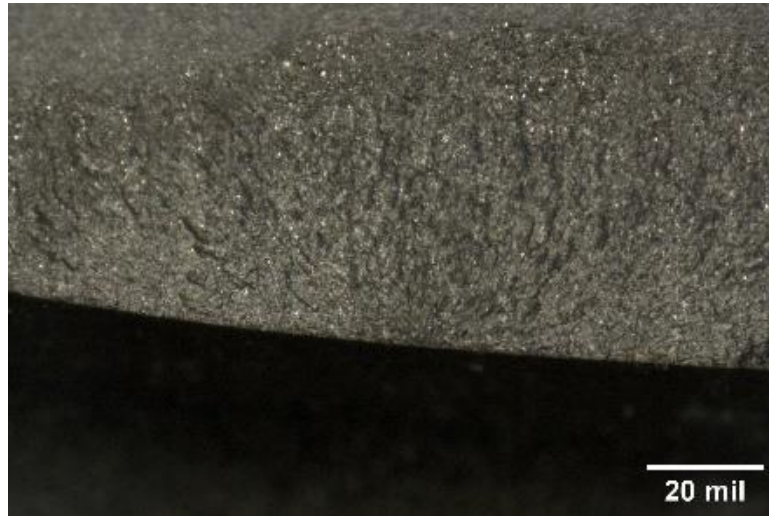
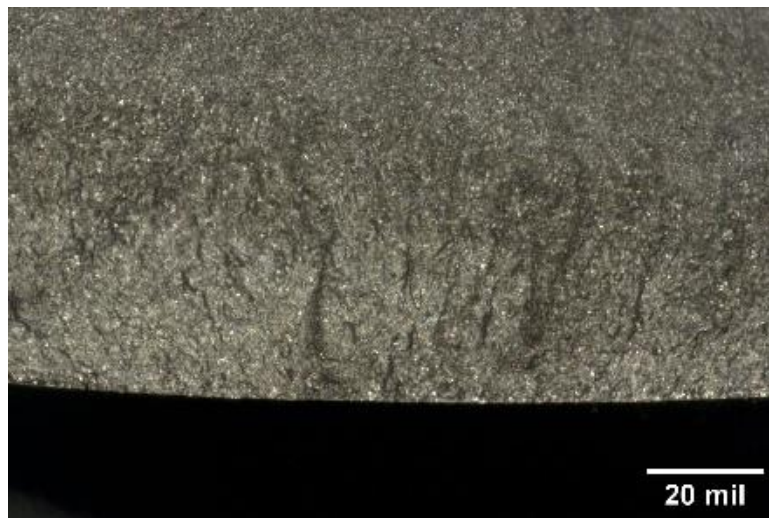
Figure 32 shows fracture surfaces of some of the other repaired blades as a comparison to see what the typical initiation sites look like. These are blades A-3, B-4, and C-5, and each of these failures occurred at the max stress location near the root of the blade. The initiation point for each of these examples points towards the surface of the blade where the max stress is depicted in Figure 16, which is represented by the center of all the striation lines that point towards the bottom middle of the fracture surface in each image. Every blade that was tested, both baseline and repaired blades, failed at this point with a similar initiation to the images being shown below. These fractures surfaces are examples of what the typical failure for these tests is expected to look like.

Figure 32: Initiation point on the fracture surface of blade a.) A-3, b.) B-4, and c.) C-5.
