Vibration Bending Fatigue Analysis of Additively Repaired Ti-6Al-4V Airfoil Blades

A thesis submitted in partial fulfillment of the
requirements for the degree of
Master of Science in Mechanical Engineering

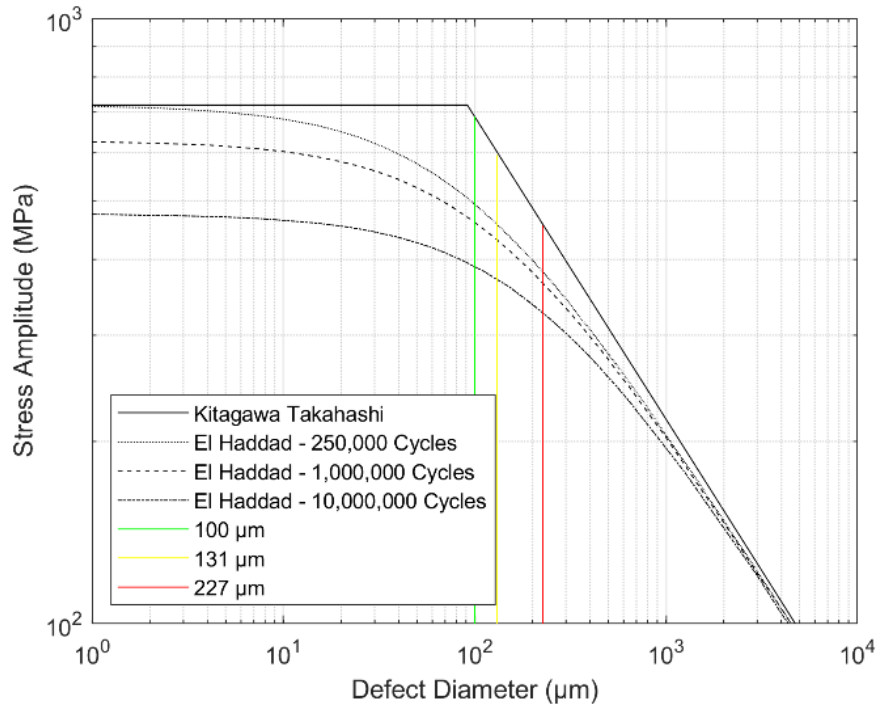
Figure 33 is a modified Kitagawa Takahashi diagram [26] showing infinite life prediction as well as finite life prediction using the El Haddad model [27]. As the legend describes, the solid curve represents the Kitagawa Takahashi model, and the dashed curves represent the El Haddad model that incorporates three different limits of cycles to failure. Each of these three curves were plotted using the El Haddad model, represented by the equation

The three El Haddad curves show the allowable stress amplitude to achieve the 2.5e5, 1e6, and 1e7 cycles that were chosen for comparison purposes. The green, yellow, and red vertical lines that have been added to the graph represent failure from a 100 μm , 131 μm or 227 μm pore, respectively. Each line was found by drawing a straight horizontal line from the interception of the y-axis of the graph until it intercepted the Kitagawa Takahashi line, then drawing a vertical line straight down until it intercepted the x-axis. The green line was chosen to represent the pore size threshold that is safe to operate under for the fatigue performance of the repaired blade to fall within the same range as the baseline data. When the pore size starts to approach the ranges beyond this value, specifically higher than the 227 μm threshold, this is where the fatigue performance begins to significantly deteriorate. The goal overall was to understand the consequences of having pores larger than these thresholds on the blade performance, as well as seeing how the experimental limits of pore size would compare to this model.

Figure 33: Kitagawa-Takahashi diagram with El Haddad Curves. The green line represents failure from a 100 μm pore, the yellow line is 131 μm , and the red line is 227 μm .

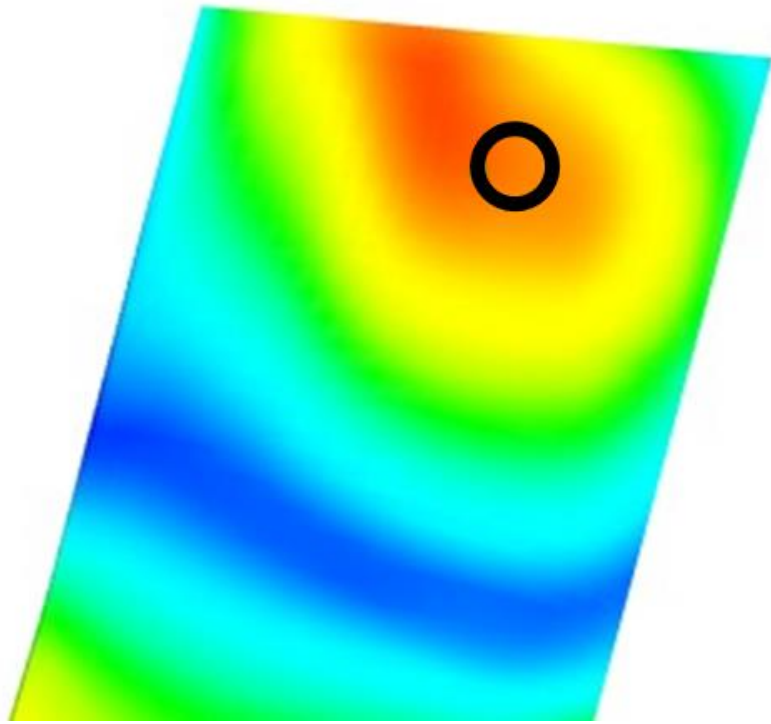
Focusing on specific pores was required to have a good comparison between multiple repairs and the gas pore that was found in the initiation cite of blade B-3. This gas pore was located on the FEA model, as shown in Figure 34. Using the pore size that was measured in the CT scan and these stress values at the locations of the pores, SIFs for various pores were calculated. The SIF showed the significance of the stress at specific locations associated with the pore size. The SIF was calculated using the equation

In Equation 4, it is shown that the stress has a larger effect than the area of the pore when finding the value of the SIF. This means that the stress would not need to be that much larger for a smaller void for it to have a larger SIF than that of a larger void with a smaller stress. Notice in Figure 34 that the location of the pore that initiated failure is very near the area of maximum principal strain. This further explains why the gas pore caused initiation even though it was much smaller than the largest pore found in the repair section, and this was due to the high stress it was experiencing.

Figure 34: Maximum principal strain plot of blade in mode two vibration simulation using FEA with black circle representing the location of the gas pore that was found on the fracture surface of blade B-3.
