The Ryggfonn Project

Avalanche Data from the Winters 1994/95 and 1995/96

581200-32

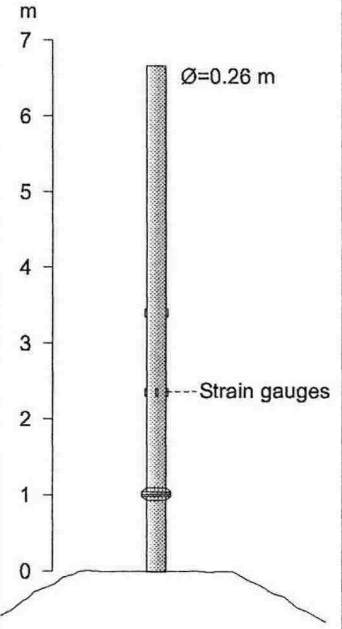
Mast on top of dam

- A 15 m high and 75 m wide retaining dam in the avalanche runout zone. On top of the dam is a 6.5 m high steel mast that is instrumented with strain gauges and sometimes an anemometer.
- A 4.5 m high concrete structure fitted with three load cells, each with an area of 0.72 m², situated 230 m up-slope from the dam.
- A 10 m (from 1994: 8.5 m) high tubular steel tower situated 320 m up-slope from the dam. The tower consists of four sections, each having a diameter of 1335 mm and plate thickness 15 mm.

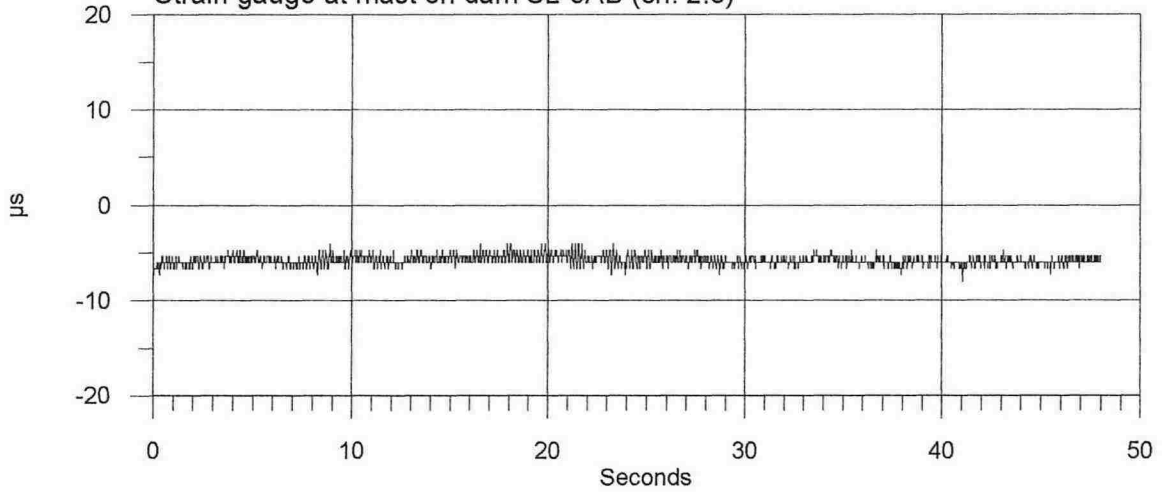
Strain gauge at mast on dam SL-5AB (ch. 2:3)

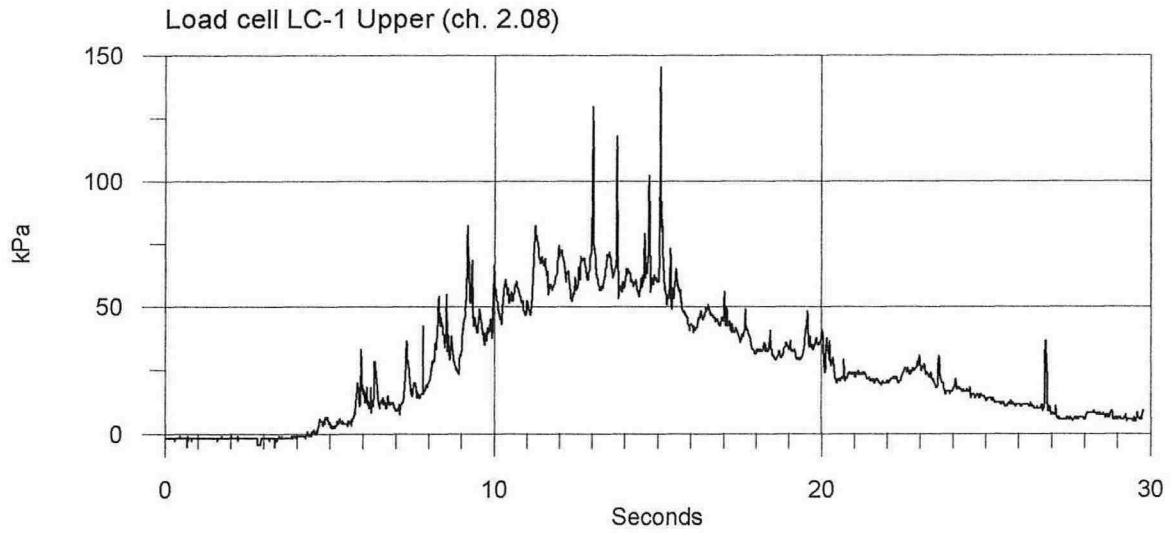
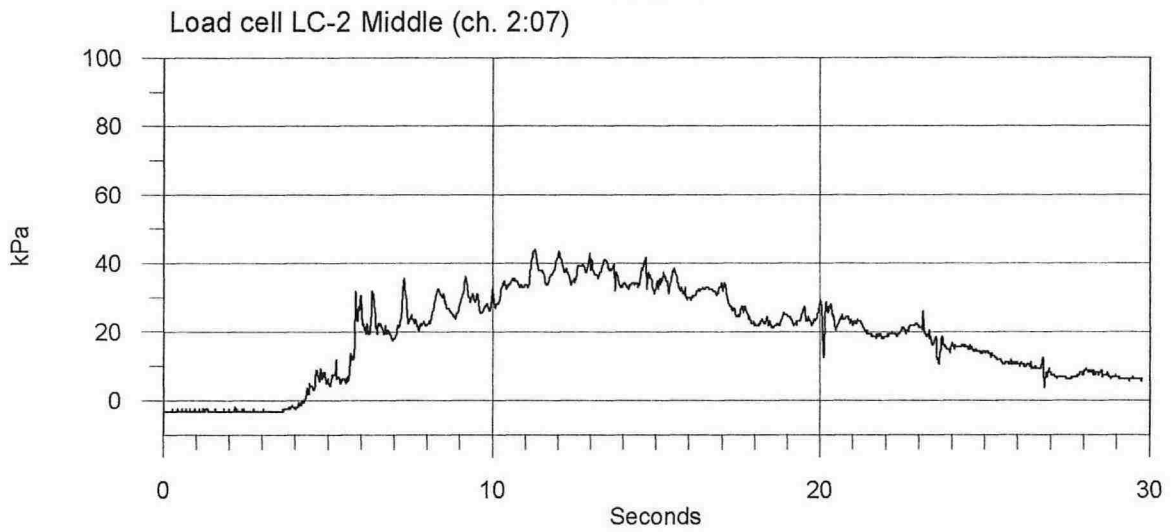
Figure No.
17

Avalanche 95.03.03, artificially released
Impact pressures on load cells on concrete structure

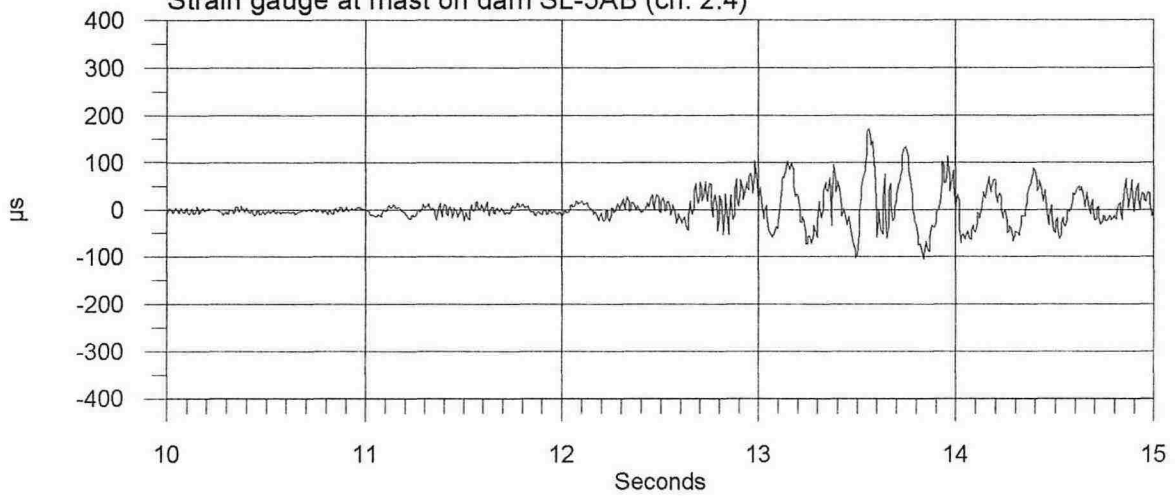
Strain gauge at mast on dam SL1/3 (ch. 2:1)

Strain gauge at mast on dam SL-5AB (ch. 2:4)

The mast on the dam was also hit by the avalanche and the resulting oscillations caused deformations of more than 600 μ S (Figure 26).
