# MDOT State Study 316 – Development of Advanced Landslide Investigation Protocol Using Geophysical Methods for Mississippi

## FINAL REPORT

1. Report No. FHWA/MDOT-RD-23-316	2. Government Accession No.	3. Recipient's Catalog No.	
4. Title and Subtitle Development of Advanced Landslide Investigation Protocol Using Geophysical Methods for Mississippi		5. Report Date: June 30, 2023

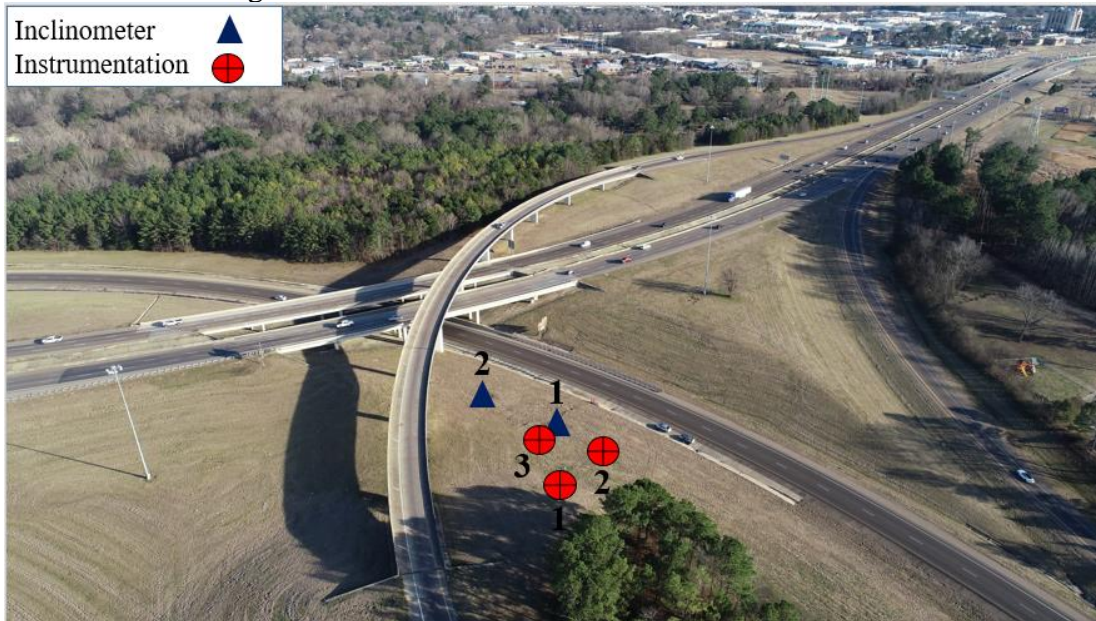
**Figure 3.4** Instrumentation Layout at I-Slope 1

Two 15 ft. boreholes, labeled as Instrumentations 1 and 2 in Figure 3.4, were drilled and instrumented in the as-built section of I-Slope 1. Another 15 ft. deep borehole, known as Instrumentation 3 in Figure 3.4, was drilled and instrumented in the repaired area. Instrumentation 1 was positioned at the crest of the slope, while Instrumentations 2 and 3 were placed in the middle. At each instrumentation location, moisture sensors and water potential sensors were installed at depths of 5 ft (1.5 m), 10 ft (3 m), and 15 ft (5 m). Furthermore, at Instrumentation 1, a rain gauge and air temperature sensor were installed. In the as-built section, Inclinator 1 was positioned, and in the repair section, Inclinator 2 was installed. Both inclinometers were placed in the middle of the slopes.

can be seen in Figure 3.4.

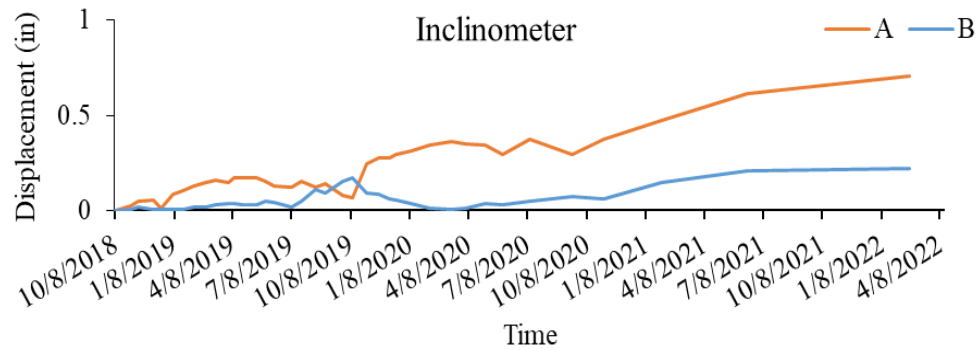
**Figure 3.6** Deformations in the As-Built Section from surficial levels of Inclinator 1 at I-Slope 1

The slope inclinometer measurements were collected at 2 ft. intervals along the inclinometer pipe to observe the horizontal movement of the slope. The inclinometer data was then analyzed to determine the slope's movement. Figure 3.5 and Figure 3.6 display the horizontal movement data from Inclinometer 1 at the as-built section and the time-dependent movement along the crest of the slope, respectively. Similarly, Figure 3.7 and Figure 3.8 show the horizontal movement data from Inclinometer 2 at the repaired section and the time-dependent movement along the crest of the slope. The figures indicate that no significant movement was observed in either section, or the performance of both slope sections was satisfactory.

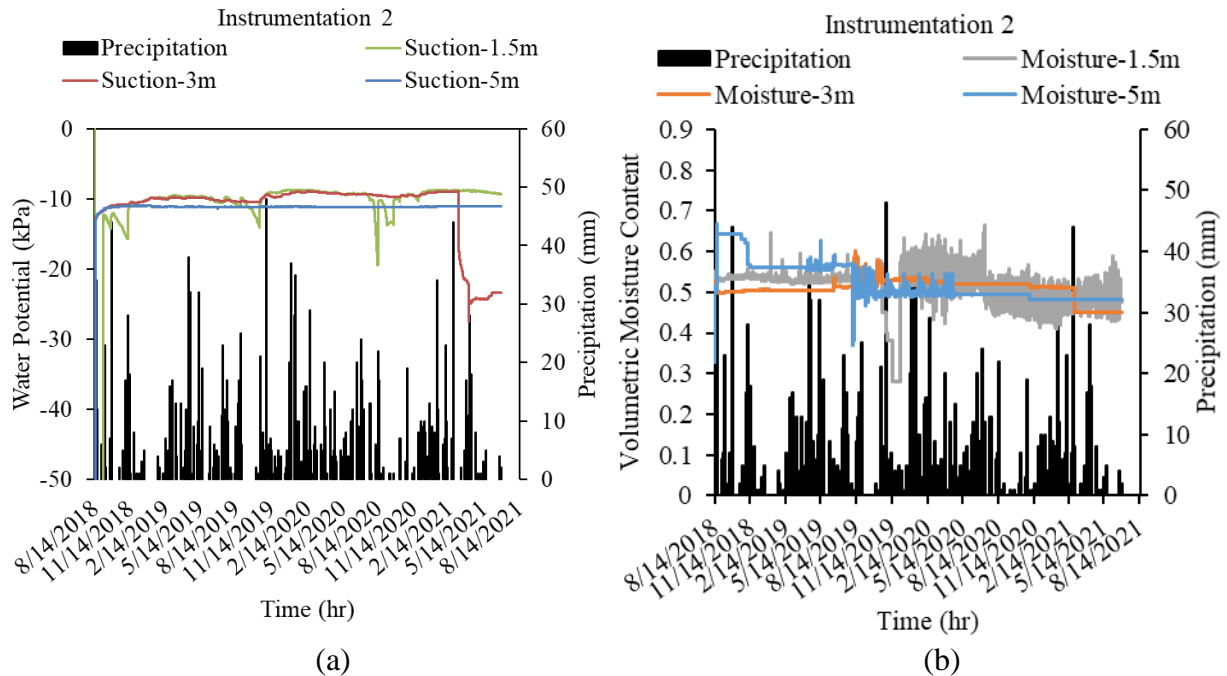
**Figure 3.10** Variation of parameters at I-Slope 1 (a) Matric Suction, (b) Moisture Content and Rainfall data from Instrumentation 2

The sensors collected data at the crest, middle, and toe of the slope, and variations in the in situ matric suction profile and moisture content at 5 ft. (1.5 m), 10 ft. (3 m), and 15 ft. (5 m) depths with rainfall are presented in Figures 3.9 to Figure 3.11. The moisture content and matric suction variations at Instrumentation 1, Instrumentation 2, and Instrumentation 3 are presented in Figure 3.9, Figure 3.10 and Figure 3.11, respectively. The highest rainfall occurred in late December 2018, but few variations in moisture content were observed at any of the three depths within the 2-year monitoring period; the matric suction showed no variations.

Figures 3.9 to 3.11 present variations in the moisture content(volumetric) with time. The moisture content changes at the site slopes' soil layers are influenced by the water infiltration after rainfall events. Typically, variations in moisture content are inversely related to variations in the

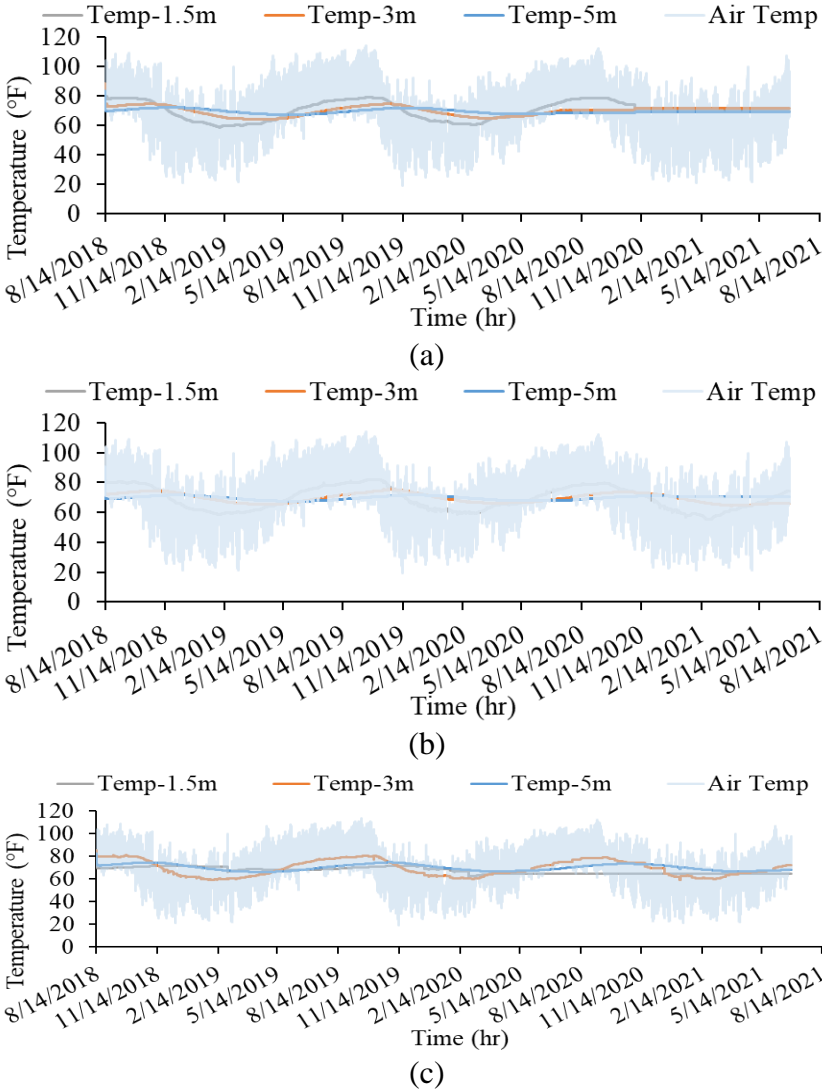
**Figure 3.12** Variations of Air and Soil Temperature at I-Slope 1 (a) Instrumentation 1, (b) Instrumentation 2, and (c) Instrumentation 3

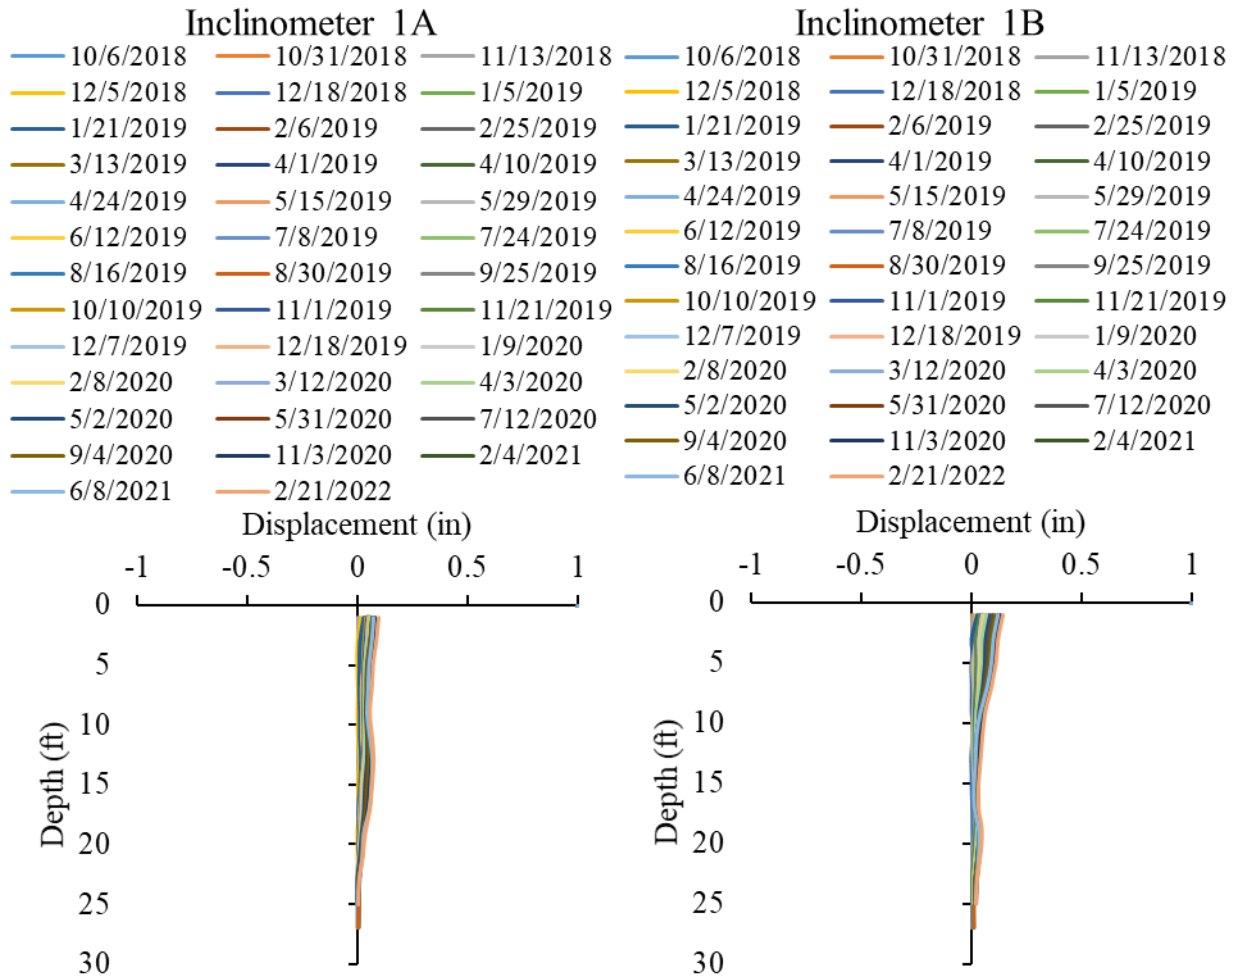
**Figure 3.15** Displacements at Inclinator 1 at I-Slope 2

The slope's horizontal movement data was obtained by collecting measurements at 2 ft. intervals along the slope inclinometer pipe. These measurements were then analyzed to determine the movement of the slope. Figure 3.15 presents the data from Inclinometer 1 at the reinforced section, while Figure 3.18 shows the time-dependent movement at the slope's surface. Similarly, Figure 3.15 displays the horizontal movement data from Inclinometer 2 at the as-built section, and Figure 3.18 represents the time-dependent movement at the slope's surface. The figures indicate no significant movement in either section, demonstrating satisfactory slope performance. It should be noted that the inclinometer was struck by an external object at the surface in late 2021, rendering the results from late 2021 inconsistent with the previously observed trend shown in Figure 3.17.

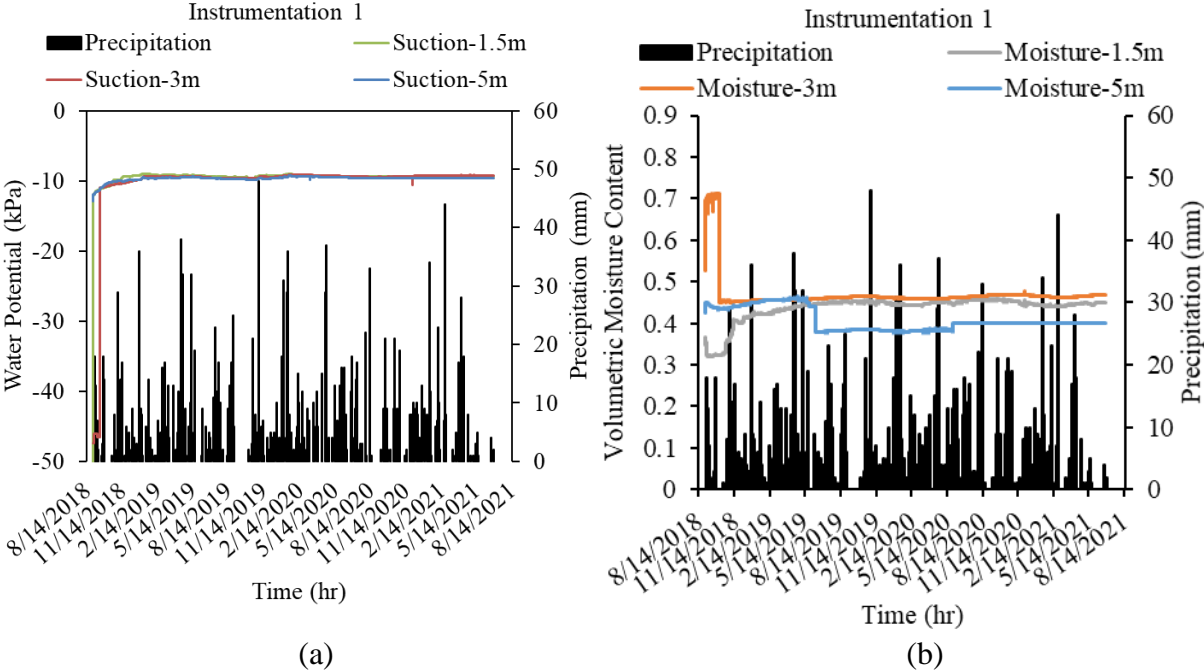
**Figure 3.19** Variation of parameters at I-Slope 2 (a) Matric Suction, (b) Moisture Content and Rainfall data from Instrumentation 1

Figures 3.19, 3.20, and 3.21 display the variations in the in situ matric suction profile and moisture content at depths of 5 ft. (1.5 m), 10 ft. (3 m), and 15 ft. (5 m) with rainfall. During the initial three months after Instrumentation 1 and Instrumentation 2 installation, an initial variation in moisture was observed, indicating an adjustment period for moisture distribution. However, no

changes were observed in the matric suction at these locations. Minimal moisture variations were observed at the crest of the slope (Instrumentation 1) over the two-year monitoring period. In contrast, variations were observed at the middle of the slope (Instrumentation 2) during the summer and late December of 2019, indicating rainwater infiltration. Surface cracks near the slope's toe were observed, and a significant moisture variation was detected, suggesting rainwater infiltration through the cracks.

Figure 3.19 to Figure 3.21 display the variations of in situ matric suction with daily rainfall data at different depths (5 ft., 10 ft., and 15 ft.) in the slope's crest, middle, and toe. The matric suction exhibited a low and steady change at the middle and toe of the slope.

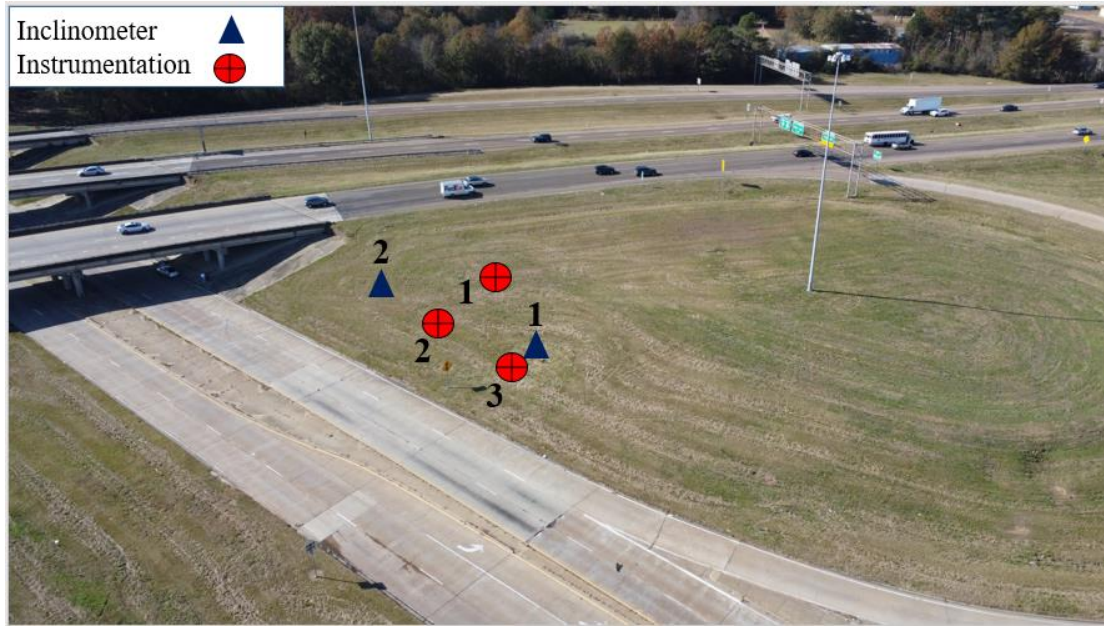
**Figure 3.24** Instrumentation Layout at I-Slope 3

I-Slope 3 consists of reinforced and as-built sections. The reinforced section includes Instrumentation 1 and 2, while the as-built section includes Instrumentation 3. Figure 3.24 illustrates the locations of these instrumentation points. Instrumentation 1 borehole is positioned at the crest of the slope, while Instrumentation 2 and Instrumentation 3 are located in the middle of the slope. Each instrumentation location is equipped with moisture and water potential sensors at depths of 5 ft (1.5 m), 10 ft (3 m), and 15 ft (5 m). Instrumentation 1 also features a rain gauge and air temperature sensor. Additionally, two inclinometers were installed in the middle of both sections, whose locations are presented in Figure 3.24. Inclinometer 1 was installed at the as-built section, and Inclinometer 2 was installed at the repaired section.

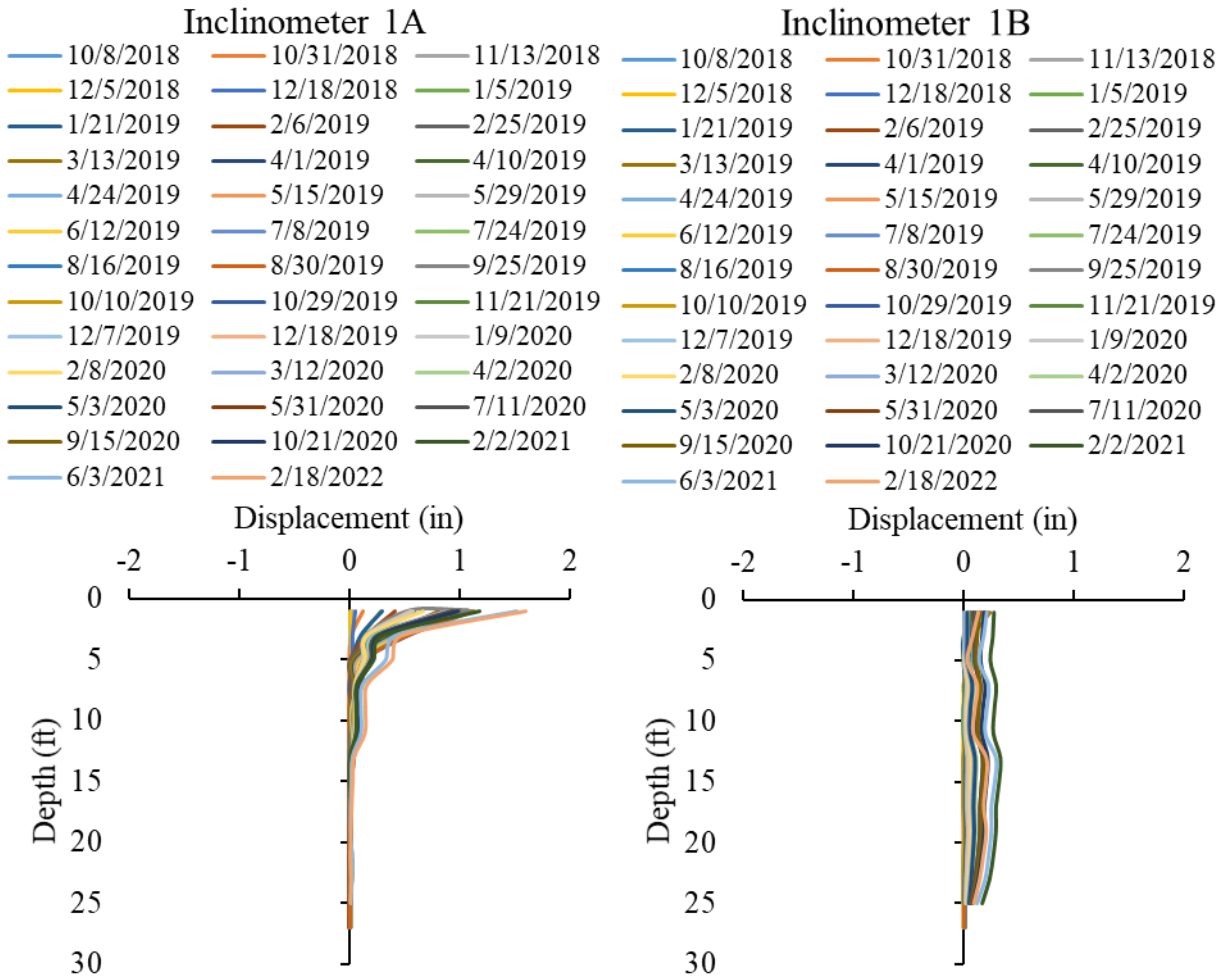
**Figure 3.25** Displacements at Inclinator 1 (as built section) of I-Slope 3

Inclinometer data collected at 2 ft. intervals down the pipe were collected and analyzed to assess the slope's movement. Figure 3.25 shows the horizontal movement data from Inclinometer 1 in the reinforced section, while Figure 3.28 illustrates the time-dependent movement at the slope's surface. The analysis revealed that the as-built section of I-Slope 3 experienced movement starting in January 2019, with a maximum displacement of 1.6 inches at the slope surface within a year. The movement occurred at a shallow depth of approximately 6 ft. and requires maintenance. On the other hand, Inclinometer 2 in the reinforced section exhibited no movement, indicating satisfactory performance at the repaired section of the slope.

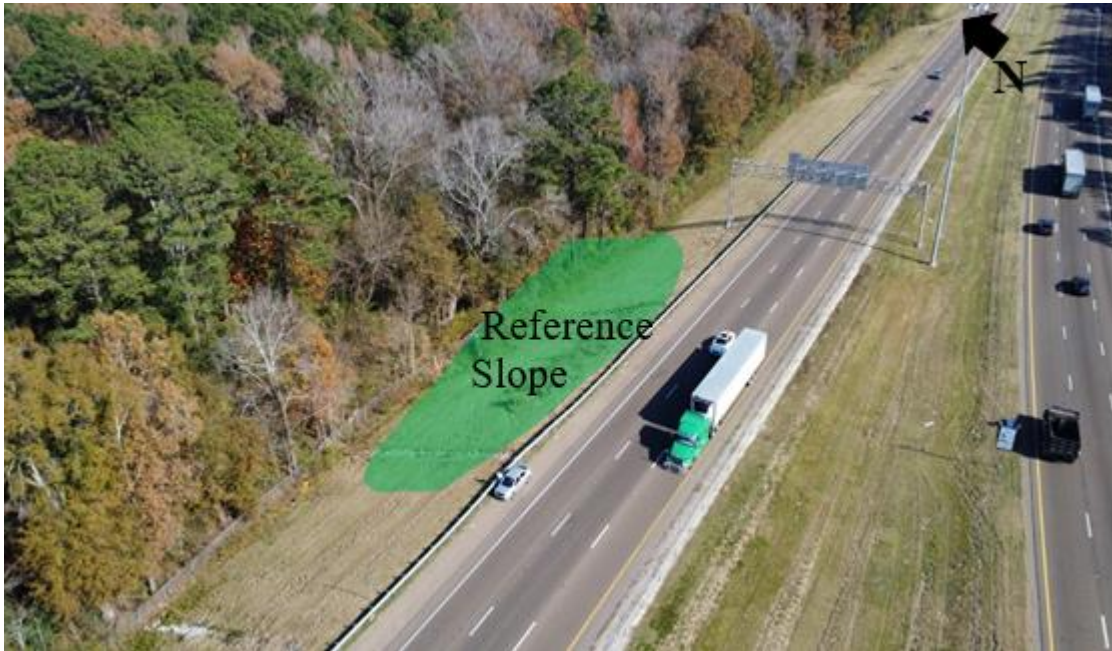
**Figure 3.33** Location of I-Slope 4

Slope 4, located along I20 E near Highland Drive, is a 3.5H:1V slope with a height of 20 ft. Notably, no pre-existing failure areas were reported for this slope, so the investigation focused solely on the as-built section. Figure 3.33 provides a visual representation of the slope's location.

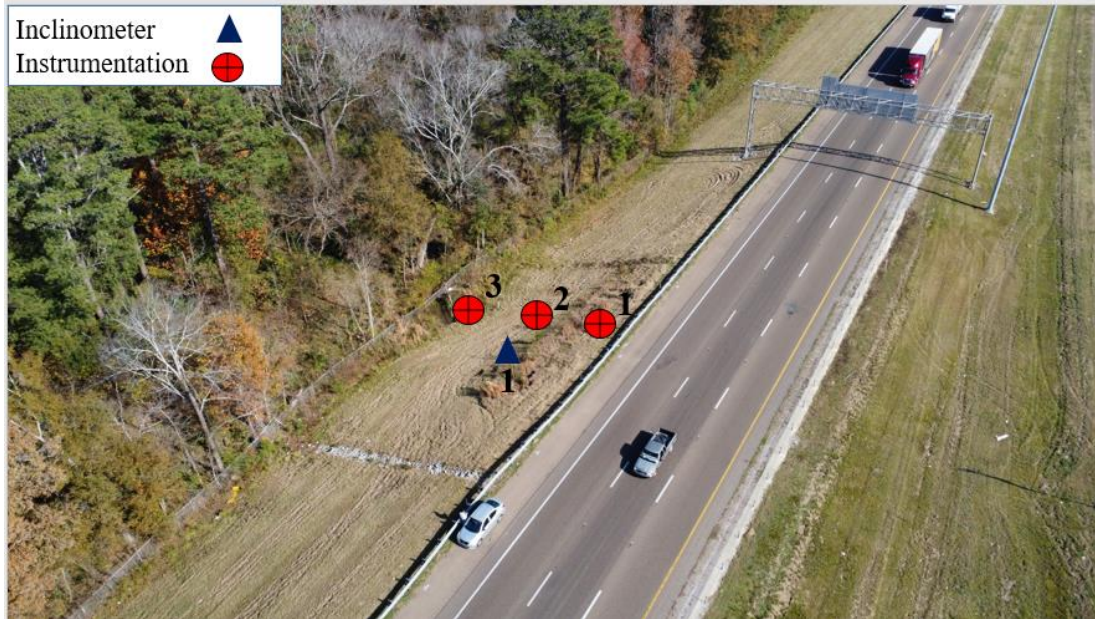
**Figure 3.34** Instrumentation and Inclinometer at I-Slope 4

In the reinforced section of I-Slope 4, three 15 ft. boreholes (Instrumentation 1, Instrumentation 2, and Instrumentation 3) were drilled and equipped with instrumentation at the crest, middle, and toe of the slope, as depicted in Figure 3.34. The instrumentation included moisture and water potential sensors installed at depths of 5 ft (1.5 m), 10 ft (3 m), and 15 ft (5 m) at each location. Additionally, a vertical inclinometer was installed in the middle of the slope near Instrumentation 2 to measure slope displacement. Near Instrumentation 1, a rain gauge and air temperature sensor were installed to monitor precipitation and atmospheric conditions. Detailed photographs of the sensor installations can be seen in Figure 4.38. Furthermore, an inclinometer was installed at a depth of 30 ft. in the middle of the slope to assess deeper slope movements.

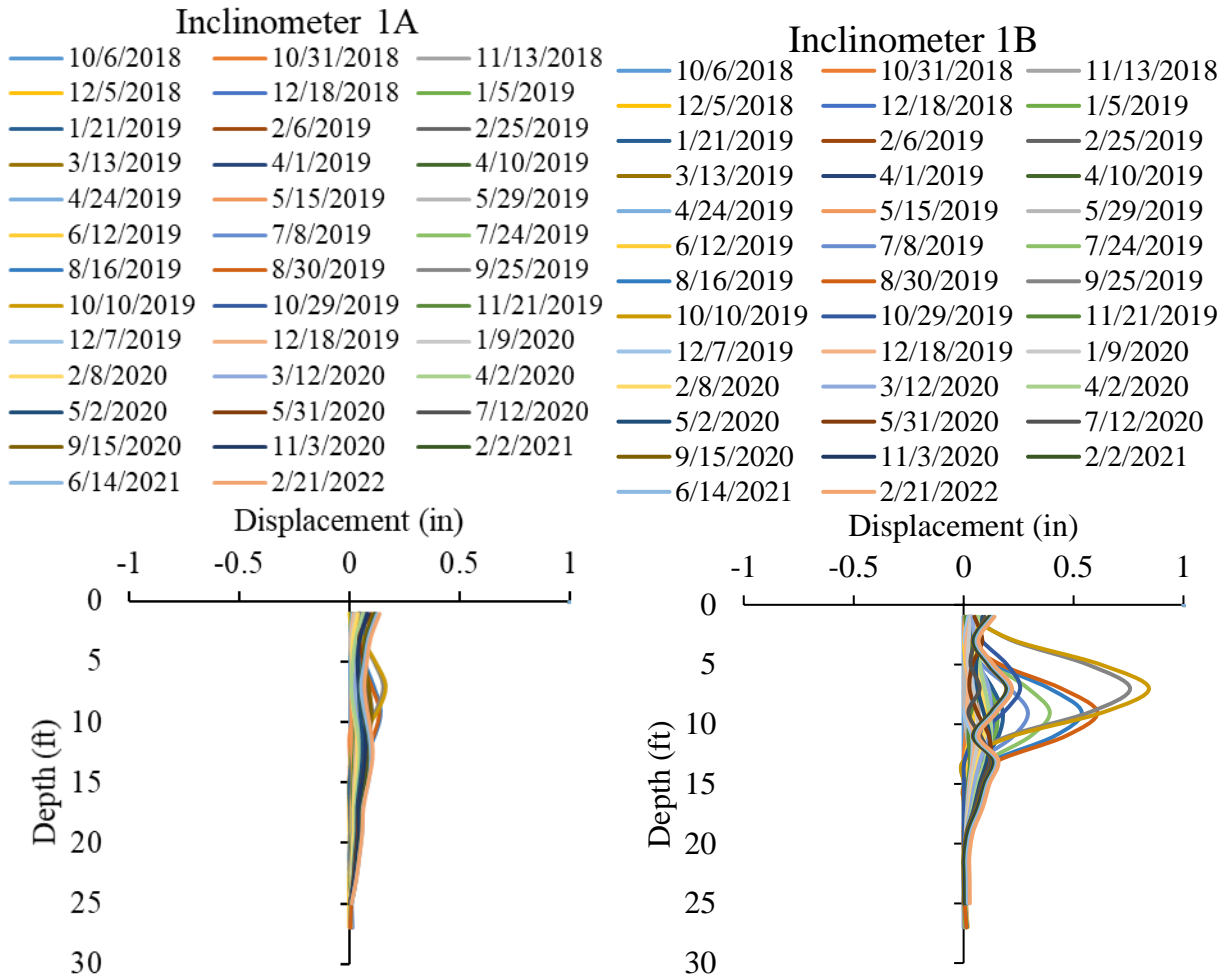
**Figure 3.35** Displacements at Inclinator 1 at I-Slope 4

Inclinometer measurements were conducted along the slope inclinometer pipe at 2 ft. intervals to gather data on the horizontal movement of the slope. The collected data were then analyzed to assess the slope's movement. Figure 3.35 displays the horizontal movement data from Inclinometer 1, while Figure 3.36 illustrates the time-dependent movement at the surface of the slope. The data reveals that no significant movement was observed; however, some movement was detected at depths ranging from 5 ft. to 10 ft. During the field inspection, it was noted that a void had formed near Inclinometer 1, as depicted in Figure 3.36, due to erosion of the slope surface. To address this issue, it is recommended to backfill the void with lean clay fill materials.

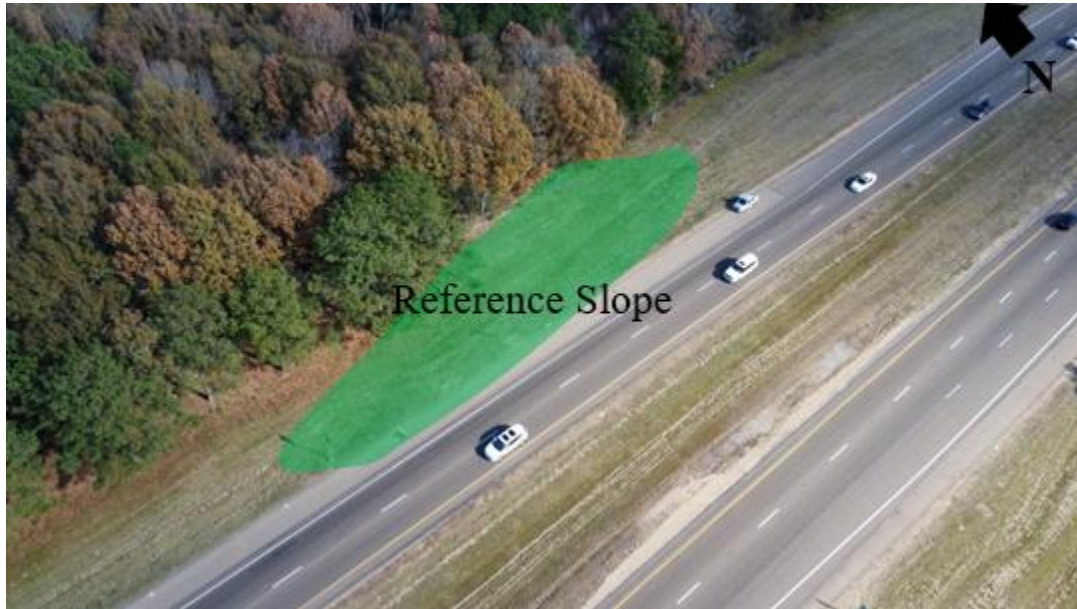
I-Slope 6, a 5H: 1V slope with a height of 15 ft., is located along I20E near McRaven Road, as shown in Figure 3.50. Part of the slope that had shown prior movement had been rebuilt and re-graded to reinstate the drainage structure. The repaired section and the as-built section were included in this study for analysis and evaluation.

**Figure 3.50** Location of I-Slope 6

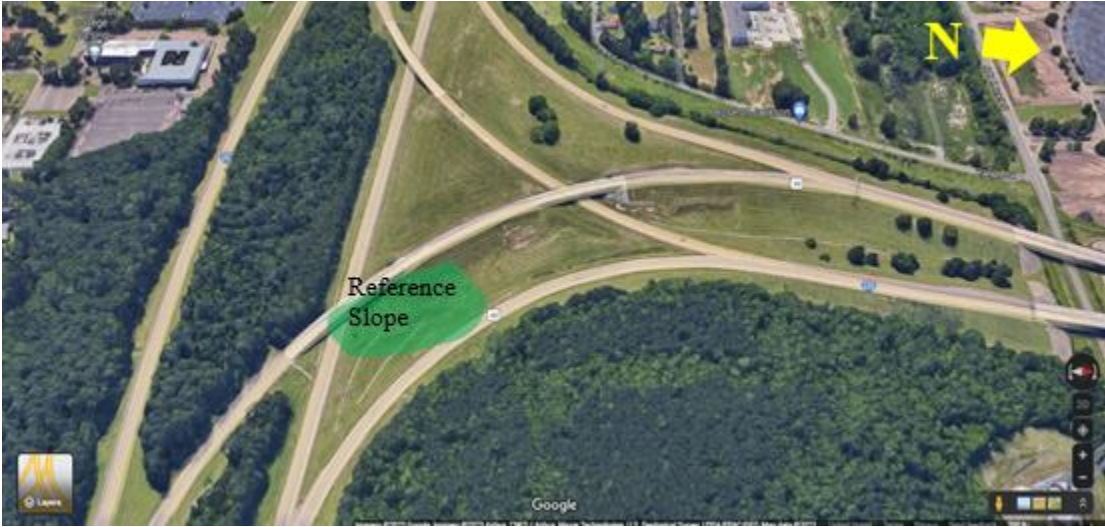
I-Slope7 is located along the exit from I220 South toward I20 East; the location is shown in Figure 3.60. The slope was repaired using H-piles, and a slope inclinometer was installed to monitor movement in the repaired area. JSU’s GeoDevelopment research team monitored the slope movement every two weeks, and the lateral overtime deformation variations are presented in Figures 3.61 and 3.62. The figures show no significant deformation or movement in the slope.

**Figure 3.60** Location of I-Slope 7

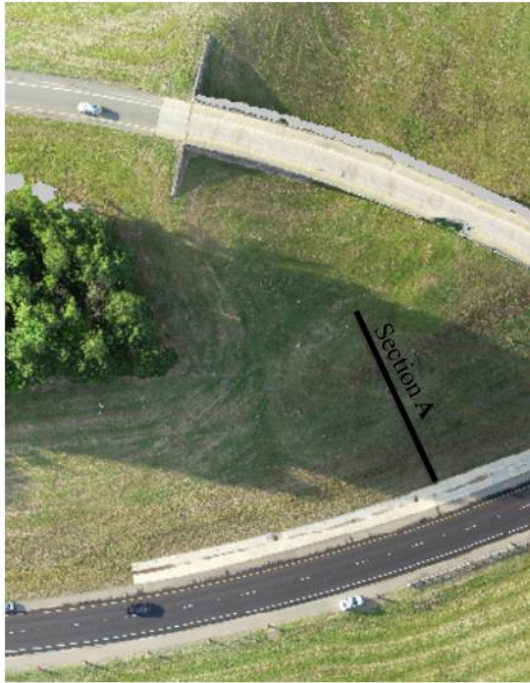
Profile views of the slope were developed using two methods. The views that were captured of the slope in the summer of 2021 were extracted, and a profile was created manually, as shown in Figure 4.4. Images captured by the drone in spring 2022 and fall 2022, georeferenced DEMs, were imported into Civil 3D and surface profiles were created using the kriging interpolation method. The surface profile of the slope was created using the alignment and surface profile tools within Civil 3D. Figure 4.6 and Figure 4.7 show the 3D model, surface topography of the slope, and the surface profile views obtained in spring 2022 and fall 2022, respectively.

**Figure 4.4 Site 1 Drone Image (Summer 2021)**

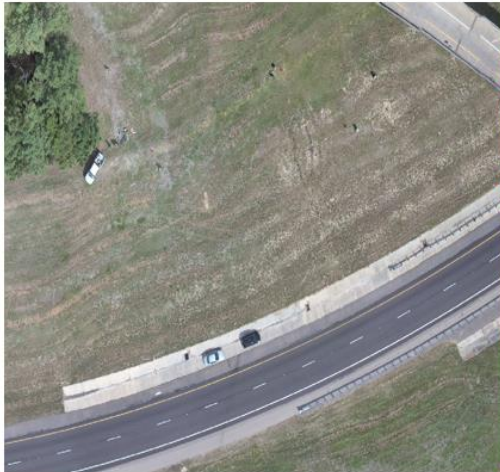
**Figure 4.5 Site 1 Drone Image (Fall 2021)**

The results from the drone testing for instrumented Slope 1 are presented in Figure 4.4 to Figure 4.7. The images were captured during different seasons, beginning in 2021, and were imported into correlator 3D software. The coordinate system was set to the State Plane Coordinate System Mississippi US-West, and an aerial triangulation was performed with multiple tie points to stitch the images together and develop a digital elevation model (DEM) and digital terrain model (DTM). Ground control points (GCPs) with coordinates that had been identified on the field were used to georeference the DEM. The images were orthorectified and stitched to create an orthomosaic representation of the entire slope site, and 3D models were developed for selected seasonal surveys.

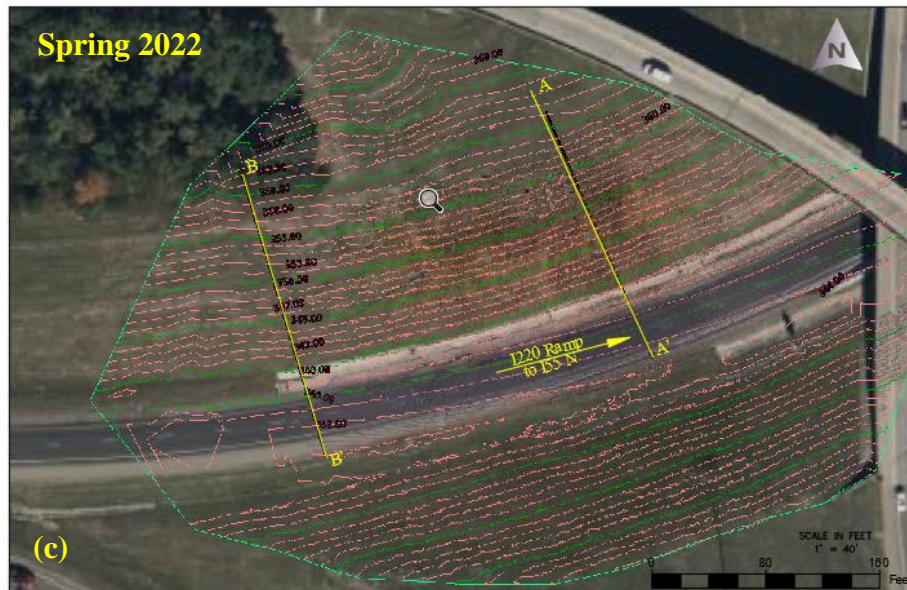
The point clouds were georeferenced using five ground control points (GCPs) with known coordinates. First, the drone images were ortho-mosaicked and then georeferenced, using the GCPs identified on the field. Other GCPs were then identified on the georeferenced drone imagery mosaic. The GCPs extracted from the drone were incorporated in Trimble RealWorks to georeference the LiDAR point clouds. Georeferencing of the point clouds was done by either selecting points and assigning them to the known GCPs obtained either from pre-identified GCPs on the field or from georeferenced drone orthomosaics. The georeferenced point cloud was then processed, using a ground extraction algorithm to extract the lowest ground surface scan points. This method eliminated unwanted scan points such as vegetation, vehicles, buildings, and similar items. Only the bare ground point clouds were extracted.

The bare ground point clouds collected for all seasons were imported into Civil 3D, and surfaces were generated using the kriging interpolation method. Topographic surface views were generated at 1 ft. major and 5 ft. minor contour intervals and are presented in Figure 4.8(a – d). The surfaces from all seasons were overlaid, and alignments were created along the slope. Surface profiles were then created, using the alignments. Surface profiles along Sections A-A and B-B are presented in Figure 4.8 (e) & (f). Overlaying the surface topographies of different seasons presented the opportunity to stack the surface profiles and create accurate representations of temporal variations in the slope’s surface.

**Figure 4.8** LiDAR Point Cloud Surface Topography Instrumented Slope 1: I220 - I55N (a) Summer 2021 (b) Fall 2021 (c) Spring 2022 (d) Fall/Winter 2022 Section (e) Overlaid Surface Profile A-A' (f) Overlaid Surface Profile B-B'

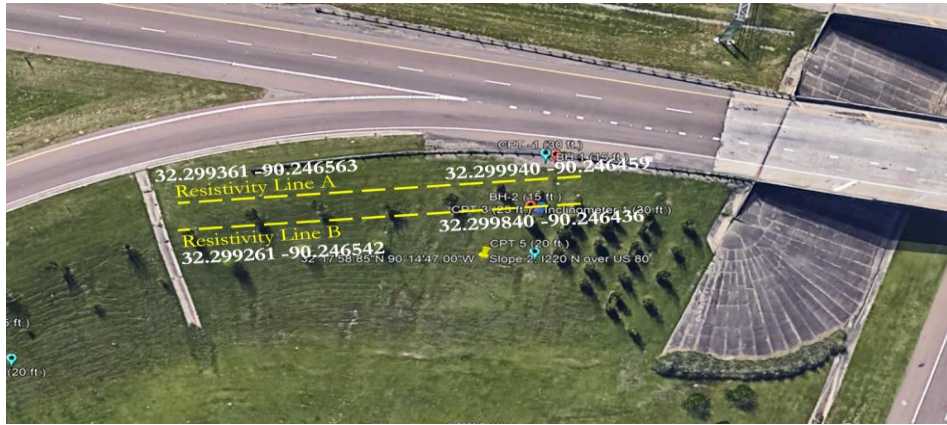
The location of Instrumented Slope 2 is presented in Figure 4.9. I-Slope 2, located near the Metrocenter mall along I220 N over the ramp from US 80E, is 23ft. high with a grade of 3H:1V. A portion of the slope had previously experienced failure and was subsequently repaired with H-piles installed at the crest of the slope. ERI testing was conducted at different seasonal intervals at both the repaired and as-built sections of the slope; the results are presented in Figure 4.10 (a-e).

The ERI test was conducted along a length of 220 ft. (67m) and two lines (A and B) at the crest and midway of the slope, respectively. The ERI test line and slope location are presented in Figure 4.9. ERI results for Line A from the testing conducted from spring 2021 through fall/winter 2022 are presented in Figure 4.10 (a – e).

**Figure 4.9** Location of Slope 2

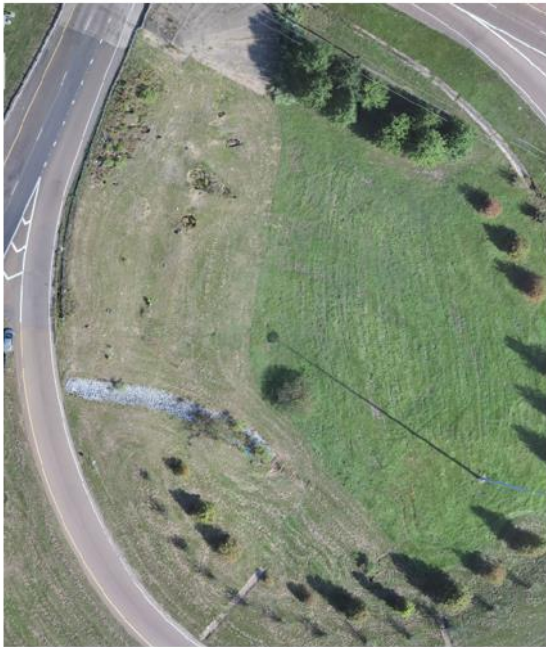
Figure 4.13 (b) shows the 3D model, surface topography of the slope, and the surface profile views for fall 2021. The DEMs of different seasons make the changes experienced near the bridge abutment at the crest evident and show that the voids at the toe of the slope have grown larger over time.

Figure 4.13 Drone Image of Slope 2 in Fall 2021: (a) DEM, (b) 3D Model and Surface Profile

Multiple drone surveys were taken during different seasons from summer 2021 through fall 2022. The images were post-processed using specialized software, with the coordinates set to the State Plane Coordinate System Mississippi US-West. An aerial triangulation was performed with multiple tie points to stitch the images together and develop digital elevation models (DEMs) and digital terrain models (DTMs). Ground control points (GCPs) with known coordinates pre-identified on the field were used to georeference the DEMs. Images were orthorectified and stitched to create an orthomosaic representation of the entire slope site. DEM representations for different seasons are presented in Figure 4.12 - Figure 4.14. The imagery captured by the drone in fall 2021 had high-quality overlapping, which enabled the development of a high-quality 3D model, as presented in Figure 4-13.

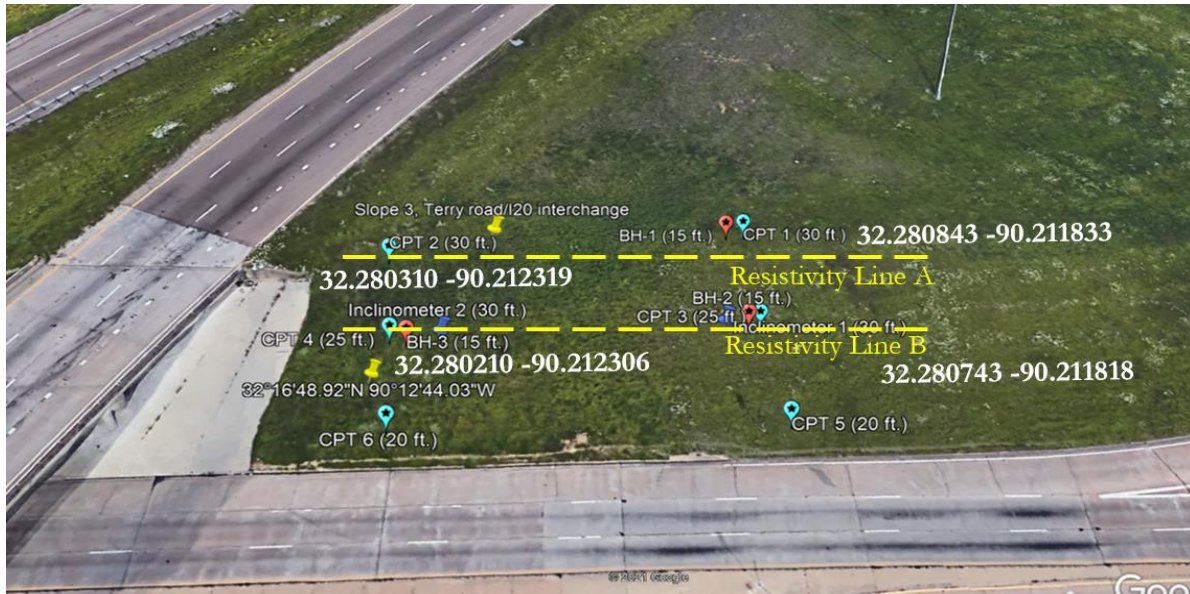
**Figure 4.17** Location of Slope 3 and ERI Test Lines

The ERI test for Instrumented Slope 3 was conducted along a 165-foot (50-meter) length of the crest and middle (lines A and B) of the slope. The test line and slope location are presented in Figure 4.17. The results obtained from testing Line A during different seasons from spring 2021 through fall/winter 2022 are presented in Figure 4.18 (a – e).

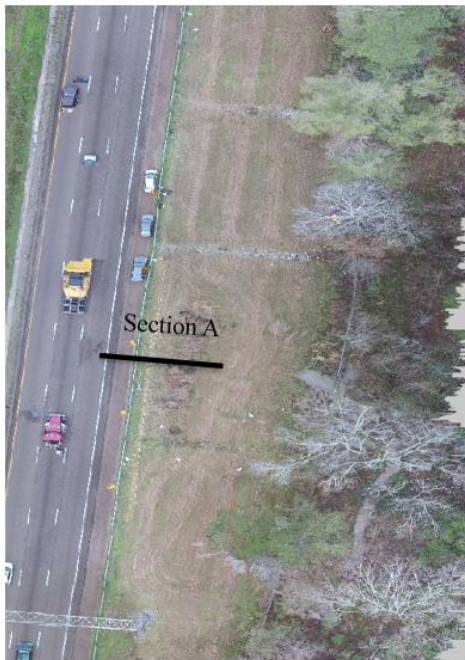
**Figure 4.31** Drone Imagery of Slope 4 in Fall/Winter 2022: (a) Digital Elevation Model, (b) 3D Model and Surface Profile, (c) Surface Topography

For the drone imagery collected in fall/winter 2022, the georeferenced DEM was imported into Civil 3D, and the surface was created using the kriging interpolation method. The surface profiles were created by using the alignment and surface profile tools within Civil 3D. Figure 4.31 (b) and (c) show the slope 3D model and the surface profile views for fall 2022, respectively.

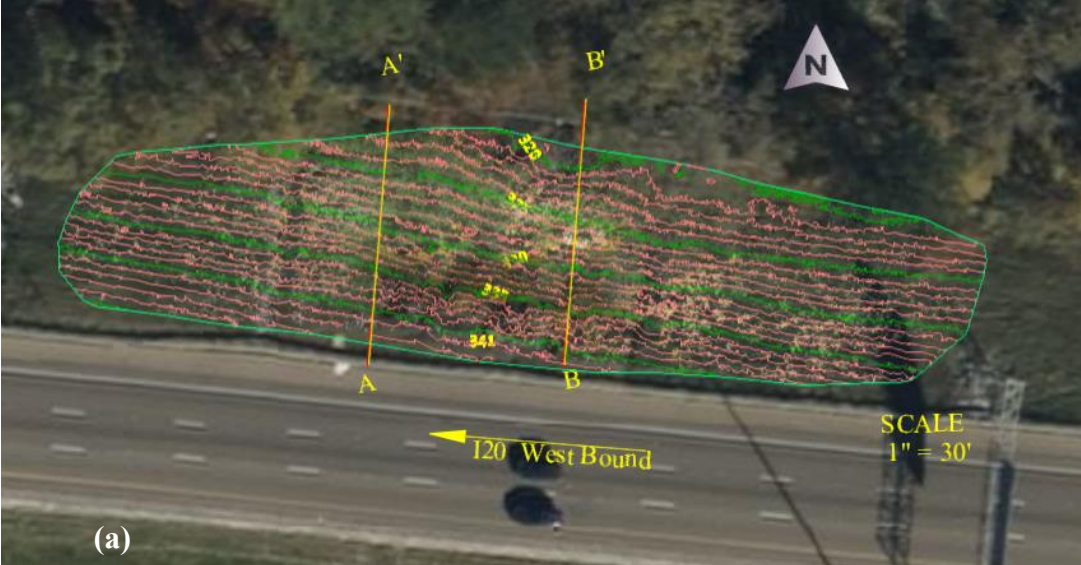
Figure 4.32 LiDAR Point Cloud Surface Topography Seasonal Variations in Slope 4: (a) Summer 2021, (b) Fall 2021, (c) Spring 2022, (d) Fall 2022

Topography and profile views of Slope 4 developed from the Terrestrial LiDAR scanning data collected during different seasons from summer 2021 through fall/winter 2022 are presented in **Figure 4.32**. Laser scanning was performed at several stations, and the overlapping point cloud data were collected. The point clouds were post-processed on a computer and registered together to form a single point cloud that was georeferenced, using field ground control points with known coordinates. The low surface points were extracted, using a ground extraction algorithm, to create the bare ground point clouds. The bare ground point clouds were imported into Civil 3D, and

surfaces were generated using the kriging interpolation method. Topographic surface views were generated at 1 ft. major and 5 ft. minor contour intervals and are presented in Figure 4.32 (a-d).

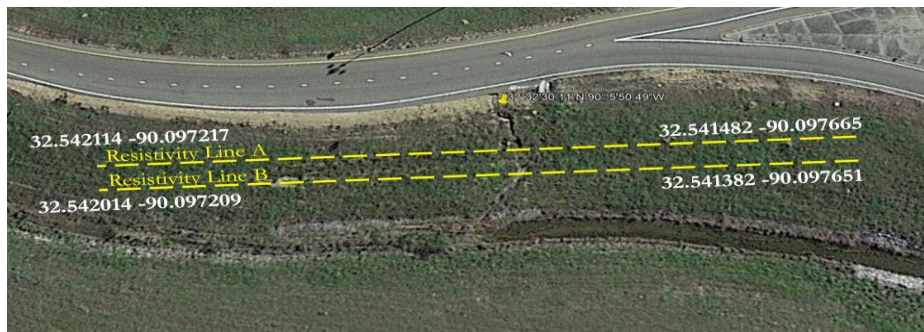
**Figure 4.34** Slope 5 ERI Test Lines Location

An ERI test was conducted of 270 feet between the crest and the middle (Lines A and B) of Slope 5. The test lines and slope location are presented in Figure 4.34. The results obtained for Line A during different seasons from spring 2021 through fall/winter 2022 are presented in Figure 4.35 (a-e).

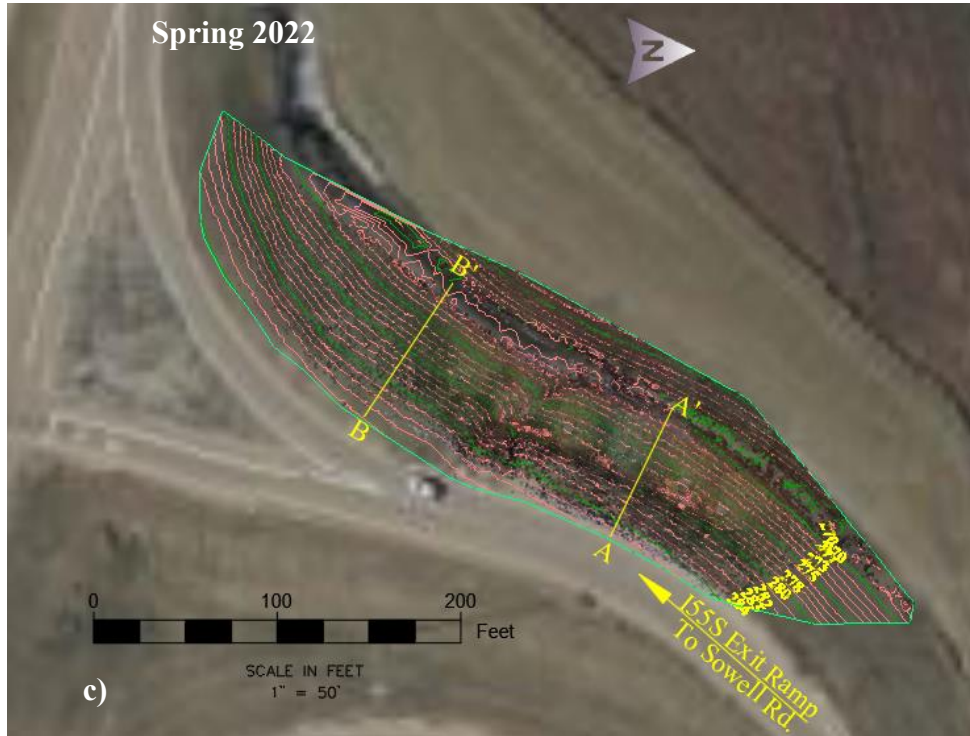
**Figure 4.40** LiDAR Point Cloud Surface Topography Seasonal Variations in Slope 5: (a) Summer 2021, (b) Fall 2021, (c) Spring 2022, (d) Fall 2022

Topography and profile views of Slope 5 developed from the terrestrial LiDAR scanning data collected during different seasons from summer 2021 through fall/winter 2022 are presented in Figure 4.40. Laser scanning was performed at several stations, and the overlapping point cloud data was collected, post-processed on a computer and registered together to form a single point cloud. The combined point cloud was then georeferenced using field ground control points with known coordinates. Low surface points were extracted to create the bare ground point clouds, using a ground extraction algorithm. The bare ground point clouds for all seasons collected were imported into Civil 3D, and digital elevation model surfaces were generated using the kriging interpolation method. Topographic surface views were generated at 1 ft. major and 5 ft. minor contour intervals and are presented in **Figure 4.40** (a-d).

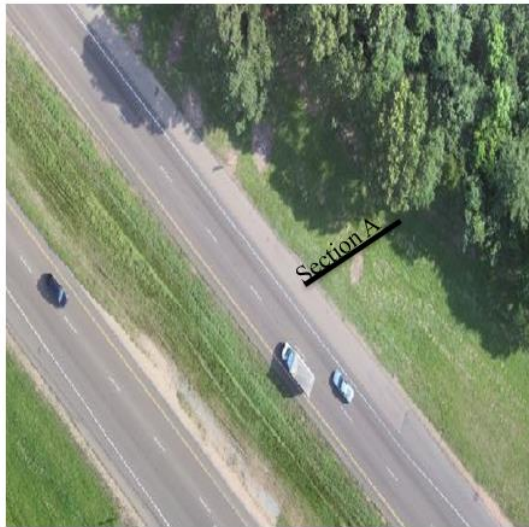
**Figure 4.45** Drone Image of Slope 6 (Summer 2021)

Drone surveys were conducted during the various seasons from summer 2021 through fall 2022, and the aerial imagery captured was processed using specialized software. The coordinates for the imagery were set to the State Plane Coordinate System Mississippi US-West. Aerial triangulation was performed with multiple tie points to stitch the images together and develop a digital elevation model (DEM), digital terrain model (DTM), and mosaics. The DEM and orthomosaic digital image representations are presented in Figure 4.415 to Figure 4.47.

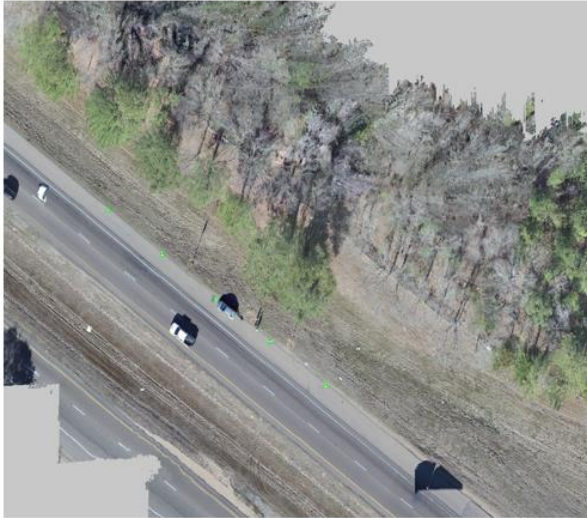
**Figure 4.47** Drone Images of Slope 6 (Fall/Winter 2022): (a) Digital Elevation Model, (b) 3D Model & Surface Profile, (c) Surface Topography & Profile

The profile views of the slope were developed using two methods. The elevations were extracted, and a profile was created manually for the imagery captured in summer 2021, as shown in Figure 4.41. A georeferenced DEM was imported into Civil 3D for the imagery collected in fall/winter 2022, and the surface was created using the kriging interpolation method. Then, a surface profile was created along the slope, using the alignment and surface profile tools in Civil 3D. Figure 4.437 (b) & (c) show the 3D model of the slope and the surface profile views for fall/winter 2022. The orthomosaic failed for spring 2022 and could not be included in this report.
