# MDOT State Study 316 – Development of Advanced Landslide Investigation Protocol Using Geophysical Methods for Mississippi

## FINAL REPORT

1. Report No. FHWA/MDOT-RD-23-316	2. Government Accession No.	3. Recipient's Catalog No.	
4. Title and Subtitle Development of Advanced Landslide Investigation Protocol Using Geophysical Methods for Mississippi		5. Report Date: June 30, 2023

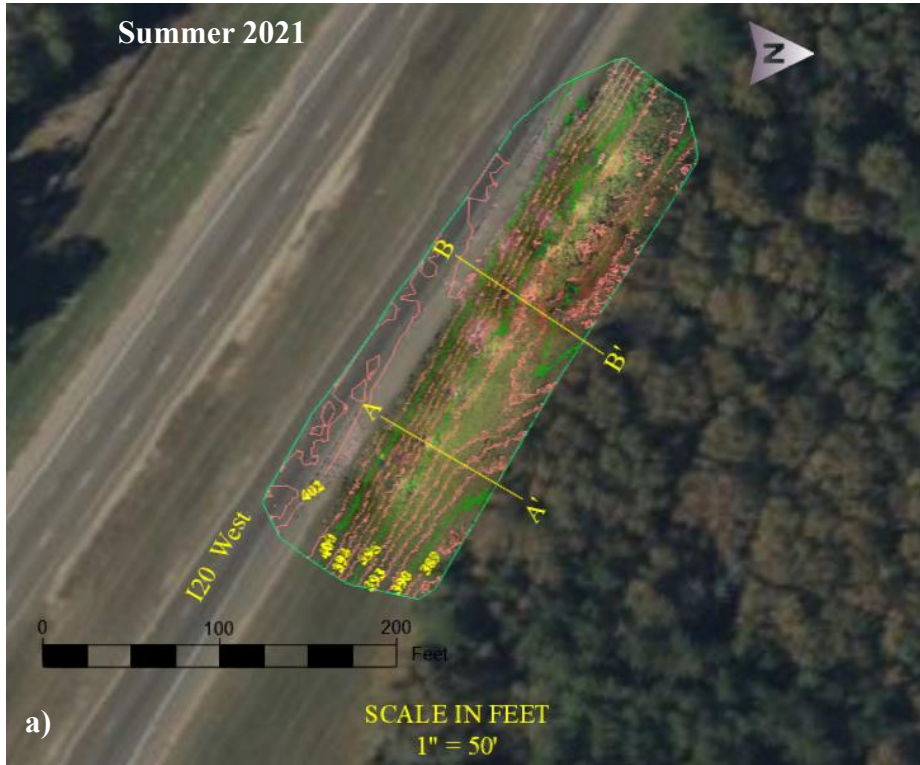
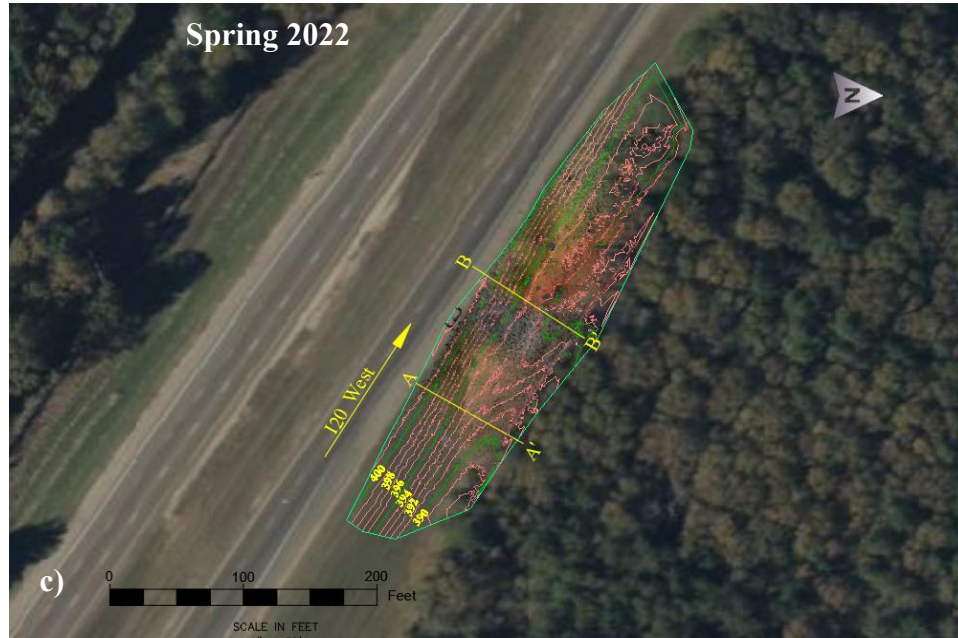
**Figure 4.48** LiDAR Point Cloud Surface Topography Seasonal Variations of Slope 6: (a) Summer 2021, (b) Fall 2021, (c) Spring 2022, and (d) Fall/Winter 2022

Topography and profile views of Slope 6 developed from the terrestrial LiDAR scanning data collected during different seasons from summer 2021 through fall/winter 2022 are presented in Figure 4.448. Laser scanning was performed at several stations to collect point cloud data, which was then processed on a computer and registered to form a single point cloud. The combined point cloud was then georeferenced using field ground control points with known coordinates. Low surface points were extracted using a ground extraction algorithm to create the bare ground point clouds imported into Civil 3D. Digital elevation model surfaces were generated using the kriging interpolation method. Topographic surface views were generated at 1 ft. major and 5 ft. minor contour intervals and are presented in Figure 4.448 (a-d).

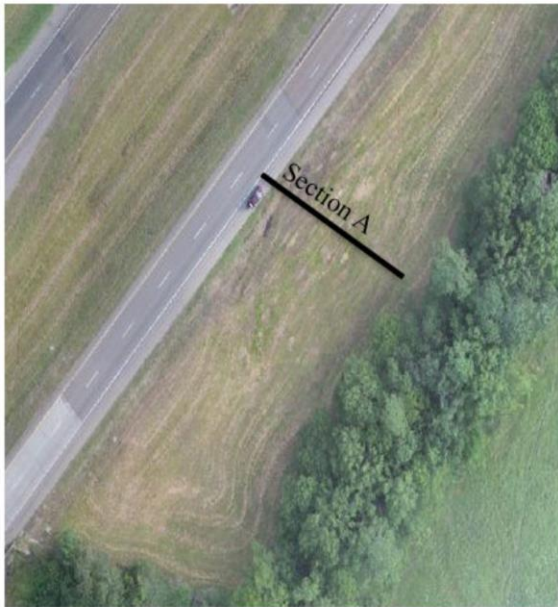
**Figure 4.54** Drone Images of Failed Slope 2

A drone survey of failed Slope 2 commenced in summer 2021, and the aerial imagery captured by the drone was processed using specialized image processing software. Aerial triangulation was performed with multiple tie points to stitch the images together and develop a digital elevation model (DEM), digital terrain model (DTM), and mosaics. DEM and orthomosaic digital image representations of the failed slope are presented in Figure 4.53. The elevations from the DEM along section A were extracted, and a profile was created manually, as shown in Figure 4.54.

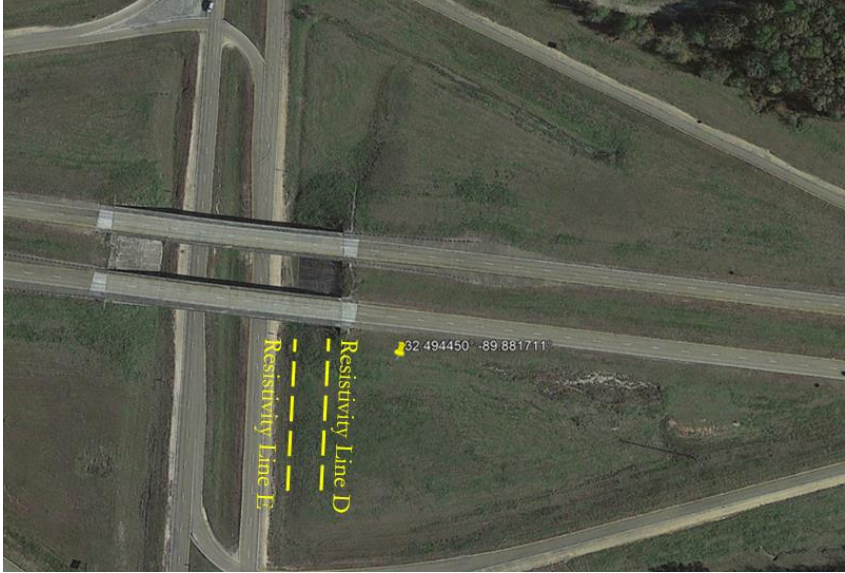
**Figure 4.60** Location of ERI Lines at Failed Slope 4 - SR25/43 Interchange Left Abutment

**Left Abutment:** The ERI test was performed along two lines spanning 81 ft. (Lines D and E) at the left bridge abutment. The ERI test lines and slope location are presented in Figure 4.60; the results for Lines D & E are presented in Figure 4.61 (a) & (b).

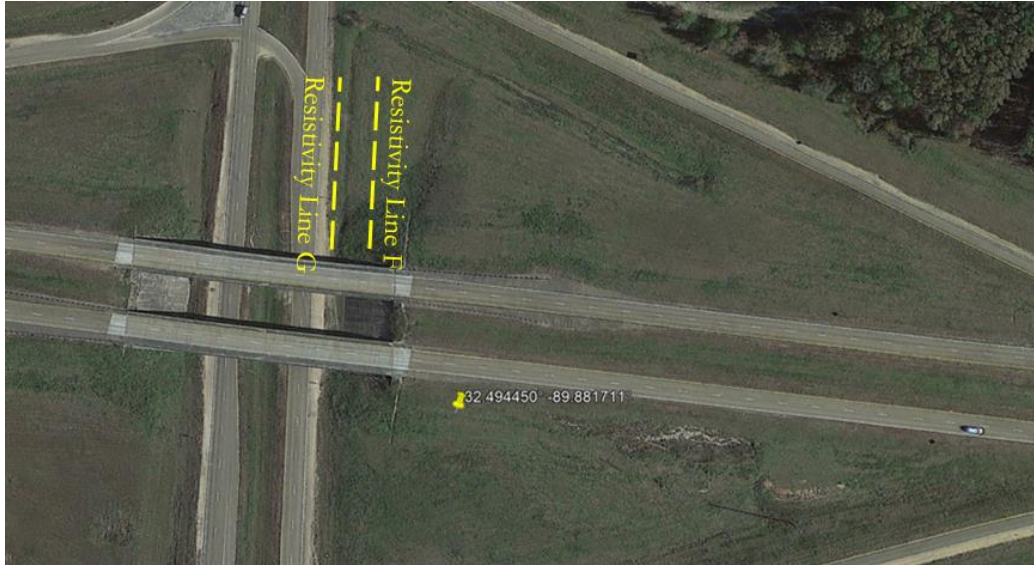
**Figure 4.62** ERI Test Location of Failed Slope 4- SR25/43 Interchange Right Abutment

**Right Abutment:** At the right bridge abutment of the SR25/43 interchange, the ERI test was completed along two lines spanning 81 feet (Lines F and G). The ERI test lines and slope location are presented in Figure 4.62. The results for Lines F & G are presented in Figure 4.63 (a) & (b).

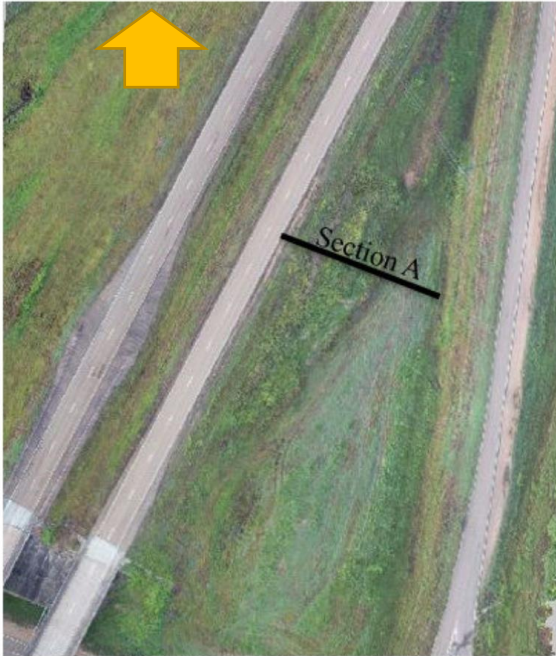
**Figure 4.64** Slope 4 Failures: (a) Failure along SR25, (b) Failure of Left Abutment, (c) Failure of Right Abutment

In summer of 2021, a drone survey mission commenced at three locations: along the slope of SR25 southbound, and along the left and right bridge abutments of the SR25/43 interchange. The aerial imagery captured by the drone was processed using specialized image processing software. Aerial triangulation was performed with multiple tie points to stitch the images together and develop a digital elevation model (DEM), digital terrain model (DTM), and mosaics. The elevations along Section A of the DEM were extracted, and surface profile views were manually created. DEM and orthomosaic 3D digital image representations of the failed slope are presented in Figure 4.64 (a-c). The slide failure along SR25 southbound is presented in Figure 4.64 (a); failures of the left and right bridge abutments of the SR25/43 interchange are presented in Figure 4.64 (b) & (c), respectively.

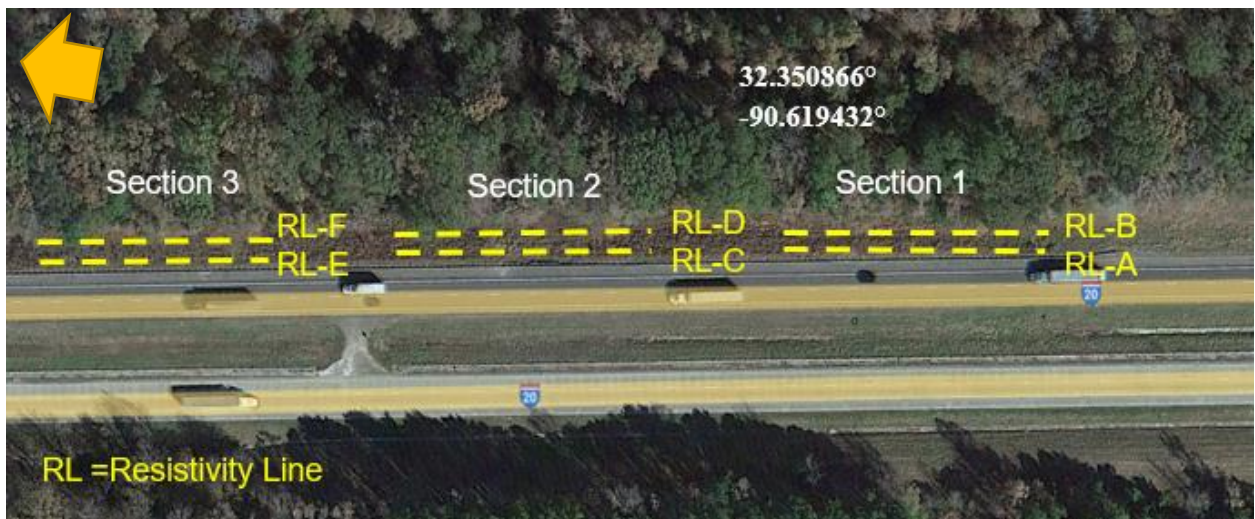
**Figure 4.68** Location of ERI Test Lines in Failed Slope 5 (Big Black River)

ERI tests for failed Slope 5 were carried out in the summer of 2021 at the three locations identified in Figure 4.68 as Sections 1, 2 and 3. In Section 1, the ERI test was conducted along two test lines (Lines A & B) over a span of 323 ft., and the results are presented in Figure 4.69 (a) and (b). In Section 2, the ERI test was conducted along Lines C & D over a span of 270 ft., and the results are presented in Figure 4.70 (a) and- (b). In Section 3, the ERI test was conducted along Lines E and F, over a span of 108 ft., and the results are presented in Figure 4.71 (a) and (b). The results for Sections 1 and 2 show high resistivity zones along the whole test span up to 10 ft. depth. Wet soil zones are present below the deformed soil, up to 65 ft. depth. The higher resistivity shown by the ERI profiles for Section 3 is probably because the images were taken at a depth of 26 ft. and the wet zones are below that depth.

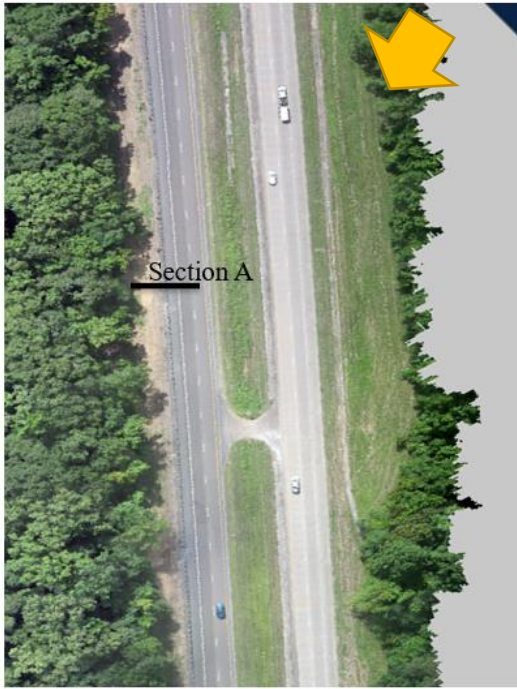
Figure 4.72 Drone Images of Failed Slope 5: (a) Digital Elevation Model, (b) Surface Topography and Profile (Summer 2021)

A drone survey mission was conducted for failed Slope 5 (Big Black River Slope) in the Summer of 2021 at three locations designated as Sections 1, 2 and 3 in Figure 4.6872. The aerial imagery captured by the drone was processed using specialized image processing software. Aerial triangulation was performed with multiple tie points to stitch the images together and develop a digital elevation model (DEM), digital terrain models (DTM), and mosaics. DEM was imported into Civil 3D, and the surface was created using the kriging interpolation method. Alignment along the slope was created, and a surface profile view was generated. Figure 4.72 (a) and (b) show the 3D model of the slope and the surface profile views.

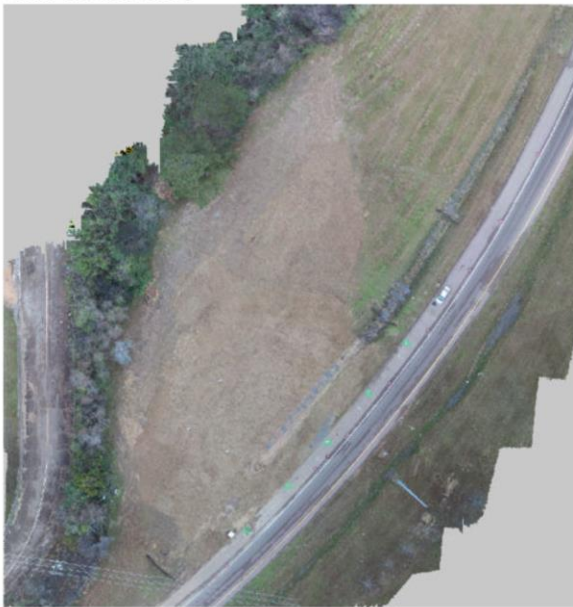
**Figure 4.79** Drone Images for Failed Slope 6: (a) DEM, (b) 3D Model View, (c) Surface Topography and Profile (Fall/Winter 2022)

DEMs were imported into Civil 3D, and the surface was created using the kriging interpolation method. Alignment along the slope was created, and a surface profile view was generated along Line A, shown in Figure 4.78 (a) and Figure 4.79 (a). The summer 2021 and fall/winter 2022 DEM and orthomosaic 3D models are presented in Figure 4.78(a), Figure 4.79(a) and Figure 4.79 (b), respectively. The topographic contour views and surface profile views along

Line A for summer 2021 and fall/winter 2022 are presented in Figure 4.78 (b) and Figure 4.79 (c), respectively.

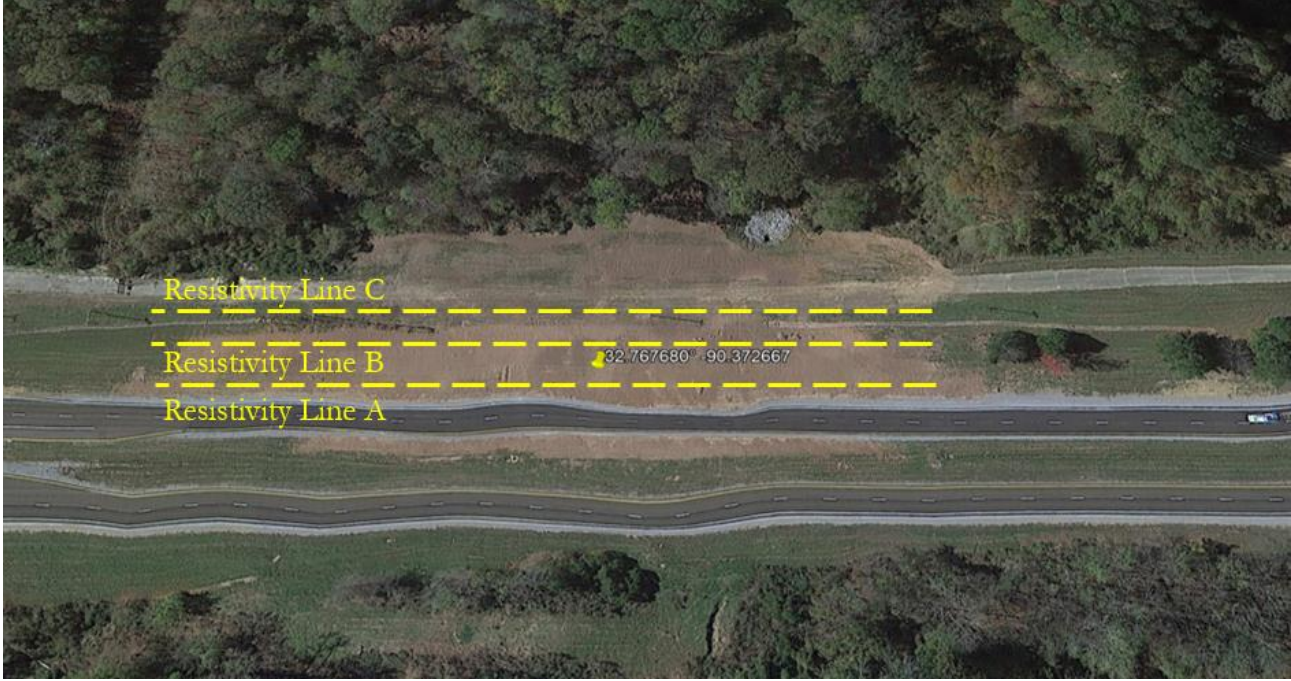
**Figure 4.81** Location of ERT Test Lines for Failed Slope 7

The ERI test for failed Slope 7 was conducted along three lines: Lines A & B, which spanned 270 feet at the crest and middle, and Line C, which spanned approximately 82 ft. at the toe of the slope. The location of the slope and test lines are presented in Figure 4.81. The ERI results for Lines A & B for summer 2021 are presented in Figure 4.82 (a), (b) and (c). The ERI results indicated that from the surface of the crest up to a depth of 15 ft., there are high resistivity layers that indicate loose soil with air voids. Low resistivity areas exist below the loose soil,

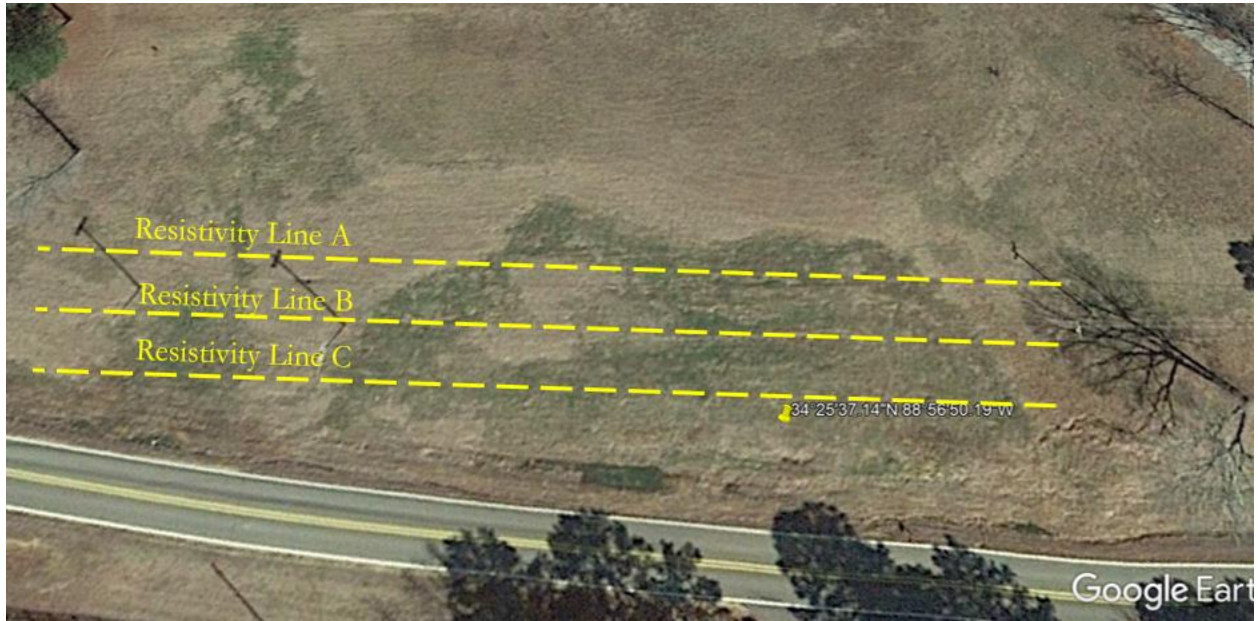
**Figure 4.84** Location of ERI Test Lines in Failed Slope 8

ERI tests were performed along three lines, Lines A, B & C, for failed Slope 8, all spanning 378 feet. The location of the slope and the test lines are presented in Figure 4.84. The results for Lines A, B & C are presented in Figure 4.865 (a), (b) and (c). The results showed the presence of high resistivity layers, indicating loose soil with air voids, from the surface of the crest (Line A) down to 6 ft. and also below 47 ft. Low resistivity areas are below the loose soil, indicating wet soil along the entire span, likely caused by rainfall infiltration.

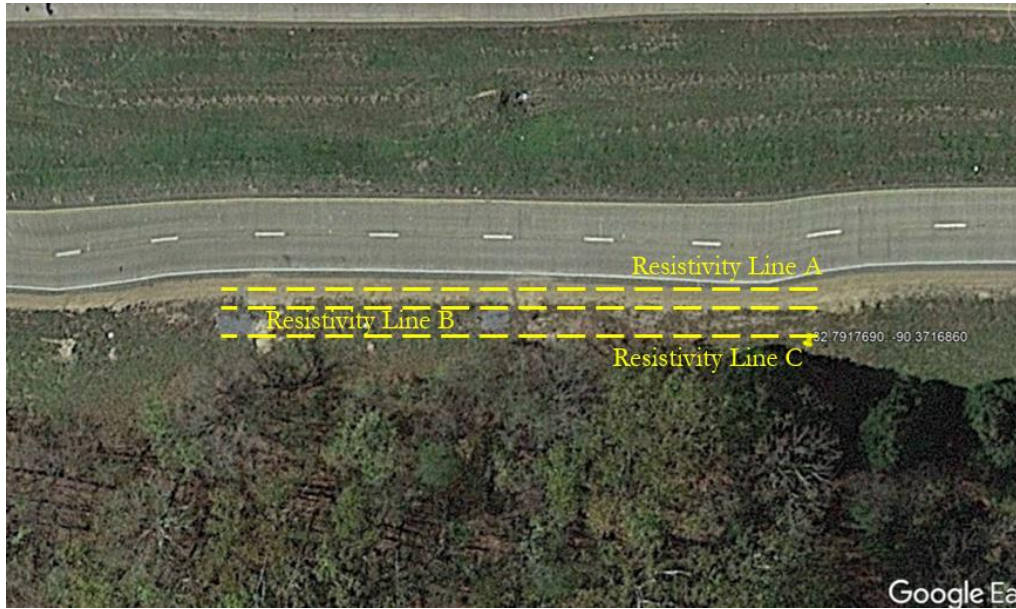
**Figure 4.90** Location of ERI Test Lines in Failed Slope 10

ERI tests were conducted for failed Slope 10 along three lines, A, B & C, each spanning 486 feet, with electrodes spaced at intervals of 9 ft. The location of the slope and the test lines are presented in Figure 4.90. The results for Lines A, B & C are presented in Figure 4.91 (a), (b) and (c). The results revealed high resistivity layers at all three lines up to approximately 25 ft. depth, indicating deformed soil. Low resistivity areas exist directly below the loose soil, indicating perched water conditions caused by rainfall infiltration.

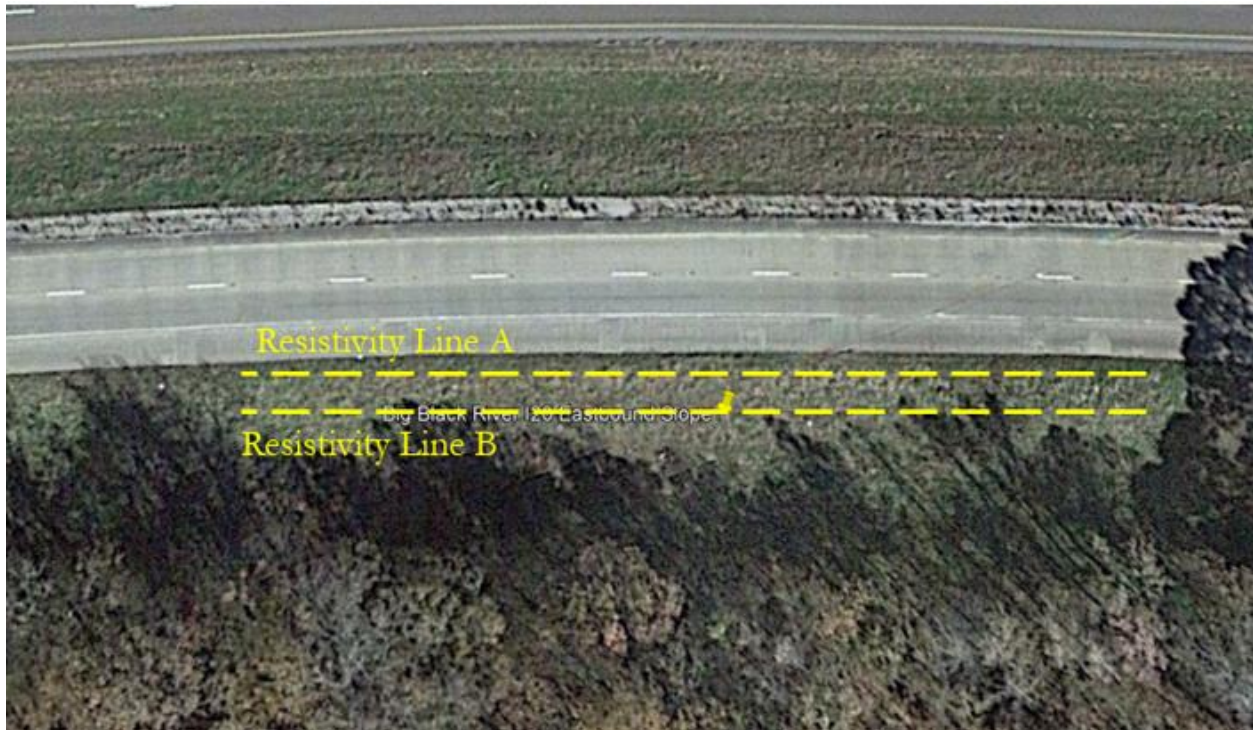
**Figure 4.94** ERI Test Lines in Failed Slope 12

ERI tests for failed Slope 12 were performed along the A and B lines that span approximately 220 ft. and are equipped with electrodes spaced at 5 ft. intervals. The location of the slope and test lines are presented in Figure 4.94. The ERI results for Lines A & B are presented in Figure 4.95 (a) & (b) and show that high resistivity layers are present up to approximately 8 ft. depth, indicating deformed soil. Low resistivity areas exist directly below the loose soil, indicating perched water conditions from rainfall infiltration.

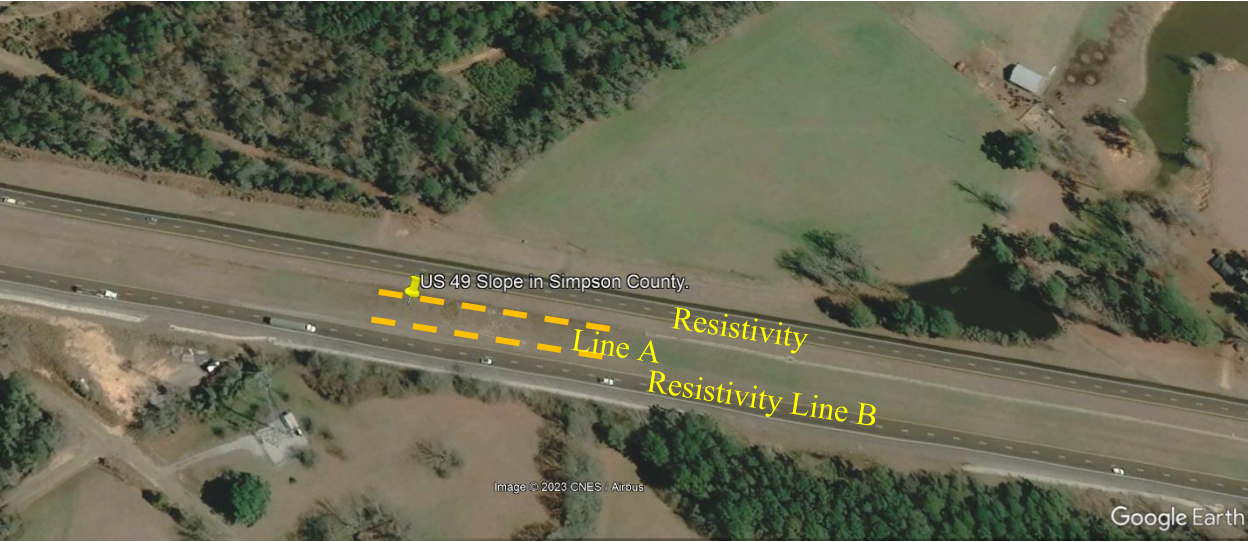
**Figure 4.98** Location of ERI Test Lines in Failed Slope 14

ERI tests were conducted for failed Slope 14 across two lines, A & B, spanning 320 ft. and equipped with electrodes spaced at 5 ft. intervals. The location of the slope and test lines are presented in Figure 4.98. The ERI results are presented in Figure 4.99 (a) and (b).

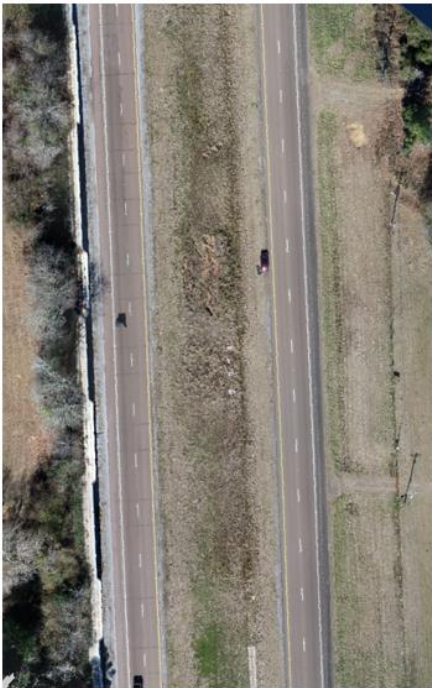
**Figure 4.100** Drone Images of Failed Slope 14: (a) Digital Elevation Model, (b) Surface Topography & Profiles, (c) 3D Model & Surface Profile (Spring 2022)

Drone survey missions were conducted over failed Slope 14 in spring 2022 and fall 2022, and the aerial imagery captured was processed using specialized image processing software. Aerial triangulation was performed with multiple tie points to stitch the images together and develop digital elevation model (DEMs), digital terrain models (DTMs), and mosaics. The DEM and orthomosaic digital image representations are presented in Figure 4.100 (a) & Figure 4.101 (a).

The DEMs were imported into Civil 3D, and surfaces were created using the kriging interpolation method. Alignments along the slope were created, and surface profile views were generated along the slope. The topographic contour views and surface profile views for spring 2022 and fall 2022 are presented in Figure 4.100 (b) & Figure 4.101 (b) respectively. The 3D

model representation of the slope and surface profile views for spring 2022 and fall 2022 are presented in Figure 4.100 (c) and Figure 4.101 (c) respectively.

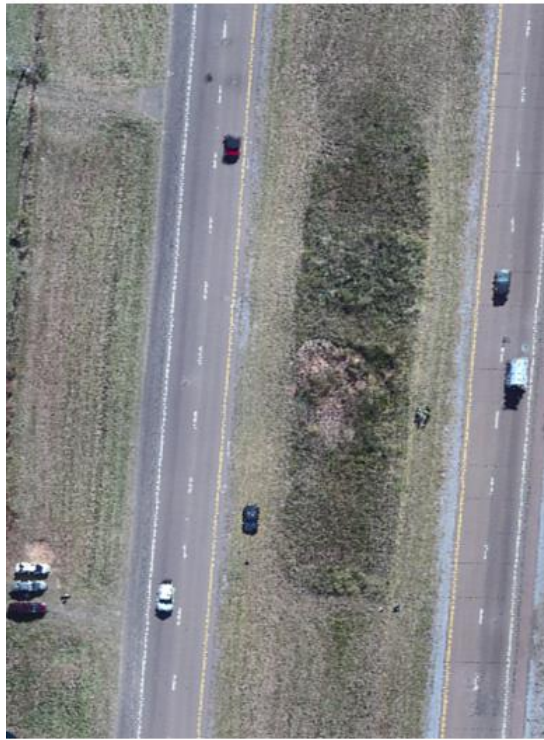
**Figure 4.101** Drone Images of Failed Slope 14: (a) Digital Elevation Model, (b) Surface Topography & Profiles, (c) 3D Model & Surface Profile (Fall 2022)

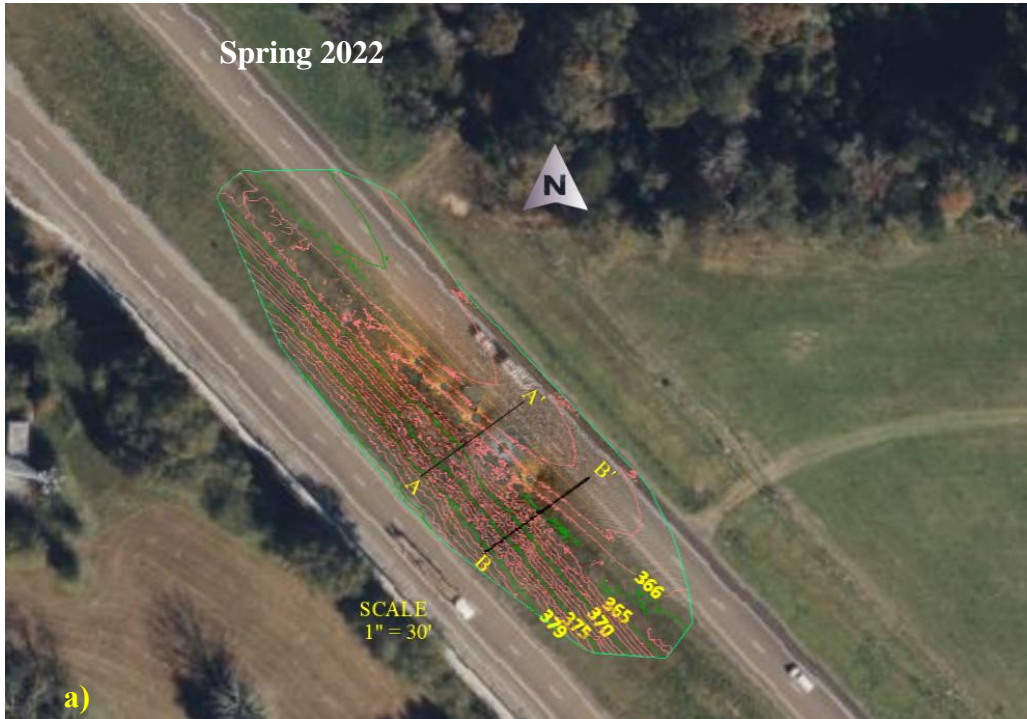
**Figure 4.102** LiDAR Point Cloud Surface Topography for Failed Slope 14: (a) Fall 2021, (b) Fall 2022

Terrestrial LiDAR scanning data was collected after the failure of Slope 14 in spring 2022 and then again in Fall 2022 after the slope was stabilized with vetiver grass. Laser scanning was performed at several stations, and the overlapping point cloud data were collected, then post-processed and registered together to form a single point cloud, which was then georeferenced using field ground control points with known coordinates. Using a ground extraction algorithm, low surface points were extracted to create the bare ground point clouds. The bare ground point clouds for all seasons collected were imported into Civil 3D, and digital elevation model surfaces were generated using the kriging interpolation method. Topographic surface views were generated at 1 ft. major and 5 ft. minor contour intervals for spring 2022 and fall 2022 and are presented in Figure 4.102 (a) and (b), respectively. The surfaces from the two seasons were overlaid, and alignments were created along the slope. Stacked surface profiles were then created using the alignments along Sections A-A' and B-B' and are presented in Figure 4.103 (a) & (b).

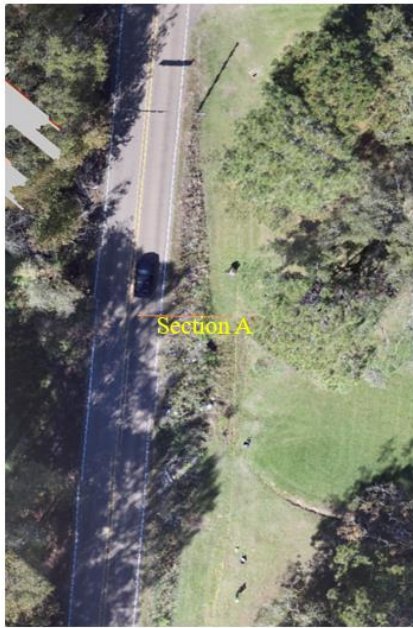
Figure 4.104 Drone Images of Failed Slope 15: (a) Digital Elevation Model (b) Surface Topography and Profile (Fall 2021)

A drone survey mission was conducted over failed Slope 15 in the fall of 2021, and the captured aerial imagery was processed using specialized image processing software. Aerial triangulation was performed with multiple tie points to stitch the images together and develop a digital elevation model (DEM), digital terrain models (DTMs), and mosaics. The DEM and orthomosaic digital image representations are presented in Figure 4.104 (a). The DEM was imported into Civil 3D, and the surface was created using the kriging interpolation method. Alignment along the slope was created, and a surface profile view was generated along Section A. The topographic contour and surface profile for fall 2021 are presented in Figure 4.104 (b).

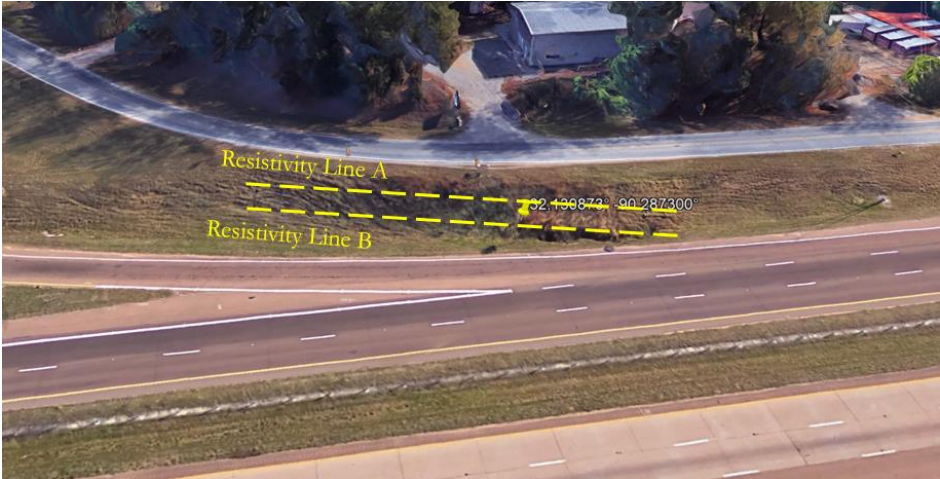
**Figure 4.112** Location of ERI Test Lines in Failed Slope 18

ERI tests were conducted at failed Slope 18, along Lines A and B spanning approximately 275 ft. and equipped with electrodes spaced at 5 ft. The locations of the slope and test lines are presented in Figure 4.112. The test results are presented in Figure 4.113(a) and (b). The slope is deformed at the surficial level, and there are low resistivity zones at Line A, at shallow depths up to approximately 12 ft., indicating infiltration of water due to surficial soil deformation. High

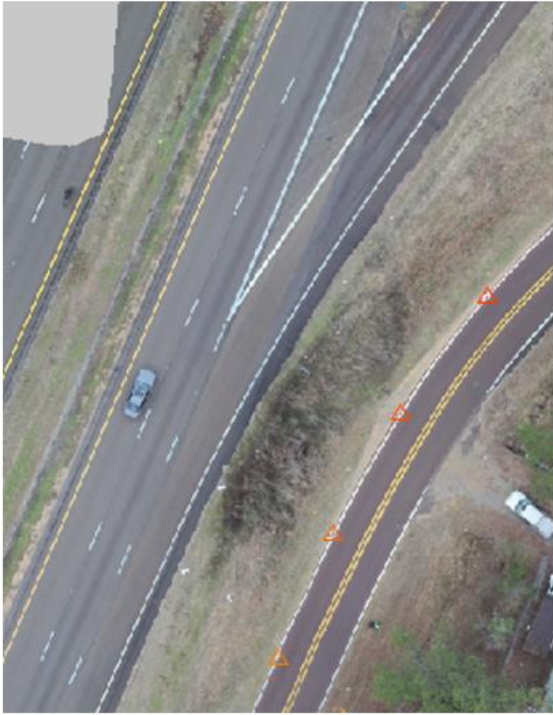
**Figure 4.114** Drone Images of Failed Slope 18: (a) Digital Elevation Model, (b) Surface Topography, and (c) 3D Model and Surface Profile (Fall 2022)

A drone survey mission was carried out over failed Slope 18 in fall/winter 2022, and the aerial imagery captured was processed using specialized image processing software. Aerial triangulation was performed with multiple tie points to stitch the images together and develop a digital elevation model (DEM), digital terrain models (DTMs), and mosaics. The DEM and orthomosaic digital image representations are presented in Figure 4.114 (a). The DEM was imported into Civil 3D, and the surface was created using the kriging interpolation method. Alignment was created and a surface profile view was generated along the slope (section A). The topographic contour is presented in Figure 4.114 (b). The 3D model representation created from the drone imagery, along with the surface profile view, is presented in Figure 4.114(c).

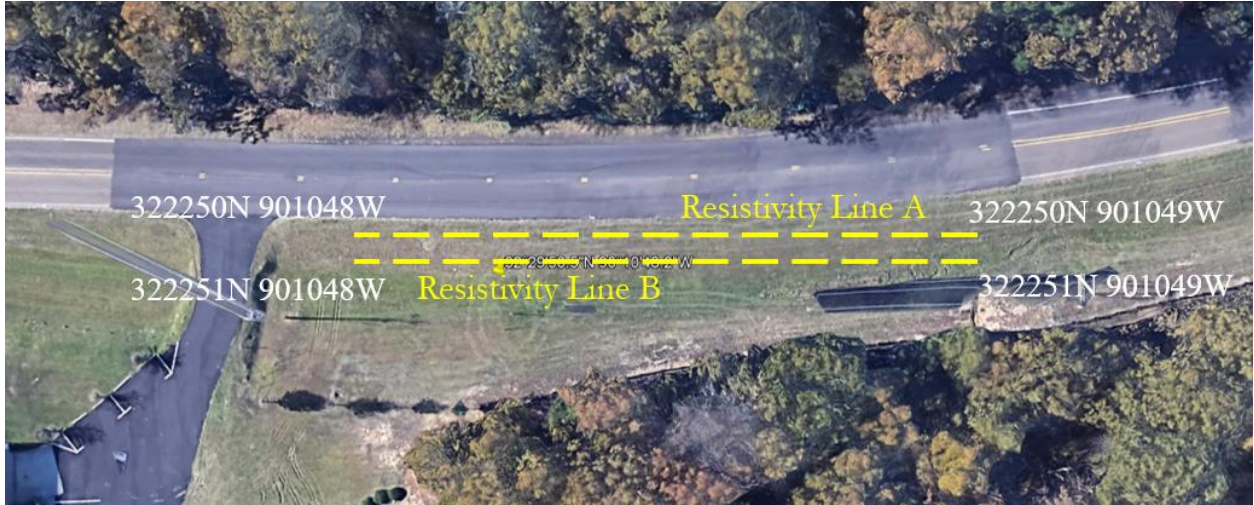
Figure 4.116 Location of ERI Test Lines in Failed Slope 19

ERI tests were conducted for failed Slope 19 along lines A and B that spanned 440 ft. and were equipped with electrodes spaced at 8 ft. intervals. The location of the slope and test lines are presented in Figure 4.116. ERI results for Lines A & B are presented in Figure 4.117 (a) and (b). Patches of low resistivity zones exist at both lines, across the entire horizontal span of the ERI profile, as the slope and road have suffered extensive settlement over the years due to the condition of the soil.

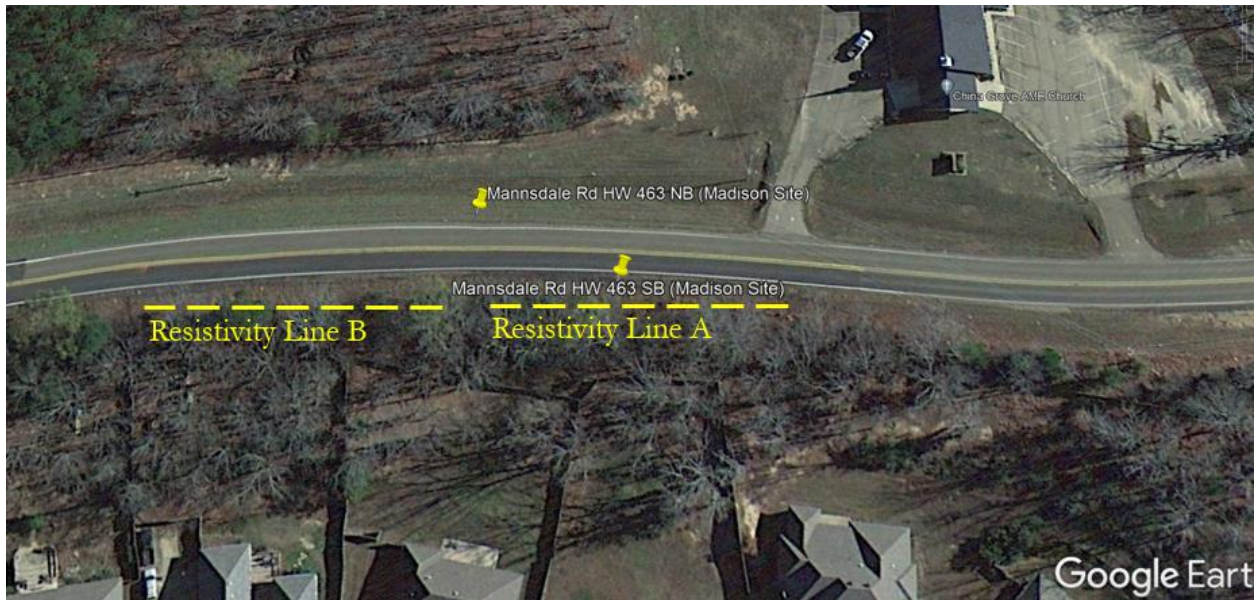
**Figure 4.121:** ERI Test Lines at Failed Slope 20

ERI tests were performed along Lines A and B of failed slope 20 that spanned 495 ft. and were equipped with electrodes spaced at 9 ft. intervals. The locations of the slope and ERI test lines are presented in Figure 4.121. The ERI results are presented in Figure 4.122 (a) and (b). Patches of high resistivity exist along both lines in the shallow depths, indicating loose or deformed soil. Low resistivity areas exist directly below the loose soil, from 15 to 30 ft. depths, indicating perched water conditions from rainfall infiltration.

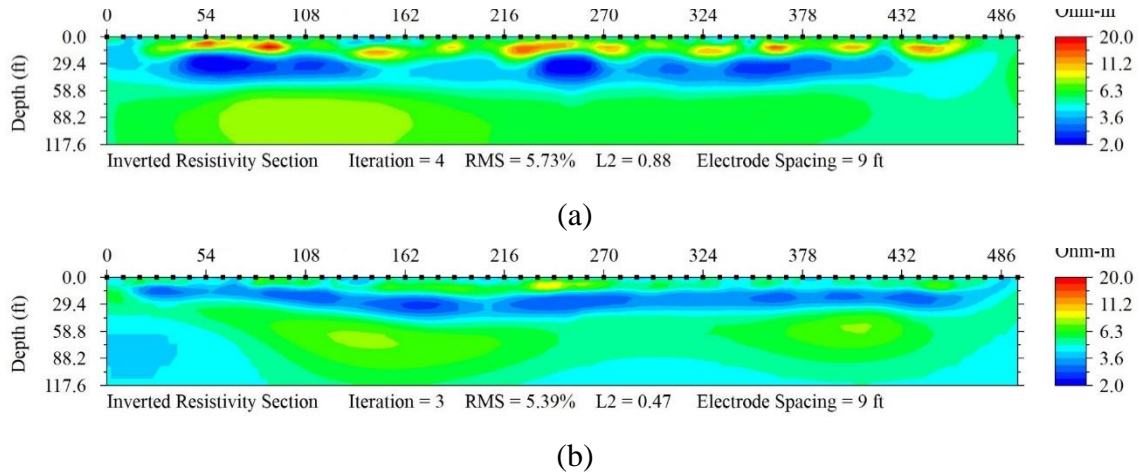
**Figure 4.122** ERI Test Results of Failed Slope 20: (a) Line A and (b) Line B

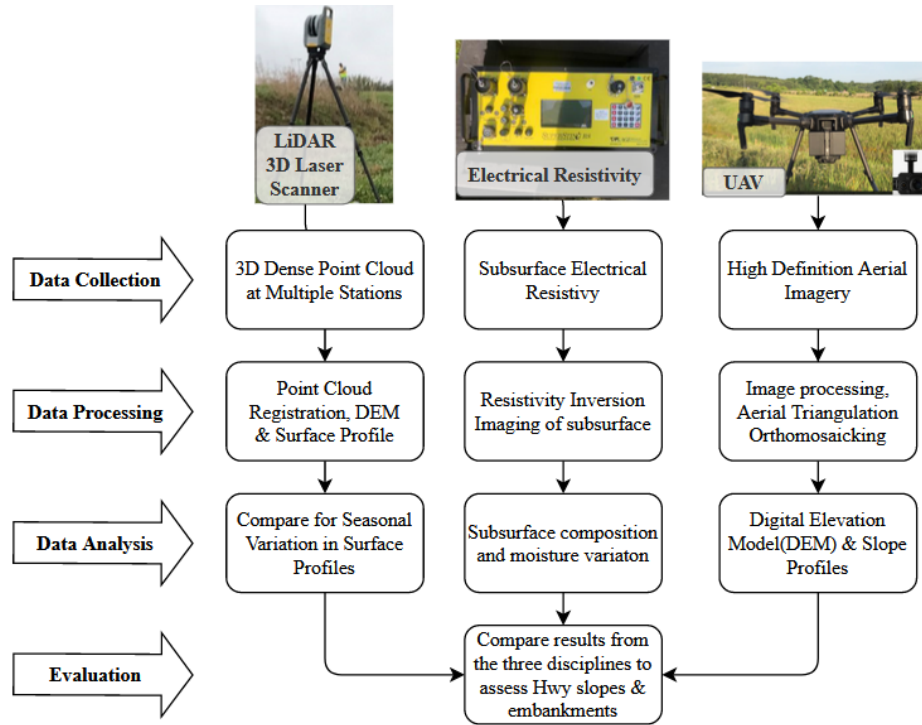
**Figure 5.2** Schematic of Methodology (Nobahar et al., 2023)

Data collected from UAV, LiDAR, and ERI investigations for the four slopes in central Mississippi listed below were used to evaluate their current conditions. The methodology schematic is presented in Figure 5.2

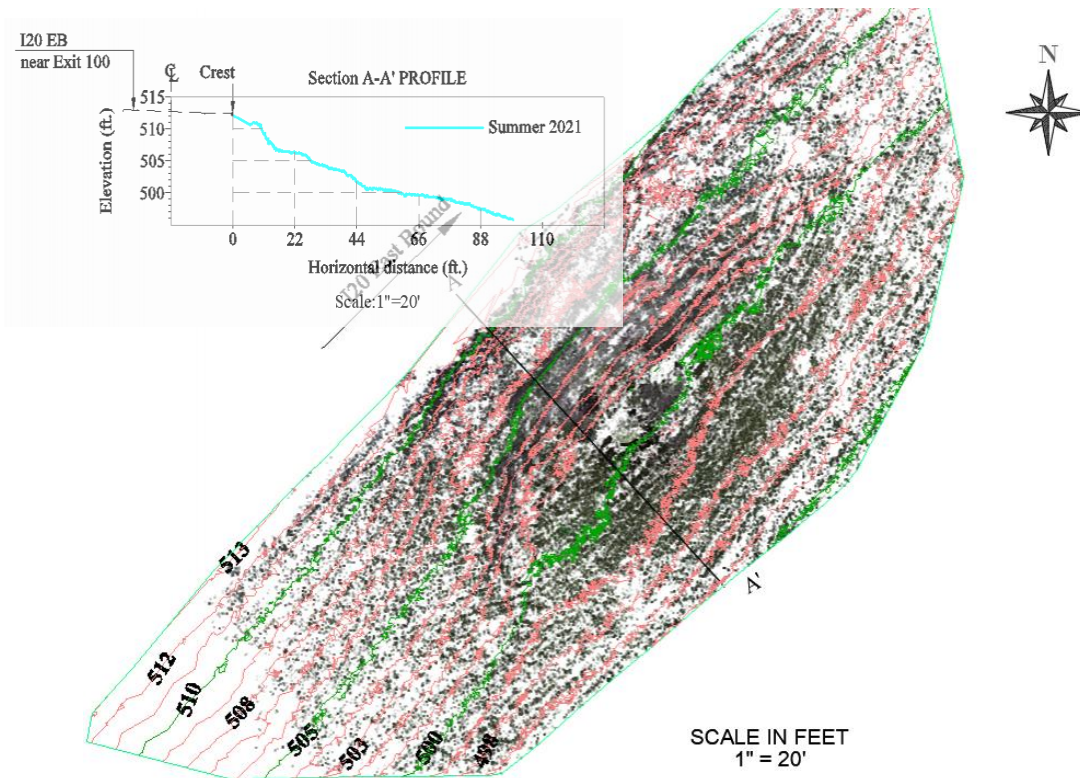
**Figure 5.8** LiDAR Results: Surface Topography and Profile View

The elevations presented below are from the Mississippi State Plane Coordinate System and are different from the drone results, which are in the GPS system. The surface topography and profile obtained from the LiDAR survey are presented in **Figure 5.8**. Regardless of the coordinate system, the surface profile developed from the LiDAR point cloud is similar to that obtained from the drone DEM.

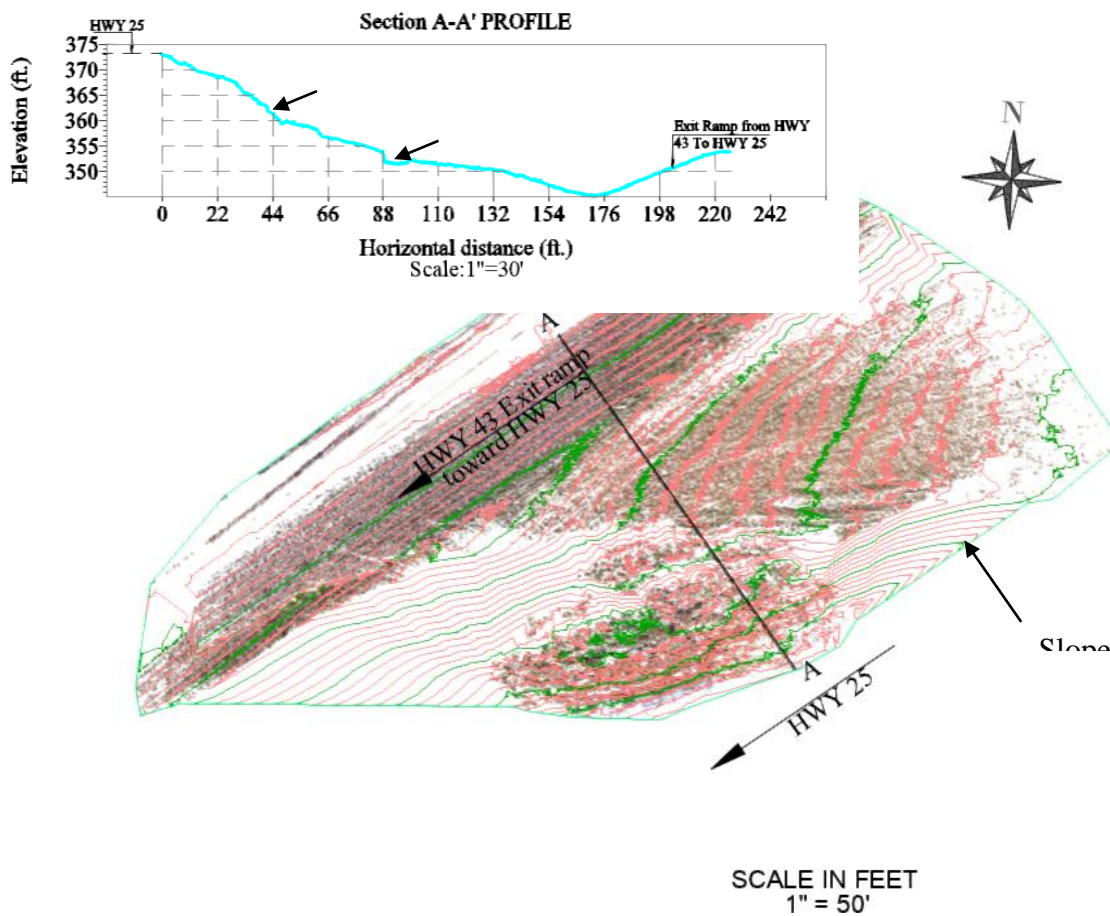
**Figure 5.13** Slope along SR 25 LiDAR Results: Surface Topography and Profile

Point cloud data collected from the terrestrial LiDAR survey was processed and analyzed, and the resulting surface topography and surface profiles are presented in Figure 5.13. The LiDAR surface profile is similar to that provided by the UAV, except that it is more detailed, once again proving that LiDAR point clouds provide greater detail in surface profiles than UAVs. The failure area can also be identified in the LiDAR surface profile by the drop in elevation on the surface profile view. The subsurface resistivity on the ERI profile at this point also indicated high resistivity soil, indicating the presence of loose deformed soil and thus providing corroboration. Continuous LiDAR monitoring of the slope can detect changes and variations in slope profiles over time.

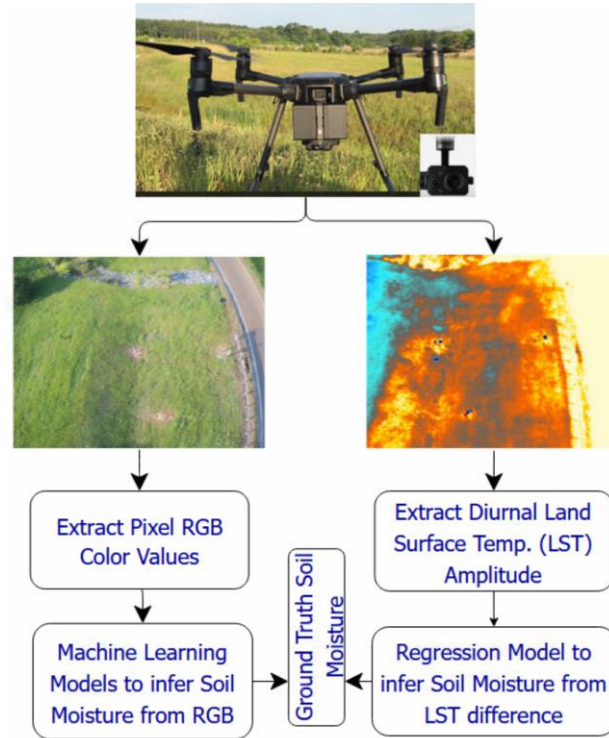
**Figure 5.14** Methodology of Predicting Soil Moisture from UAV Images(Salunke et al., 2023)  
**SMC from Optical Images**

Imagery captured by unmanned aerial vehicles (UAVs) has proven to be effective in predicting important soil properties, such as moisture content. Salunke et al., (2023) conducted a study to develop a statistical and machine-learning model that could predict the amount of moisture in soil from UAV-captured optical and thermal images. The color and temperature information obtained from the images captured by a UAV was used to develop machine learning (ML) and statistical models that could predict soil moisture. The methodology used for this process is presented in Figure 5.14 below.

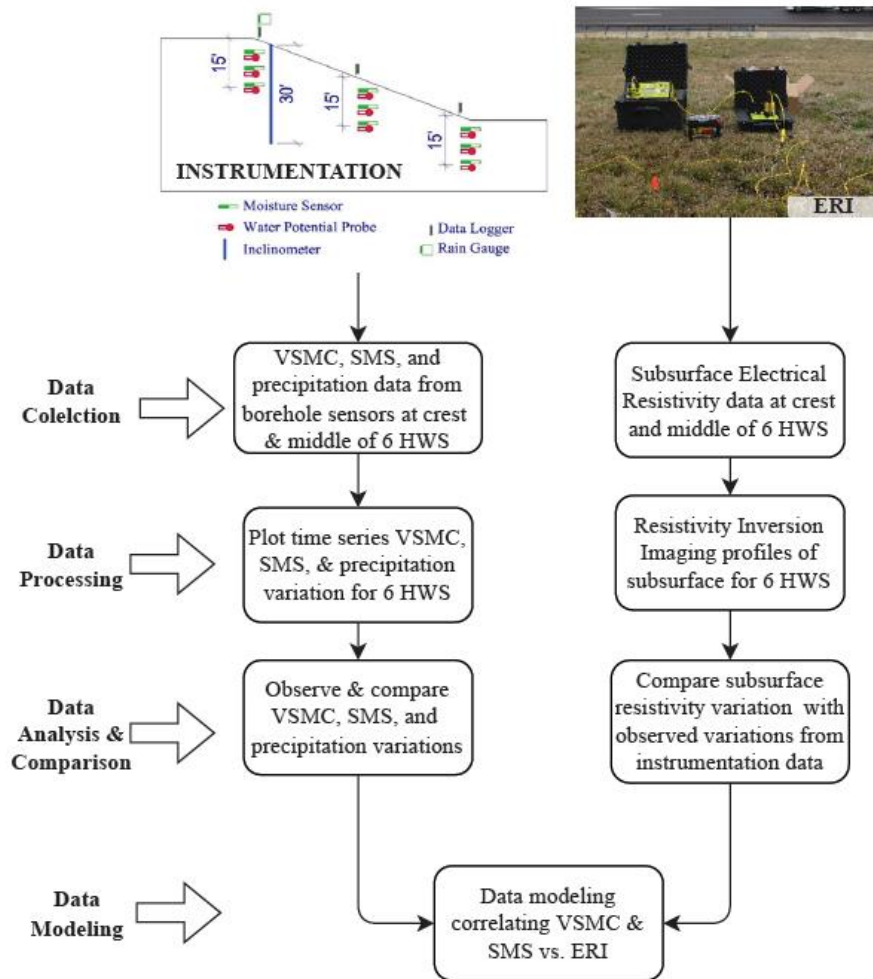
**Figure 5.19** Methodology for Developing Resistivity vs Soil Moisture and Soil Suction Models (Nobahar et al. 2022 Geotechnics)

maintenance, and can be conducted over a large area as many times as needed. In contrast, installing borehole sensors is destructive; the equipment and sensors are expensive, subject to wear and tear, lose connectivity over time and eventually become worthless, and provide spatially restrictive readings of soil moisture and suction that can only cover a small area. The results from the ERI testing of six highway slopes in the Jackson metro area were correlated with instrumentation data to develop resistivity vs. soil moisture and resistivity vs. matric suction models. The methodology for developing these resistivity models is presented in Figure 5.19.
