Article

Influence of Anodizing by Electro-Chemical Oxidation on Fatigue and Wear Resistance of the EV31A-T6 Cast Magnesium Alloy

Keywords: rare earth magnesium alloy; electro chemical oxidation; plasma electrolytic oxidation; microstructure; fatigue strength; dry sliding; wear resistance

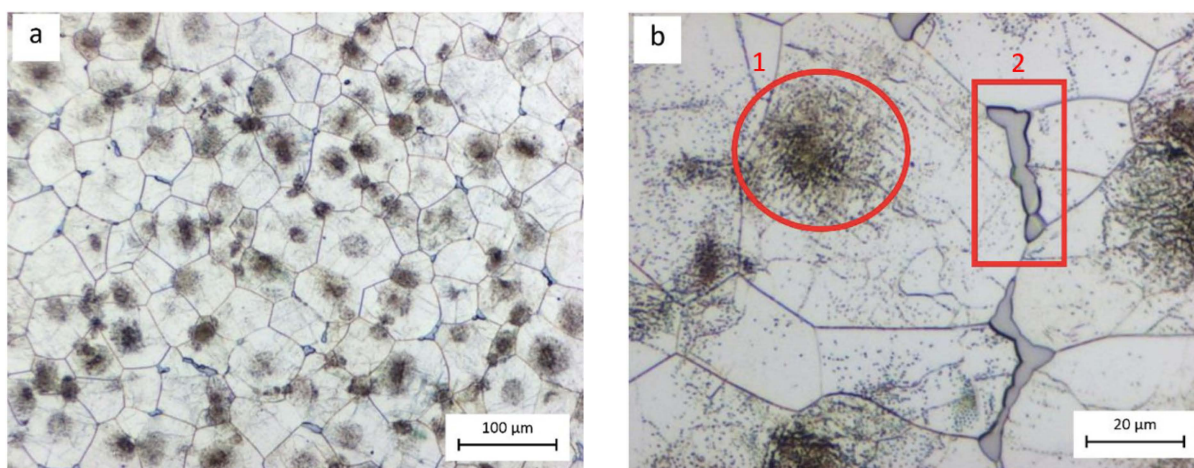
Figure 1. Microstructure of the cast EV31A-T6 Mg alloy after etching with Nital 2 [38]: general view (a) and high-magnification detail (b) showing Zr-Zn clusters at grain core (1) and residual eutectic microconstituent (α -Mg + $Mg_{12}Nd_xGd_{(1-x)}$) at grain boundaries (2).

Figure 1 shows the microstructure of the EV31A cast alloy after T6 heat treatment, where typical needle-like Zr-Zn clusters were observed at the grain core. In this alloy, Zr addition contributes to grain refining, while Zn beneficially affects mechanical properties and mitigates adverse effects of Fe and Ni impurities on corrosion behavior [36]. Residual eutectic microconstituent (α -Mg + $Mg_{12}Nd_xGd_{(1-x)}$) was detected at grain boundaries (Figure 1b), as also reported in [28,37].

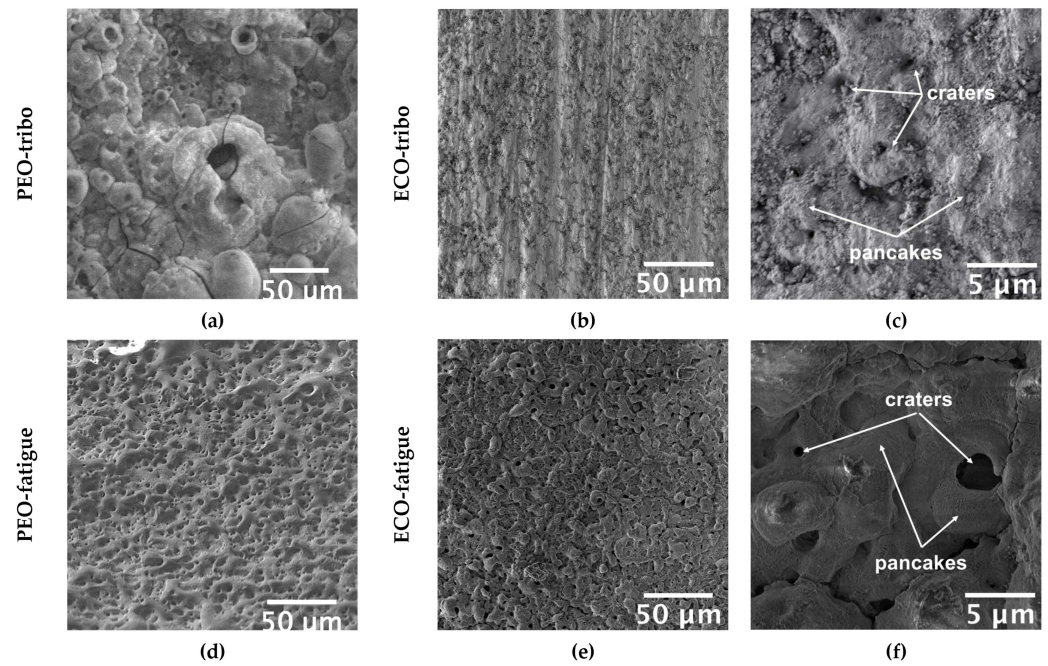
Figure 2. Surface morphology (FEG-SEM images) of the PEO (a,d) and ECO (b,c,e,f) layers on cast EV31A-T6 Mg alloy samples for tribological (a–c) and fatigue (d–f) testing. Light rubbing marks (vertical grooves) are visible in (b) due to the procedure for removing the thin powdery top layer after ECO treatment.

Figure 2 compares the free surface morphology of PEO- and ECO-treated EV31A. Shallow grooves on the surface of flat sliders for tribological tests (Figure 2b,c) are due to the light rubbing procedure carried out to remove the thin powdery top layer, as described in Section 2. However, both tribological and fatigue samples (unaltered after treatment, Figure 2e,f) show typical craters generated by local discharge events occurring during the anodic oxide growth. Pancake morphology, due to molten oxide ejected from discharge channels and rapidly cooled, as well as a few microcracks due to thermal stresses, were also observed. However, the low intensity of micro-discharges in ECO induced a rather fine surface morphology, as indicated by lower roughness values than PEO (Table 3) and the images in Figure 2 (a vs. b; d vs. e).

This comparison was possible only at the lowest load (5 N) since, above 5 N, the PEO layer was utterly worn out before the end of the test. In steady-state conditions, both the ECO and the PEO treatment led to an increase of COF compared to the untreated EV31A alloy due to the increase in the abrasive component of friction, in agreement with previous findings [28,46,47]. However, the COF increase brought about by ECO is lower than by PEO (+75% instead of +200%, as shown by average steady-state COF data in Figure 7b). This result is due to the lower roughness of the ECO layer (Table 3), generated by its more compact microstructure (Figure 3), as discussed in Section 3.1. Figure 7b also shows that, for ECO layers, COF is not significantly affected by normal load. The slight COF increase with increasing normal load may be ascribed to the decreasing stability of the iron oxide-based transfer layer which forms on the surface of sliders as a consequence of mild tribo-oxidation of the steel counterpart under the combined action of mechanical stresses and frictional heating, as also observed in previous studies [28]. Figure 8 shows the accumulation onto the surface of the ECO layer of reddish transfer layers, which is facilitated by both the topography of the anodic layer (Figure 2) and the load support provided by the ECO layer itself.

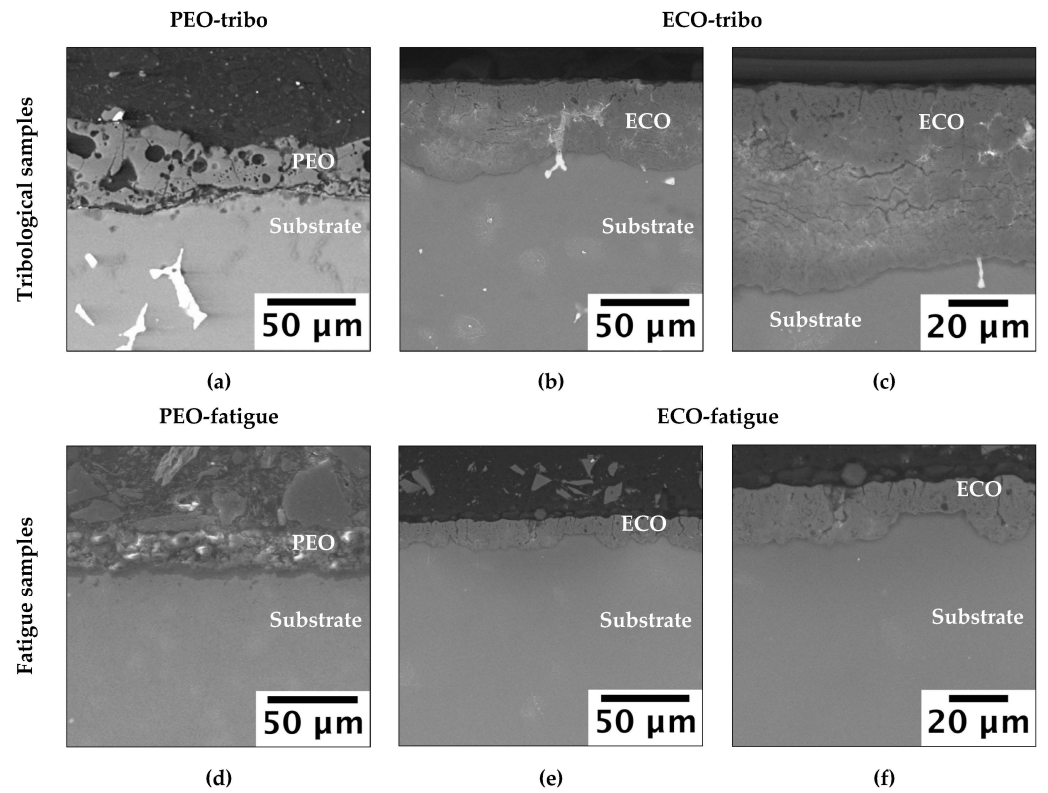
Figure 3. Polished cross sections (BSE images) of the anodic layers on cast EV31A-T6: PEO (a,d) and ECO layers (b,c,e,f) on samples for tribological (a–c) and fatigue (d–f) testing.

Cross-section backscattered electron (BSE) images of the ECO layers are shown in Figure 3 and compared with the corresponding PEO layers. The interface between the ECO layer and the substrate is wavy due to the local thickening of the anodic oxide due to breakdown events and the presence of Gd- and Nd-rich second-phase particles [39]. The thickness of the ECO layer on samples for fatigue tests was deliberately kept lower than for tribological tests (Table 3) to minimize detrimental effects related to the build-up of stresses and defects in the outer layer of the coating. As reported in [40], fatigue strength decreases with increasing anodized layer thickness. However, all ECO layers (Figure 3b,c,e,f) were fairly dense and displayed only a few tiny pores and discharge channels, primarily located in the outermost zone. Conversely, PEO layers (Figure 3a,d) showed many large pores and cracks, most noticeably in the tribological samples (Figure 3a). The main reason for these differences is related to less intense micro-arcs generated by the improved control of the discharge regime in the ECO process, as already observed in previous works [26].

BSE images in Figure 3b,c and elemental X-ray maps recorded by EDS on polished cross sections (Figure 4) evidenced the incorporation of the Nd- and Gd-rich eutectic

samples. However, for each type of sample, the ECO layers attain higher Lc3 than PEO due to the smoother surface (R_q always about one order of magnitude lower than for PEO, Table 3) and more compact microstructure (Figure 3).

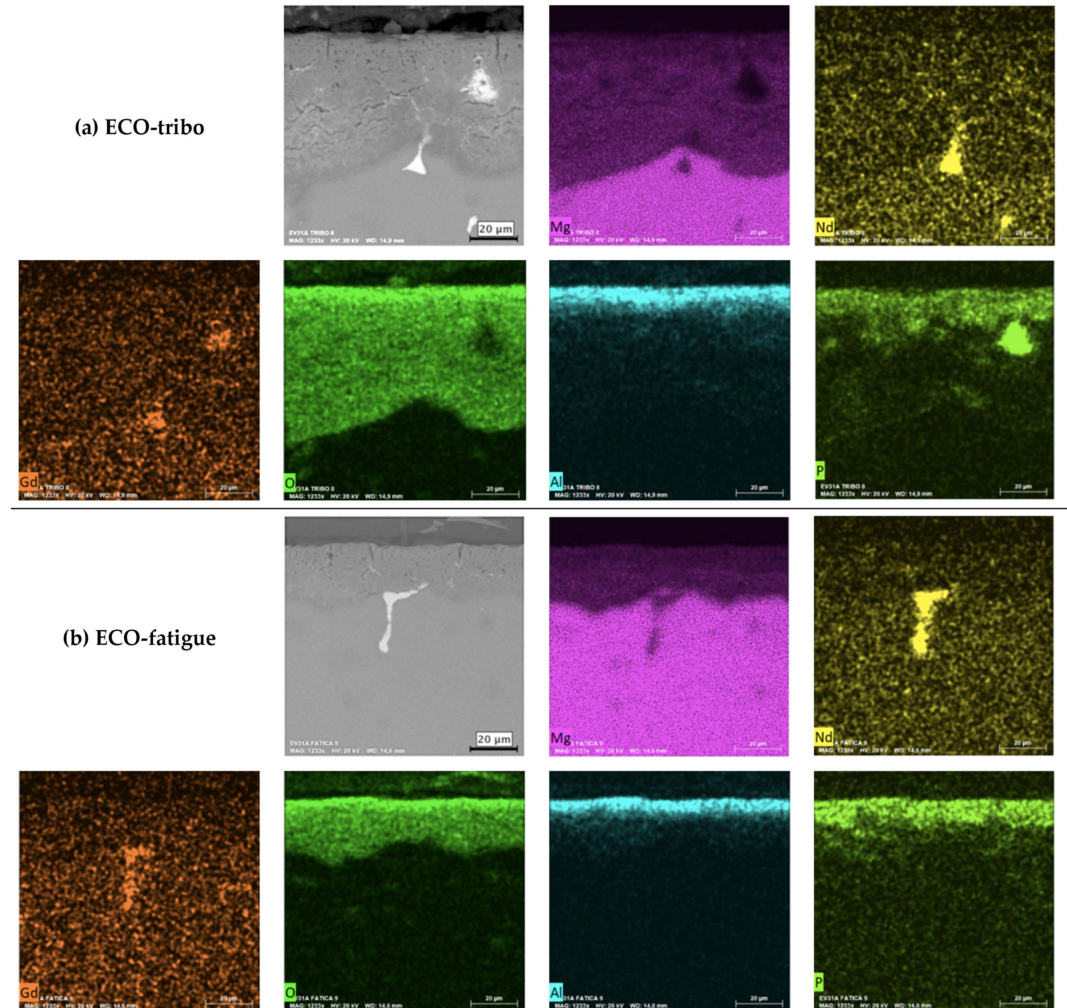
Figure 4. BSE images and EDS X-Ray maps showing elemental distribution in cross section for the ECO layer on cast EV31A-T6: tribological (ECO-tribo) (a) and fatigue (ECO-fatigue) samples (b).

microconstituent layer and the overall distribution of the elements in second-phase particles within the growing ECO-produced anodic oxide. RE-containing particles incorporated into the ECO layer underwent a slight volume increase due to oxidation, as also observed by Arrabal et al. [39].

Regarding elements from the electrolyte (Al and P), X-ray maps in Figure 4 show that Al-rich species were mainly located in the outer areas of the ECO layer, while P-rich species were detected at a higher depth from the surface. The distribution of these elements is influenced by the ionic mobility of the corresponding species, as discussed by Monfort et al. [41] and Matykina et al. [42].

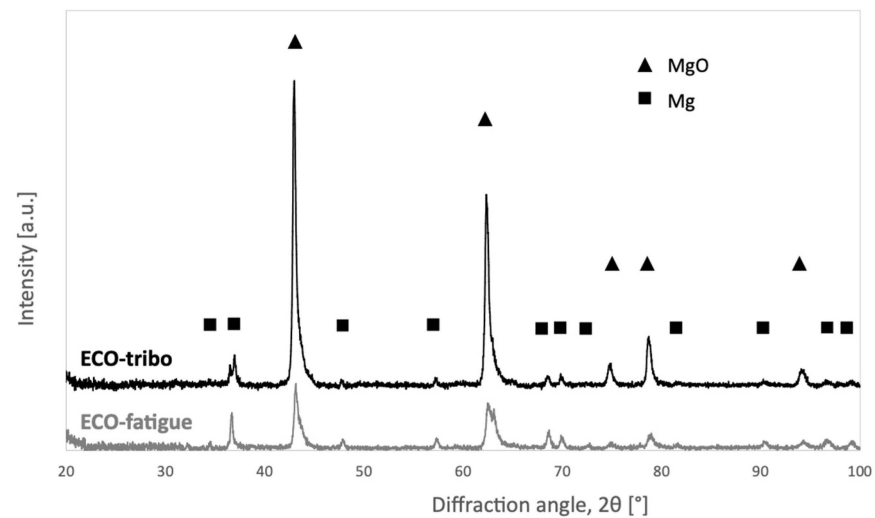
Figure 5. X-ray diffraction patterns, representative of the through-thickness composition of ECO layers on cast EV31A-T6.

XRD analyses (Figure 5) revealed that MgO is the main crystalline constituent of the ECO layers. Also, peaks from the Mg substrate were detected, indicating that XRD patterns represent the coating's full-thickness composition. The lower thickness of the ECO-fatigue layers led to a higher contribution from the Mg substrate than the thicker ECO-tribo layers.

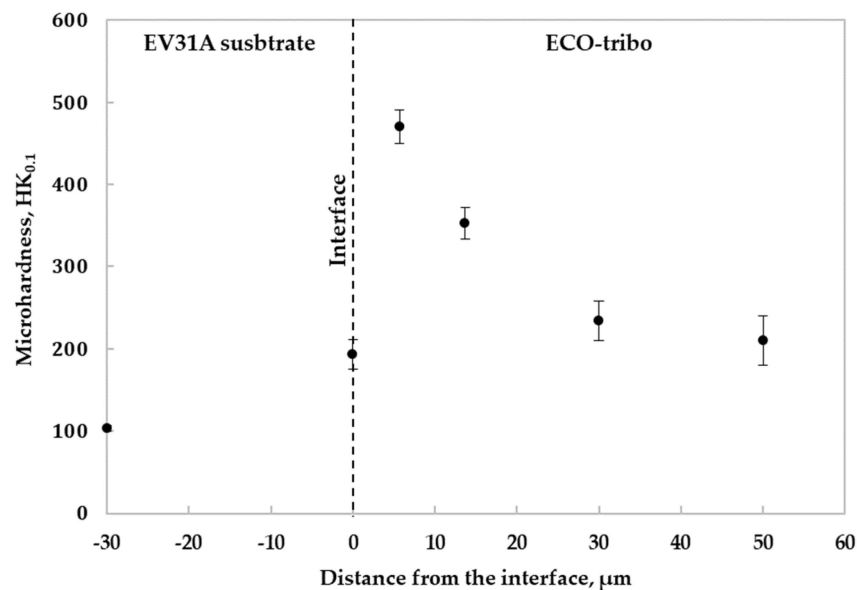
Figure 6. Cross-sectional Knoop indentation profiles of ECO layers on tribological samples (ECO-tribo).

Figure 6 shows a representative $HK_{0.1}$ vs. depth profile measured on the polished cross section of the ECO-tribo layer. The highest microhardness within the ECO layer (about 470 $HK_{0.1}$) was found at about 6 µm from the coating-substrate interface, close to the base material. The microhardness value decreased towards the outer surface of the layer, reaching a plateau between 230 and 210 $HK_{0.1}$ at about 30 µm from the coating-substrate interface. A similar trend was obtained by Durdu et al. [43], even though with higher microhardness values; in particular, the highest microhardness was measured in the

densest inner layer, approximately at 7 μm from the coating-substrate interface, while a decrease of about 50% was measured at 30 μm distance from it.

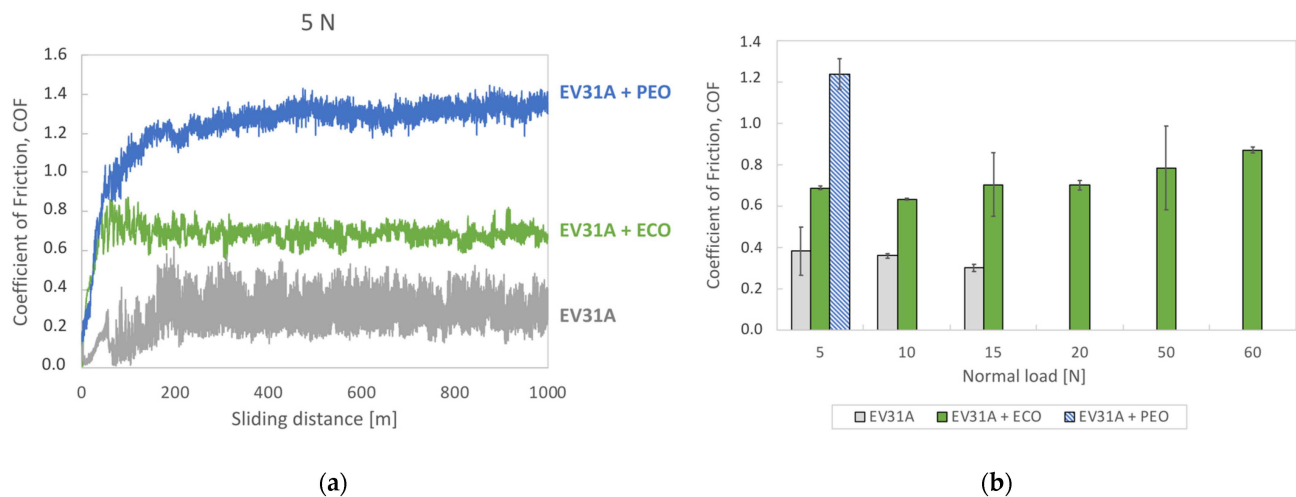
Figure 7. Dry sliding tests (vs. 100Cr6 steel, 1000 m, 0.3 m/s): dynamic COF as a function of sliding distance for untreated and ECO-treated EV31A at 5 N, compared to PEO-treated EV31A [28] (a); average values of steady-state coefficient of friction for all tested conditions (data for PEO-treated EV31A at 5 N from [28]) (b).

Representative plots comparing the coefficient of friction (COF) as a function of sliding distance for ECO- and PEO-treated EV31A and the untreated substrate are shown in Figure 7a.

The average wear depth values measured on sliders (Figure 9b) showed that, even though PEO decreased wear in comparison to the untreated substrate, already at 5 N, the maximum wear depths measured on the PEO layer were comparable to its thickness and the oxide layer was almost completely worn out. The remaining portions of the PEO layer still contributed to support the load and protect the substrate from full involvement in the contact, as demonstrated by the absence of a friction/wear transition in the plots of Figure 7a. Additionally, the SEM observation of worn surfaces showed that both anodic

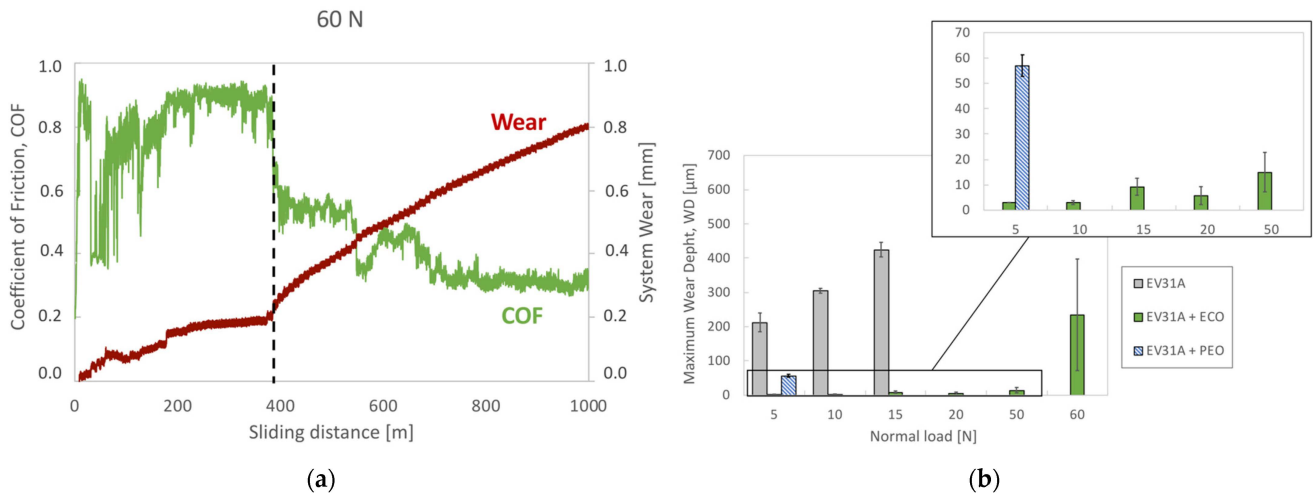
Figure 9. Dry sliding tests (vs. 100Cr6 steel, 1000 m, 0.3 m/s): dynamic coefficient of friction vs. system wear as a function of sliding distance for ECO-treated EV31A at 60 N, showing a transition in the friction and wear behavior (due to involvement of the substrate in the contact, i.e., end of coating life) at about 400 m (a); maximum wear scar depth of sliders measured after dry sliding tests: the inset highlights data for ECO and PEO layers up to 50 N (data for PEO-treated EV31A from [28]) (b).

For ECO-treated sliders, when the applied load increased to 60 N, a transition appeared in both COF and vertical displacement plots (related to system wear, i.e., wear of both cylinder and slider, Figure 9a). It is worth recalling here that vertical displacement plots show data from the LVDT (Section 2.2): an increasing trend denotes material removal (i.e., wear), while a decreasing trend denotes material deposition (i.e., the formation of transfer layers). More specifically, plots in Figure 9a show that, after about 400 m, the COF measured for coated sliders decreased to comparable values to those measured for untreated EV31A, while the wear rate increased. This friction/wear transition is attributed to the involvement of the substrate in the contact due to the complete consumption of the anodic oxide layer, as wear scars suggest (discussed here below). Hence a maximum load at which the coating still survives the test without any friction and wear transitions was identified, corresponding to the end of the coating life. Above this maximum load (i.e., at 60 N for ECO), a remarkable increase in wear depth was observed (Figure 9b). The maximum load for ECO coating in dry sliding tests (Table 3) was one order of magnitude higher than for PEO layers (50 vs. 5 N) due to the beneficial combination of hardness, thickness, and adhesion of the ECO layer (Table 3).

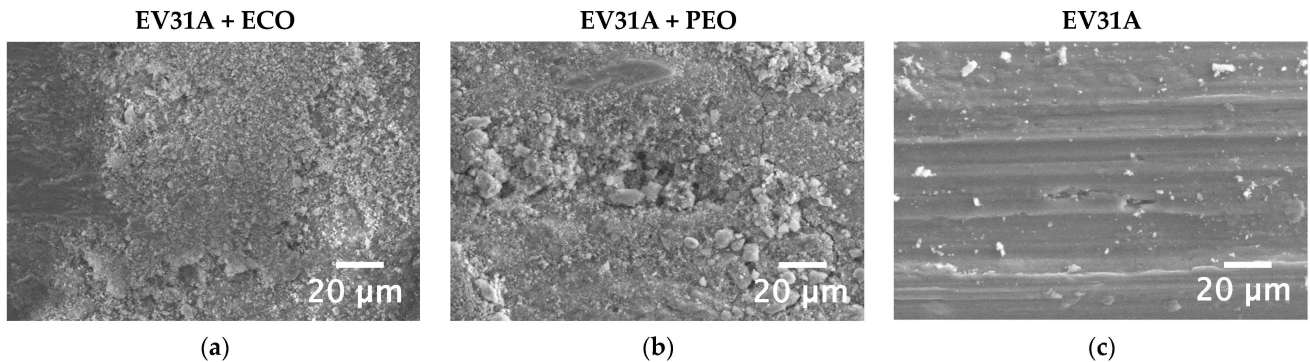
Figure 10. Dry sliding tests (vs. 100Cr6 steel, 5 N, 1000 m, 0.3 m/s): SEM micrographs of wear scars comparing ECO (a) and PEO-treated (b) samples with untreated EV31A-T6 (c).

layers (ECO, Figure 10a and PEO, Figure 10b) limited the occurrence of heavy plastic deformation compared to the untreated alloy (Figure 10c). However, whilst the transfer layer on ECO-treated EV31A consists of fine and partly compacted debris from mild tribo-oxidation of the steel counterpart, the transfer layer on PEO includes many angular fragments due to the onset of fracture in the anodic oxide.

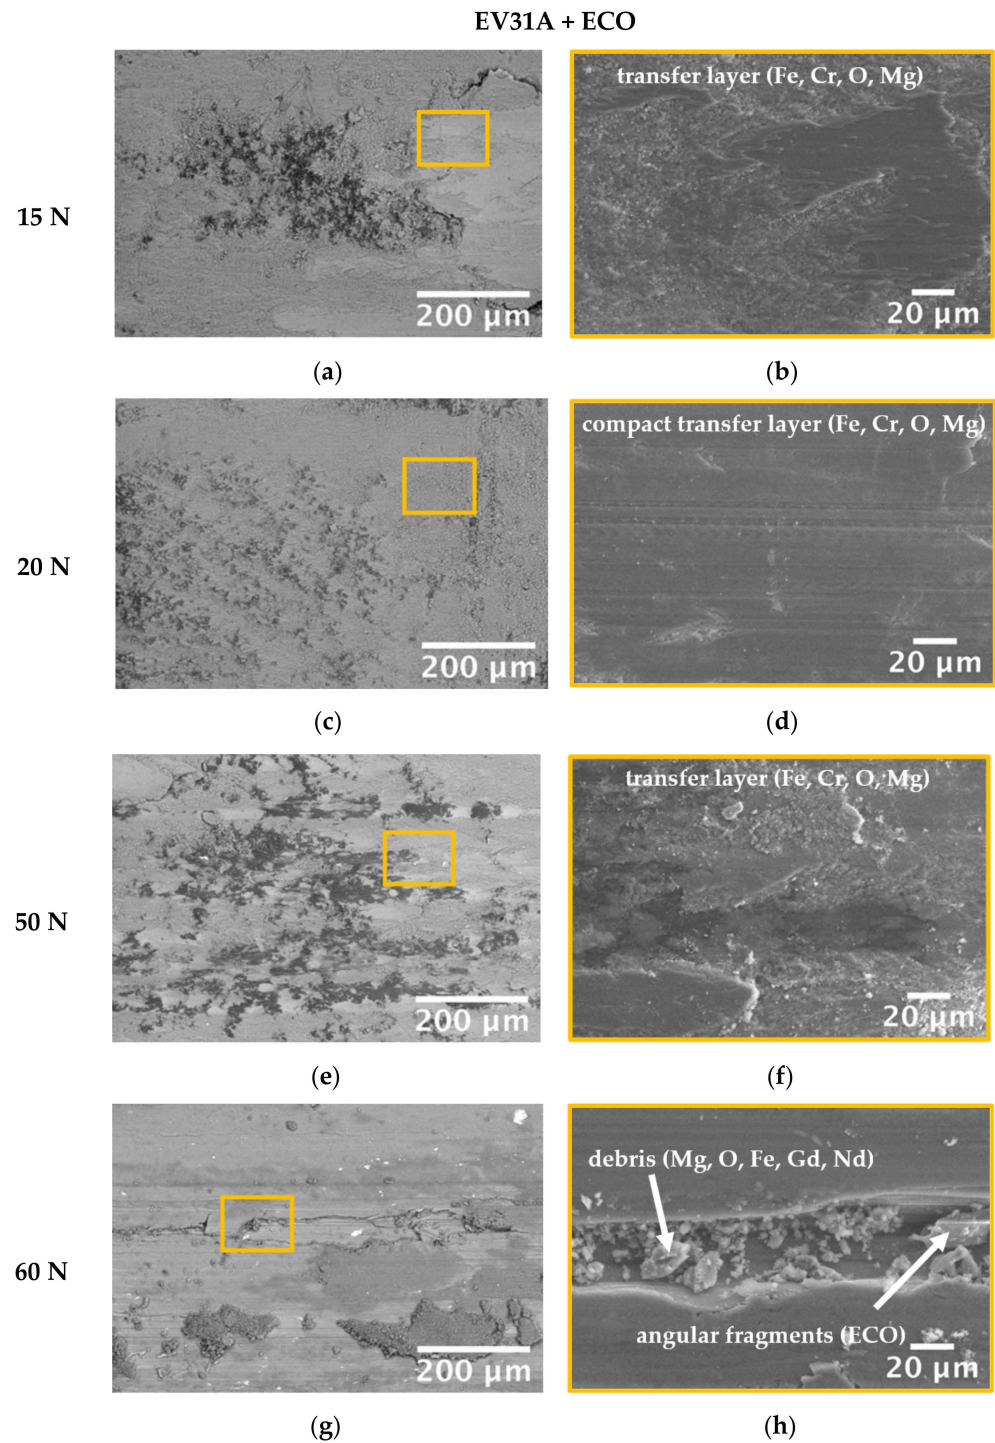
Figure 11. Dry sliding tests (vs. 100Cr6 steel, 1000 m, 0.3 m/s): SEM micrographs of wear scars on ECO-treated sliders at 15 (a,b), 20 (c,d), 50 (e,f) and 60 N (g,h): BSE images (a,c,e,g) and higher magnification SE details (b,d,f,h) in the areas highlighted by the orange frames. The labels indicate the main elements detected by EDS.

Conversely, the wear depth on the ECO-treated EV31A remains well below the thickness of the anodized layer in the load range from 5 to 50 N, and the worn surface was covered by the previously discussed iron oxide transfer layer, whose stability may also be accounted for the wear depth trend as a function of load in Figure 9b. The high-magnification observation of wear scars on ECO layers (Figure 11) showed that the transfer layer achieved maximum compactness and hence protective efficiency at 20 N (Figure 11c,d), leading to a slight wear depth decrease. Conversely, at 50 N the protective transfer layer started to be consumed (Figure 11e,f), and the wear depth increased (Figure 9b). At 60 N, the substrate appeared at the center of the wear scar (Figure 11g,h): inside deep grooves and plastically deformed areas, wear debris from the substrate and the anodized layer was detected. Angular fragments due to microcracking of the ECO layer were detected inside these grooves (Figure 11h). Microcrack-driven damage accumulation and coating removal in flakes are typically observed in anodic layers on Mg alloys involved in sliding contacts [48].

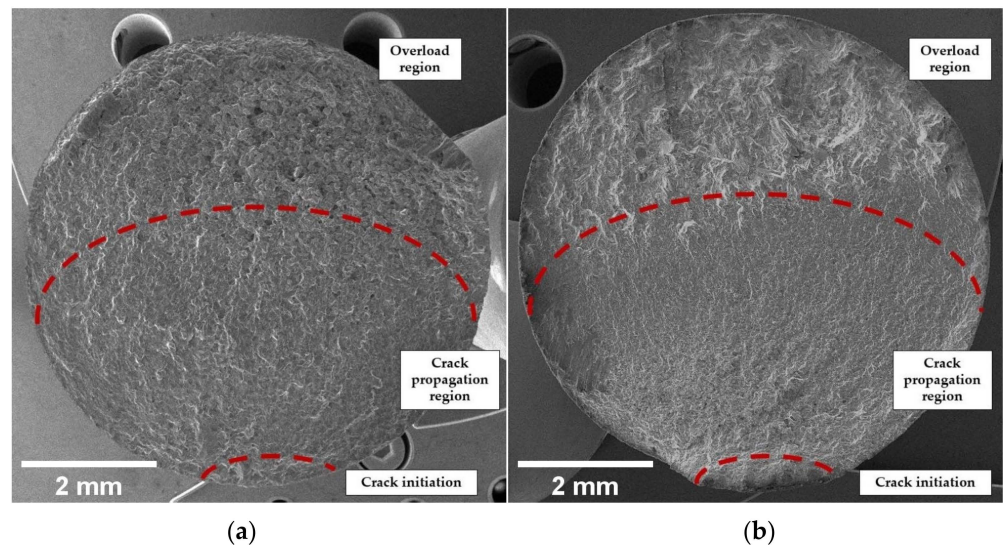
Figure 12. Fatigue tests (4-point rotating bending): SEM overview of the fracture surface of ECO-treated (a) and PEO-treated (b) samples, with distinct regions of fatigue failure.

At low magnification (Figure 12), ECO- and PEO-treated samples show comparable fracture surfaces consisting of three distinct regions of fatigue failure: crack nucleation, crack growth, and final failure induced by overloading. A high magnification analysis of the ECO-treated samples is reported in Figures 13–15, which show (i) crack nucleation sites, (ii) crack propagation zone, and (iii) final failure zone, respectively. Corresponding images for PEO-treated samples can be found in [29].

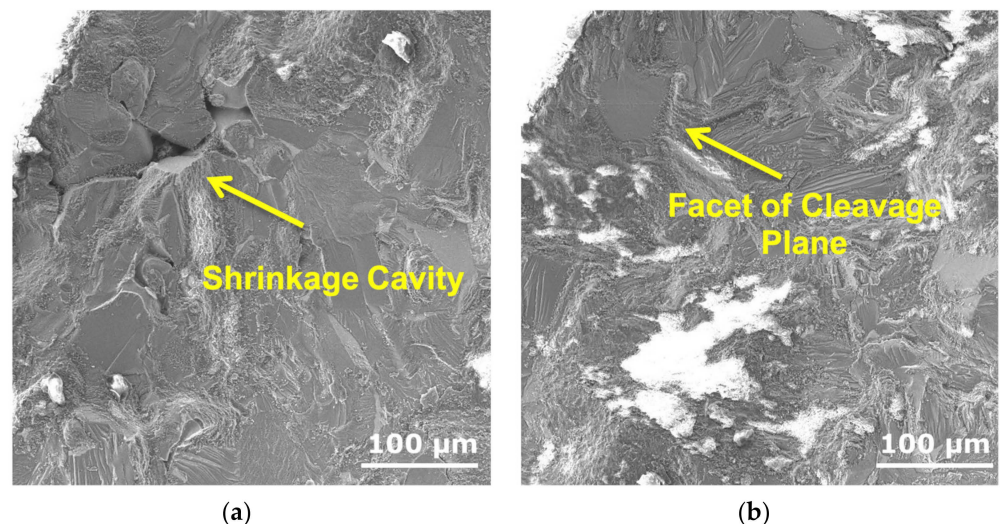
Figure 13. Fatigue tests (4-point rotating bending), fracture surface analysis: SEM images showing crack initiation below the ECO layer-substrate interface at a shrinkage cavity (a) and isolated facet of cleavage plane (b) in ECO-treated EV31A-T6 samples.

Figure 13 shows that the crack nucleation occurred in the base alloy, slightly below the coating/substrate interface, where the fatigue samples experience the maximum stresses. The nucleation regions were characterized by small shrinkage cavities (Figure 13a) or flat and smooth facets of cleavage planes in correspondence with large grains (Figure 13b). The low number of effective slip systems in the Mg alloys and the high density of dislocations and defects, which increase with increasing grain size, led to the formation of localized damage that propagates fast because of the cyclic loading. Therefore, fatigue crack nucleation was related to features typical of casting Mg alloys similar to those reported in [29,49] and not to defects or decohesion in the anodized layer.

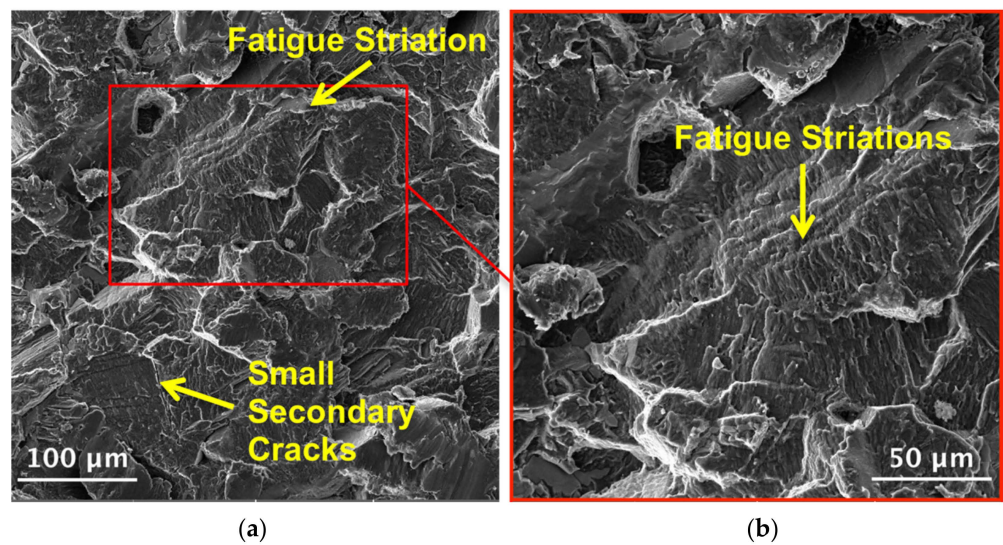
Figure 14. Fatigue tests (4-point rotating bending), fracture surface analysis: SEM images of the crack propagation region showing the typical fatigue striations and small secondary cracks (a,b).

Figure 14 shows images of the crack propagation region, highlighting the presence of the typical fatigue striations. Their formation is generally transgranular, associated with the plastic deformation ahead of the fatigue crack tip induced by twinning mechanisms and dislocations slip. In this region, small secondary transgranular cracks are also clearly visible [50,51].

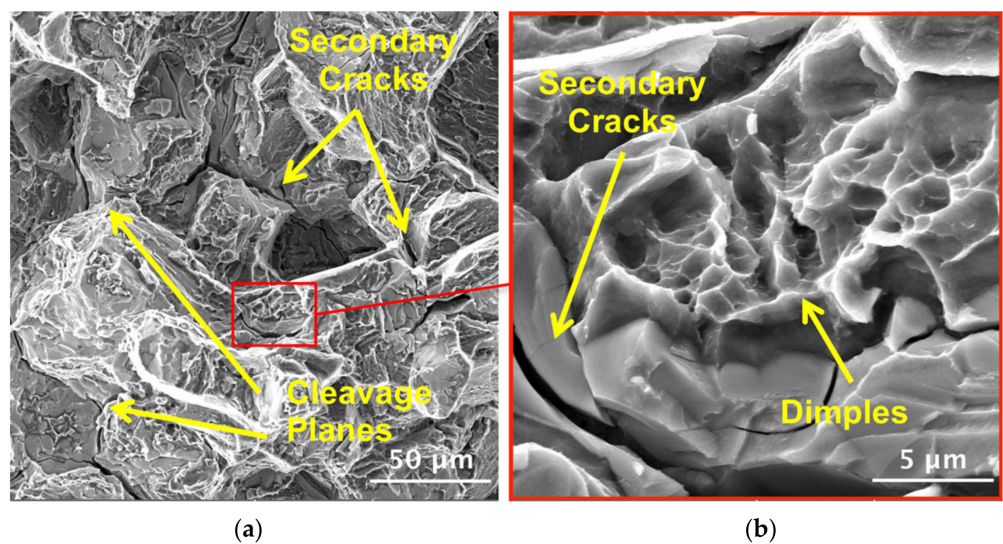
Figure 15. Fatigue tests (4-point rotating bending), fracture surface analysis: SEM images of the overloading region. Intergranular fracture with cleavage planes and secondary cracks (a) and small areas with ultrafine deep dimples (b).

Finally, the overloading regions (Figure 15) are characterized by an inter-granular fracture mechanism with a brittle morphology, cleavage planes, and secondary cracks, surrounded by small areas with ultrafine deep dimples (Figure 15b), typical of local plastic deformation.
