## Fatigue Response of Cracked Aluminum Panel with Partially Bonded Composite Patch

THESIS

Jason J. Denney, Captain, USAF

DEPARTMENT OF THE AIR FORCE  
AIR UNIVERSITY  
**AIR FORCE INSTITUTE OF TECHNOLOGY**

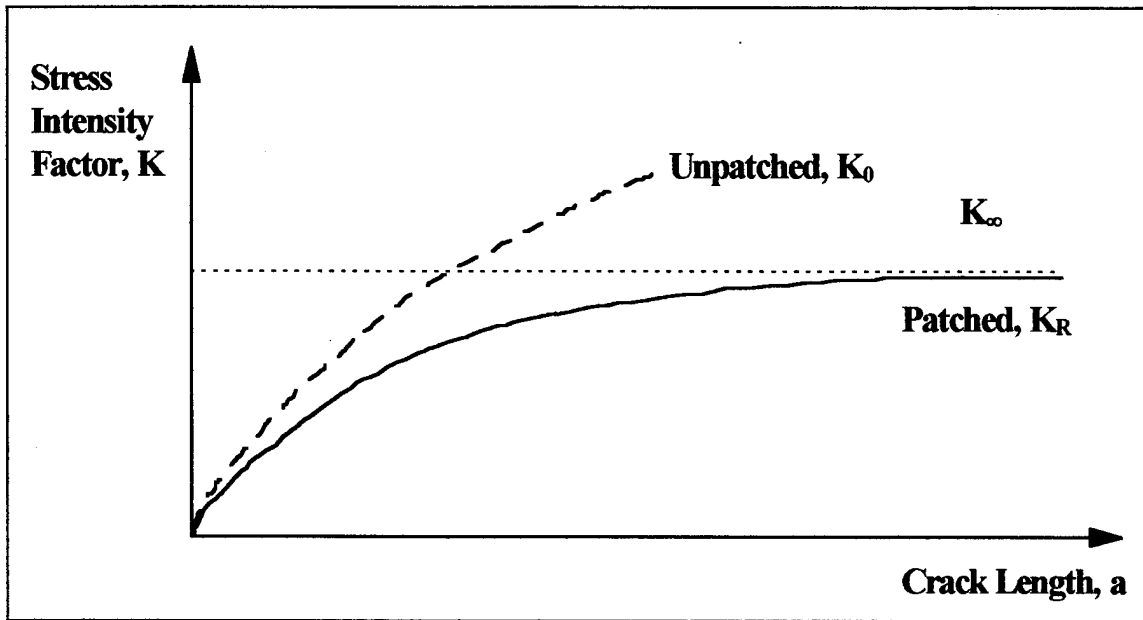
Bonded composite repairs have proven to be as strong as or even stronger than bolted joints, making them a viable option to the aircraft repairer. Bonded composite patches have demonstrated their ability in reducing the stress intensity factor,  $K$ , as shown schematically in Figure 1, thus reducing the crack growth rate resulting in increased overall fatigue strength and extended structural service life (7). With a properly designed

Figure 1. Reduction in Stress Intensity Factor with Repair (7)

patch, the stress intensity factor reaches a limiting value,  $K_\infty$ , no matter what length the crack reaches. Further, a well designed patch significantly increases the time between inspection intervals as shown in Figure 2 (40). For the USAF this implies increased combat capability and decreased costs due to reduced downtime. Even with all these benefits of composite patching, this technique does have the drawback, i.e. it requires,

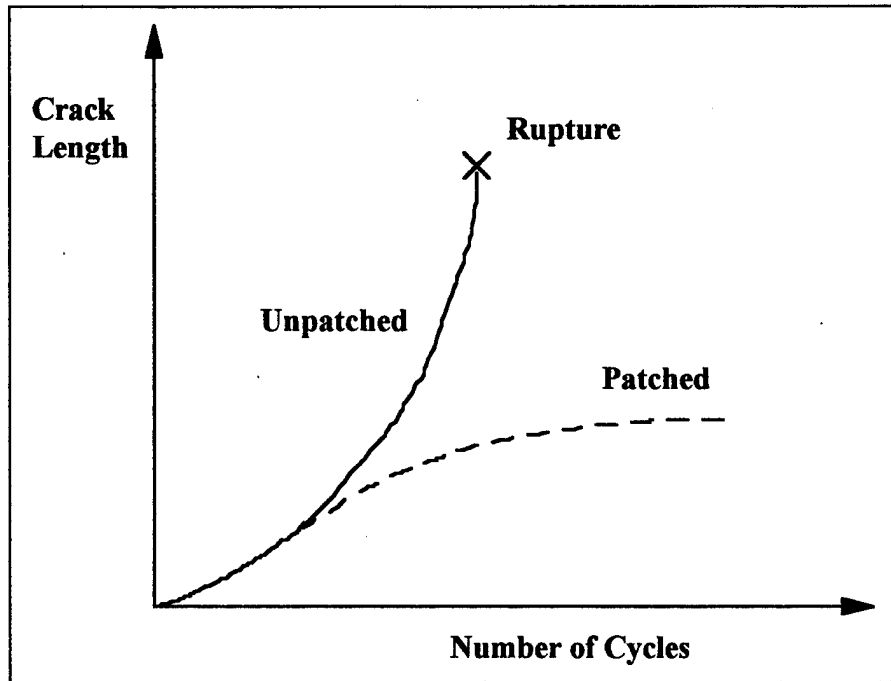
**Figure 2. Effect of Patching on the Lifetime of a Cracked Structure (40)**

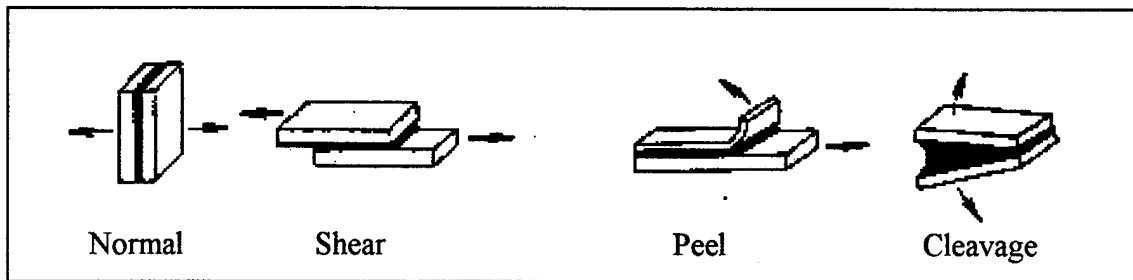
Shear and normal loads or a combination of them, peel and cleavage loading, make up the primary loads acting on adhesive bonds as shown in Figure 4 (15). An ideal repair would eliminate peel and cleavage loading. However, minimizing their effects using good repair practices is the best that can be done. A single-sided lap-joint, the configuration investigated in this effort, creates unwanted secondary bending moments due to the offset of the neutral axis. These bending moments create high peel forces at the ends of the repair which also happens to be the location of highest shear. Tapering the repair ends and increasing the overlap length, one-half the longitudinal length, of the repair reduces

**Figure 4. Loading on Adhesive Bonds (15)**

that cause peel and cleavage loading on the adhesive bond as shown in Figure 4. As a rule of thumb, the repair overlap length, one half the length of the repair, is 30 times the repair patch thickness for double-lap joints and 80 to 100 times the thickness for single-lap joints (22). The extra overlap length for single-lap joints reduces secondary bending moments which in turn reduces peel and cleavage loads. The overlap length of the single-lap repair in this study was approximately 89 times, 34 mm (1.3 in), the repair thickness of 0.381 mm (0.015 in). The repair stiffness ratio,  $E_{RtR}/E_{PtP}$ , was 1.125, more than the minimum required stiffness ratio of 1 (15). The patches were then pre-cured at the University of Dayton using an autoclave to enhance storability of the patches and to reduce coefficient of thermal expansion mismatch effects during bonding to the aluminum panels. A full vacuum and a 344,738 Pa (50 psi) positive pressure was applied to the patches during a 1.4-2.4 °C/minute (3-5 °F/minute) temperature ramp-up to 121 °C (250 °F). Once the temperature reached 121 °C, the 344,738 Pa pressure was released while maintaining a full vacuum for one hour. After one hour, the temperature was then dropped at 1.4-2.4 °C/minute, completing the cure process.

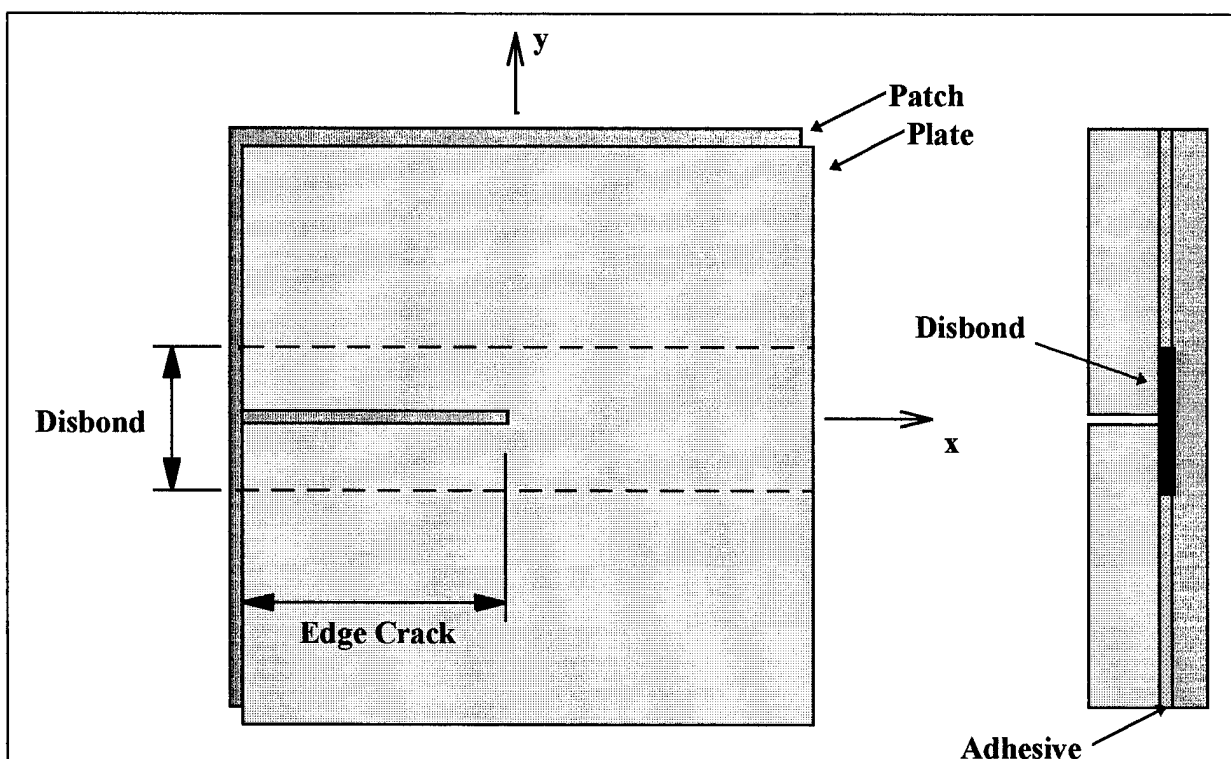
Baker has shown through experiment and analysis that the rate of crack growth can be ranked according to the size of the disbond present. He demonstrated, using teflon inserts and an edge cracked specimen, that patching efficiency falls dramatically for a disbond over the crack as the disbond size increases perpendicular to the crack as shown in Figure 5 (6). He also stated that disbonds in front of the crack tip had little effect on the rate of crack propagation. Post-test investigation of the disbonds revealed minor, if any, disbond growth. This lack of disbond growth resulted in a constant repaired stress intensity factor range,  $\Delta K_R$ , and crack growth rate,  $da/dN$  (6).

**Figure 5. Disbond Configuration Studied by Baker (6)**

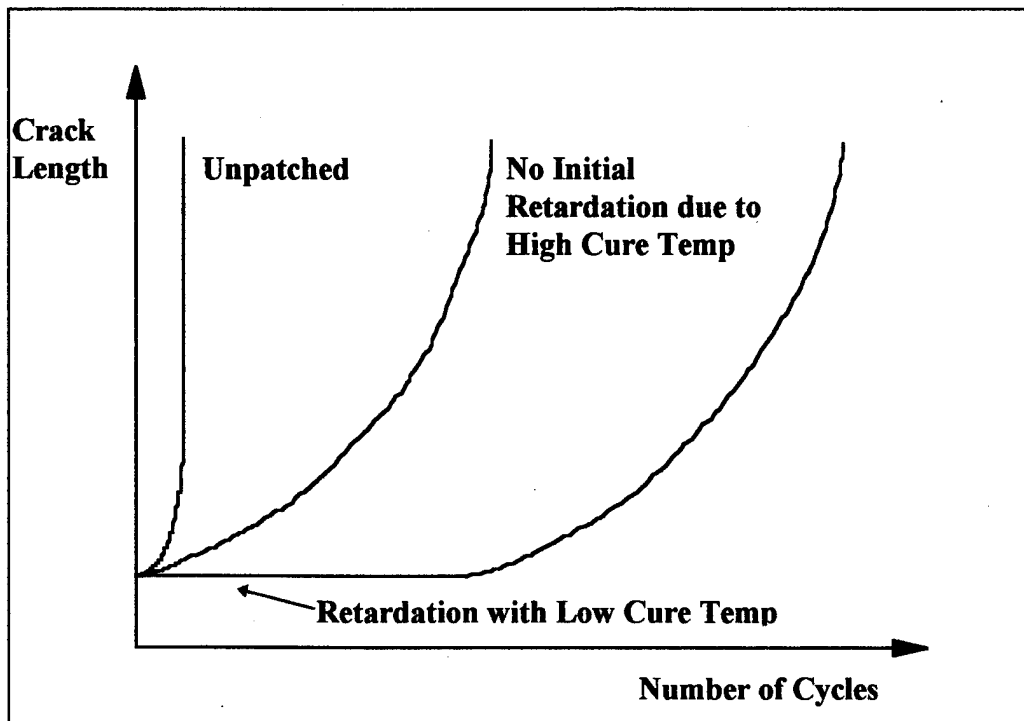
As stated previously, a good bonded repair either retards and/or significantly reduces the rate of crack growth once growth is initiated (Figure 6). Baker has shown that specimens repaired with high temperature cure adhesives, such as film adhesives, exhibit significantly less retardation. This retardation, or lack of it, is associated with the plasticity at the crack tip prior to patching. The use of elevated cure temperatures was found to anneal out the beneficial compressive stresses within the crack tip plastic zone allowing a much earlier re-initiation of crack growth. Baker showed that low cure

**Figure 6. Effect of Adhesive Cure Temperature on Crack Retardation.**

temperature acrylic adhesives had extensive retardation as compared to high cure temperature film adhesives (6, 7, 8).

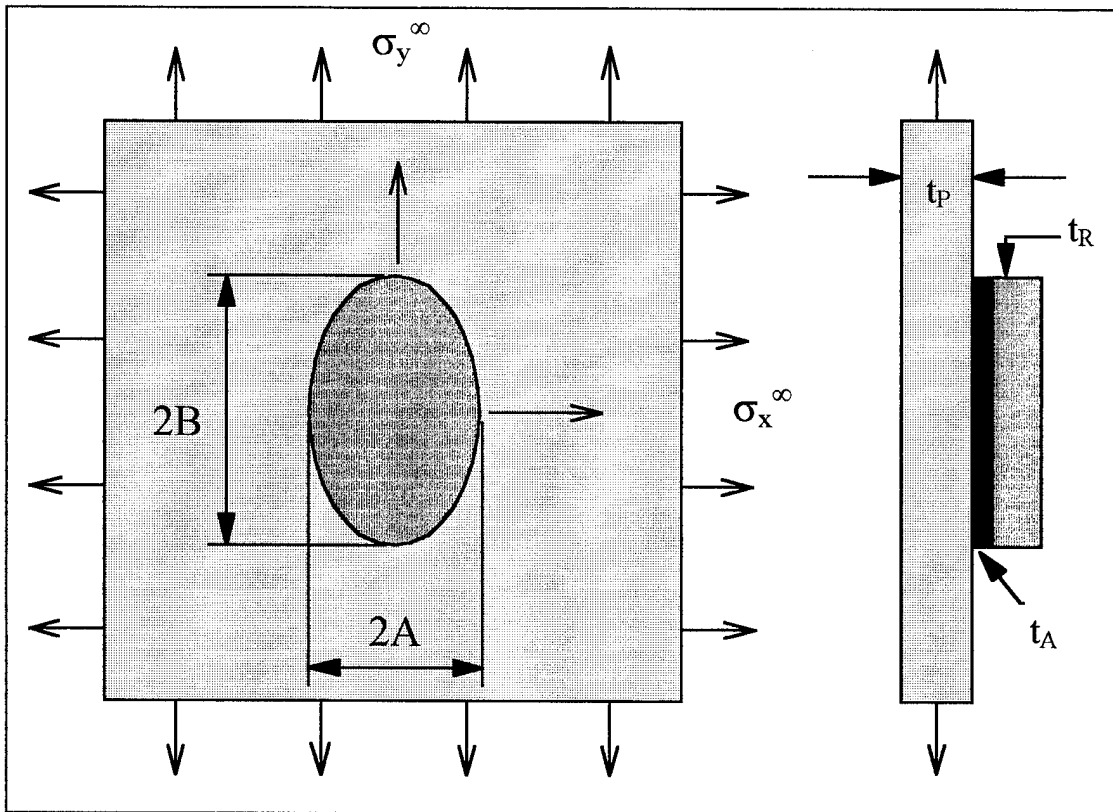
The analysis is divided into two stages, each with its own simplifying assumptions. The first stage, stage I, involves a bonded reinforcement on an uncracked plate as shown in Figure 7 with the sole purpose of determining the normal stress distribution,  $\sigma_0$ , in the plate within the domain of the bonded reinforcement. The major assumption here is that the adhesive forms a rigid-bond such that there is no relative displacement between the reinforcement and the plate. This assumption is reasonable because the load transfer zone

**Figure 7. Bonded Reinforcement on Uncracked Plate (15:114)**

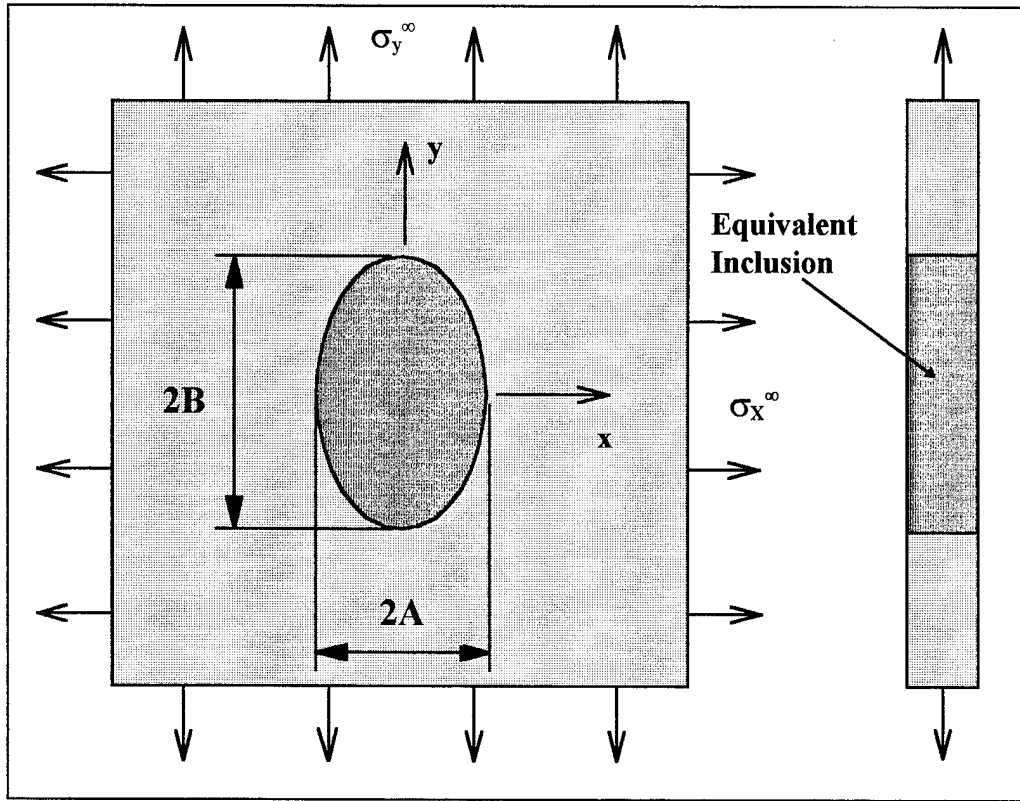
In stage I, also called the inclusion analogy, the plate and reinforcement are viewed together as an equivalent inclusion of higher stiffness than the surrounding plate as shown in Figure 8. This equivalent inclusion is possible because the load transfer length,  $1/\beta$ , is small compared to the dimensions A and B of the reinforcement. To determine the normal stress distribution,  $\sigma_0$ , in the reinforced plate, the analysis involves the calculation of: (1) the elastic constants of the equivalent inclusion in terms of the reinforcement and the plate; (2) the stress in the equivalent inclusion; and (3) the load sharing between the reinforcement and the plate. Calculating the stress in the equivalent inclusion can only be accomplished for certain simple shapes, which is why Rose modeled an elliptical reinforcement. Within an elliptical inclusion, the stress is uniform as shown in Figure 9. To further simplify the analysis, Rose also uses the overall assumption that both the

Figure 8. Equivalent Inclusion (15:115)

reinforcement and the plate are isotropic with the same Poisson ratio. This assumption results in an equivalent inclusion stiffness of  $E_{pTP} + E_{rTR}$ . Orthotropic cases can be found in literature (34). The load transmitted across  $y = 0$  within the inclusion,  $|x| < A$ , is a force per unit length,  $F$ , given by

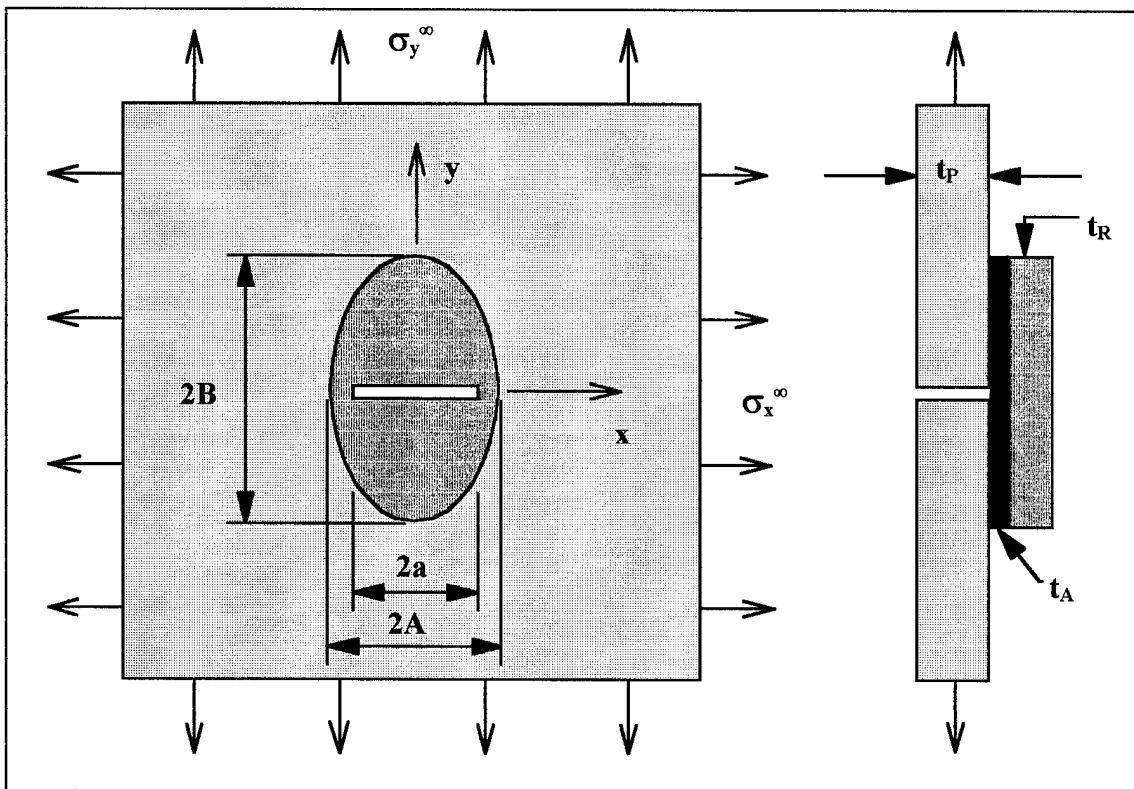
**Stage II.** Now that the stress at the crack,  $\sigma_0$ , is known, the plate is cracked along  $|x| < a, y = 0$  as shown in Figure 10. As previously stated, the reinforcement is assumed

Figure 10. Crack Introduced into Plate (15:115)

much easier to analyze as compared to the original configuration in Figure 10. The stress intensity factor for a nominal center cracked plate is commonly known to be

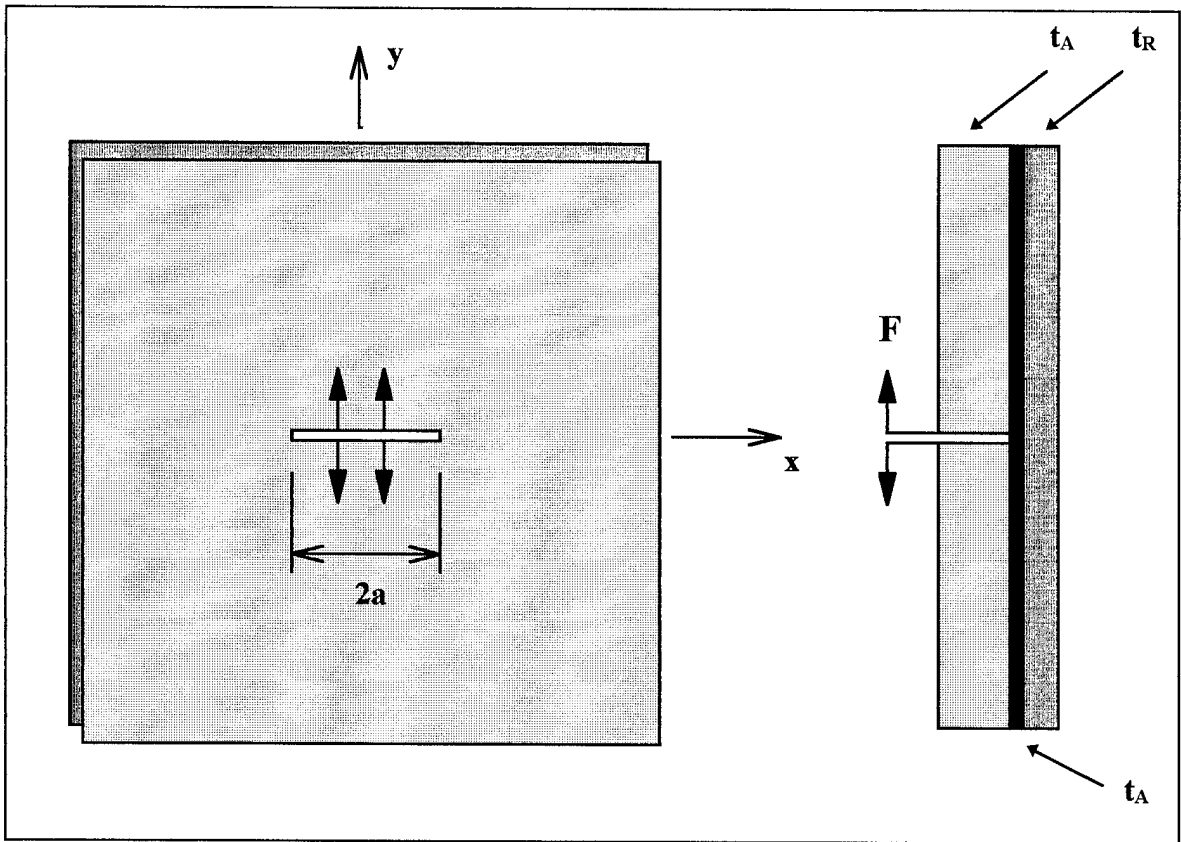
to be of infinite size because the load transfer zone at the crack is small. This allows the system to be analyzed as the simple overlap joint shown in Figure 11. The overlap joint is

**Figure 11. Overlap Joint (35:86)**

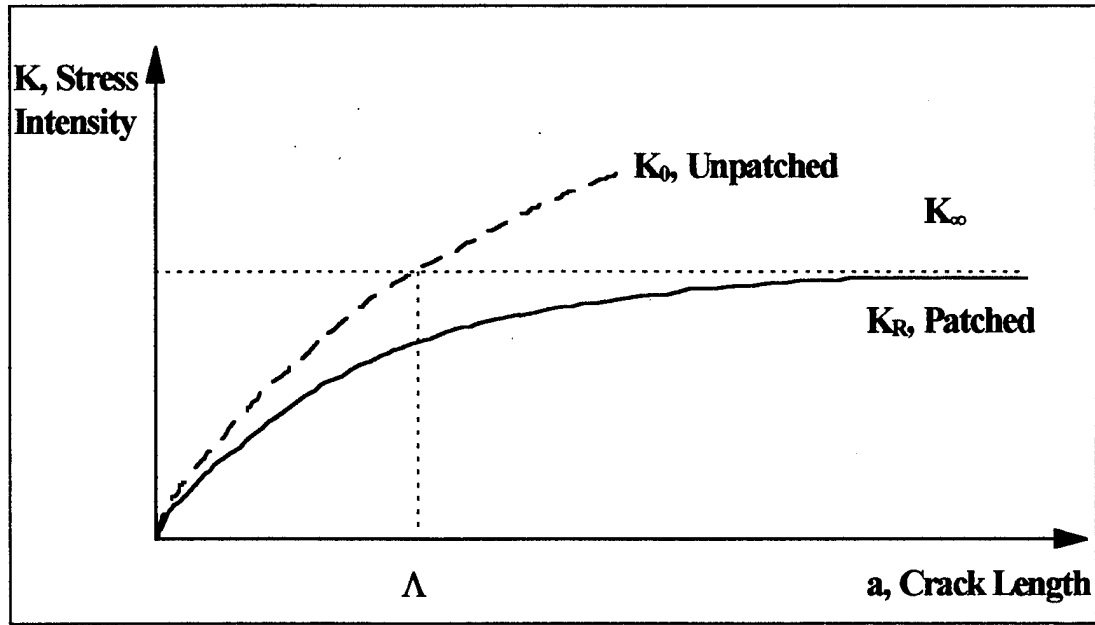
which behaves as an upper bound for the repaired stress intensity factor,  $K_R$ . However, in comparison to an unbounded  $K_0$  with crack length for a nominal center cracked plate,  $K_R$  does not exceed a limiting value of  $K_\infty$  as shown in Figure 12. Rose shows that  $K_\infty = K_0$  at a characteristic crack length,  $\Lambda$ , given by

Figure 12. Variation of  $K_R$  with Crack Length with the Two Asymptotes,  $K_\infty$  and  $K_0$ . (32:86)

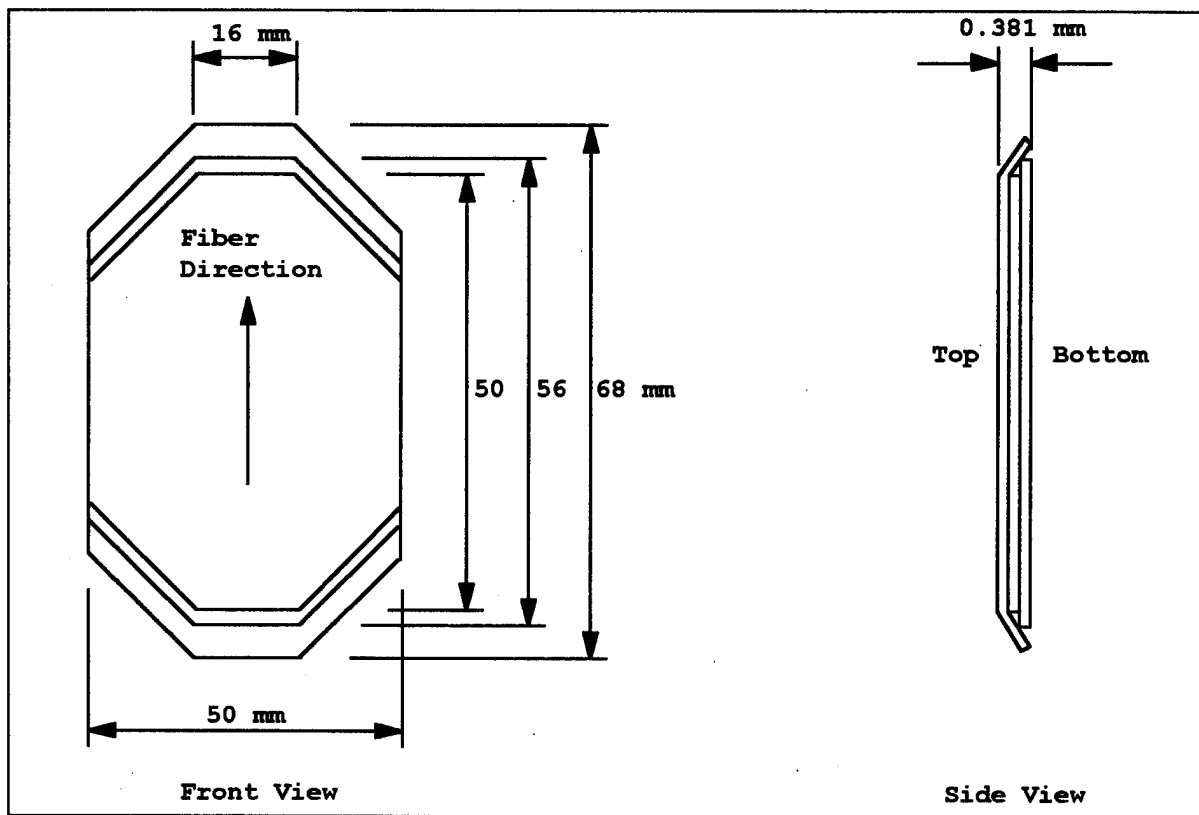
Additionally, each individual template was kept chilled before its use which also aided in eliminating sticking to the prepreg tape. All three plies were layed-up unidirectionally, i.e. the fibers were in the direction of load, with the following order from top to bottom, medium, small and large as shown in Figure 13. The larger cover-ply is common practice

**Figure 13. Patch/Reinforcement Lay-up**

in composite patch repair, protecting the underlying plies from damage as well as shielding the bondline from environmental attack. Tapering of the plies reduces out of plane loads

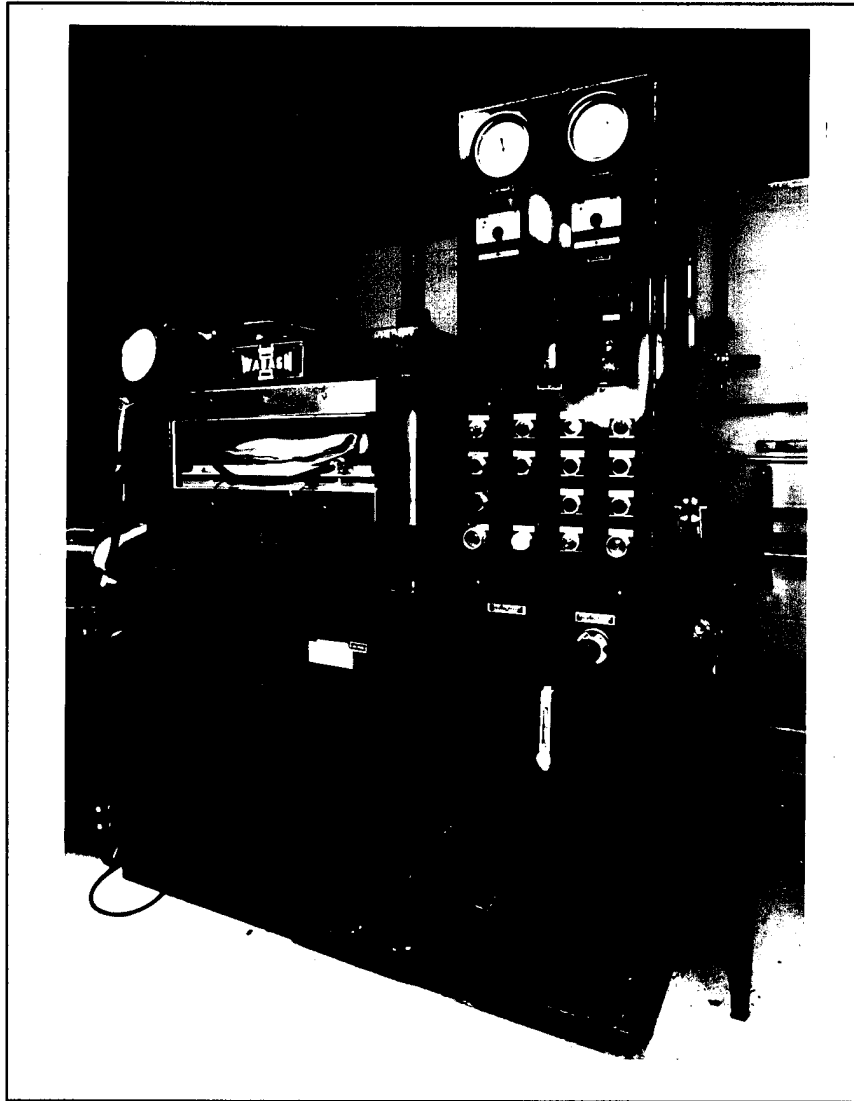
Two patches employed the EA-9394 paste adhesive instead of the AF-163-2 film adhesive. EA-9394 is a two-part paste adhesive consisting of a liquid epoxy resin and a cross-linking agent. Following mixing of the two components, the adhesive was spread onto the patch as evenly as possible using a clean razor blade. A light scrim cloth was then applied over the paste to act as a carrier cloth for the adhesive system. Another thin layer of adhesive was applied over the scrim cloth. Finally, the adhesive was spread onto the specimen before application of the patch over the cracked surface. Paste adhesives have the advantage of room or temperature cure, however, the two specimens that employed this adhesive received a 93 °C (200 °F) cure for one hour, with the same ramp-up and ramp-down in temperature as the AF-163-2 film adhesive. All equipment and procedures matched that of the AF-163-2 film adhesive specimens. The vacuum bag is shown in Figure 14 and the hydraulic press is shown in Figure 15.

**Figure 15. Hydraulic Press**

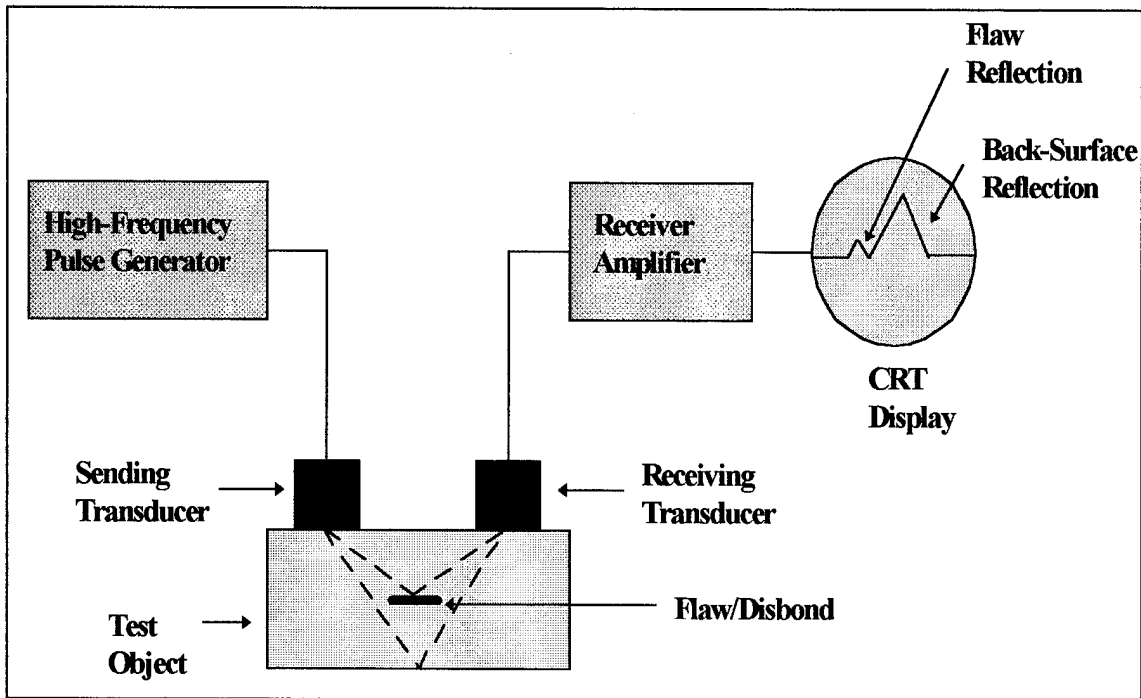
integrity, as well as, disbond size and location. A schematic of the ultrasonic equipment is shown in Figure 16. A sending transducer sends a high-frequency pulse through the test object (patch and aluminum panel). When a disbond is encountered, the transmission of the high-frequency pulse is interrupted. These pulses, as well as, the through the test

**Figure 16. Schematic of Ultrasonic Equipment**

object pulses are received by another transducer which feeds the information to an amplifier and CRT display. The result is a two-dimensional contour map of the bondline indicating disbond sizes and shapes. The ultrasonic tank is shown in Figure 17. The specimen configuration is shown in Figures 18.

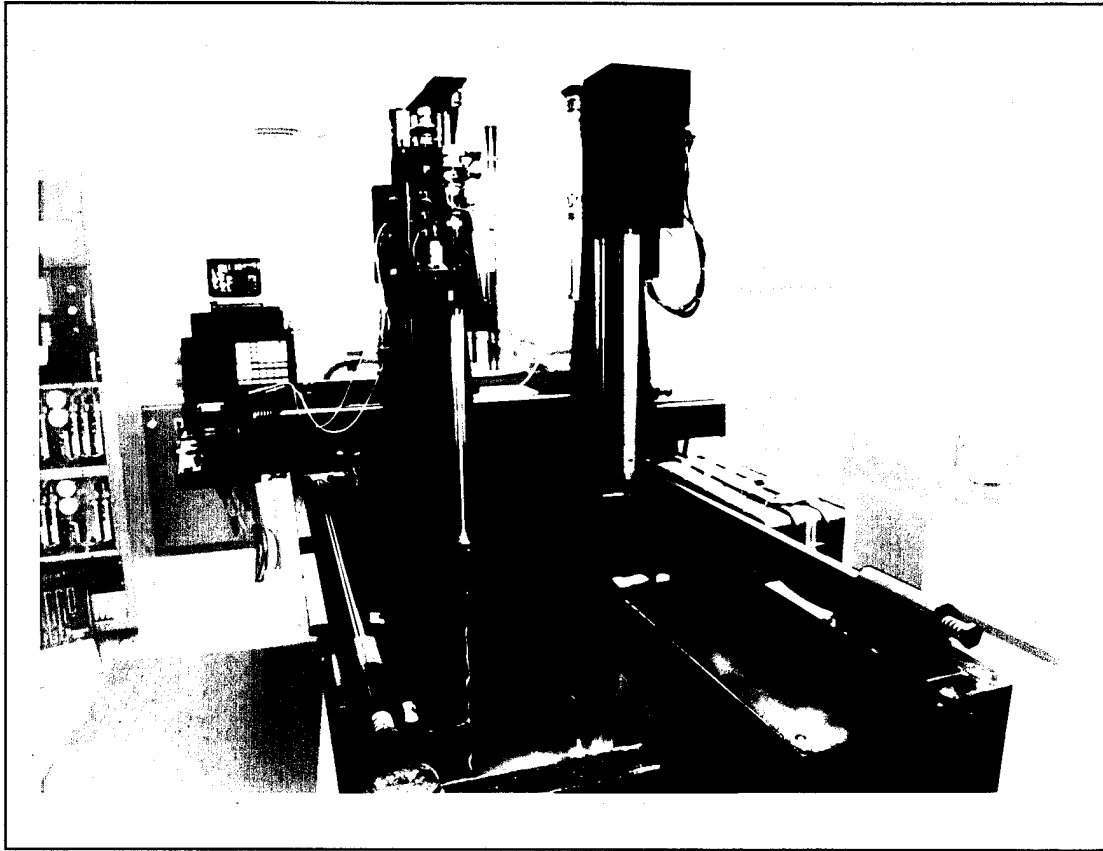
**Figure 17. Ultrasonic Tank**

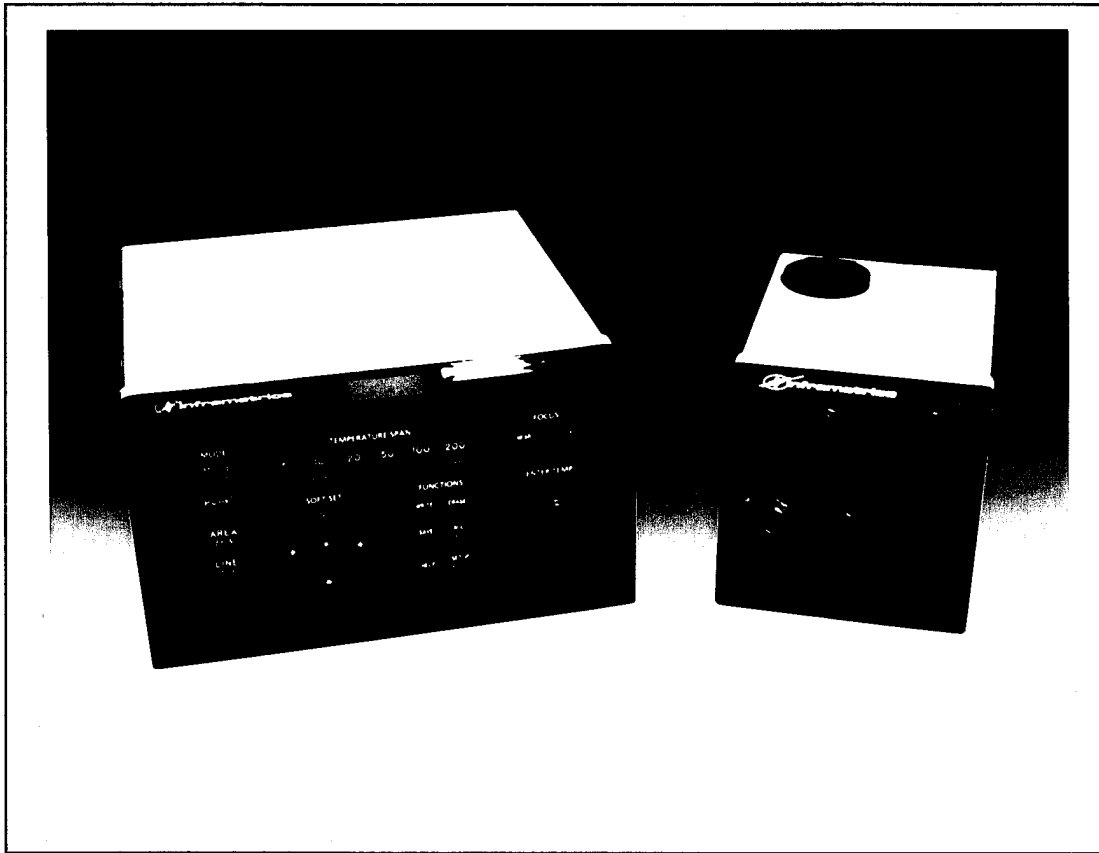
**Figure 20. Infrared Camera and Controller**

Disbond growth/size was qualitatively studied in real time using an Inframetrics infrared camera and controller (Model #7089). The infrared images were displayed on a monitor and recorded by a VCR to keep an ongoing log of disbond behavior for each specimen. The infrared equipment used is shown in Figure 20. Hard copy disbond data in terms of C-SCAN printouts were obtained periodically via the ultrasonic tank mentioned before. The experimental apparatus is shown in Figures 21 and 22.

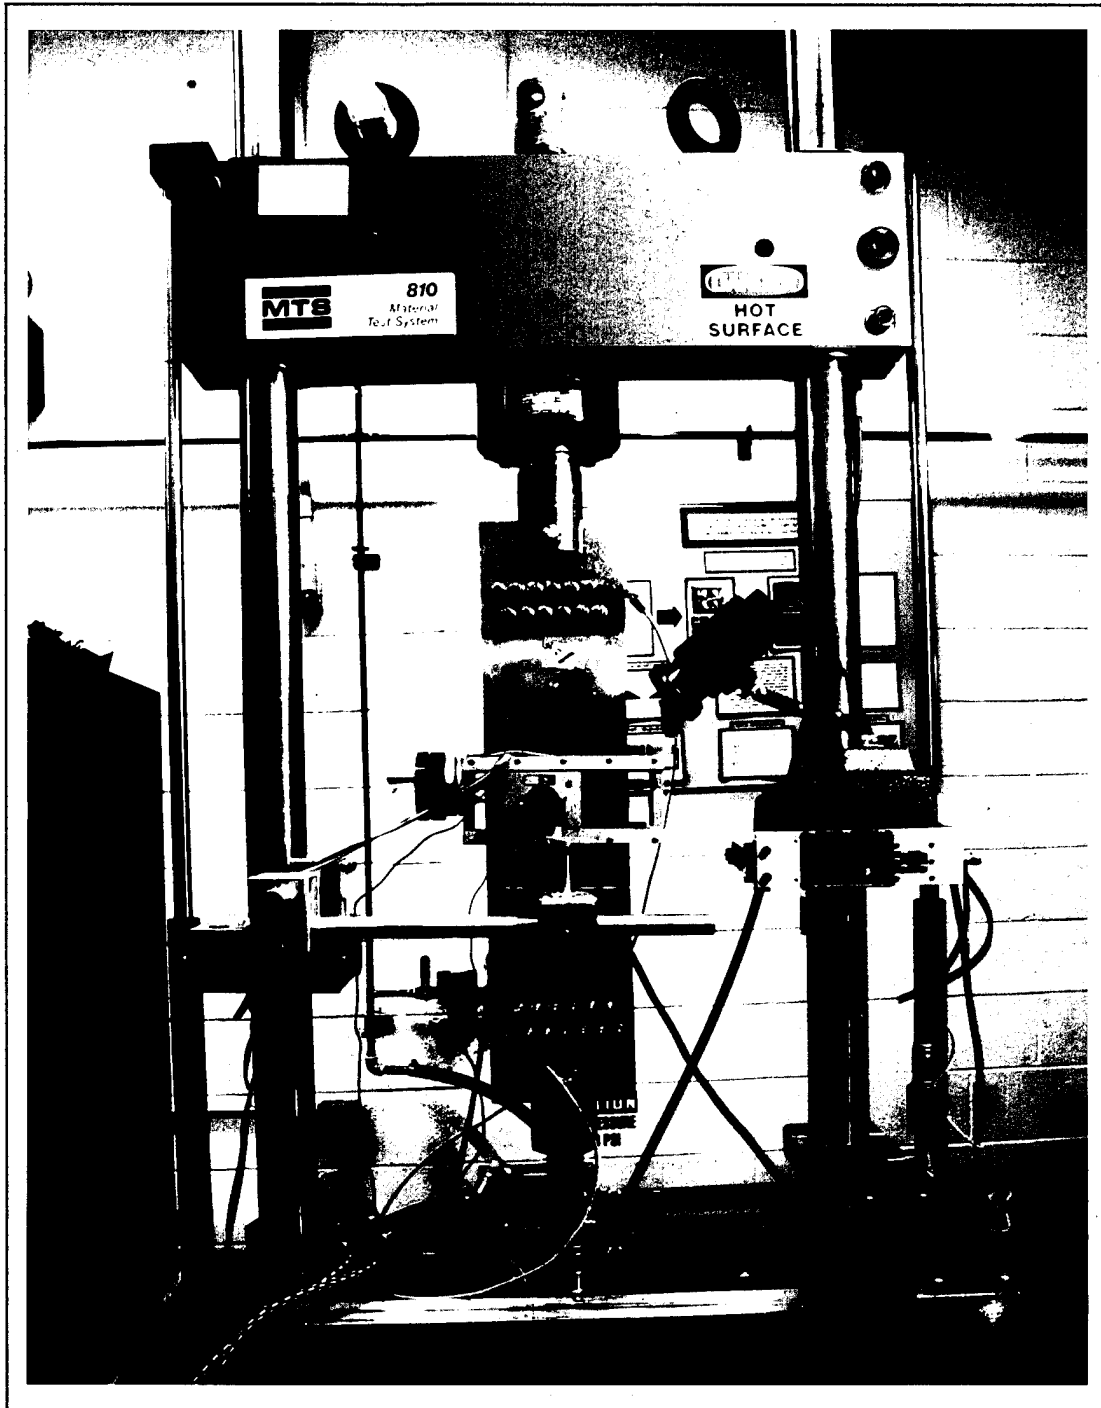
**Figure 21. Experimental Apparatus**

After the grips were bolted to the specimen, the specimen was inserted into the test stand with the microscope facing the fatigue crack and the infrared camera facing the patch. Current leads, from the DC current source, were attached to each end of the specimen and voltmeter leads were welded one inch on either side of the fatigue crack as shown in Figures 19 and 23. Alignment of the specimen and microscope was then accomplished using a level. Required program information was then entered including a

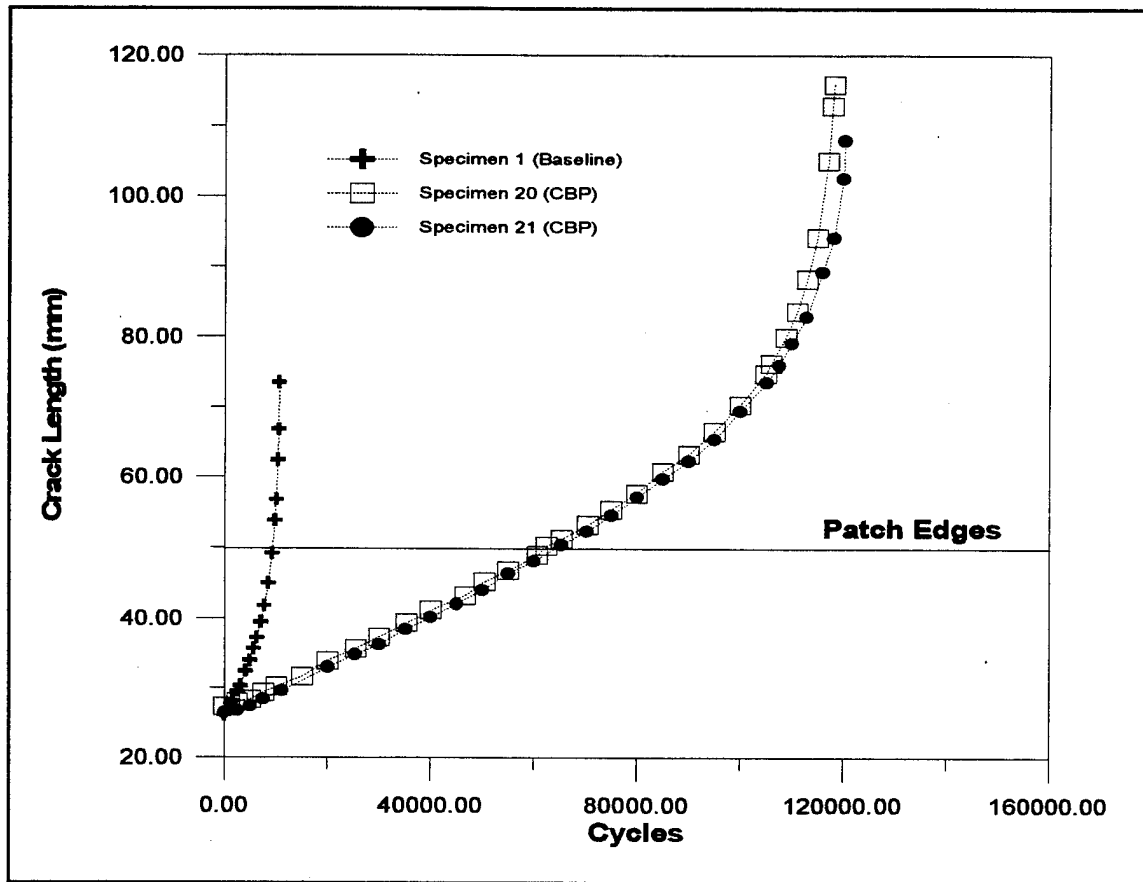
**Figure 24. Baseline vs. CBP Crack Growth**

Figure 24 shows the comparison between the crack length versus cycles curve for the baseline and two CBP specimens. At first glance, Figure 24 looks like a typical collection of fatigue life curves, however, it really tells the story about the mechanics and efficiency of bonded repairs. The first, and most important, feature of Figure 24 is that the crack growth rate,  $da/dN$ , was relatively constant within the domain of the patch repair. This is also shown by examining Figure 25 in which a three-point least squares method (37) was used to calculate the crack growth rate,  $da/dN$ . As shown in Figure 25, the crack growth rate was constant within the patch repair. In agreement with Rose (33) and Baker(8), the crack growth rate, and therefore, the repaired stress intensity factor range,  $\Delta K_R$ , were constant inside the patch. Actually, not until the crack has extended beyond each edge of the patch does the crack growth curve change from linear to the more recognizable parabolic shape characteristic of metal fatigue. The initial stress intensity factor,  $K$ , for the baseline test was  $24.26 \text{ MPa}\sqrt{\text{m}}$  and the average initial repaired stress intensity factor,  $K_R$ , for the two CBP specimens was  $5.43 \text{ MPa}\sqrt{\text{m}}$ .  $K_R$  was calculated using the Rose model (33, 34, 35). This significant reduction in the stress intensity

factor with repair was the result of: (1) load sharing by the patch; and (2) crack bridging which reduced the crack opening displacement. The second insight gained from Figure 24 and also shown in Figure 26, for the first 20,000 cycles of both CBP specimens, is that no retardation in the crack growth rate occurred during the earlier portion of crack growth inside the patch. Again, this is in agreement with Baker (6, 7, 8) and with Figure 6. The use of the elevated cure temperature film adhesive, AF-163-2, allowed the beneficial compressive stresses in the crack tip plastic zone to be annealed out during bonding of the boron/epoxy patch to the aluminum panel, eliminating retardation in the earlier portion of

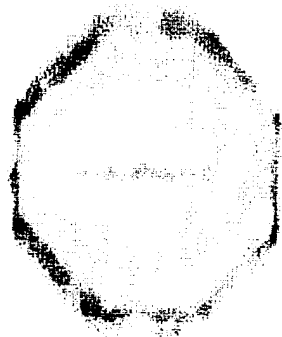
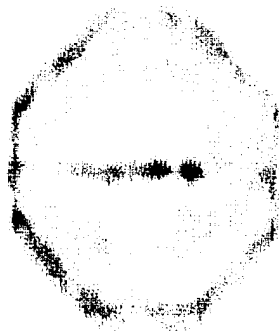
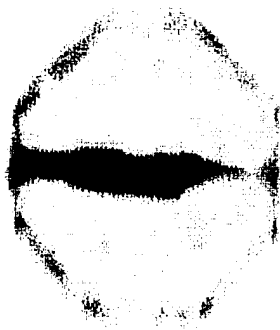
**Figure 27. CBP C-SCANs**

Figure 27 shows the representative pictures obtained by C-scanning at different stages of testing of Specimen 20. Specimen 21 demonstrated similar behavior. The three C-SCANS shown are for 0, 62,492 and 106,003 cycles which correspond to crack lengths of 27.238 mm (1.07235 inches), 50.221 mm (1.9772 inches) and 76.211 mm (3.00045 inches). The 0 cycle C-SCAN shows no bondline flaws, i.e. a perfectly bonded patch. The 62,492 cycle C-SCAN was taken when the crack tips had reached the patch edges. Slight cyclic disbonding was evident in the wake of the crack tip, however, it was not

significant and had little effect, if any, on the crack growth rate,  $da/dN$ . This is in agreement with Baker's observations (6). This again confirms that the crack growth rate,  $da/dN$ , and repaired stress intensity factor range,  $\Delta K_R$ , should remain constant for crack growth inside the patch. Only after the crack had extended beyond the patch edges did considerable disbonding occur as in the 106,003 cycle C-SCAN. Also upon visual inspection of the specimen after failure, it was determined that the cyclic disbonding occurred between the adhesive and the boron/epoxy patch. This agreed with the findings of Baker (8) and Russell (36) who attributed this disbonding to the light glass scrim cloth impregnated in the epoxy of the patch and the high stresses at the repair-adhesive interface due to the use of a high modulus adhesive.

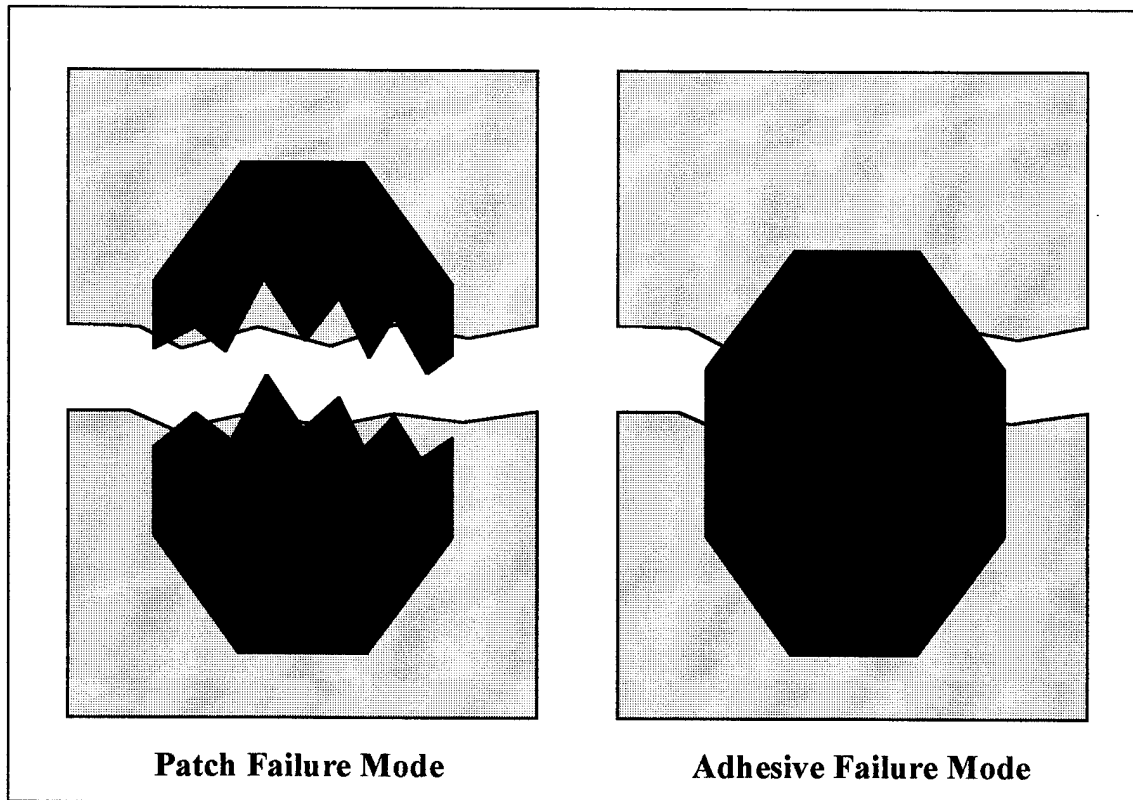
**Figure 28. Failure Modes**

Two major modes of failure occur in bonded patch repair, the patch failure mode and adhesive failure mode. Figure 28 illustrates these two failure modes. In the patch

failure mode, the patch fails with the aluminum. In the adhesive failure mode, the adhesive fails cohesively. Photographs of Specimens 20 and 21 can be found in Appendix A.

Finally, the two FWD specimens failed by the patch failure mode as shown in Figure 28 and Appendix A.

Again, the two CTD specimens failed by the patch failure mode as shown in Figure 28 and Appendix A.

All three ED specimens failed by the patch failure mode as shown in Figure 28 and Appendix A.

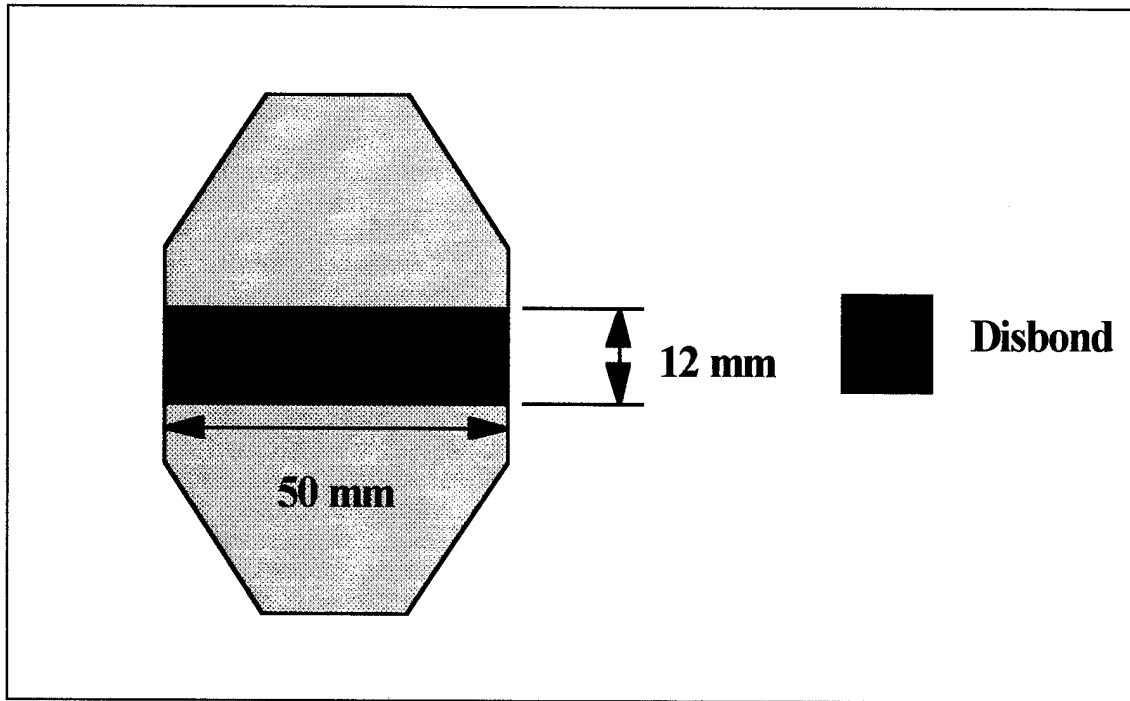
**Figure 29. FWD Dimensions**

was equal to the area of the largest boron/epoxy ply which was 2822 mm<sup>2</sup>. The disbond of the FWD specimens was 600 mm<sup>2</sup> with the dimensions shown in Figure 29 which was

dimensions as shown in Figure 29. The 43,018 cycle C-SCAN represents the point at which the crack tips had reached the patch edges with no growth of the intentional disbond. Even after the crack had grown beyond the patch edges, the disbond did not increase in size or change shape. This lack of disbond growth was also reported by Baker (6) in his study of intentional FWD specimens, i.e. there was no cyclic disbonding. Also, as with Hart-Smith's (22) observations, the adhesive bond did not behave as a weak link, in fact, the bondline proved to be relatively damage tolerant of the FWD. As a result of this lack of cyclic disbonding, the crack growth rate within the patch repair was constant as shown in Figures 30 and 31.
