## Fatigue Response of Cracked Aluminum Panel with Partially Bonded Composite Patch

THESIS

Jason J. Denney, Captain, USAF

DEPARTMENT OF THE AIR FORCE  
AIR UNIVERSITY  
**AIR FORCE INSTITUTE OF TECHNOLOGY**

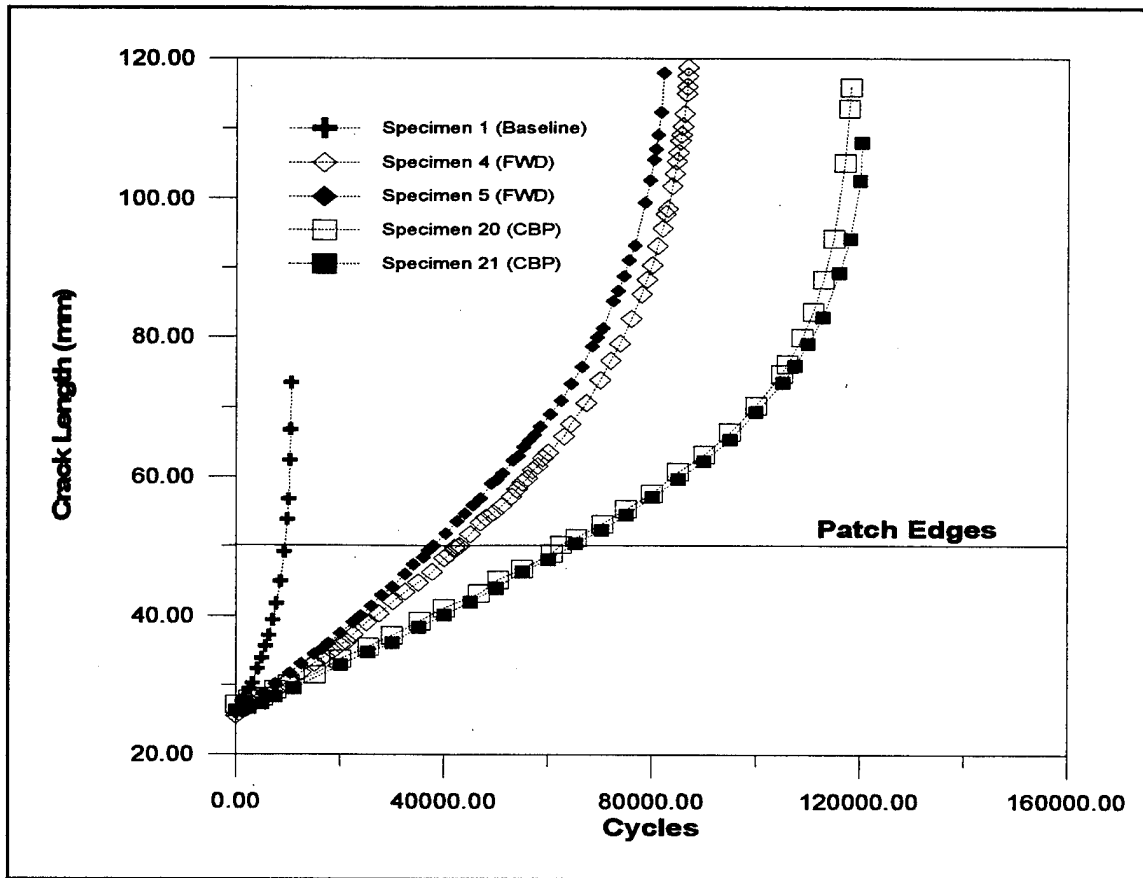
**Figure 30. FWD vs. Baseline and CBP Crack Growth**

Figure 30 shows the crack length versus cycles curve for the baseline, the two FWD specimens and the two CBP specimens. The crack growth rates for both FWD specimens were constant within the patch indicating that the repaired stress intensity factor range,  $\Delta K_R$ , was also constant. Again, as with the CBP specimens, the crack growth curves remained constant until the crack tips had extended beyond the edges of the patch. This behavior is evident from Figure 31 using the three-point least squares method (37) to determine the relative change in crack growth rate with crack length. For comparison purposes, the average crack growth rate within the patch for the FWD and CBP specimens are shown in Table 9. On the average, the crack growth rate for the FWD specimens were 1.65 times greater than that for the CBP specimens. The greater crack growth rate was due to the point of load transfer from the plate to the patch being moved away for the crack as shown in Figure 32. Load transfer through the adhesive to the patch ceases at the point of disbonding which resulted in the aluminum plate having to carry excess load around the crack as compared to a perfectly bonded patch. This is essentially what occurs in a bolted repair. As soon as the load transfers at the rivets/bolts, the remaining load has no other means of transfer into the repair leaving it free to strain the remaining material around the crack. This causes a greater crack opening displacement,

dimensions as shown in Figure 29. The 43,018 cycle C-SCAN represents the point at which the crack tips had reached the patch edges with no growth of the intentional disbond. Even after the crack had grown beyond the patch edges, the disbond did not increase in size or change shape. This lack of disbond growth was also reported by Baker (6) in his study of intentional FWD specimens, i.e. there was no cyclic disbonding. Also, as with Hart-Smith's (22) observations, the adhesive bond did not behave as a weak link, in fact, the bondline proved to be relatively damage tolerant of the FWD. As a result of this lack of cyclic disbonding, the crack growth rate within the patch repair was constant as shown in Figures 30 and 31.

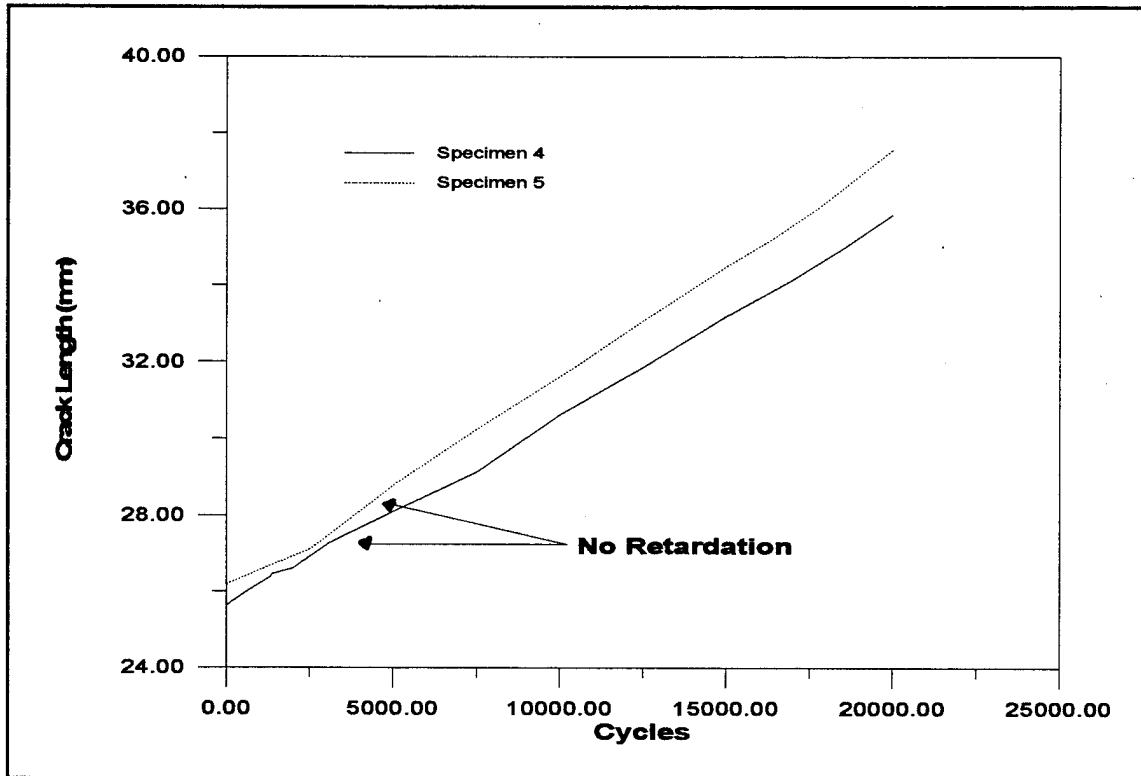
**Figure 33. FWD Retardation of Crack Growth**

As with the CBP specimens in Figure 26, the FWD specimens did not experience any retardation in the earlier portion of crack growth. Figure 33 shows this effect. Again this was the result of using a high cure temperature adhesive.

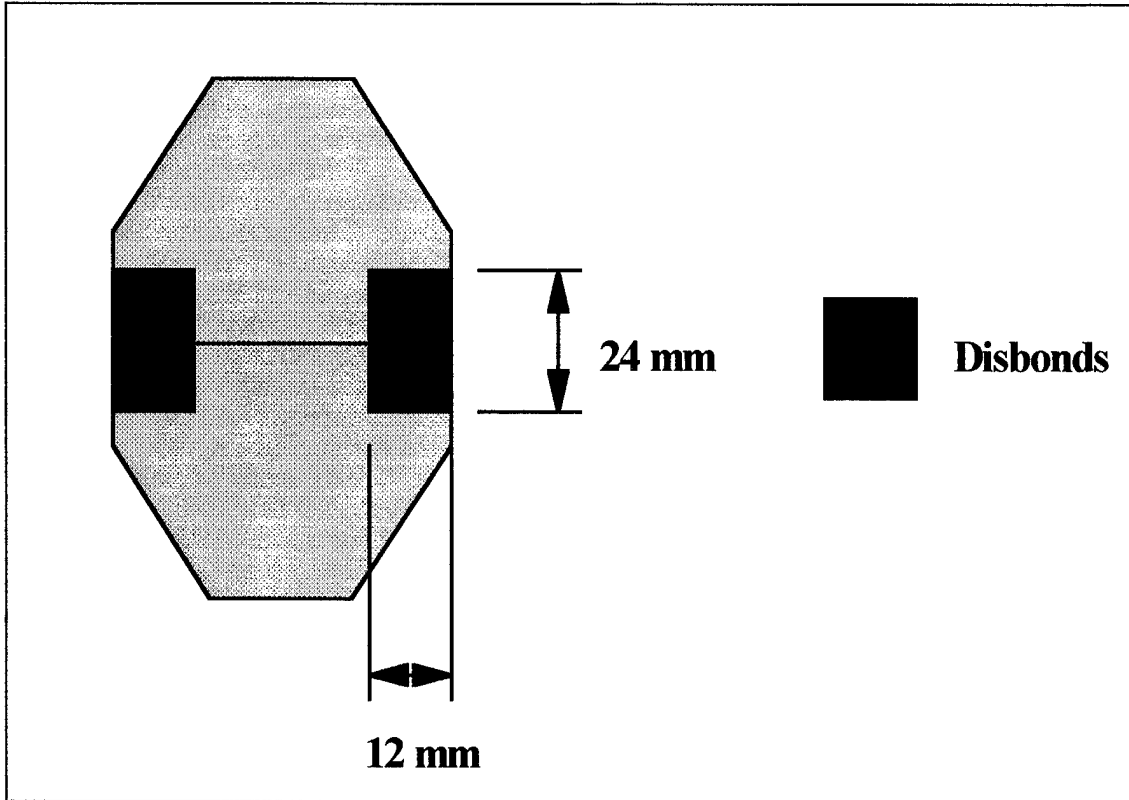
**Figure 35. CTD Dimensions**

**Crack Tip Disbonds.** Two specimens with CTD, Specimen 6 and Specimen 7, were tested with a disbond approximately 20 % of the total bond area. Each crack tip disbond was 288 mm<sup>2</sup> equaling 10.2 % of the total bond area, therefore, both crack tip disbonds resulted in a combined 20.4 % disbond of the total bond area. The disbond dimensions are shown in Figure 35. The fatigue lives of the two CTD specimens along with the baseline and CBP specimens are shown in Table 10. The fatigue life of Specimen 6 was 78 % of the average life of 119,320 cycles, for the CBP specimens, and

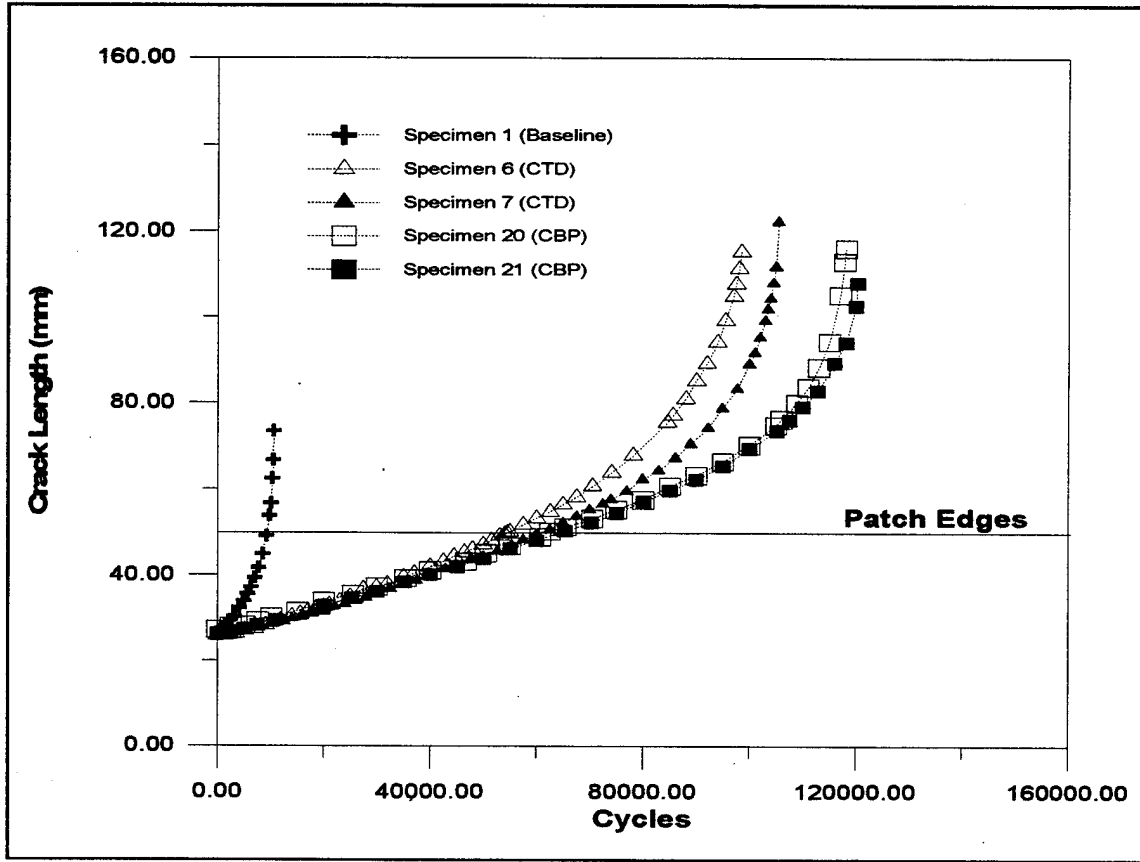
**Figure 36. CTD vs. Baseline and CBP Crack Growth**

Figure 36 shows the crack length versus cycles curve for the baseline, the two CTD specimens and the two CBP specimens. The crack growth rates for both the CTD specimens were initially constant and similar to that of the CBP Specimens, however, the crack growth rates of the CTD specimens tend to increase slightly as the crack grew further into the disbond areas and closer to the patch edges. As more of the intentional

CTD disbonds made an appearance in the wake of the crack tips during crack growth, it simulated the cyclic disbonding that Baker (6, 8) described, thus resulting in a greater crack opening displacement about the crack tip and an increased repaired stress intensity factor range,  $\Delta K_R$ . For the case studied here, this increasing trend in crack growth was small and can be assumed to be negligible as shown in Figure 37. However, if the patch was wider with a similar crack tip disbond, a more noticeable effect on  $da/dN$  with crack length would have been observed. This also supports Baker's (6) observation that disbonds in front of the crack tip have little effect on the rate of crack propagation, i.e. it was not until the disbonds made an appearance behind the crack tip did they have an effect. For illustration purposes, Table 11 compares the average crack growth rates for the CTD specimens with that of the CBP specimens within the patch. The crack growth rates presented are the average growth rates, within the patch, computed by the three-point least squares method (37). On average, the crack growth rate for the CTD specimens was 1.16 times greater than that for the CBP specimens.

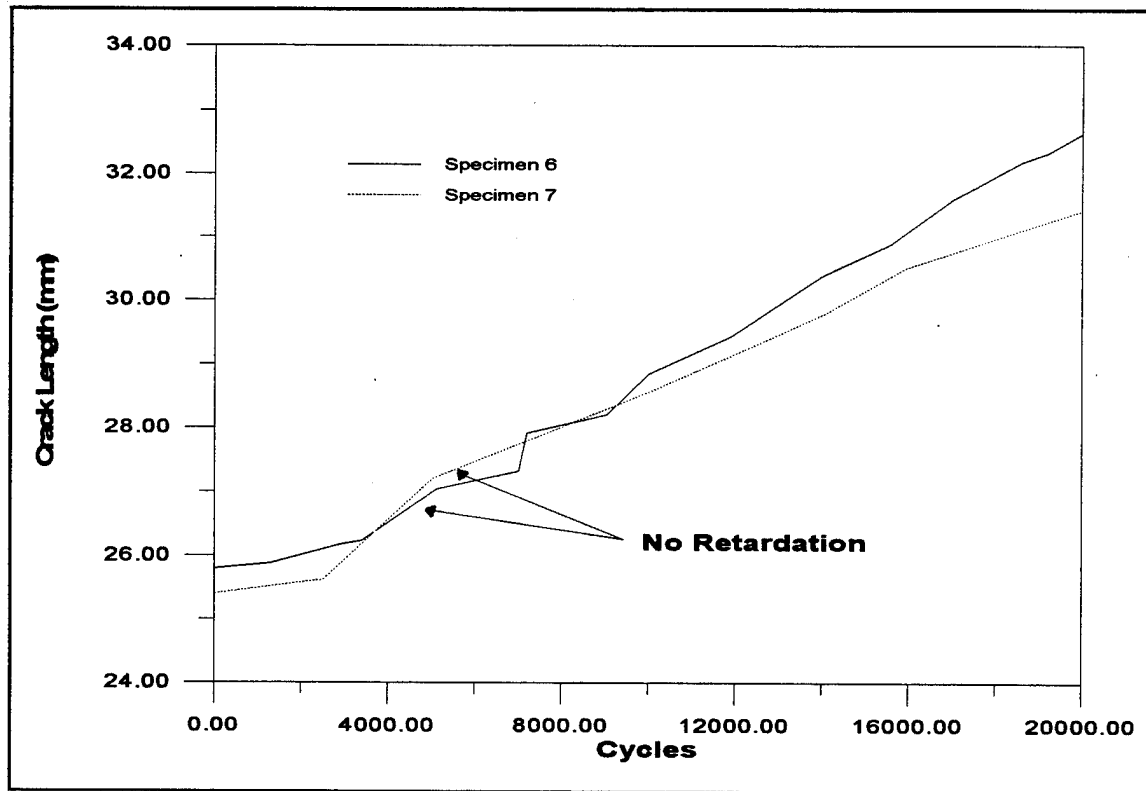
**Figure 38. CTD Retardation of Crack Growth**

As with the CBP and FWD specimens, the CTD specimens did not experience any retardation in the earlier portion of crack growth as shown in Figure 38. This was again the result of the annealing out of the beneficial compressive stresses ahead of the crack tip

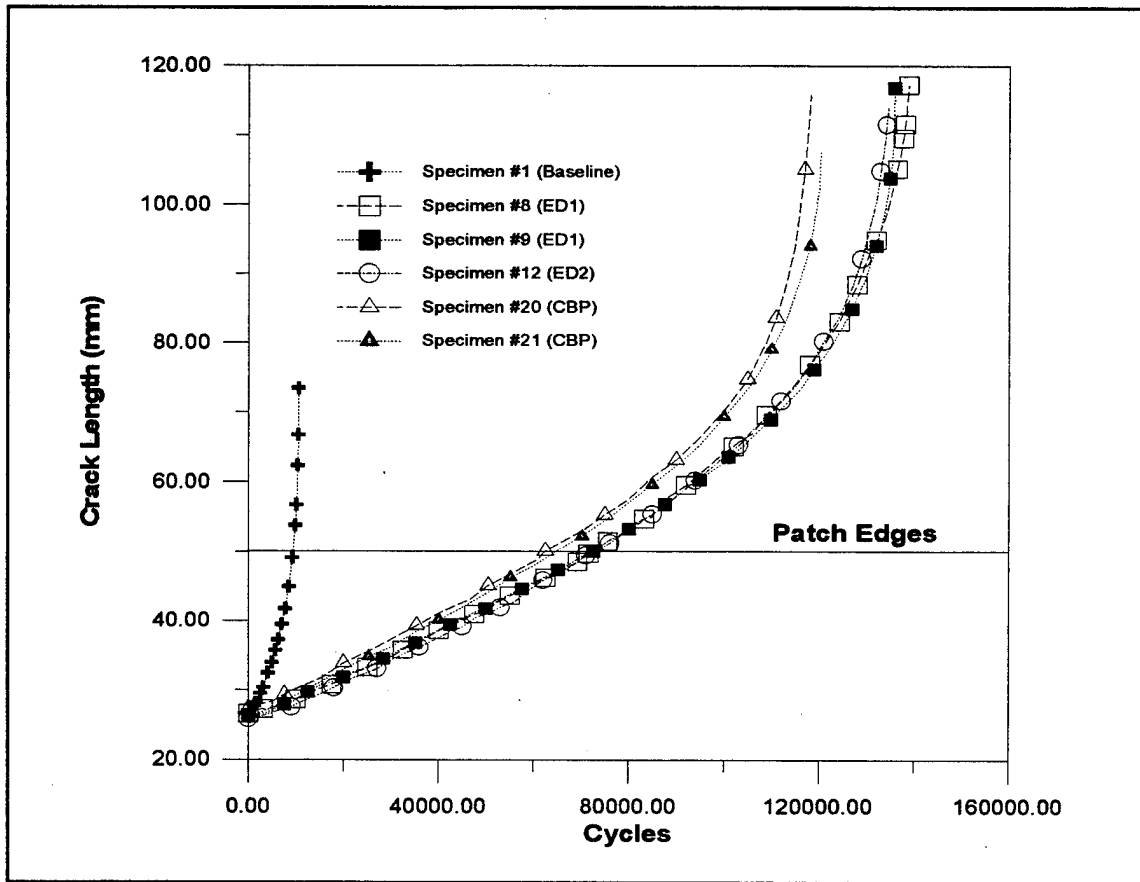
**Figure 41. ED vs. Baseline and CBP Crack Growth**

Figure 41 shows the crack growth curves for the baseline specimen, the three ED specimens and the two CBP specimens. The crack growth rates for all three ED specimens were constant within the patch, as shown in Figure 41 and Figure 42, indicating a constant repaired stress intensity factor range,  $\Delta K_R$ . As with the CBP and FWD specimens, the crack growth curves remained linear until the crack tips had extended beyond the patch. Table 13 shows the average crack growth rate within the patch as well as the initial repaired stress intensity factor,  $K_R$ , for the ED and CBP specimens. The repaired stress intensity factors were calculated using the Rose model (33, 34, 35) with the corresponding initial crack length for each specimen as shown in Table 5. In these calculations, the length of the patch with end disbonds was reduced by the length of the disbond. The presence of end disbonds essentially made the patch shorter in length. From the inclusion analogy (33, 34), the patch and the plate together behave as a region of

higher stiffness, attracting parasitic load. If this region's longitudinal length is decreased, the region of higher stiffness is reduced in size, and less load is attracted into it resulting in a reduced patch and plate stress around the crack and, thus, a reduced repaired stress intensity factor,  $K_R$ . This phenomenon is illustrated in Figure 43. However, this fact should not deter the repair designer from using a patch that meets the standard length requirements for a single-sided patch (80-100 times the repair thickness). This additional length is required for margin, especially for those cases where disbond growth is prevalent. The additional length/bond area is essentially a safety net that anchors the repair to the

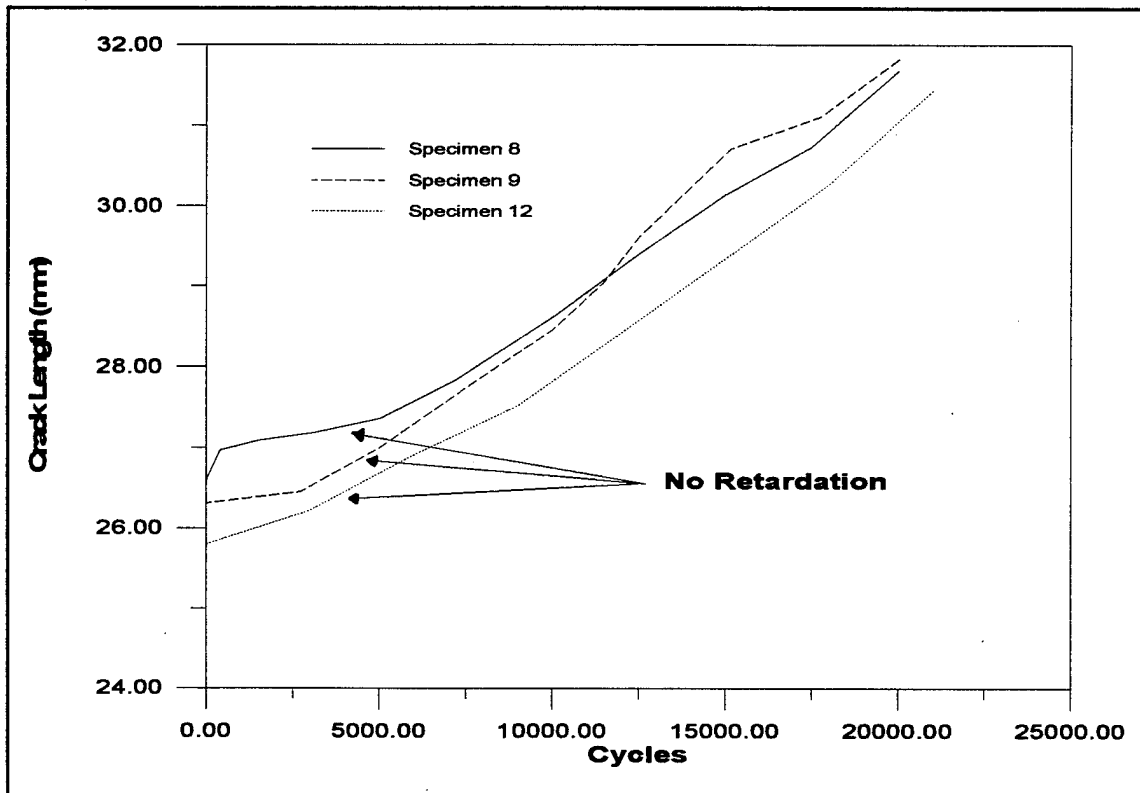
**Figure 44. ED Retardation of Crack Growth**

As with the all prior specimen configurations, the ED1 and ED2 configurations demonstrated no initial retardation as shown in Figure 44. Again, this was the result of using a high cure temperature adhesive.

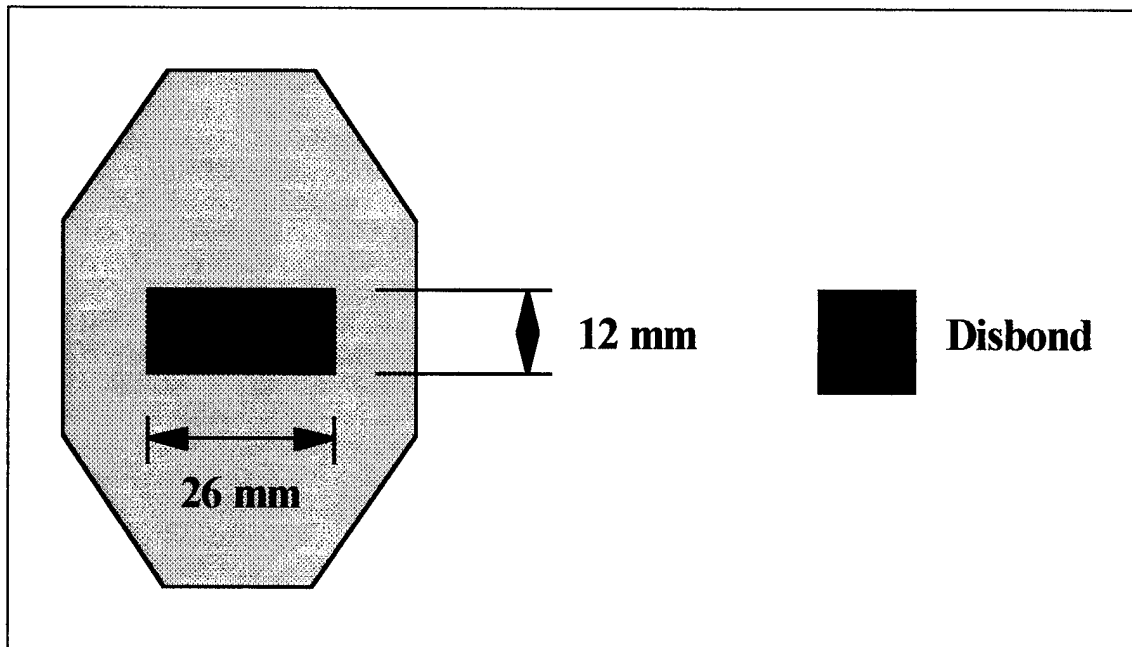
Figure 46. CD Dimensions

*Center Disbond.* Specimen 16 with a CD is presented here to investigate the effect of location, but it contained a disbond approximately one-half the size of that presented thus far. The CD specimen dimensions are shown in Figure 46. The center disbond was 312 mm<sup>2</sup>, equaling 11 % of the total bond area. It will be shown later that the effect of disbond size (between 10 % and 20 %) has far less effect than the location, and therefore, this center disbond case can be included here to investigate the effect of different locations. The fatigue life of the CD specimen, the baseline specimen and the two CBP specimens are shown in Table 14. The fatigue life of the specimen with a CD was 22.4 % less than the CBP average of 119,320 cycles. Even with this large reduction in patching efficiency as compared to the CBP specimens, the CD specimen still achieved 8.71 times life extension over the baseline specimen. As expected this fell between the average FWD specimen life extension of 7.96 times and the average CTD specimen life extension of 9.59 times. Explanation of this will follow.

With the availability of an approach to account for the disbond location and size effect on the patching efficiency, an attempt will be made to determine the patching efficiency for the disbond configurations ED2 (Figure 40) and CD (Figure 46). First, the ED2 configuration with a 20 % area disbond and a CD configuration with a 10 % area disbond will be investigated. A CD configuration, with only a 10 % area disbond, can be used to estimate the location effect because varying the area in the y-direction (as defined in Figure 52) from 20 % to 10 % disbond area around the crack has minimal effect on efficiency as demonstrated for the FWD configuration in Table 31 and as discussed in Chapter 4. Finally, size effects on a CD configuration in going from a 10 % to a 5 % area disbond will be estimated.

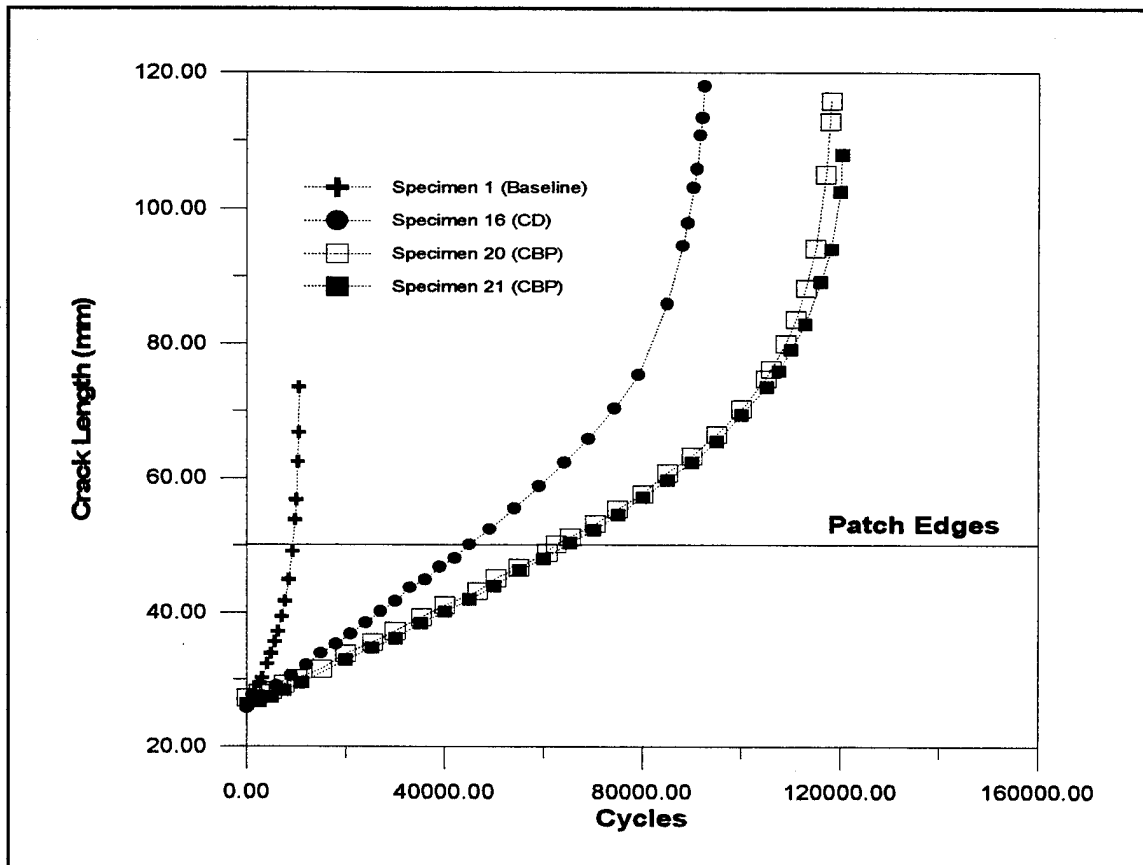
**Figure 47. CD vs. Baseline and CBP Crack Growth**

Figure 47 shows the crack growth curves for the baseline specimen, the CD specimen and the two CBP specimens. The crack growth rate for the CD specimen was constant within the patch, once again indicating a constant repaired stress intensity factor range,  $\Delta K_R$ . The crack growth rate remained constant until the crack tips had extended beyond the patch edges as shown in Figure 48. Figure 49 shows the crack growth of the CD specimen versus the two FWD specimens and the two CTD specimens. The CD specimen crack growth rate was less than the FWD specimens because the load transfer into the patch was more efficient. As the crack grew beyond the disbond and out to the patch edges the load transfer about the crack tip was not displaced as with a FWD specimen (Figure 32). The CTD specimen was more efficient than the CD specimen because the majority of the crack is perfectly bonded during crack growth within the patch

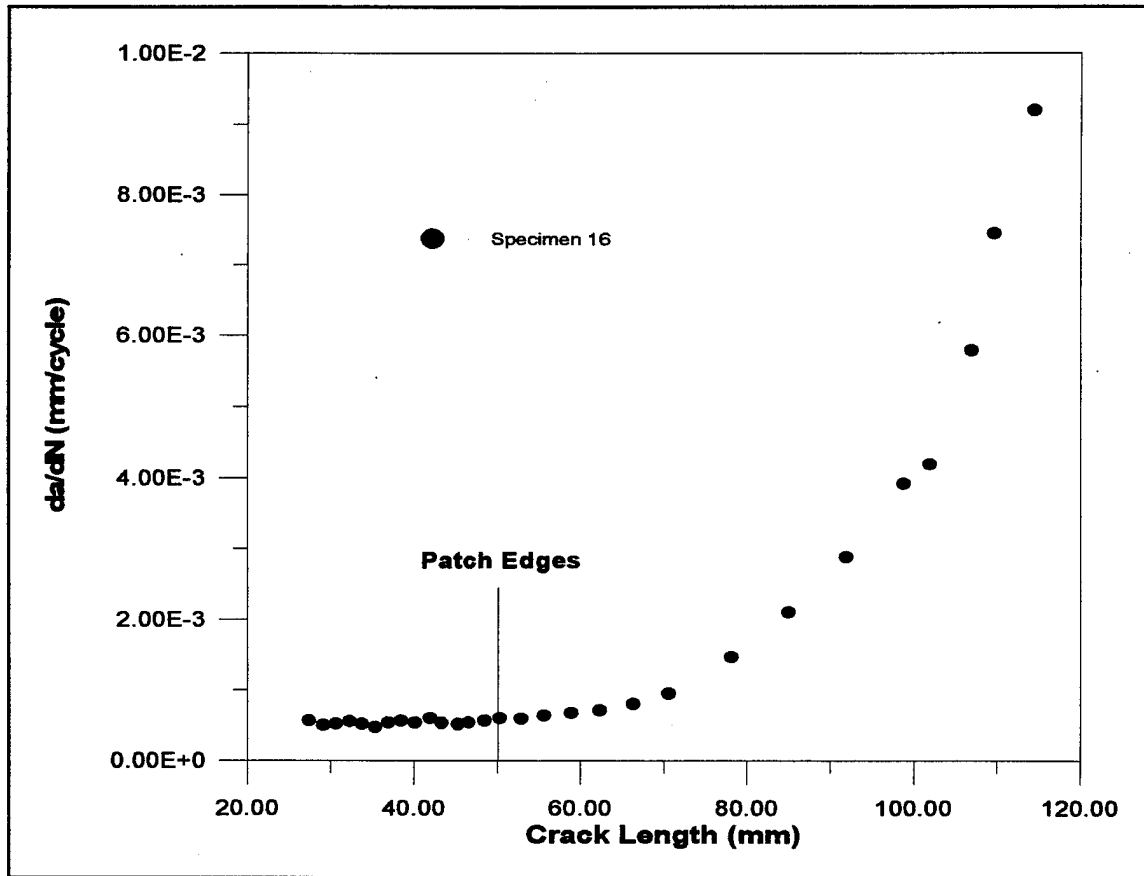
Figure 48. CD da/dN vs. Crack Length

repair, allowing more efficient load transfer into the repair around the crack. Essentially, the larger the disbond covering the crack during crack growth within the patch the greater the crack opening displacement and crack growth rate. The average crack growth rates within the patch for the FWD, CTD and CD specimens are shown in Table 15 for comparison purposes. These crack growth rates were computed by the least-squares method (37). On average, the CD specimen crack growth rate was 0.89 times that of the FWD specimens and 1.27 times that of the CTD specimens.

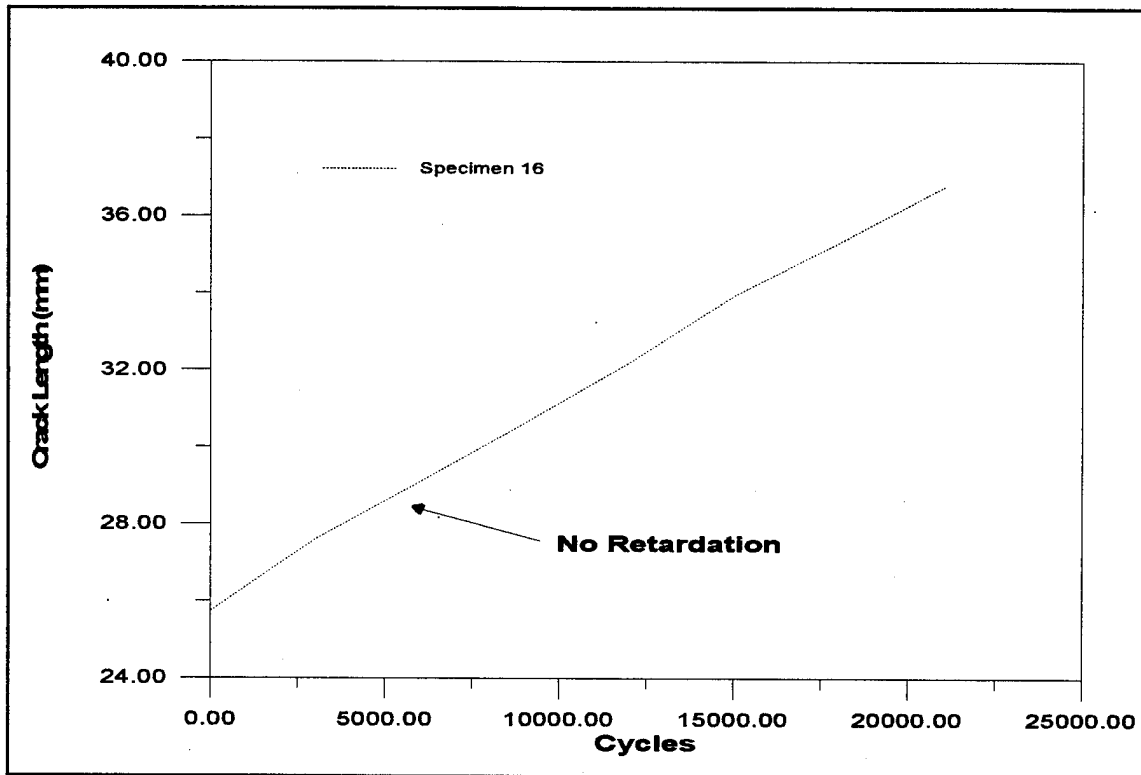
**Figure 50. CD Retardation of Crack Growth**

any retardation in the earlier portion of crack growth as shown in Figure 50.

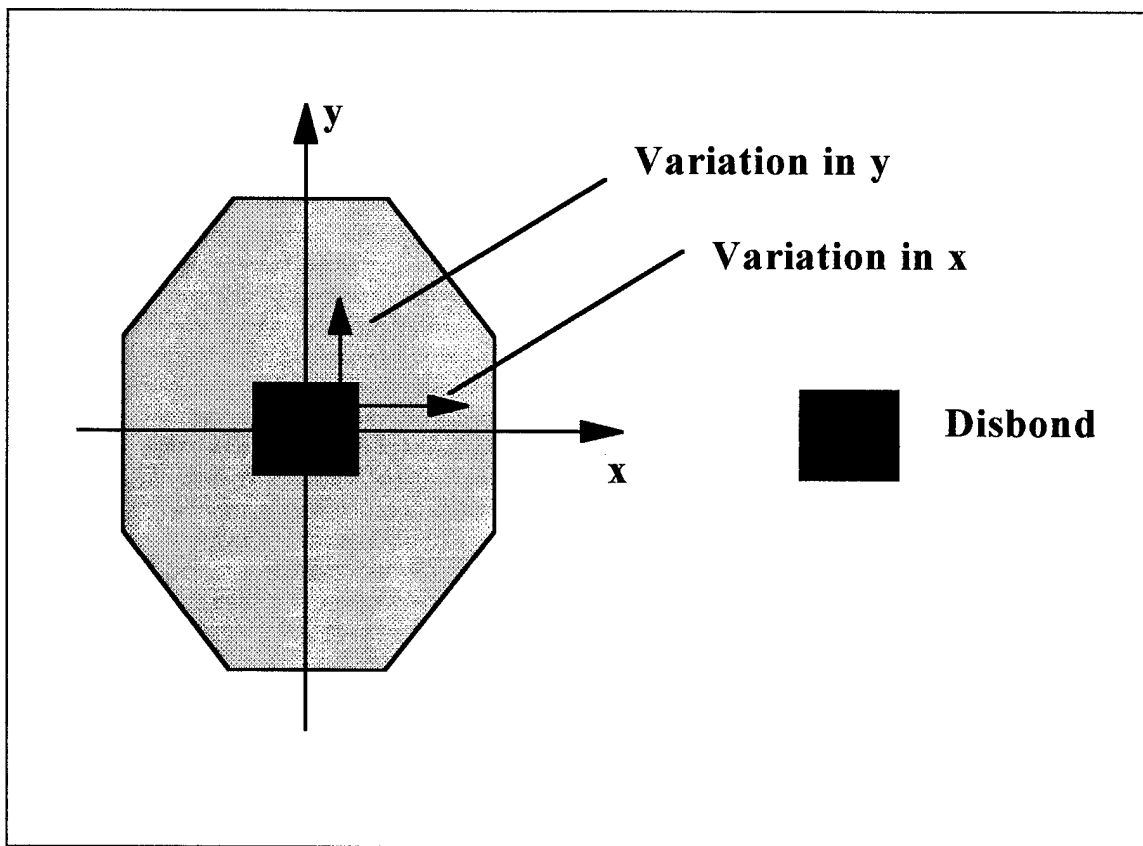
**Figure 52. Disbond Size Variation**

**Effects of Disbond Size.** This subsection is divided into two parts: (1) full width disbond (FWD) size effects; and (2) center disbond (CD) size effects. The size effects in these two parts differ by varying the disbond size relative to the x and y-directions as shown in Figure 52. FWD specimens demonstrate y-direction effects and CD specimens

demonstrate x-direction effects.

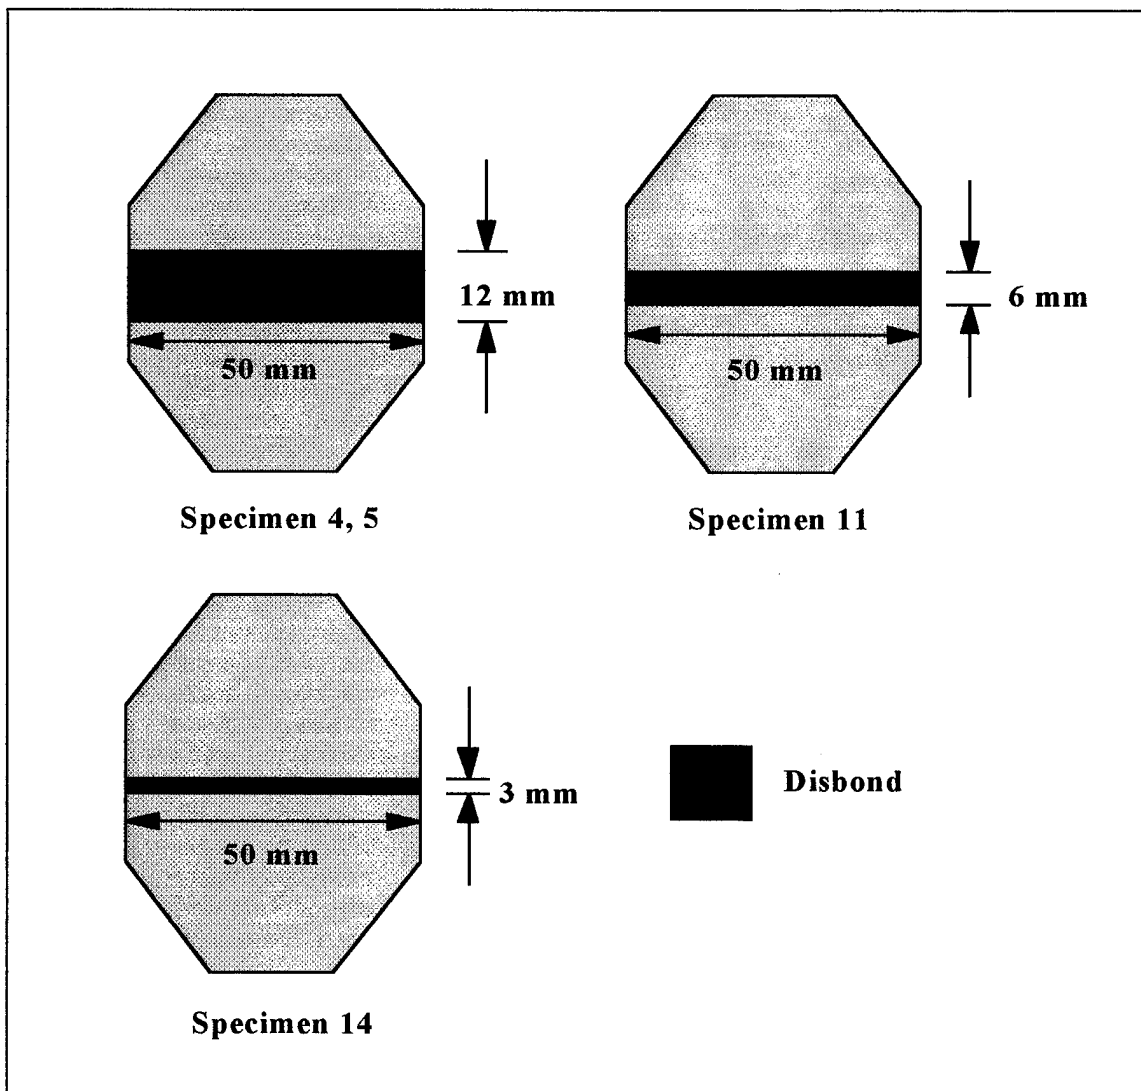
**Figure 53. FWD Configuration Dimensions**

**Full Width Disbond Size Effects.** Four FWD specimens, Specimens 4, 5, 11 and 14, were investigated for disbond size effects. The specimens and their disbond sizes with respect to the total bond area of 2822 mm<sup>2</sup> are shown in Table 16. The dimensions of the three variations of FWD size are shown in Figure 53. The fatigue lives of the FWD specimens are shown in Table 17 with the baseline and the two CBP specimens. The average fatigue life of Specimens 4 and 5 was 71 % of the CBP average of 119,320 cycles, a significant reduction in total life. Specimen 11 was 82 % of the CBP average life and Specimen 14 was 96 % of the CBP average life. This clearly shows that as the area of disbond increased in the y-direction (perpendicular to the crack), the fatigue life decreased.

Only full width disbond (FWD) configurations are investigated here for size effects (Figure 53). The computed disbond size weighting factors are shown in Table 31. The FWD

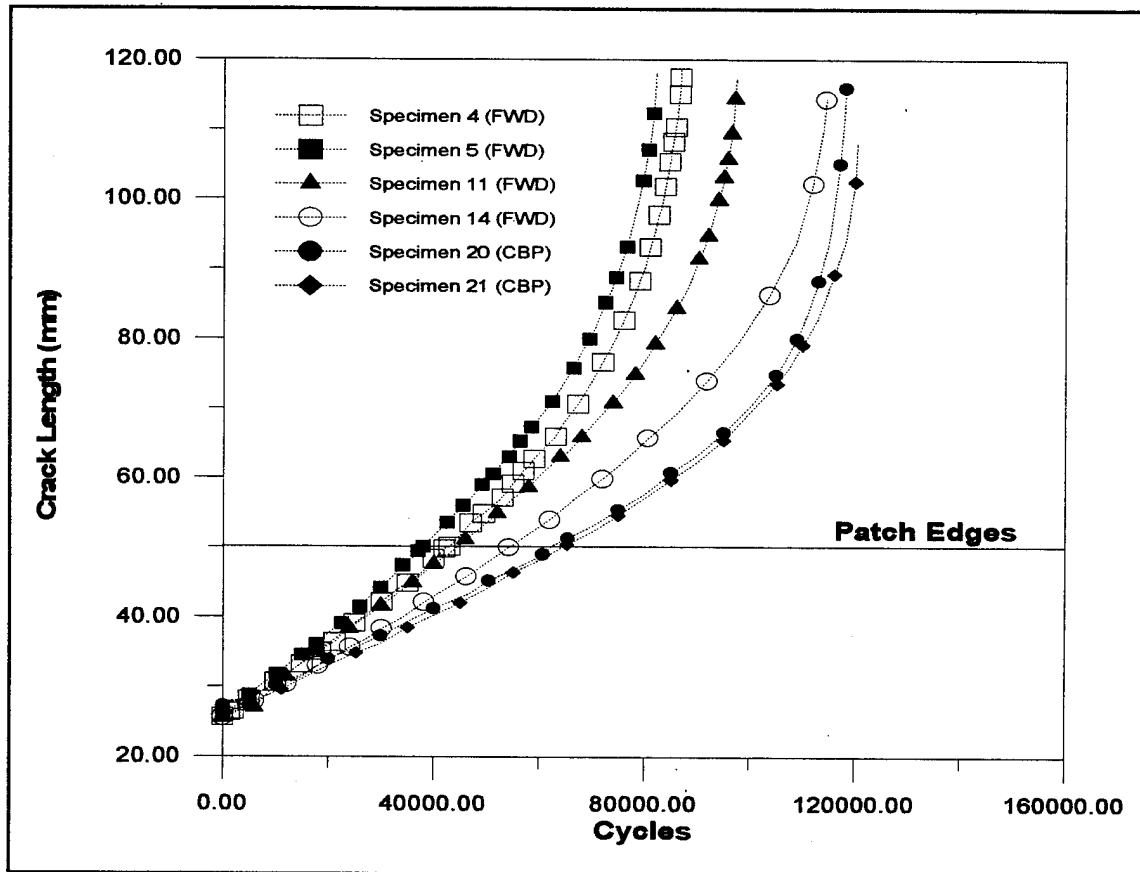
**Figure 54. FWD vs. CBP Crack Growth**

Figure 54 shows the crack growth curves for the four FWD configurations and the two CBP specimens. The crack growth rates for all the FWD specimens were constant within the patch, indicating a constant repaired stress intensity factor range,  $\Delta K_R$ . Outside of the patch, all the FWD specimens demonstrated similar parabolic trends, however, the CBP specimens exhibited a much more abrupt transition to parabolic growth as the crack grew further from the patch edges for similar crack lengths. This difference was due to the continuous cyclic disbonding that occurred about the crack within the CBP specimens that is shown in Figure 27, especially when the crack had grown outside the patch edges. As a result the repaired stress intensity factor range,  $\Delta K_R$ , increased causing a greater change in crack growth. In comparison, the FWD specimens did not show an increase in the size of the intentional disbond, to be discussed later, which resulted in a more slowly

increasing repaired stress intensity factor range,  $\Delta K_R$ , outside the patch. This led to the less abrupt change in crack growth outside the patch edges. The average crack growth rates within the patch for the three FWD size configurations and the CBP specimens are shown in Table 18. The crack growth data in Table 18 was computed using the three-point least squares method (37). Examining Table 18, it is evident that increasing the disbond size perpendicular to the crack faces decreased the patch efficiency, i.e. the crack

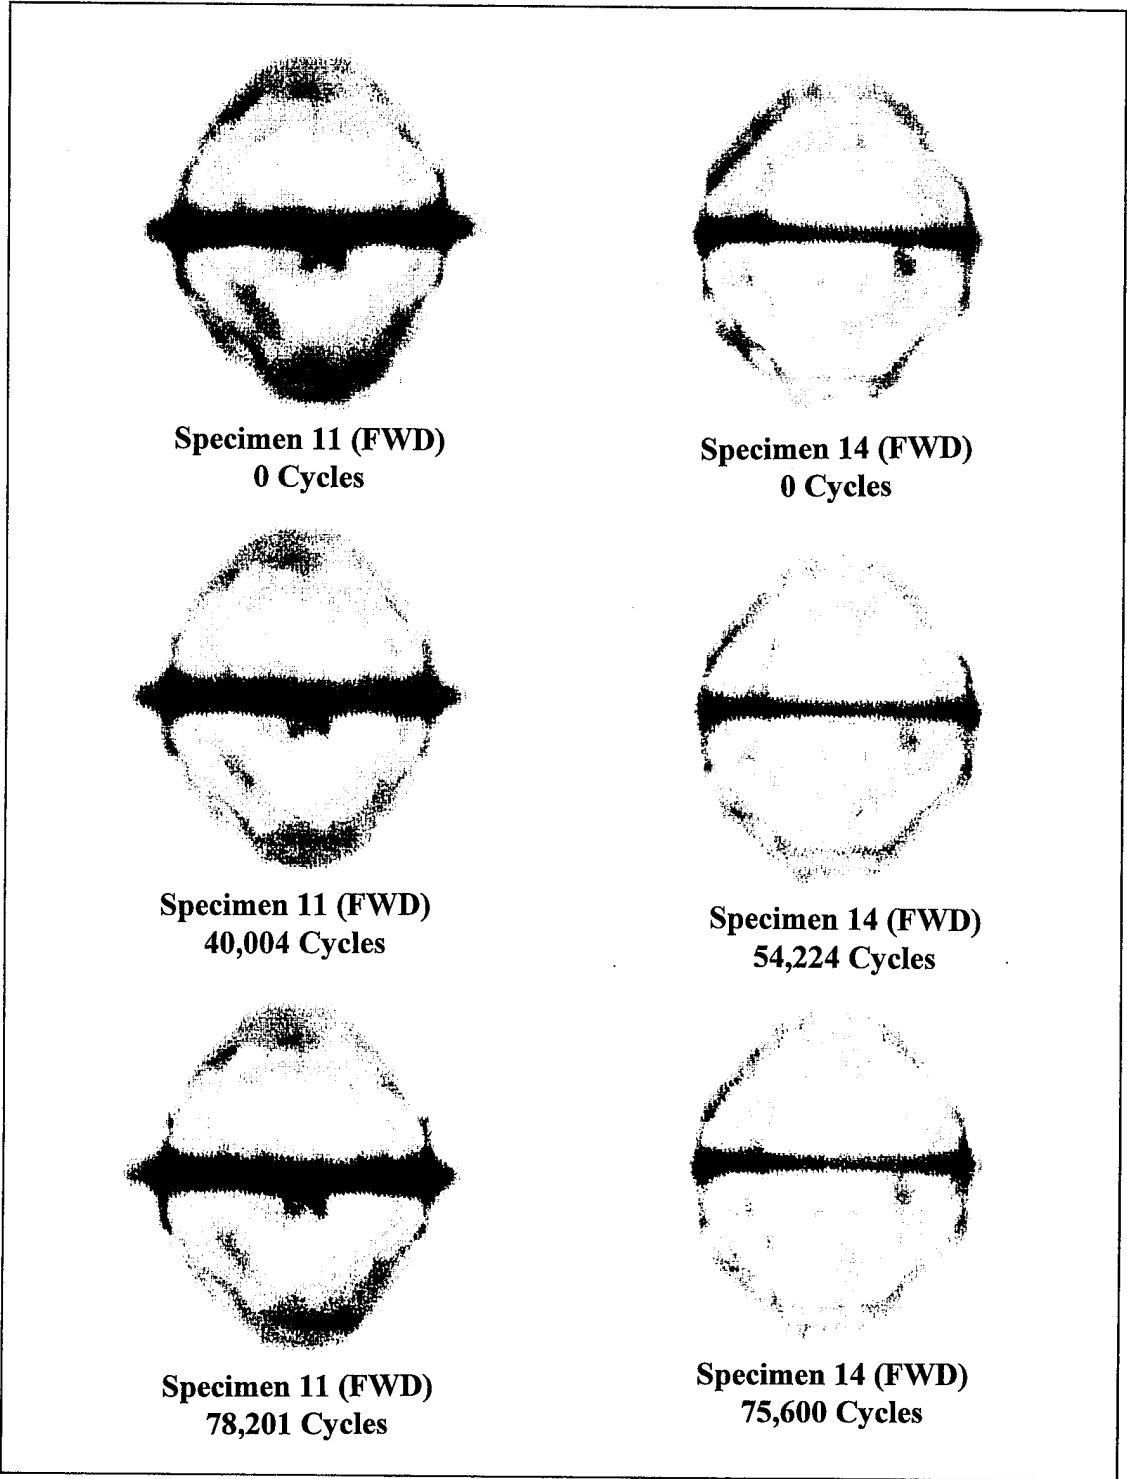
Figure 55. Specimen 11 and 14 C-SCANs

Figure 55 shows the C-SCANS for Specimens 11 (with a 10.6 % area disbond) and

14 (with a 5.3 % area disbond). C-SCANS for Specimen 4 (with a 21.3 % area disbond), demonstrating similar behavior as of Specimen 5, are shown in Figure 34. The three C-SCANS of Specimen 11 are for 0, 40,004 and 78,201 cycles corresponding to crack lengths of 25.439 mm (1.00155 inches), 47.575 mm (1.87305 inches) and 74.88 mm (2.94803 inches). The three C-SCANS of Specimen 14 are for 0, 54,224 and 75,600 cycles corresponding to crack lengths of 25.588 mm (1.0074 inches), 49.957 mm (1.9668 inches) and 62.090 mm (2.4445 inches). No intentional disbond growth was evident in agreement with Baker's (6) results and Hart-Smith's (22) observations. The bondline was damage tolerant of the disbonds, however, they still had a noticeable effect on the crack growth.

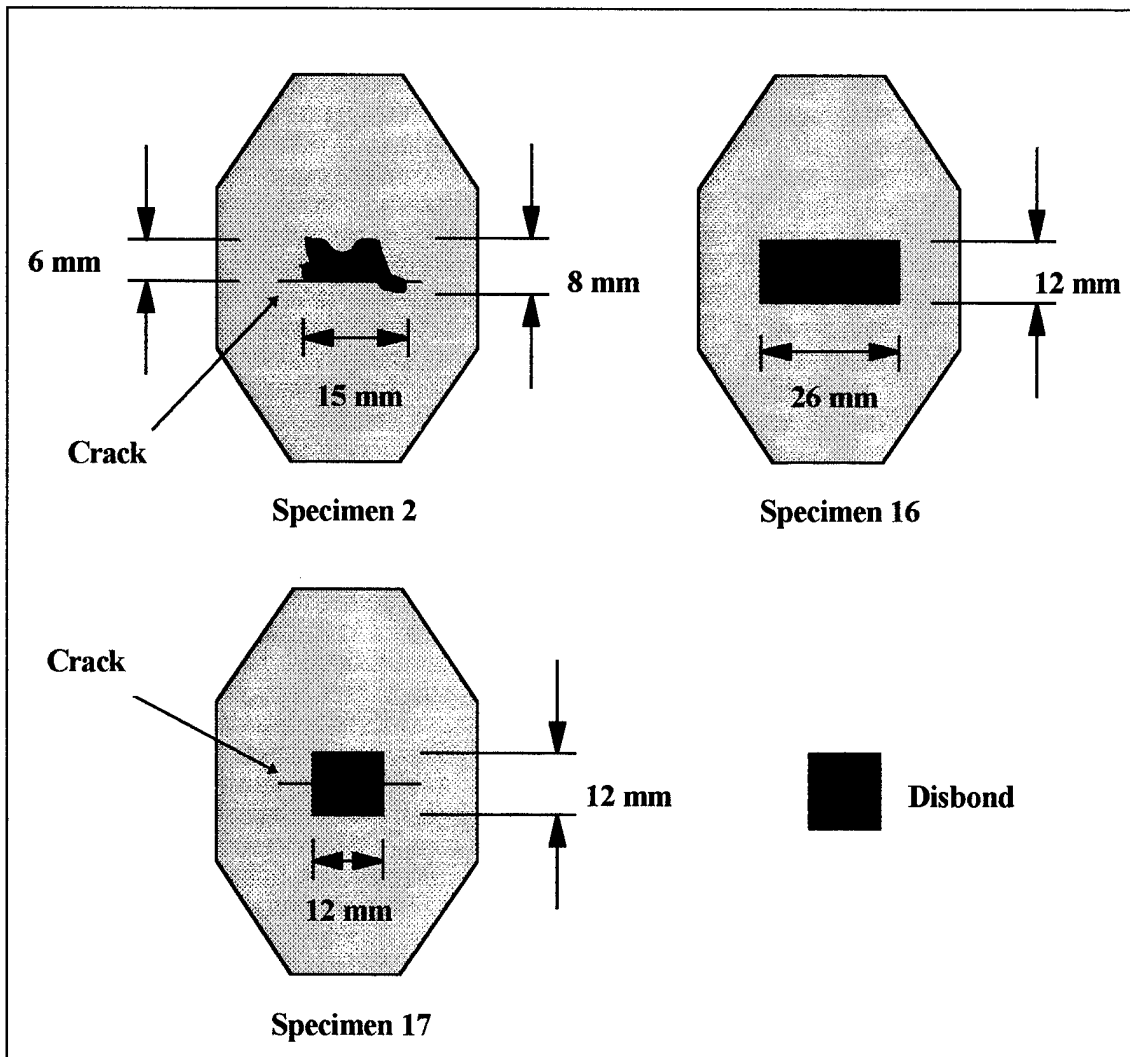
Figure 56. CD Configuration Dimensions

therefore, the disbond size shown in Table 19 is an estimate. This error was corrected for in the remaining specimens. The dimensions of the intentional disbonds along with the general shape and dimensions of the disbond in Specimen 2 are shown in Figure 56. The fatigue lives of these CD specimens along with the baseline and two CBP specimens are shown in Table 20. The fatigue life of Specimen 2 was 94 % of the CBP average of 119,320 cycles. Specimen 16 was 78 % of the CBP average and Specimen 17 was 98 %

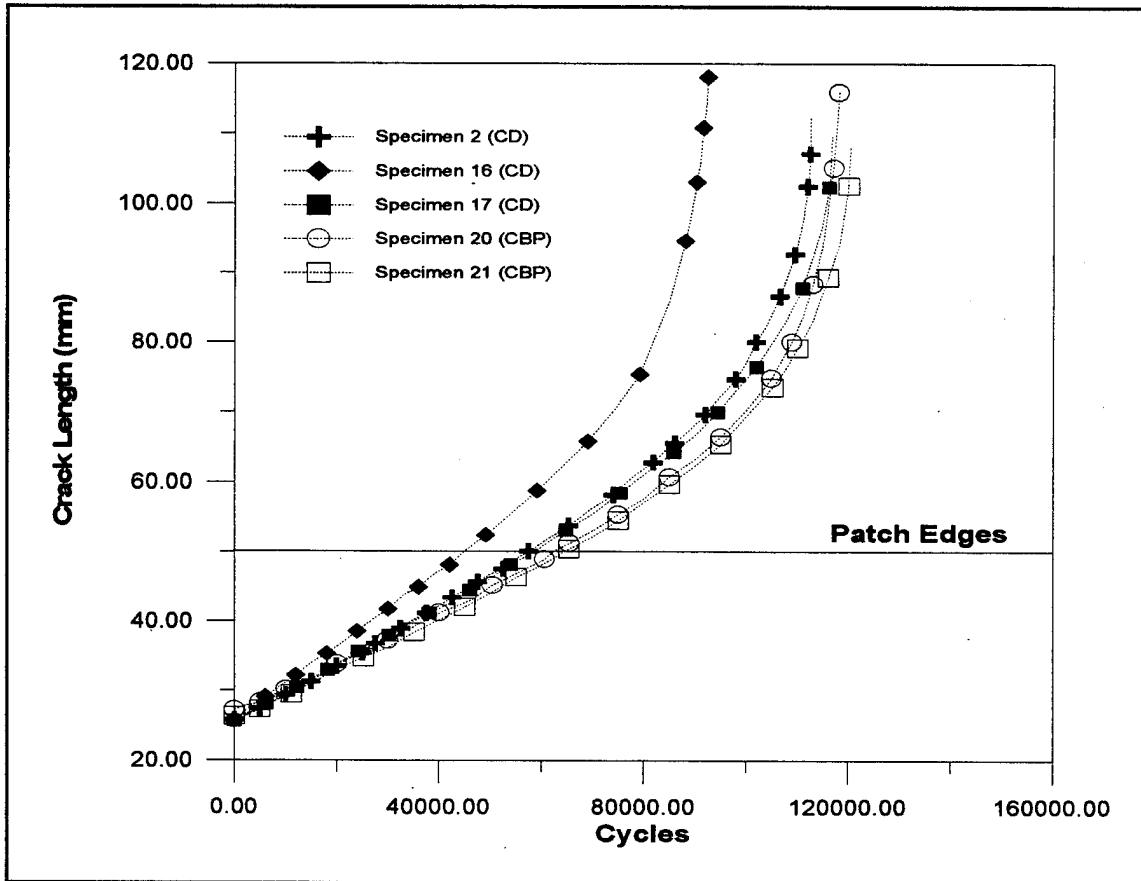
Figure 57. CD vs. CBP Crack Growth

Figure 57 shows the crack growth curves for the three CD configurations and the two CBP specimens. The crack growth rates were all constant within the patch repair. Crack growth outside the patch for the smaller CD cases, Specimen 2 and 17, followed a similar trend as the CBP specimens. This occurred because the majority of the crack was completely bonded and the cyclic disbonding had a greater opportunity to occur between the CD and the patch edges. The intentional center disbonds dominated the crack growth rate within the repair, however, outside the repair the crack growth rate was dominated by cyclic disbonding. The smaller disbonds allowed more cyclic disbonding around the crack faces during fatigue, that is why they possess the same parabolic trend as the CBP specimens outside the patch edges, i.e. the cyclic disbonding increased the repaired stress intensity factor range,  $\Delta K_R$ , which resulted in an increasing crack growth rate outside the patch. This cyclic disbonding is shown later. The average crack growth rates within the patch, based on the three-point least squares method (37), for the three CD specimens and the two CBP specimens are compared in Table 21. The crack growth rate of Specimen 2,
