## Fatigue Response of Cracked Aluminum Panel with Partially Bonded Composite Patch

THESIS

Jason J. Denney, Captain, USAF

DEPARTMENT OF THE AIR FORCE  
AIR UNIVERSITY  
**AIR FORCE INSTITUTE OF TECHNOLOGY**

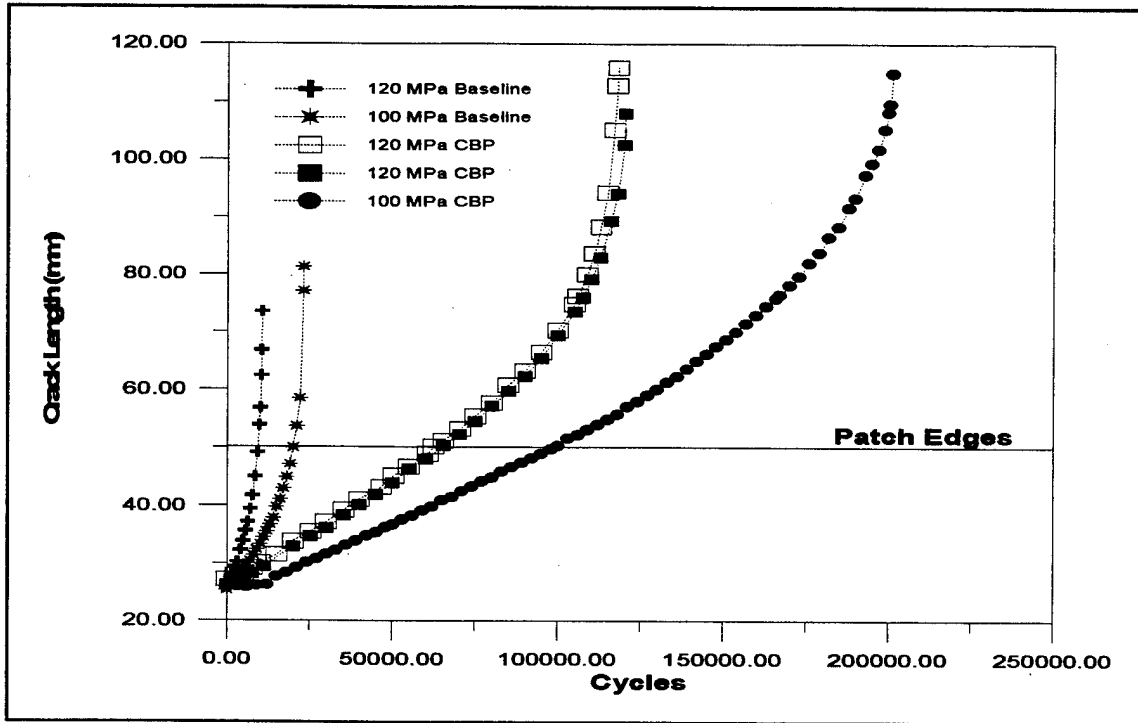
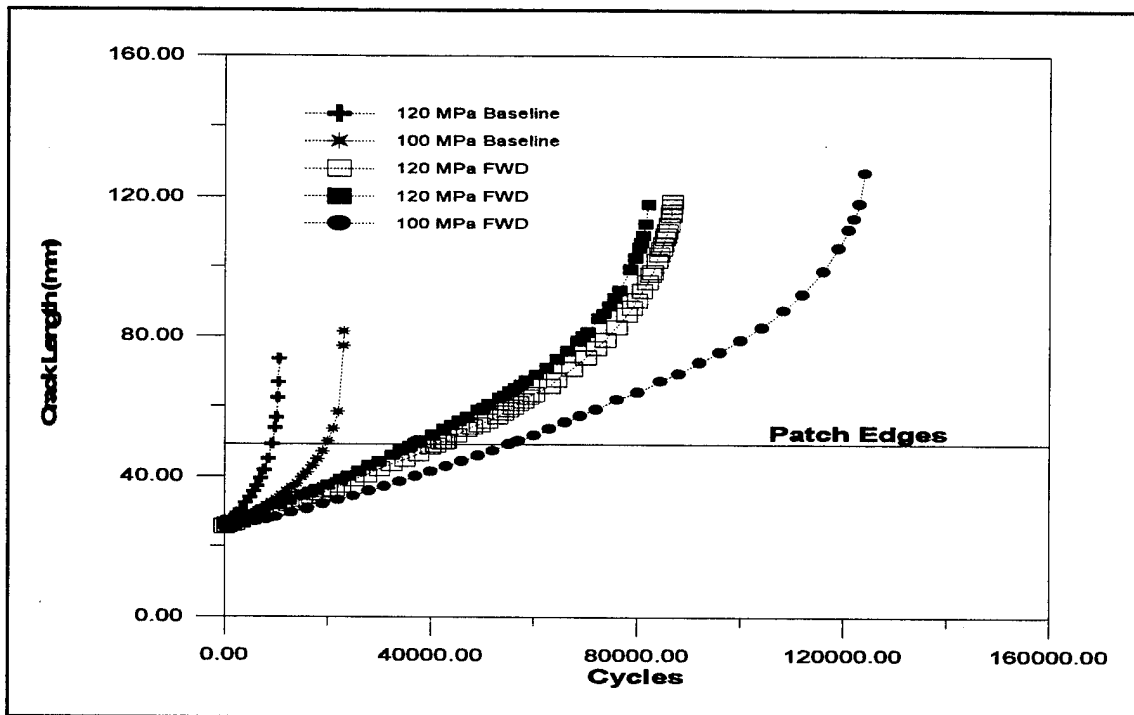
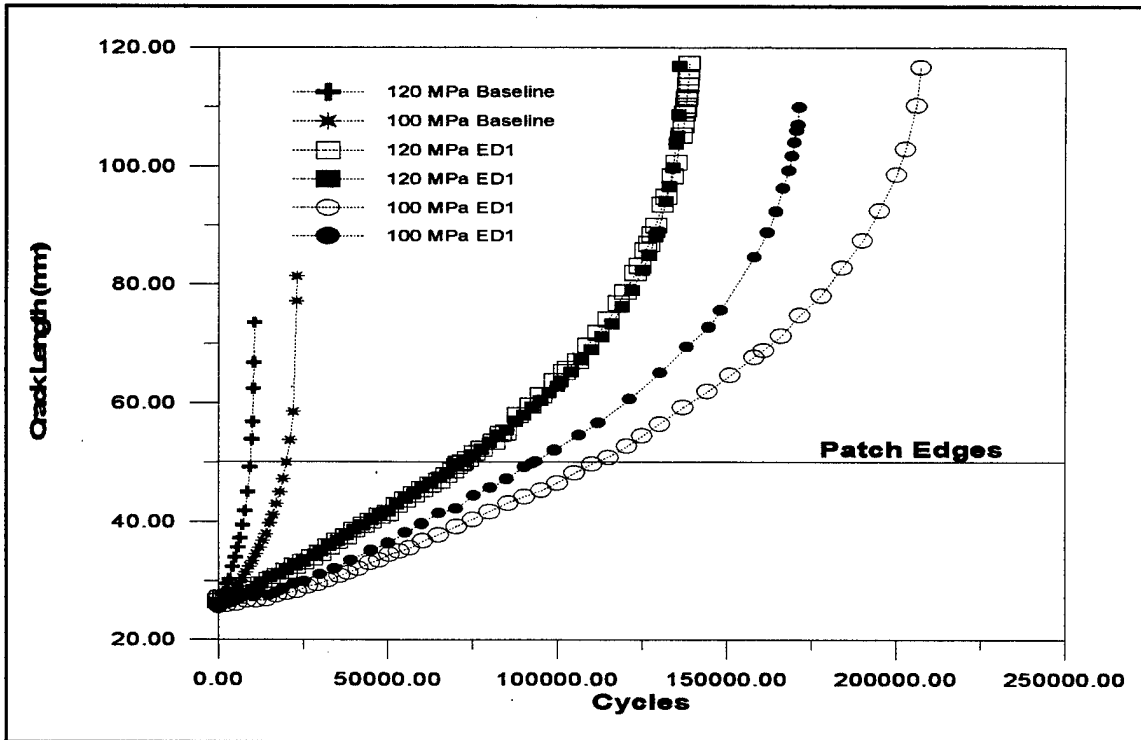
The crack length versus cycles curves for the CBP, FWD and ED1 specimens along with the baseline specimens ,with no patches, for both 100 and 120 MPa stress levels are shown in Figures 59, 60, and 61, respectively. Also, the corresponding crack growth rate versus crack length curves are shown in Figures 62, 63, and 64. It is evident from these figures that the crack growth rate was constant within the patch repair for all three configurations at both peak stress levels. Figure 62 shows that the 100 MPa CBP specimen crack growth rate remained constant long after the 120 MPa CBP specimen crack growth rates had shown an increasing trend. This behavior was the result of a lower repaired stress intensity factor in the 100 MPa CBP specimen, as well as, a resistance to cyclic disbonding caused by a smaller adhesive shear strain. The 100 MPa and 120 MPa FWD specimen crack growth rates exhibited similar trends at the same crack lengths as shown in Figure 63. In other words, the 100 MPa FWD crack growth rate did not remain constant beyond that of the 120 MPa FWD specimen because both stress level FWD specimens maintained the same pre-existing level of damage as compared to the CBP specimens which developed different levels of damage over time, resulting in different trends at the same crack length. As with the CBP specimens, the reduced crack growth rate of the 100 MPa ED1 specimens as compared to the 120 MPa ED1 specimens was the result of a lower repaired stress intensity factor and a resistance to cyclic disbonding. These characteristics will become clear upon evaluation of the C-SCANS.

Figure 59. 100 vs. 120 MPa Baseline and CBP Crack Growth

Figure 60. 100 vs. 120 MPa Baseline and FWD Crack Growth

Figure 61. 100 vs. 120 Baseline and ED1 Crack Growth

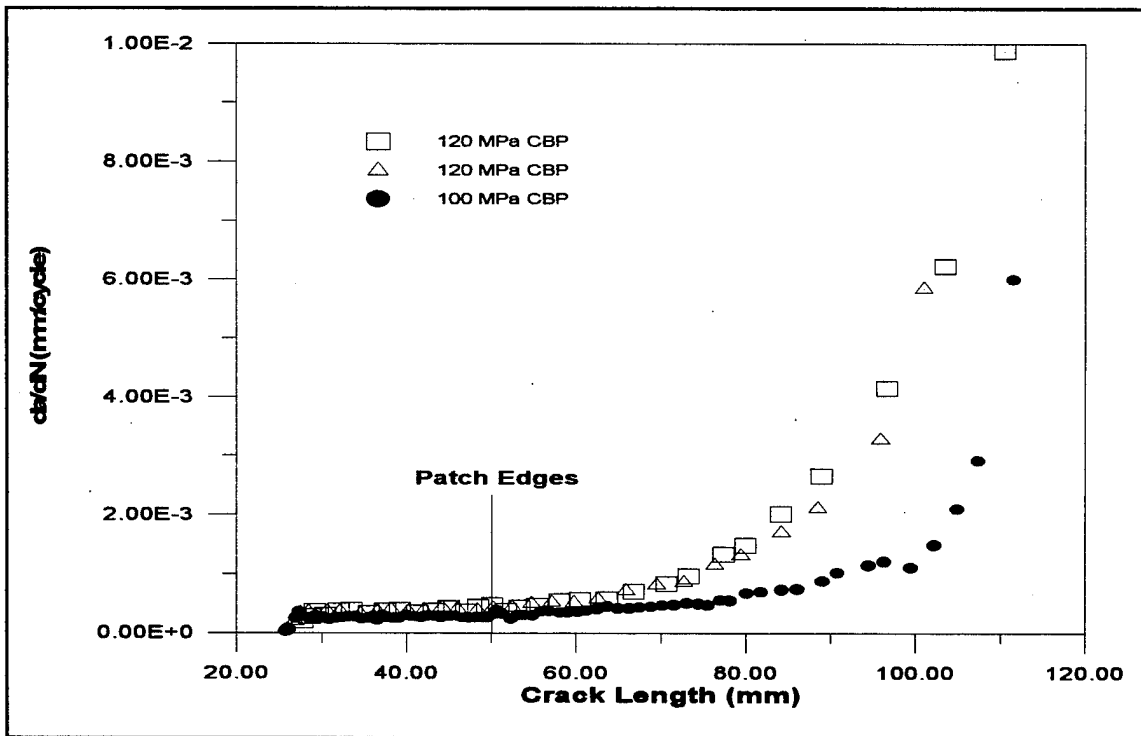
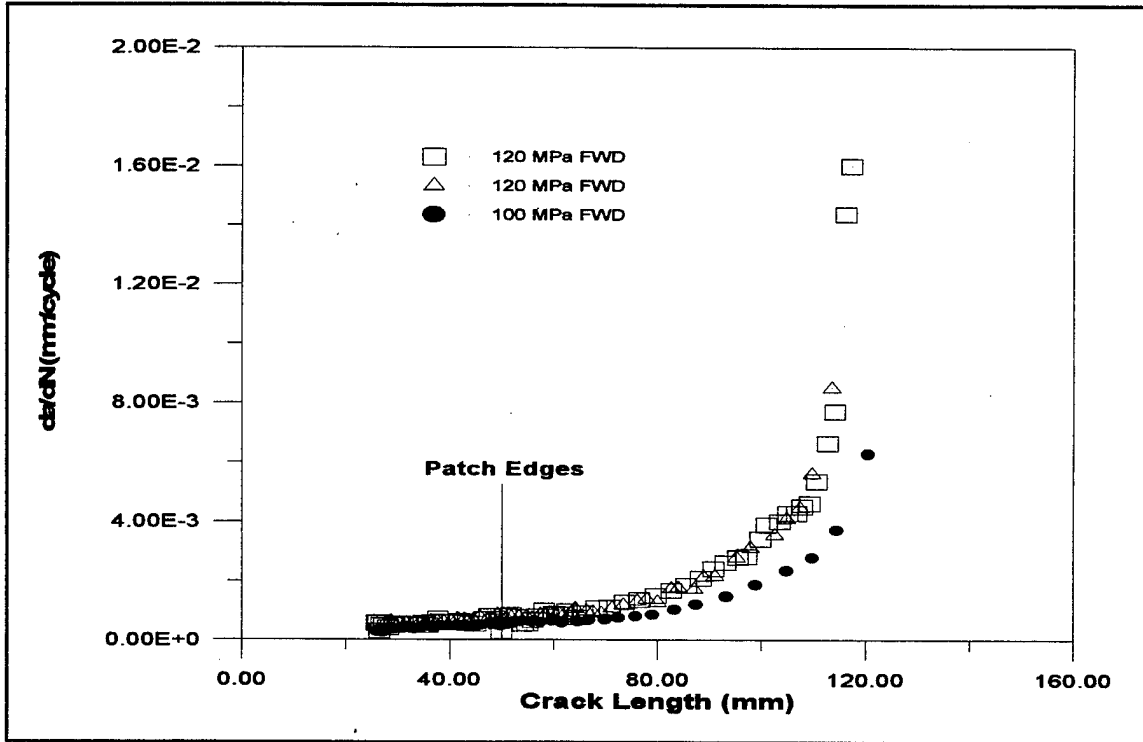
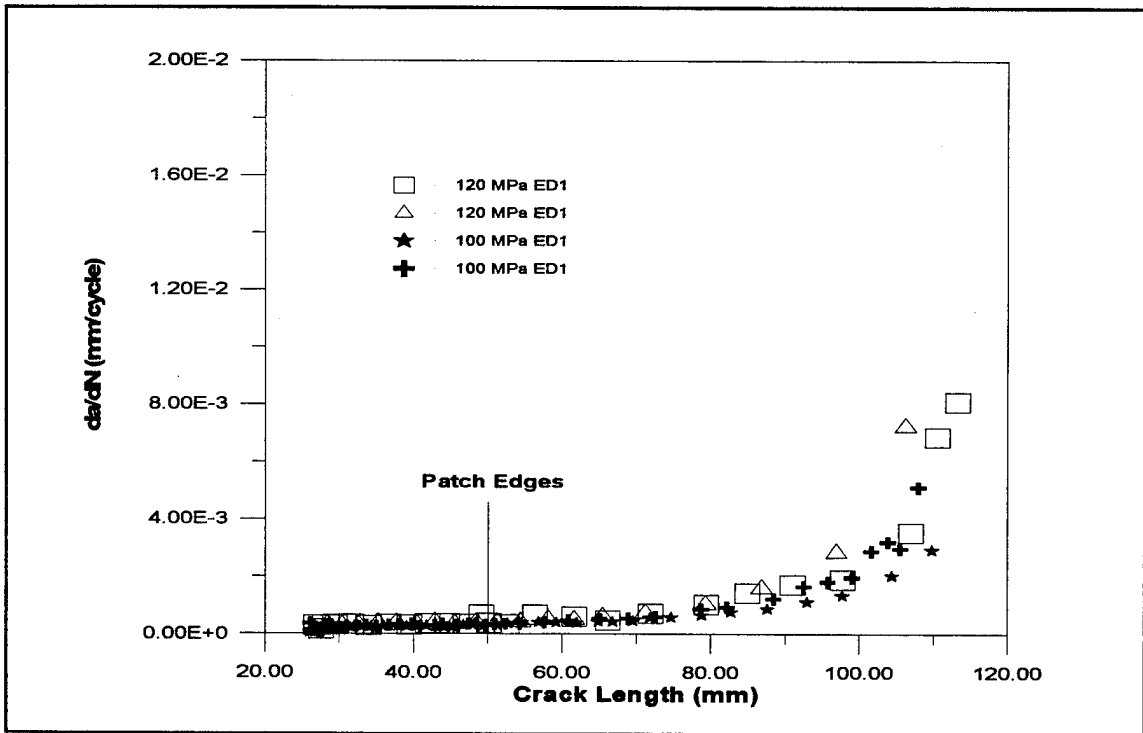
Figure 62.  $da/dN$  vs. Crack Length for 100 and 120 MPa CBP Specimens

Figure 63.  $da/dN$  vs. Crack Length for 100 and 120 MPa FWD Specimens

Figure 64.  $da/dN$  vs. Crack Length for 100 and 120 MPa ED1 Specimens

showed slight, but insignificant, cyclic disbonding. As a result, the crack growth rate,  $da/dN$ , was constant within the patch repair at both stress levels. The final C-SCAN corresponds to the point when the crack tips had exceeded the patch edges by approximately 12-13 mm on each side. At this point, Specimen 10 had just begun to show slight cyclic disbonding while Specimen 20 had suffered significant damage to its bondline, explaining the constant crack growth of Specimen 10 well beyond that of Specimen 20 outside the patch edges. The cyclic damage to Specimen 20's bondline increased the already greater repaired stress intensity factor resulting in the earlier increase in crack growth as compared to Specimen 10 for similar crack lengths as shown in Figure 62.

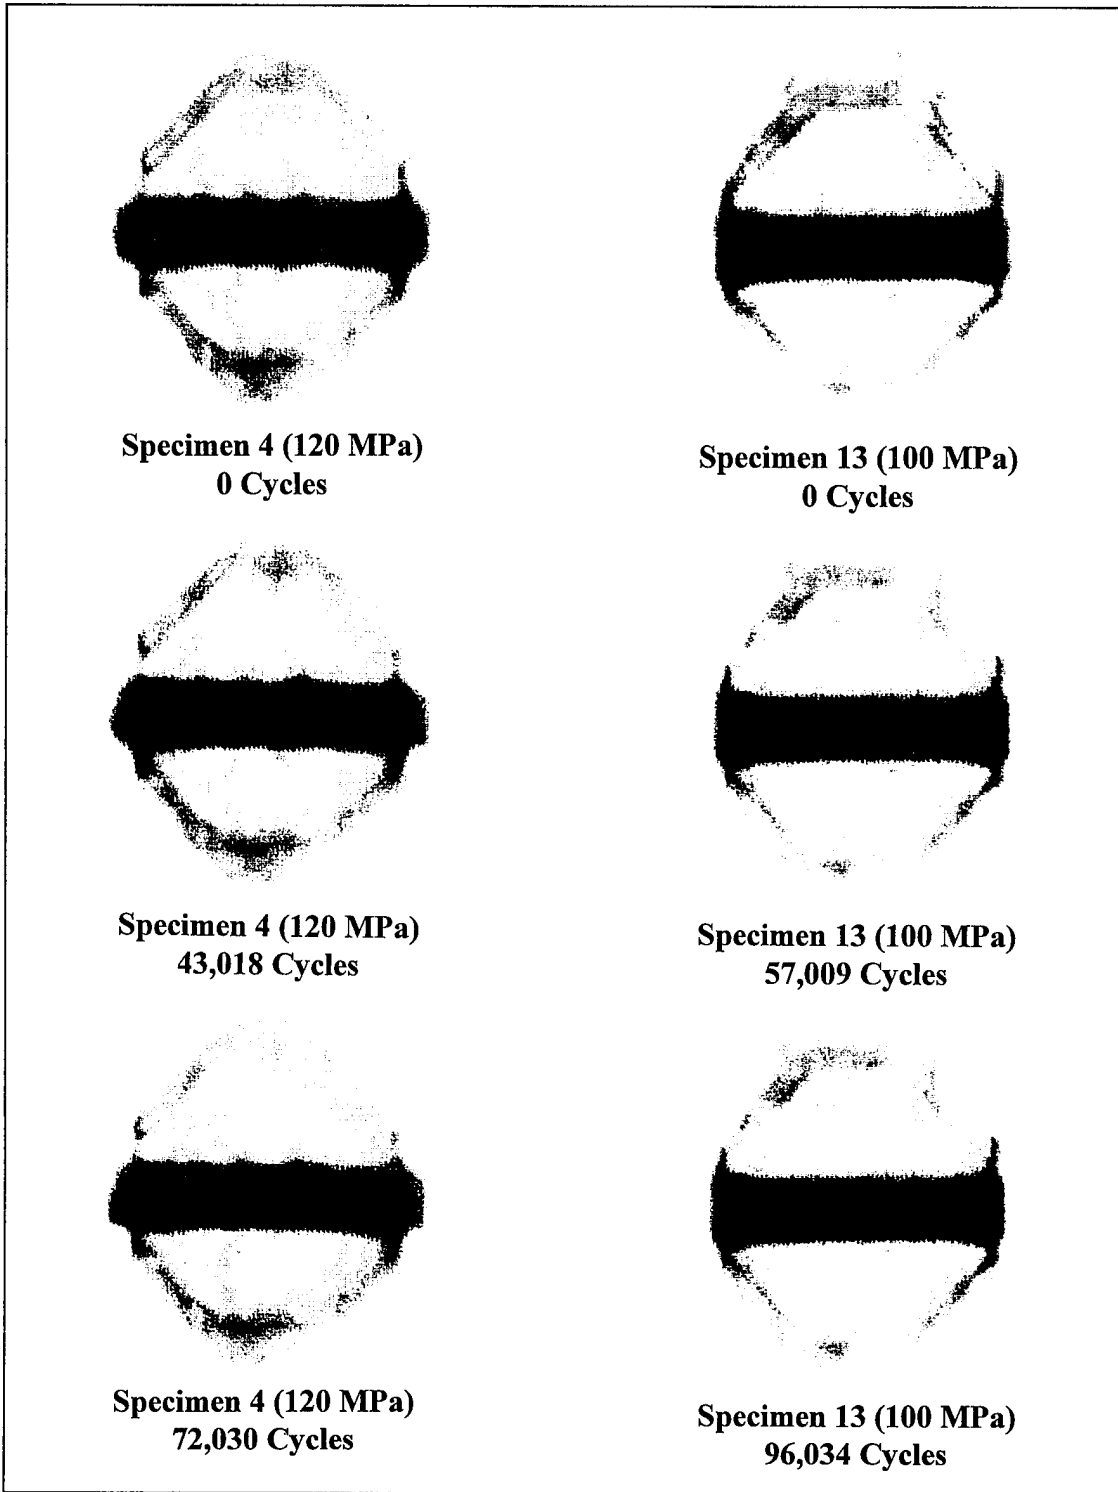
Figure 66. 100 vs. 120 MPa FWD C-SCANs

Figure 66 shows the C-SCANS for Specimen 4 and Specimen 13, tested at 120 MPa and 100 MPa, respectively. The bondline behavior of Specimen 5 (120 MPa) mirrored that of Specimen 4. The Specimen 4 C-SCANS are for 0, 43,018 and 72,030 cycles which correspond to crack lengths of 25.632 mm (1.00915 inches), 50.113 mm (1.97295 inches) and 76.68 mm (3.0189 inches). The Specimen 13 C-SCANS are for 0, 57,009 and 96,034 cycles which correspond to crack lengths of 25.796 mm (1.0156 inches), 50.219 mm (1.97715 inches) and 75.507 mm (2.9727 inches). As can be seen, none of the C-SCANS show growth of the original intentional disbond. This was consistent with Baker's (6) studies of intentional FWD specimens, as well as, the findings of Hart-Smith (22). This lack of disbond growth explains why the 100 MPa and 120 MPa specimen crack growth rates demonstrated similar trends at the same crack lengths, although not at the same rates.

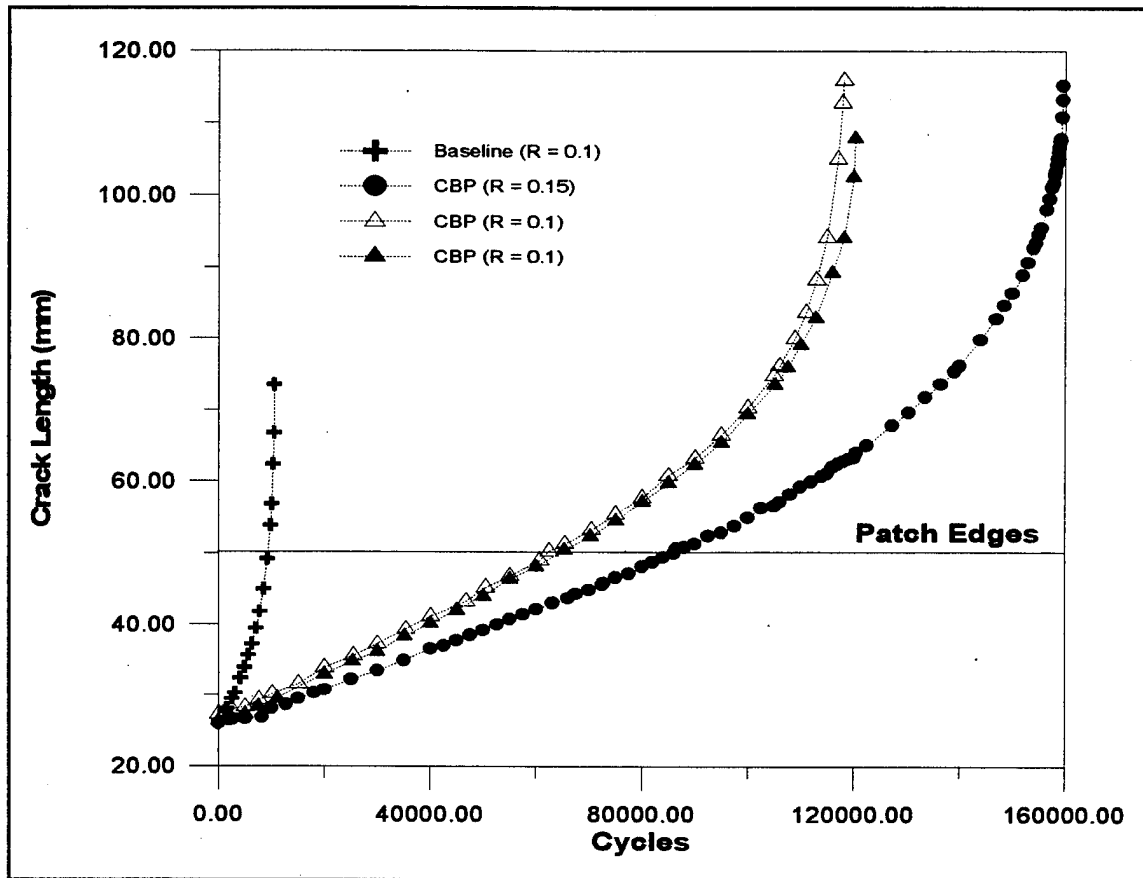
Figure 68. R = 0.15 vs. R = 0.1 Crack Growth

Figure 68 shows the crack length versus cycles curve for the  $R = 0.15$  CBP specimen, Specimen 3, and the  $R = 0.1$  baseline and CBP specimens. The crack growth rate for Specimen 3 was constant within the patch, once again indicating that the repaired stress intensity factor range,  $\Delta K_R$ , was constant. The crack growth rate changed from linear only when the crack tips had extended beyond the patch. This behavior is also

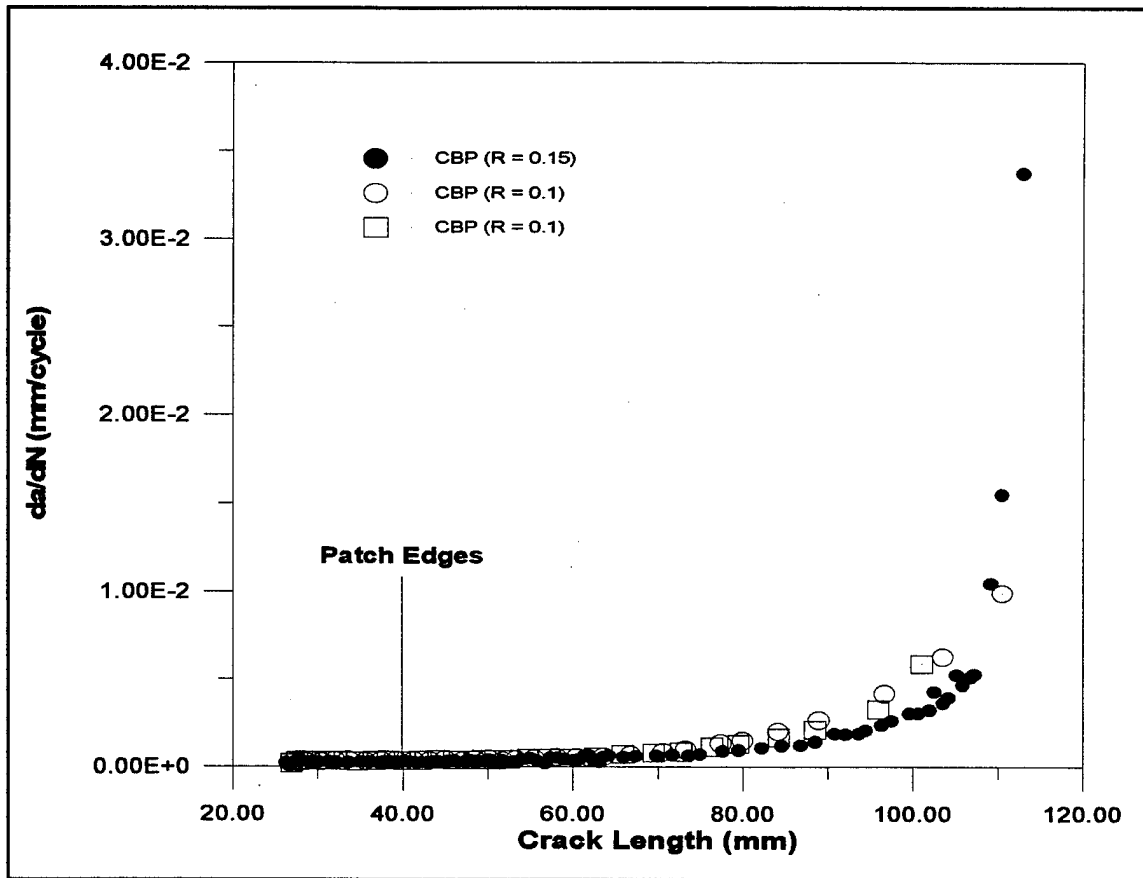
Figure 69. R = 0.15 da/dN vs. Crack Length

evident from Figure 69 using a three-point least squares method. For comparison purposes, the average crack growth rates within the patch, the repaired stress intensity factor range,  $\Delta K_R$ , and the maximum adhesive shear strain,  $\gamma_A^{\max}$ , are shown in Table 26.  $\Delta K_R$  and  $\gamma_A^{\max}$  were calculated using the Rose model. The values shown were calculated using the initial crack length of each specimen in Table 5. The repaired stress intensity factor range,  $\Delta K_R$ , for the R = 0.15 specimen was 6.2 % less than that for the R = 0.1 specimens. However, the maximum adhesive strain,  $\gamma_A^{\max}$ , for both stress ratio cases was the same because it is a function of the peak stress level and not R. On average, the crack

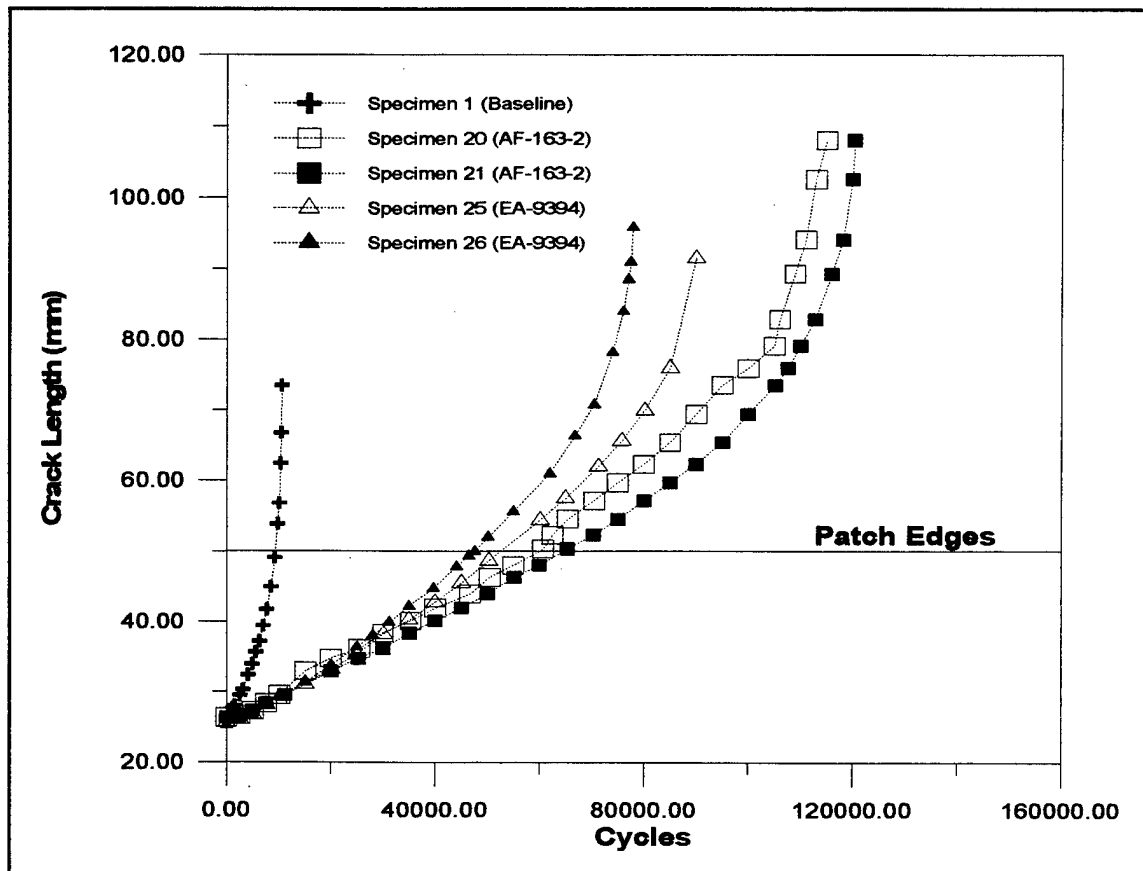
**Figure 71. EA-9394 vs. AF-163-2 Crack Growth**

Figure 71 shows the crack length versus cycles curve for the Baseline and the EA-9394 and AF-163-2 CBP specimens. As already presented, the two AF-163-2 specimens demonstrated constant crack growth within the patch repair, however, the EA-9394 specimens demonstrated a slight parabolic trend in crack growth within the patch. This indicated an increase in the repaired stress intensity factor range,  $\Delta K_R$ , with crack length. This decrease in patching efficiency was the result of significant cyclic disbonding during crack growth which is also evident by the increasing  $da/dN$  trend within the patch as shown in Figure 72. The increased level of inconsistency between the two EA-9394 specimens as compared to the two AF-163-2 specimens in Figure 71, may be due to inadequate mixing of the adhesive before application, more porosity in the bondline of one EA-9394 specimen as compared to the other, or nonuniformity of the bondline thickness.

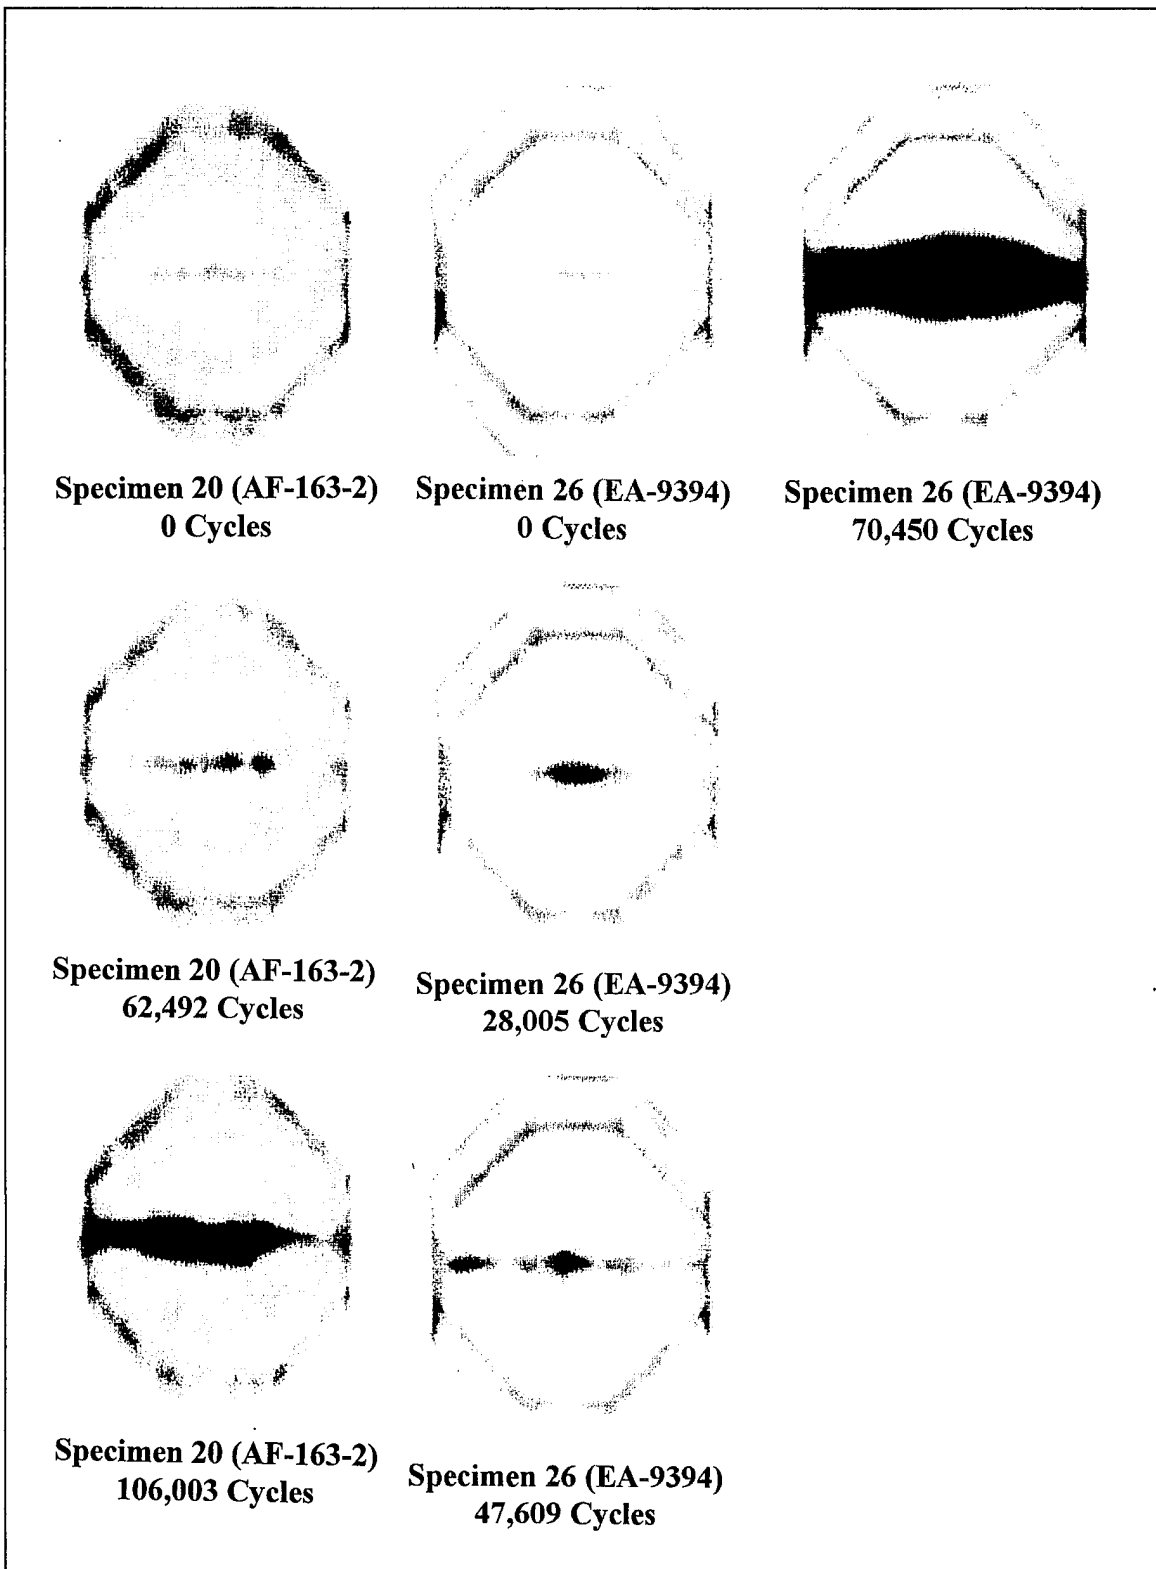
**Figure 73. EA-9394 vs. AF-163-2 C-SCANs**

Figure 73 shows the C-SCANS for Specimens 20 (AF-163-2) and 26 (EA-9394). The Specimen 20 C-SCANS are for 0, 62,492 and 106,003 cycles corresponding to crack lengths of 27.238 mm (1.07235 inches), 50.221 mm (1.9772 inches) and 76.221 mm (3.00045 inches). The Specimen 26 C-SCANS are for 0, 28,005, 47,609 and 70,450 cycles corresponding to crack lengths of 25.277 mm (0.99515 inches), 38.073 mm (1.49895 inches), 50.074 mm (1.9714 inches) and 70.793 mm (2.78715 inches). The most important feature of the EA-9394 C-SCANS, that was not present in any of the prior AF-163-2 specimen C-SCANS, is the significant amount of disbonding that occurred for

crack growth within the patch. This is evident from the 28,005 cycle C-SCAN and was due primarily to the adhesive maximum shear strain,  $\gamma_A^{\max}$ , exceeding its yield value around the crack. Disbond progression is evident for crack growth out to the patch edges (47,609 cycle C-SCAN), explaining the reduction in patching efficiency for crack growth within the repair. As with the AF-163-2 specimens, disbonding was more prevalent for crack growth outside the repair (70,450 cycle C-SCAN), however, the level of disbonding for the EA-9394 adhesive far exceeded that of any specimen employing the toughened AF-163-2 film adhesive. Again this was due to the adhesive exceeding its yield strain.

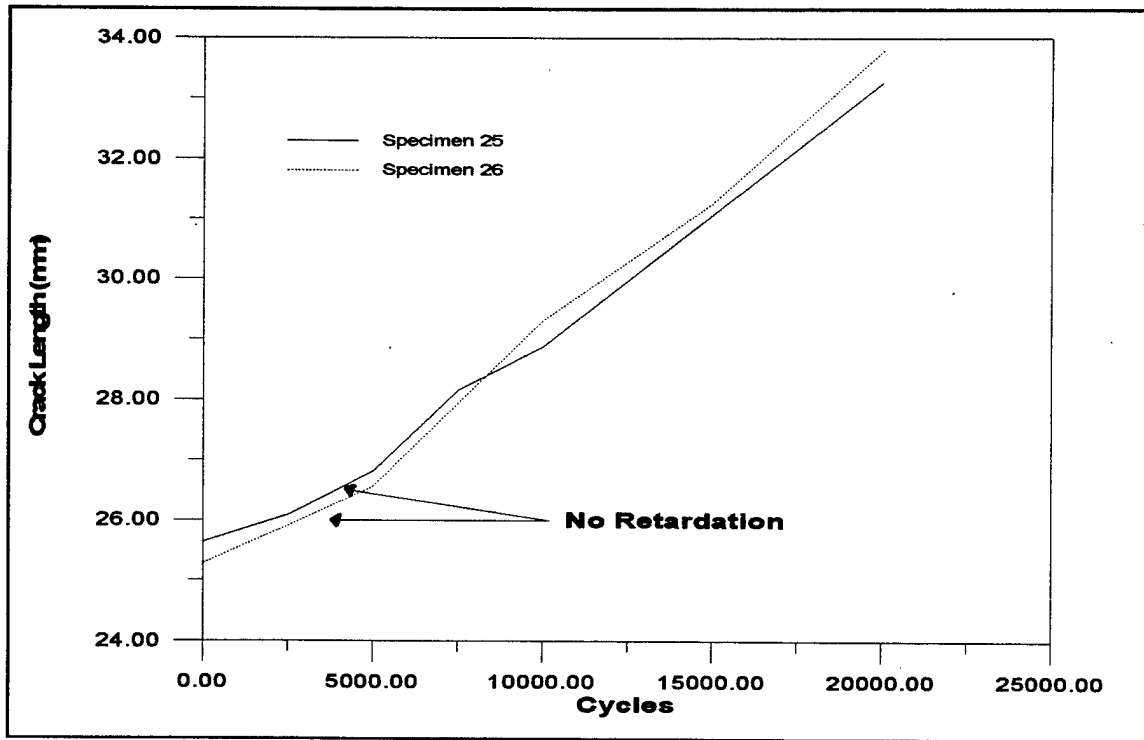
Figure 74. EA-9394 Retardation of Crack Growth

Similar to the AF-163-2 specimens, the EA-9394 specimens did not demonstrate any retardation of crack growth before re-initiation as shown in Figure 74. Again, this was the result of using a high cure temperature, 93 °C, during the bonding process which annealed out the beneficial compressive stresses in the crack tip plastic zone. This agrees with Baker's (8) findings for cure temperatures above 80 °C. If a room temperature cure had been employed, retardation may have been present.

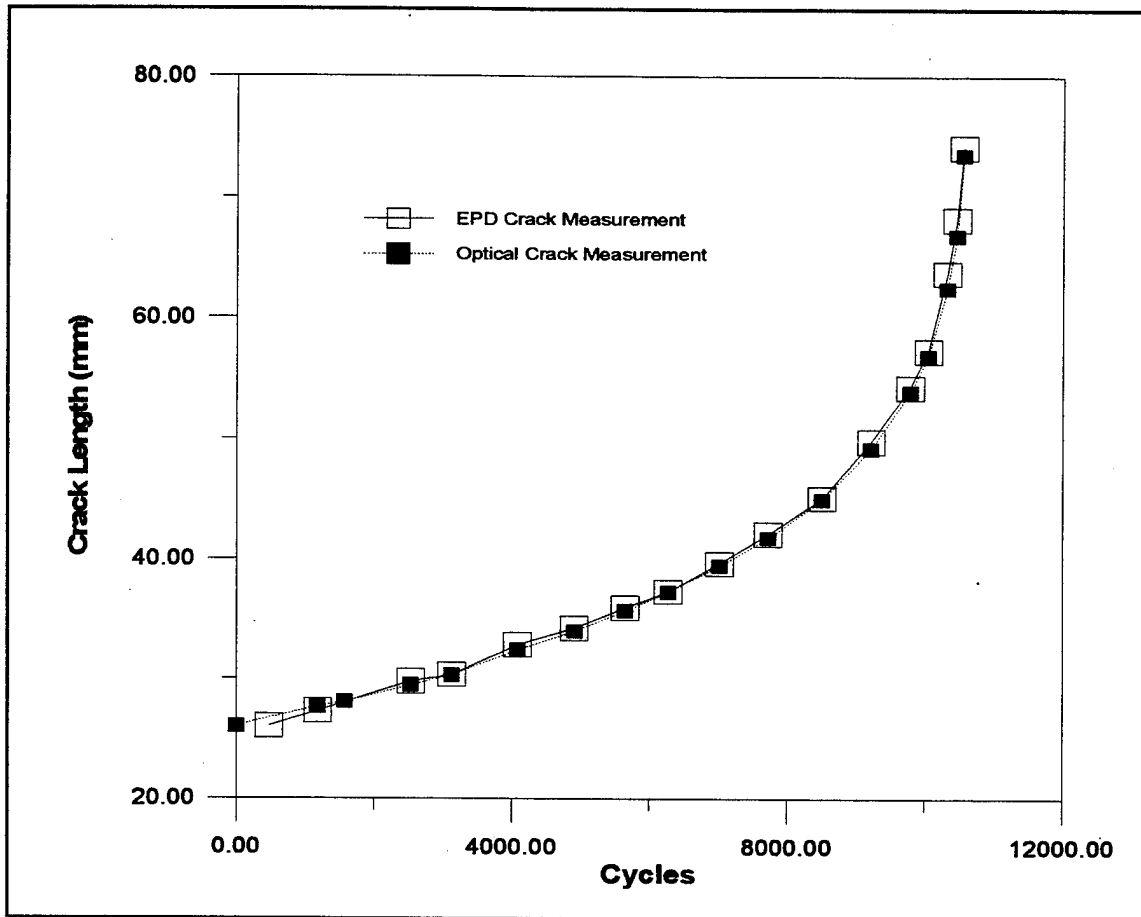
**Figure 75. Unpatched EPD vs. Optical Crack Measurements**

Before implementation of the EPD system with patched specimens, a series of tests were conducted to evaluate the accuracy of the system. As can be seen from Figure 75, the EPD prediction of crack growth, for unpatched panels, were in agreement with the optical measurements using a traveling microscope. Unfortunately, EPD was not successful with the patched panels investigated in this effort. Figures 76, 77, and 78 show EPD versus optical crack measurements for the first 30,000 - 40,000 cycles of Specimens 5, 7 and 9. All these figures demonstrate the same trend. The EPD system was measuring an increase in crack length, however, at a significantly reduced rate. The reference crack length,  $a_r$ , was updated at each optical measurement to see if the same trend occurred at different crack lengths. The repeated trend is evident in Figures 76, 77, and 78. The only possible explanation for this repeated growth trend at different crack lengths was due to contact of the fracture surface which caused a shortening of the electric voltage. In other words, a slightly greater crack opening displacement occurred on the unpatched side of

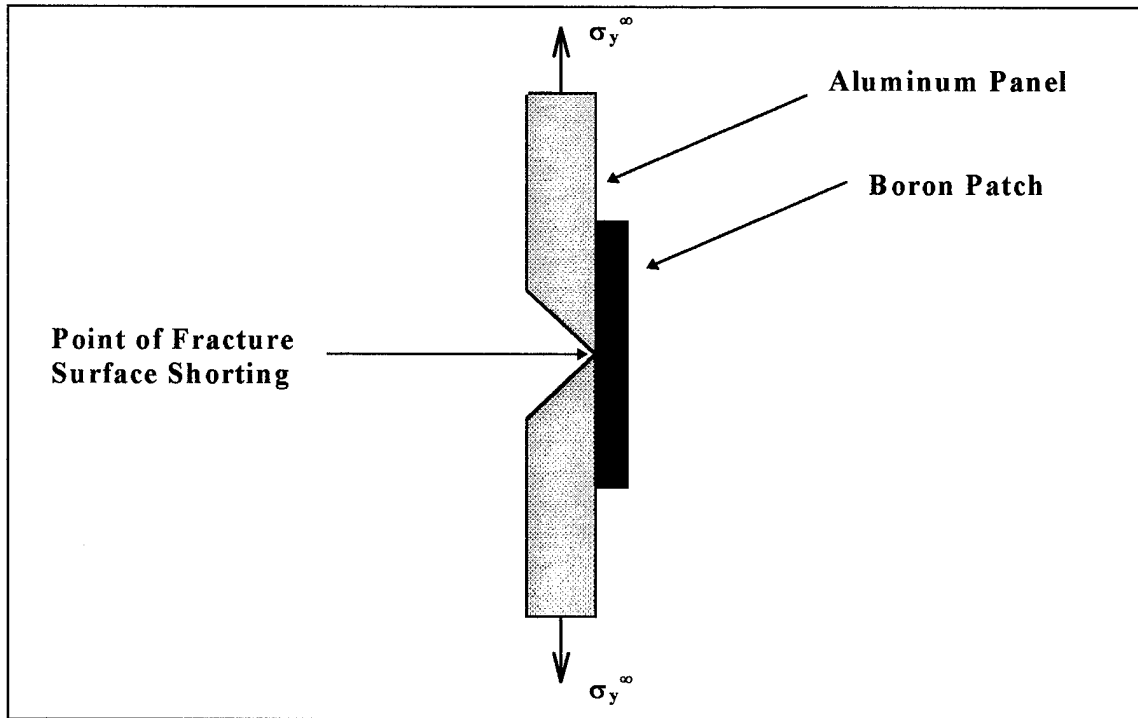
Figure 79. EPD Shorting

the aluminum panel, with the patched side possessing enough of a closure force to disallow the adequate formation of the insulating oxide film. As a result, an electrical short was created giving a under-estimation of the physical fatigue crack size. This phenomenon is illustrated in Figure 79. As a result, patched panel crack growth measurement was accomplished optically using the traveling microscope.

method was unsuccessful as an automated crack measurement tool due to electric shortening of the fracture surface in single-sided patched panels.

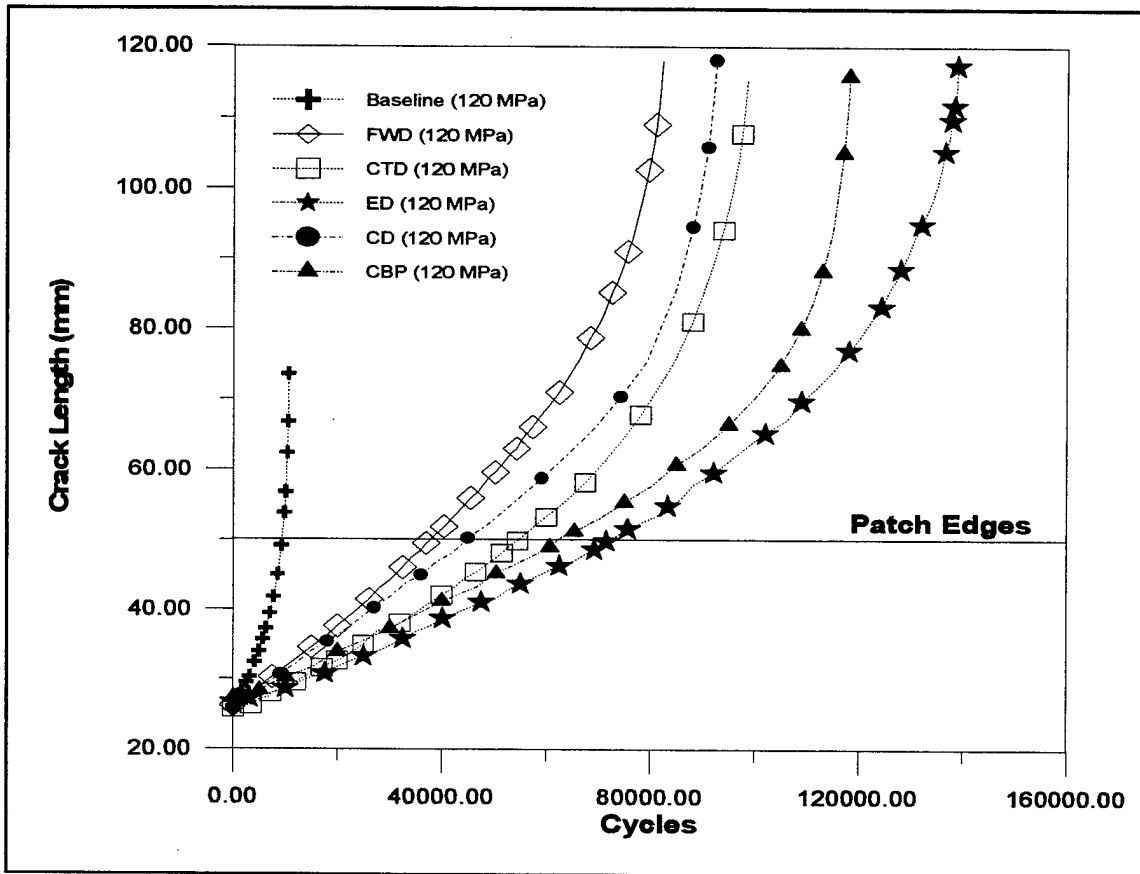
Figure 80. Summary of Disbond Location Effects

As shown above, patching efficiency is definitely dependent on disbond location, disbond size, peak stress level, stress ratio, and the adhesive. Figure 80 shows the comparison of typical crack growth curves for the five general disbond configurations

(Figure 3) investigated in this study. All these crack growth curves are at a maximum stress level of 120 MPa. The baseline configuration without a patch only has a life of 10,633 cycles. As previously discussed, a disbond covering the crack during the crack

growth within the patch (FWD, CD and CTD) resulted in a reduction of patching efficiency as compared to a completely bonded patch (CBP). Again, the full width disbond (FWD) configuration which displaced the point of load transfer from the plate to the patch away from the crack faces (Figure 32) as well as completely covering the crack with a disbond during crack growth was the worst case studied among all disbond cases, resulting in a crack growth rate within the patch that was 1.65 times that of a completely bonded patch. The crack tip disbond (CTD) and center disbond (CD) configurations, although not as severe as the FWD configuration, also had disbonds over portions of the crack that displaced the point of load transfer. The CTD and CD configurations produced crack growth rates that were 1.16 and 1.47 times that of the completely bonded patch. The CD configuration was less efficient than the CTD configuration because a larger portion of the crack was covered by a disbond during crack growth within the patch.

The end disbond (ED) configurations actually improved patching efficiency over the CBP configuration by making the patch shorter which attracted less parasitic load. However, with a thicker and higher stressed patch and panel, end disbond growth may occur due to greater peel forces as a result of secondary bending. This may cause disbond growth leading to a corresponding reduction in patching efficiency. Also, varying disbond size around the crack in both the x and y-directions (Figure 52), although not as noticeable effect as varying disbond location, resulted in a reduced patching efficiency with increased disbond size (Figure 54 and 56). For example, increasing the disbond size for both the FWD and CD configurations from only 5 % to 10 % of the total bond area resulted in an additional 28 % increase in the crack growth rate. Finally, the pre-existing disbonds in the

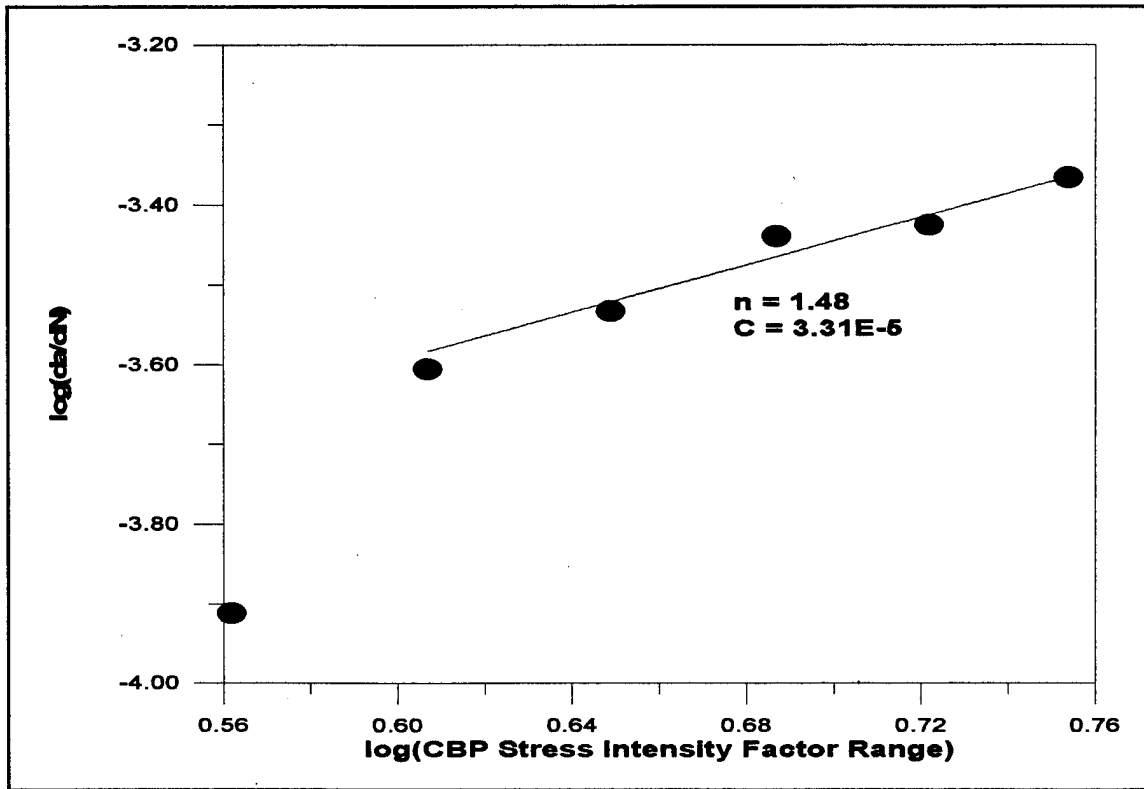
Figure 81.  $\text{Log}(da/dN)$  versus  $\text{Log}(\Delta K_{CBP})$

The parameters,  $C$  and  $n$ , are obtained from a  $\log(da/dN)$  versus  $\log(\Delta K_{\text{CBP}})$  plot from the crack growth data within a completely bonded patch. Specimen 19 (CBP) fatigued at 90, 110, 130, and 140 MPa, Specimen 10 (CBP) fatigued at 100 MPa, and Specimen 20 (CBP) and 21 (CBP) fatigued at 120 MPa produced the  $\log(da/dN)$  versus  $\log(\Delta K_{\text{CBP}})$  relationship as shown in Figure 81. From a linear curve fit of the 100, 110, 120, 130, and 140 MPa data points,  $C$  and  $n$ , for a completely bonded patch, are  $3.31 \times 10^{-5}$  and 1.48. This value of  $n$  is within the range (1.16-2.7) presented in Chapter 4. The 90

MPa data point in Figure 81 was not used to determine the parameters  $C$  and  $n$  because it was not in agreement with the other data points, probably due to scatter or due to the 90 MPa point being on the lower end of the sigmoidal  $\text{log}(da/dN)$  versus  $\text{log}(\Delta K_{CBP})$  curve.

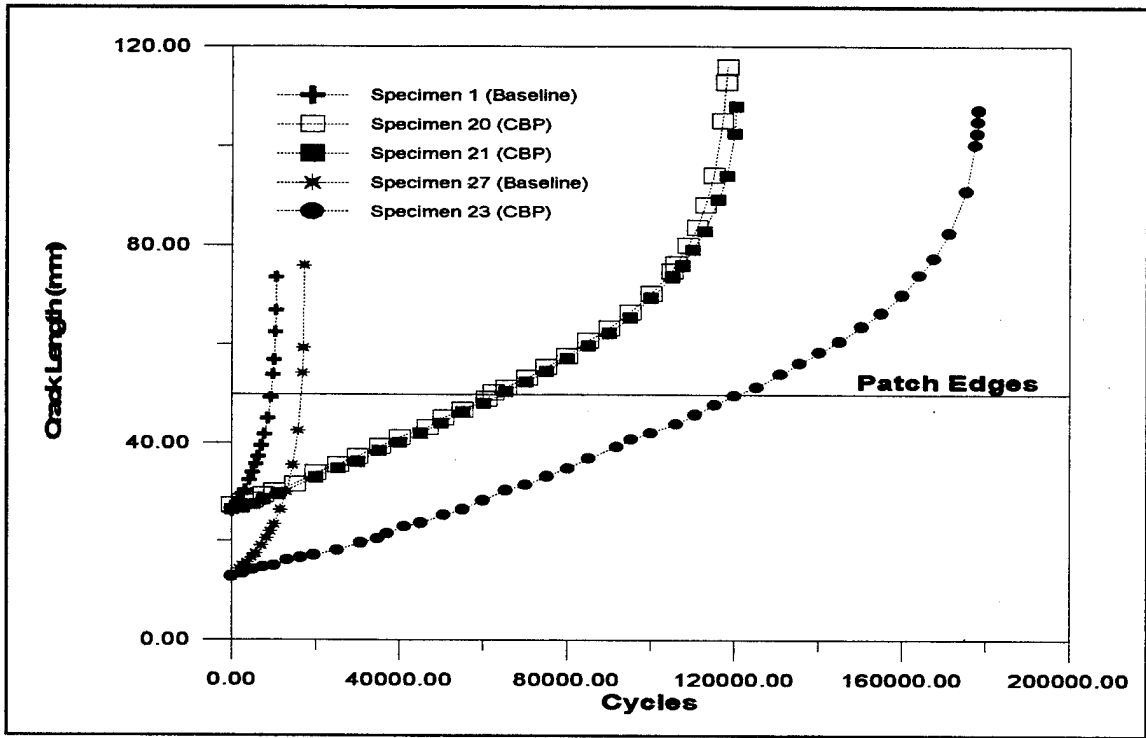
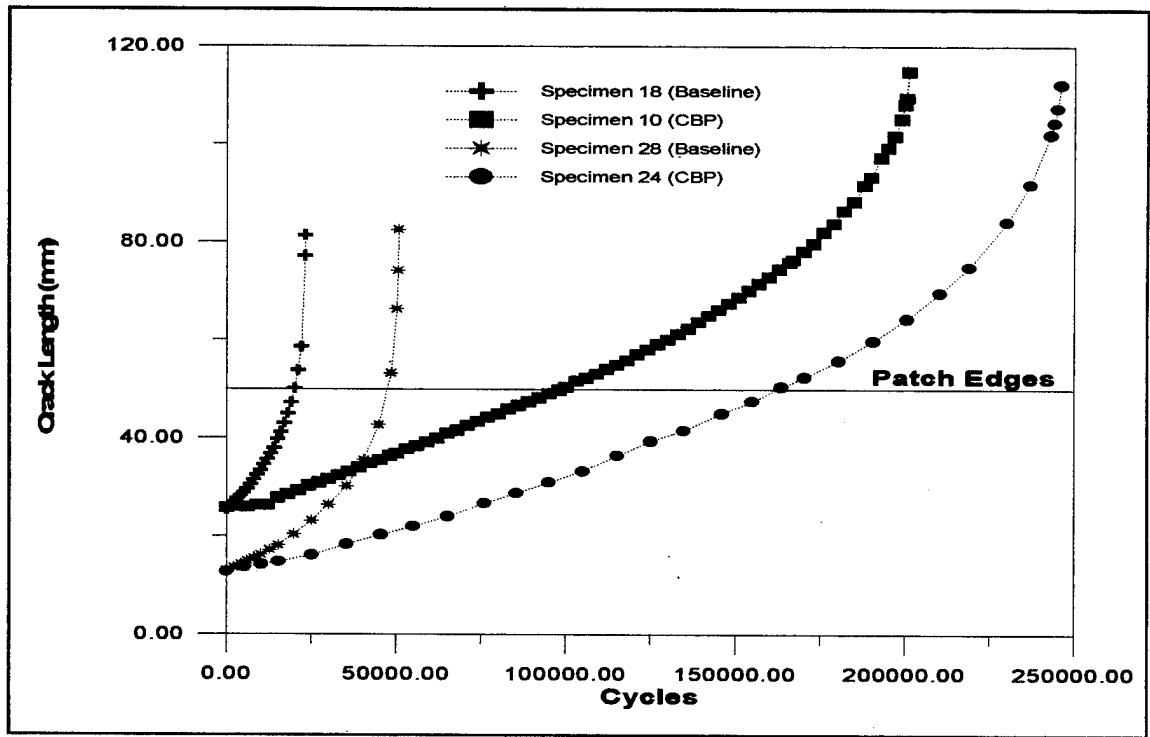
Figures 88 and 89 show the crack length versus cycles curves for the 120 MPa and 100 MPa tests for the varying initial crack lengths. As can be seen from these figures, the repaired crack growth rates for both initial crack lengths were similar within the patch, again supporting Baker's claim that patching efficiency is independent of crack length. The average crack growth rates within the patch are shown in Table 37. There was a greater reduction in repaired crack growth rate over the unrepaired crack growth rate for longer crack lengths which was expected because  $da/dN$  is dependent on  $\Delta K$  in

Figure 88. 120 MPa Crack Growth with Different Initial Crack Lengths

Figure 89. 100 MPa Crack Growth with Different Initial Crack Lengths
