## Fatigue Response of Cracked Aluminum Panel with Partially Bonded Composite Patch

THESIS

Jason J. Denney, Captain, USAF

DEPARTMENT OF THE AIR FORCE  
AIR UNIVERSITY  
**AIR FORCE INSTITUTE OF TECHNOLOGY**

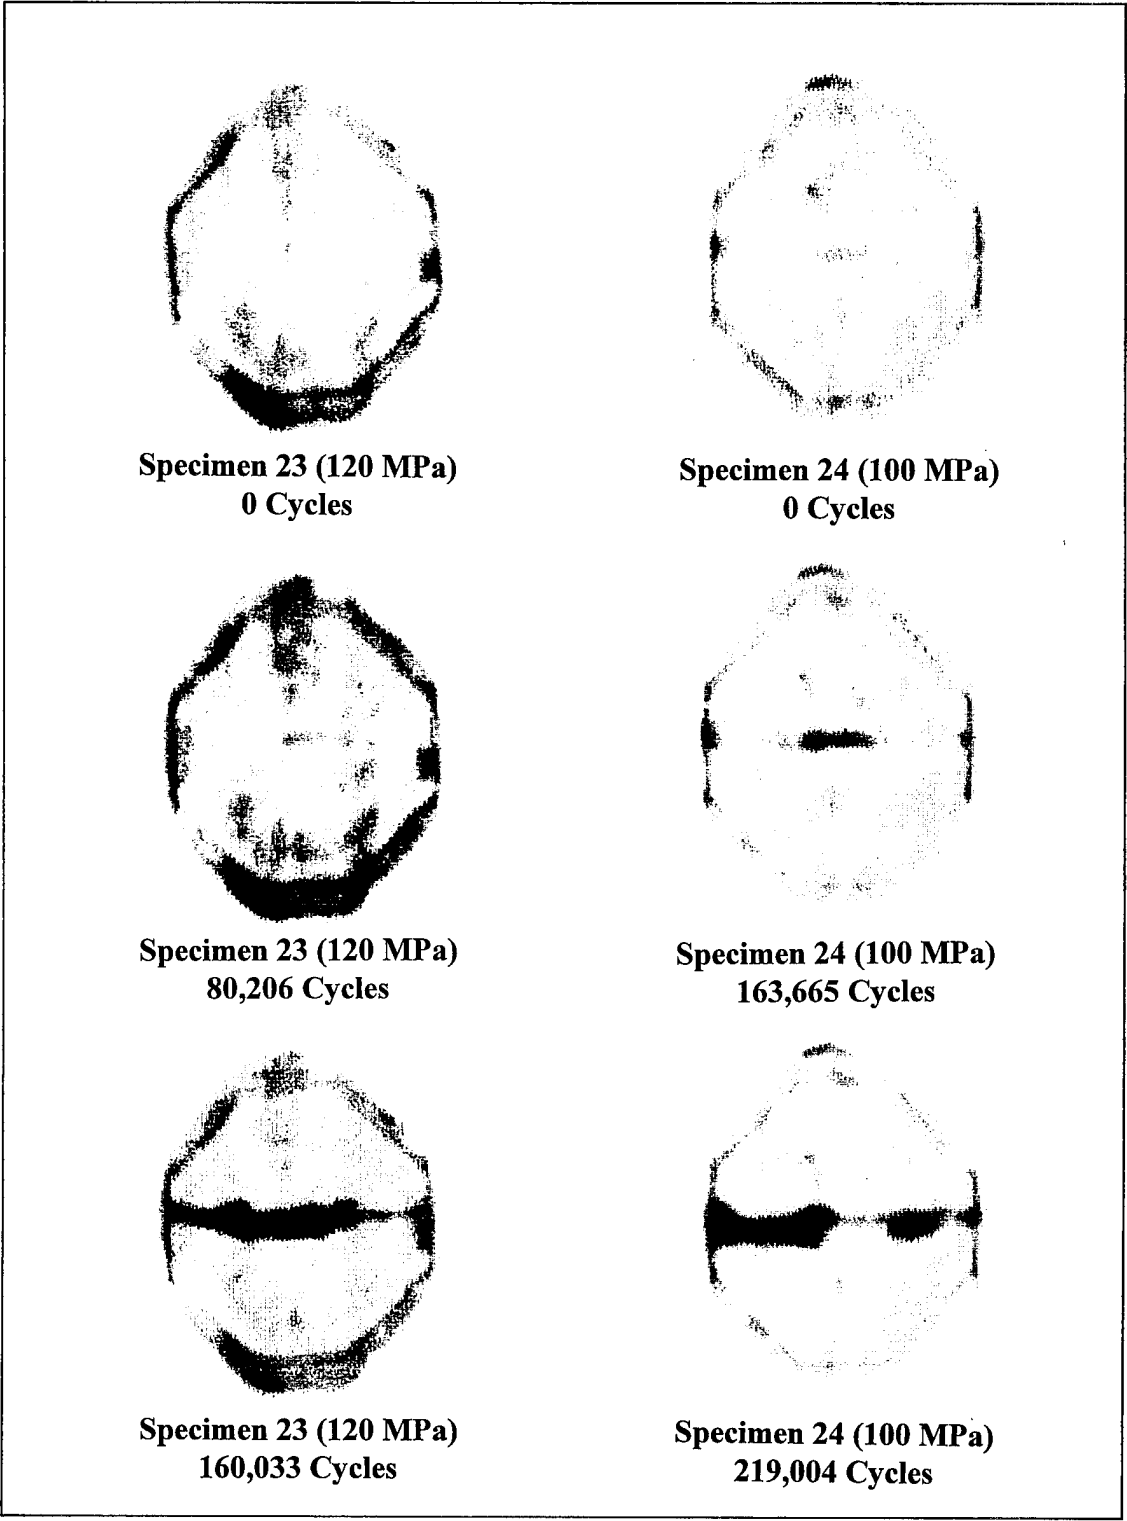
Figure 90. Specimen 23 and 24 C-SCANs

The bondline performance for the two shorter crack specimens was similar to that of the longer crack length specimens at both stress levels, i.e. insignificant cyclic disbonding during crack growth within the patch and increasing damage for crack growth outside the patch. Figure 90 shows the C-SCANs for Specimen 23 (120 MPa) and Specimen 24 (100 MPa). The Specimen 23 C-SCANs are for 0, 80,206 and 160,033 cycles corresponding to crack lengths of 12.865 mm (0.5065 inch), 34.831 mm (1.3713 inches) and 69.955 mm (2.75415 inches). The crack tips were still within the patch in the 80,206 cycle C-SCAN, therefore, very slight cyclic disbonding was observed with much higher levels of disbonding for crack growth outside the patch (160, 033 cycle C-SCAN). The 100 MPa CBP specimen (Specimen 24) C-SCANs revealed an interesting comparison to Specimen 10 (Figure 65) which was also fatigued at 100 MPa, however, Specimen 10's repair was applied to a longer initial crack length. For similar crack lengths, Specimen 24, starting with an initial crack approximately one-half the size of Specimen 10, demonstrated greater levels of cyclic disbonding for similar crack lengths. This was evident from the second and third C-SCANs for Specimen 24. This behavior occurred because Specimen 24, fatigued at the same stress level as Specimen 10, took significantly more cycles to reach the same crack lengths as a result of starting with a smaller initial crack length. Therefore, it can be concluded that cyclic disbonding is also a function of the number of cycles experienced in addition to peak stress level, stress ratio, and the adhesive shear modulus.
