Whole Life Carbon Impact of

45 Timber Buildings

Andersen, C. M. E., Garnow, A., Sørensen, C. G., Wittchen, A., Stranddorf, L. K., Hoxha, E., Rasmussen, F. N., & Birgisdottir, H. (2023). *Whole Life Carbon Impact of: 45 Timber Buildings*. (1 ed.) Institut for Byggeri, By og Miljø (BUILD), Aalborg Universitet. BUILD Rapport Vol. 2023 No. 10

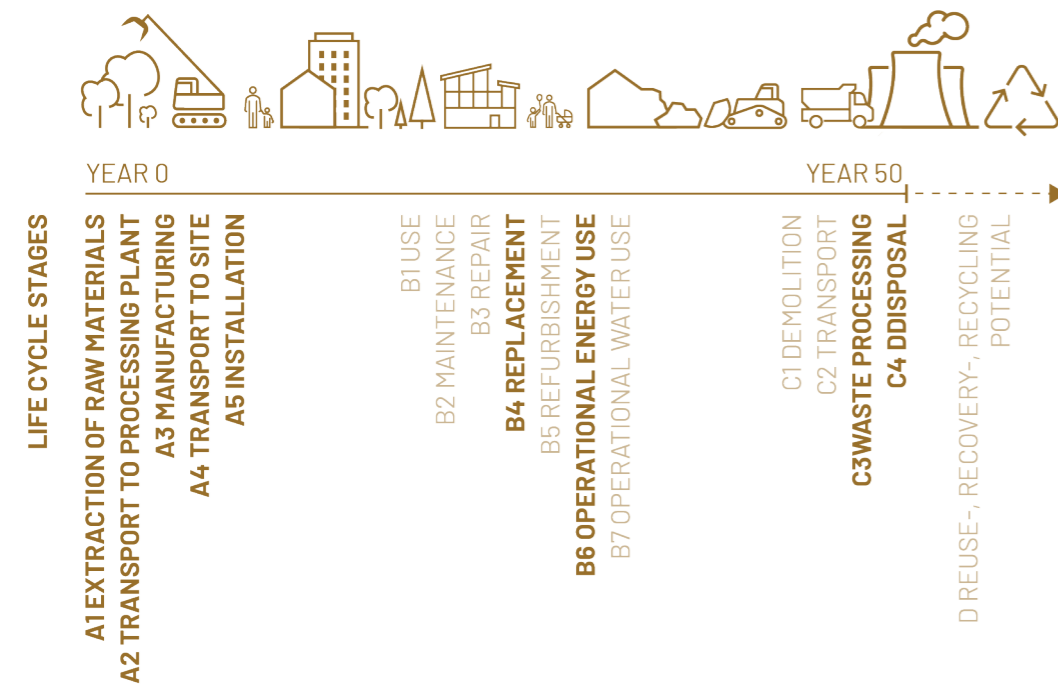
Figure 5. Life cycle stages included in the building case studies

The overall life cycle stages of buildings comprise the stages: Product (A1-A3), Construction Process (A4-A5), Use (B1-B7), End of Life (C1-C4), and Beyond Life Cycle (D), of which the marked life-cycle stages are included in the LCAs of building case studies.

This study includes the life-cycle stages of manufacture and transport of building materials (A1-3), transport to building site and construction process (A4-5), replacement of building parts (B4), operational use of energy (B6), and end-of-life waste disposal (C3-4). Figure 5 illustrates all the modules covered by EN 15798 (CEN, 2012) and indicates the modules included in this study (Andersen et al., 2021, p.16).

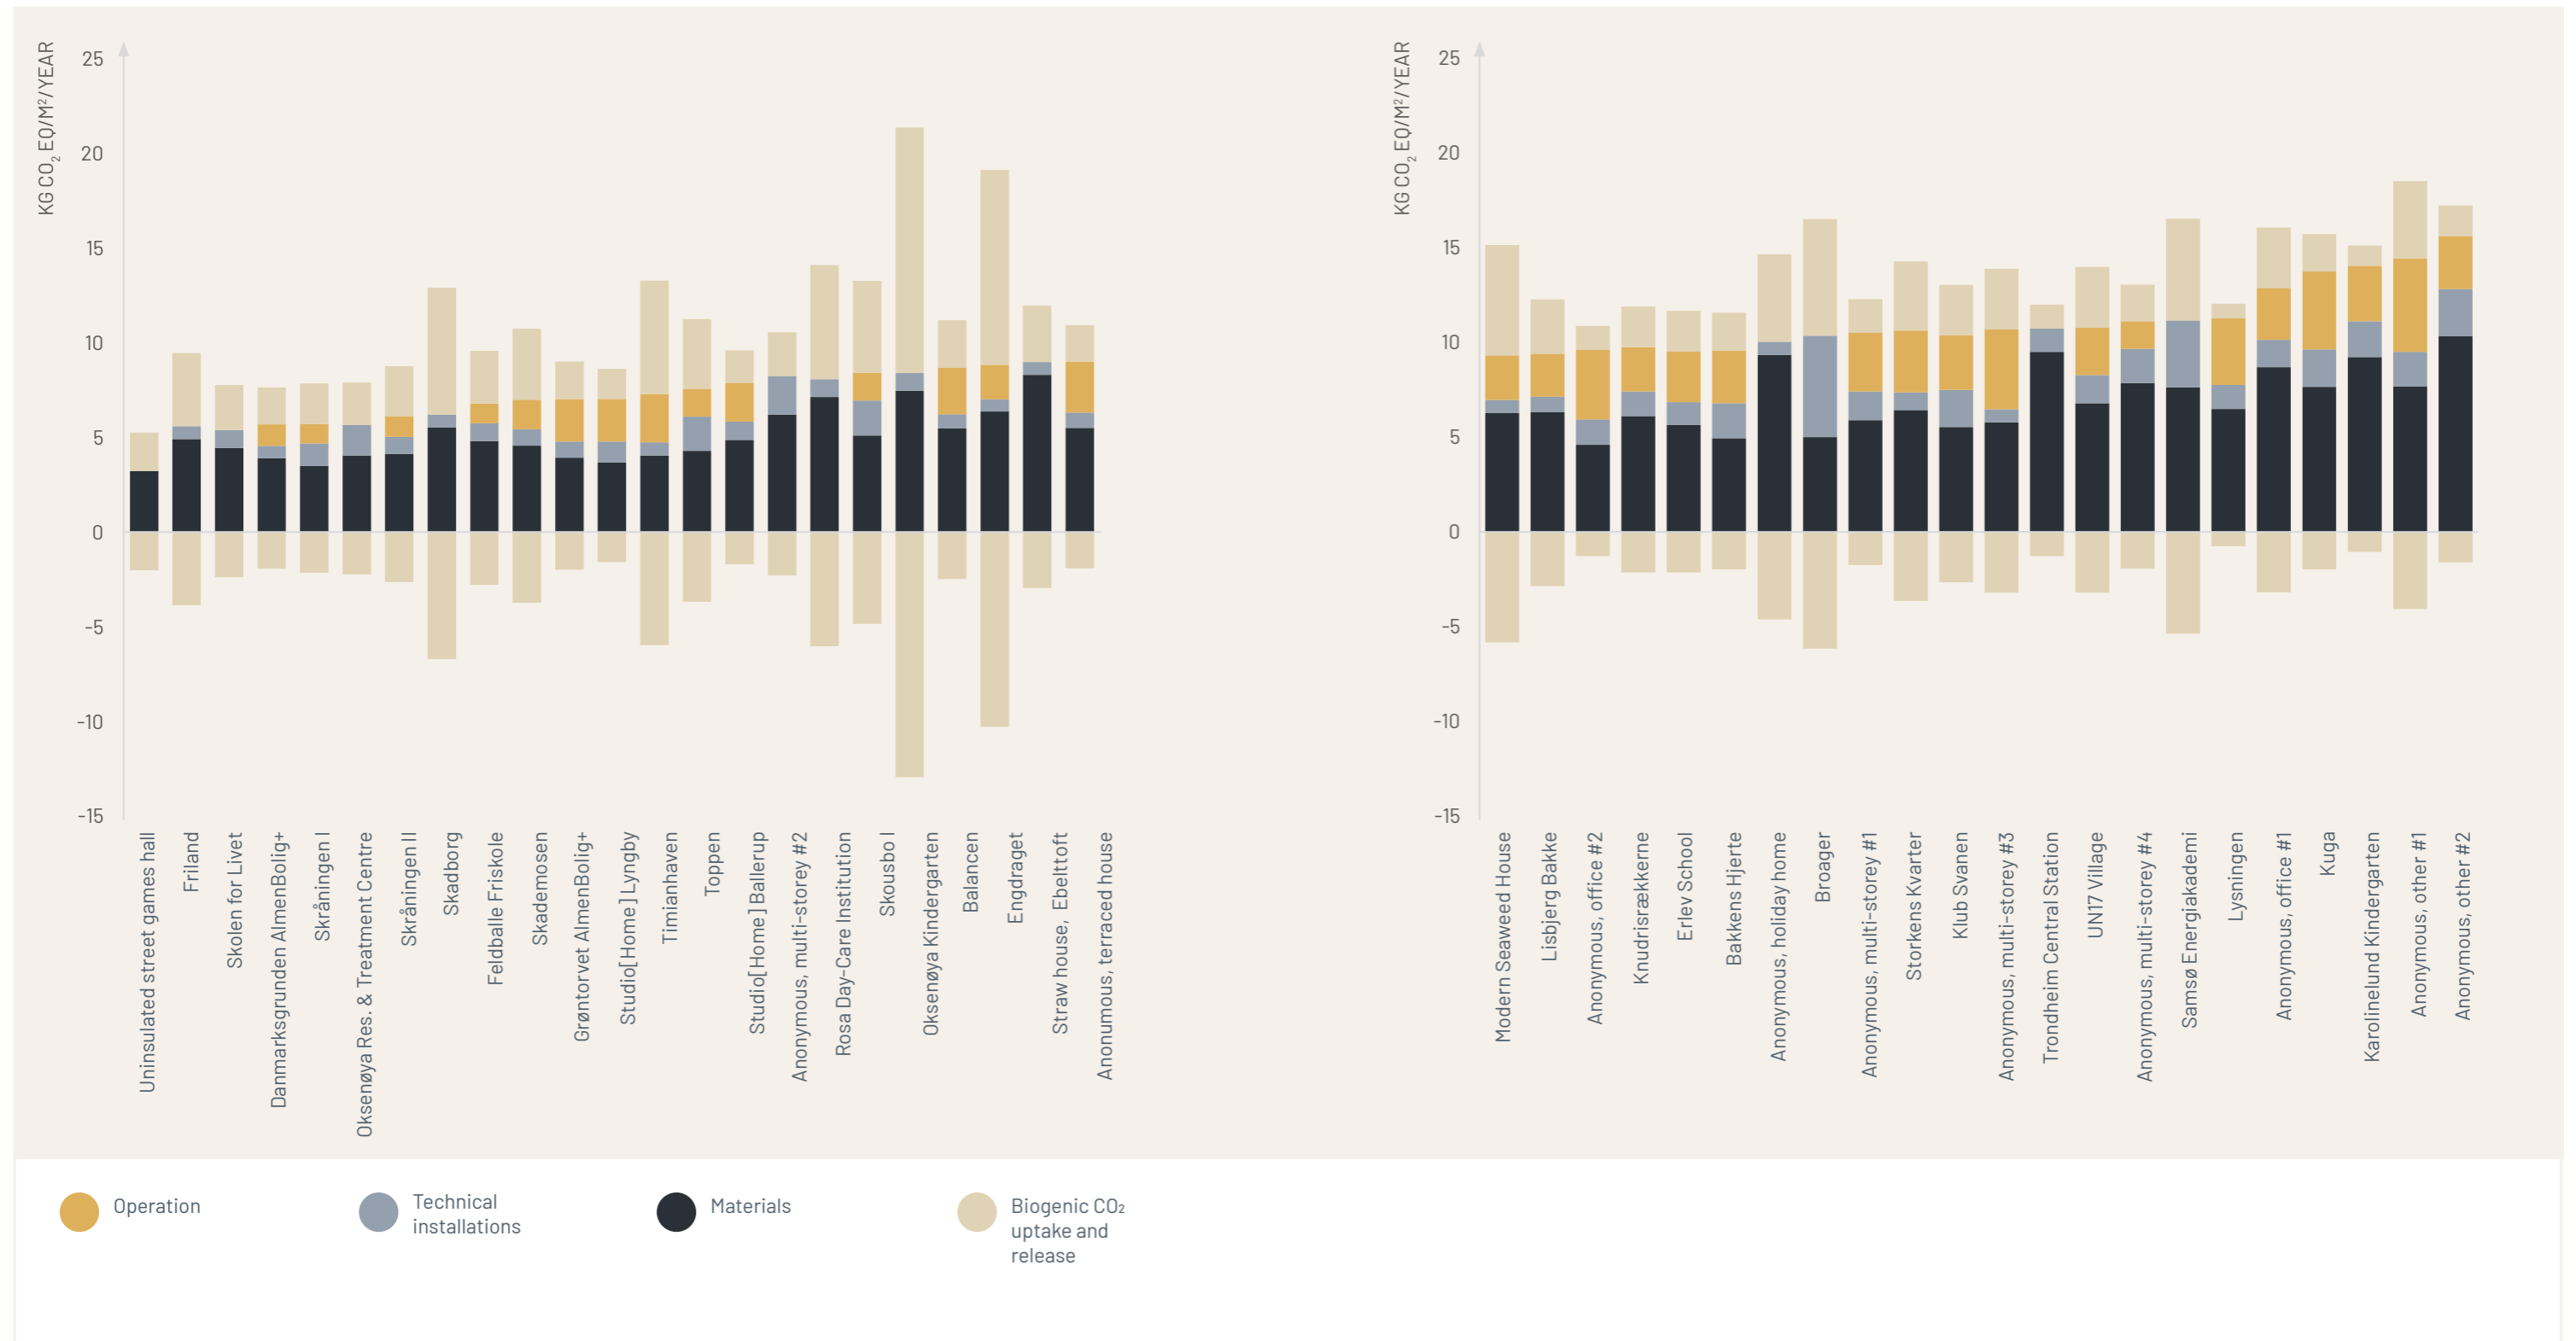
OPERATION AND MATERIALS

Below, the results of LCAs for all 45 case studies distributed on two graphs. Thus, the guidelines apply to both graphs. The results are specified in kg CO₂ eq/m²/year. The results are distributed on impact from materials, technical installations, and usage as well as biogenic CO₂ capture and emission. Please note that the technical installations for drains and water, heating, ventilation, and cooling systems are based on generic values, whereas electricity and mechanical systems are specific values.

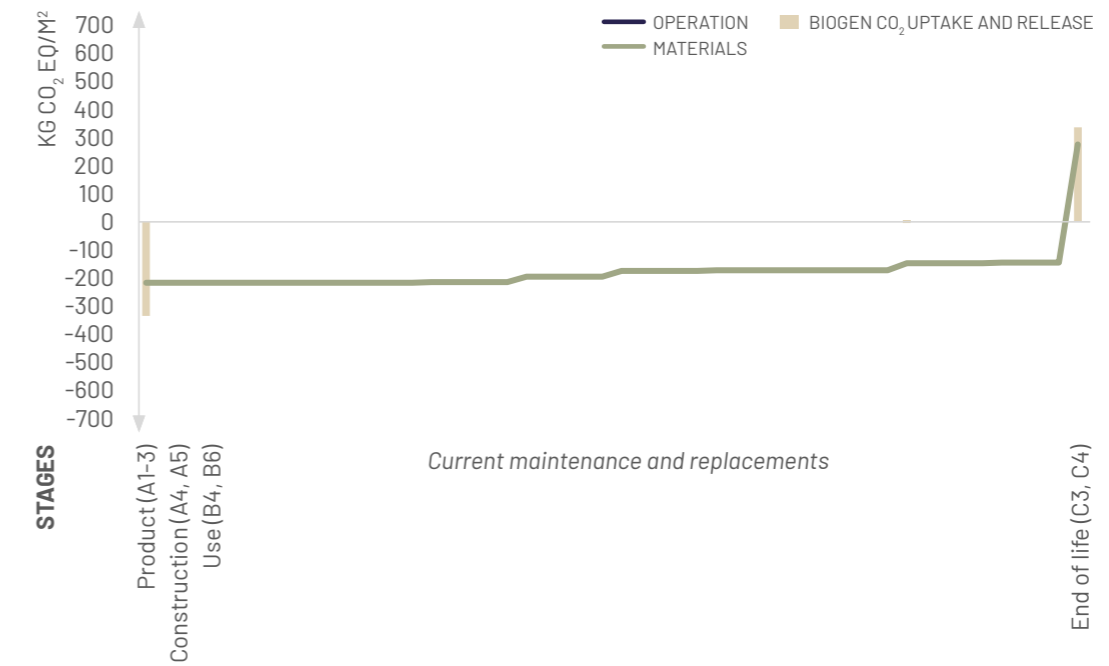
Figure 3. CO₂ accounting: life-cycle stages

The horizontal axis shows the distribution of life-cycle stages in the building over a 50-year period. In year 0, there are emissions from the Manufacture and Construction stages (A1-A3 and A4 and A5, respectively). Between years 1-49, there are emissions from the Use stage (B4 and B6). In year 50, there are emissions from the End-of-life stages (C3 and C4). The vertical axis shows the emission of greenhouse gases stated in CO₂ eq/m² distributed on materials and use. The biogenic CO₂ content is shown as columns corresponding to the capture and emission of biogenic CO₂ during the reference study period cf. the -1/+1 method.

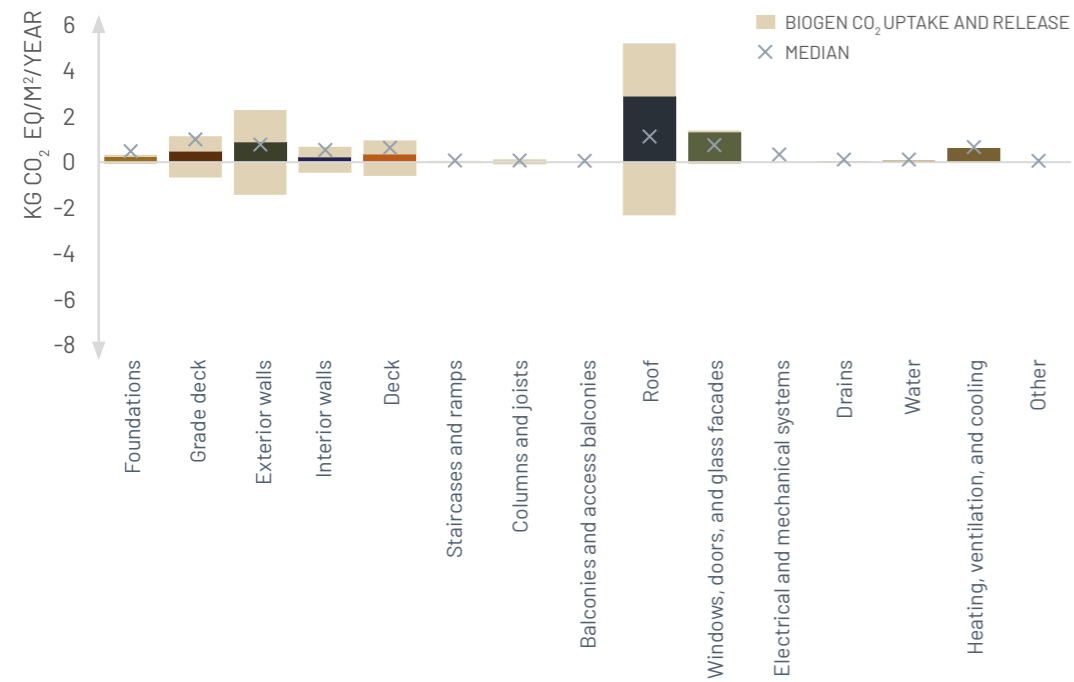
Figure 1. CO₂ accounting: building parts

The horizontal axis shows the groups of building parts, including foundations, grade decks, exterior and interior walls, decks, staircases and ramps, columns and joists, balconies and access balconies, roofs, windows, doors and glass facades, electrical and mechanical systems, drains and water, heating, ventilation, and cooling systems, etc. Please note that technical installations are based on generic values. The vertical axis shows the emission of greenhouse gases stated in CO₂ eq/m²/year. Light brown indicates the building part's biogenic CO₂ content cf. the -1/+1 method. The crosses mark the median value for the building part in all case studies.

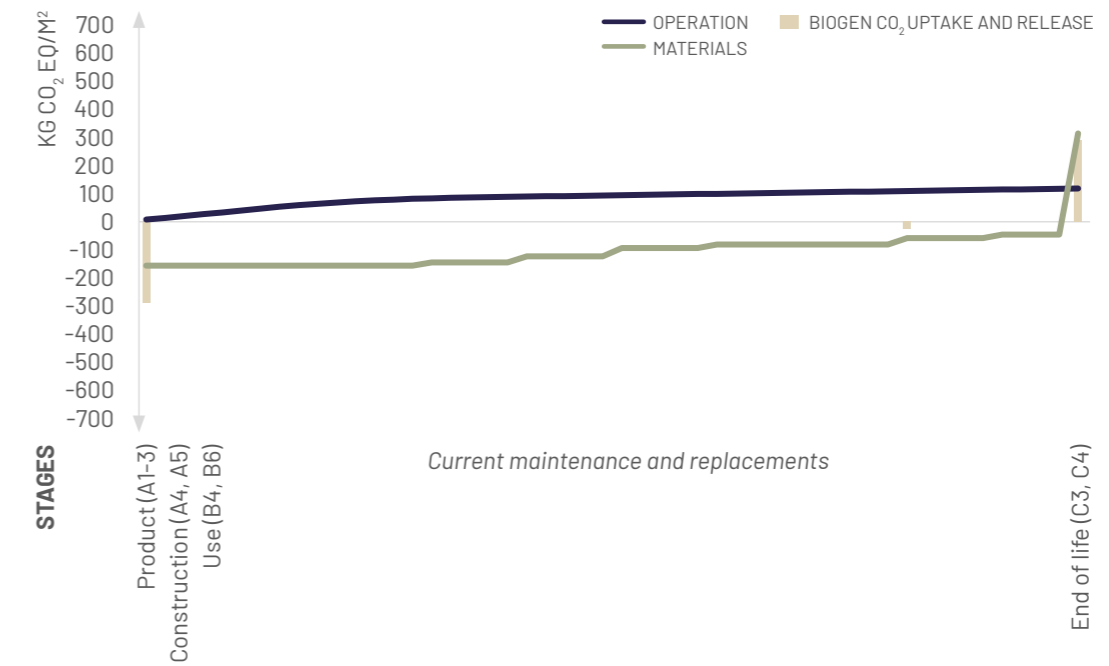
Figure 3. CO₂ accounting: life-cycle stages

The horizontal axis shows the distribution of life-cycle stages in the building over a 50-year period. In year 0, there are emissions from the Manufacture and Construction stages (A1-A3 and A4 and A5, respectively). Between years 1-49, there are emissions from the Use stage (B4 and B6). In year 50, there are emissions from the End-of-life stages (C3 and C4). The vertical axis shows the emission of greenhouse gases stated in CO₂ eq/m² distributed on materials and use. The biogenic CO₂ content is shown as columns corresponding to the capture and emission of biogenic CO₂ during the reference study period cf. the -1/+1 method.

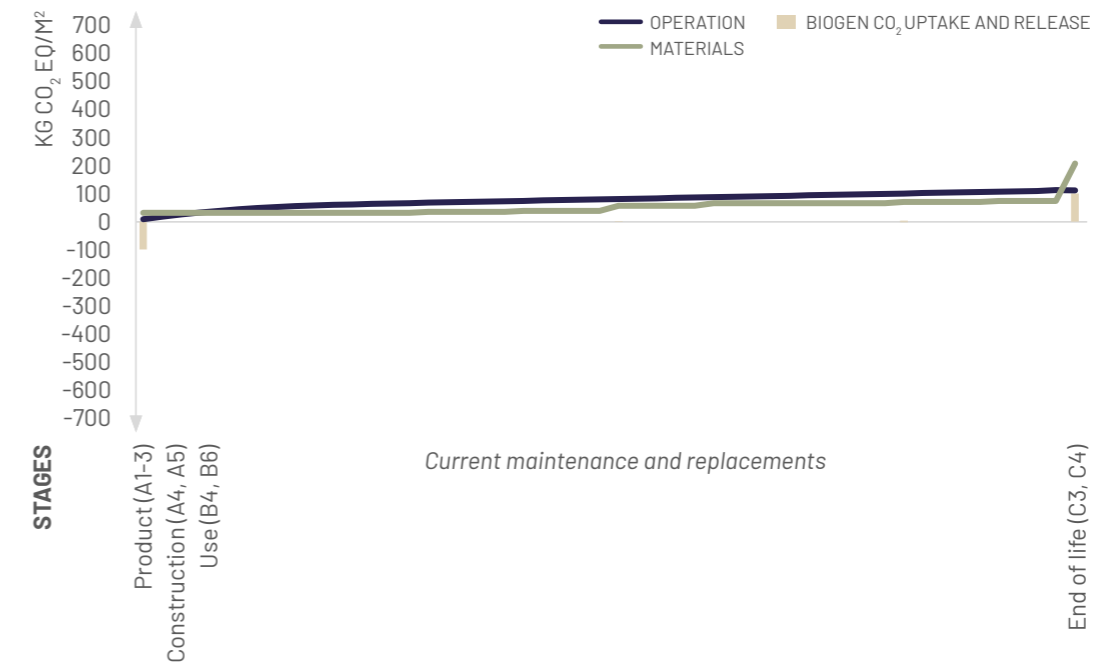
Figure 3. CO2 accounting: life-cycle stages

The horizontal axis shows the distribution of life-cycle stages in the building over a 50-year period. In year 0, there are emissions from the Manufacture and Construction stages (A1-A3 and A4 and A5, respectively). Between years 1-49, there are emissions from the Use stage (B4 and B6). In year 50, there are emissions from the End-of-life stages (C3 and C4). The vertical axis shows the emission of greenhouse gases stated in CO₂ eq/m² distributed on materials and use. The biogenic CO₂ content is shown as columns corresponding to the capture and emission of biogenic CO₂ during the reference study period cf. the -1/+1 method.

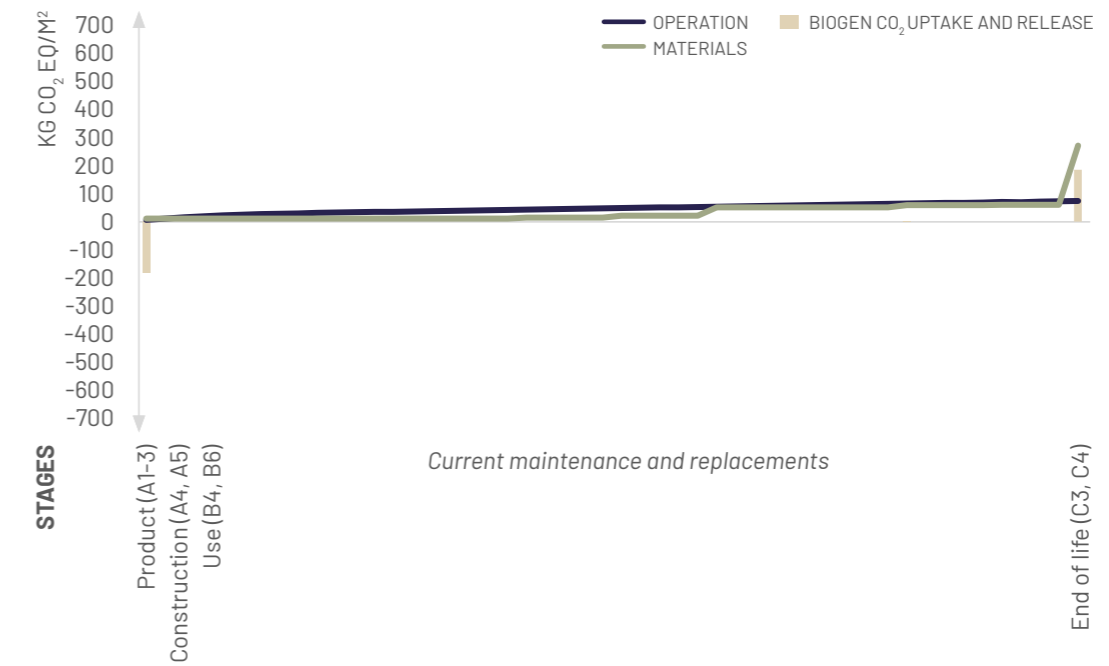
Figure 3. CO₂ accounting: life-cycle stages

The horizontal axis shows the distribution of life-cycle stages in the building over a 50-year period. In year 0, there are emissions from the Manufacture and Construction stages (A1-A3 and A4 and A5, respectively). Between years 1-49, there are emissions from the Use stage (B4 and B6). In year 50, there are emissions from the End-of-life stages (C3 and C4). The vertical axis shows the emission of greenhouse gases stated in CO₂ eq/m² distributed on materials and use. The biogenic CO₂ content is shown as columns corresponding to the capture and emission of biogenic CO₂ during the reference study period cf. the -1/+1 method.

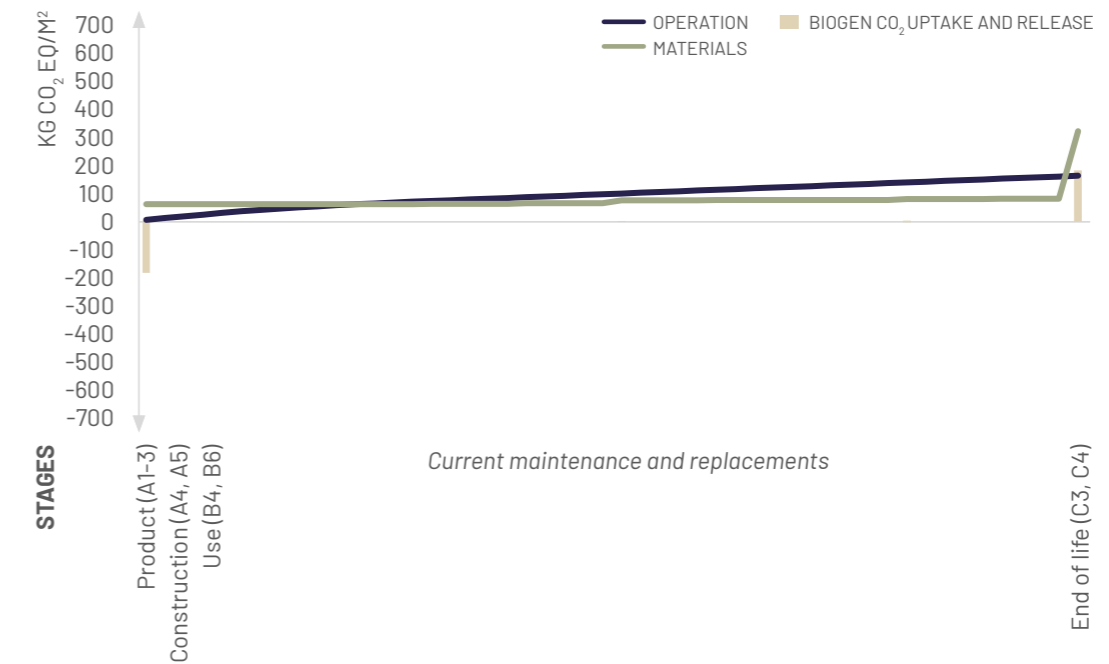
Figure 3. CO₂ accounting: life-cycle stages

The horizontal axis shows the distribution of life-cycle stages in the building over a 50-year period. In year 0, there are emissions from the Manufacture and Construction stages (A1-A3 and A4 and A5, respectively). Between years 1-49, there are emissions from the Use stage (B4 and B6). In year 50, there are emissions from the End-of-life stages (C3 and C4). The vertical axis shows the emission of greenhouse gases stated in CO₂ eq/m² distributed on materials and use. The biogenic CO₂ content is shown as columns corresponding to the capture and emission of biogenic CO₂ during the reference study period cf. the -1/+1 method.

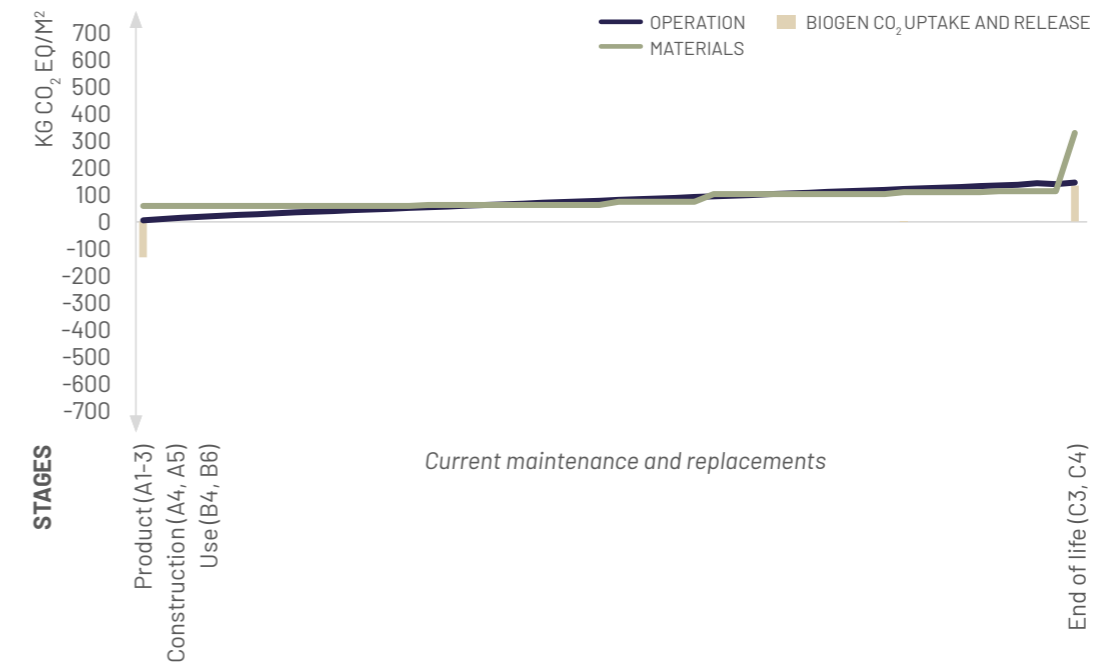
Figure 3. CO₂ accounting: life-cycle stages

The horizontal axis shows the distribution of life-cycle stages in the building over a 50-year period. In year 0, there are emissions from the Manufacture and Construction stages (A1-A3 and A4 and A5, respectively). Between years 1-49, there are emissions from the Use stage (B4 and B6). In year 50, there are emissions from the End-of-life stages (C3 and C4). The vertical axis shows the emission of greenhouse gases stated in CO₂ eq/m² distributed on materials and use. The biogenic CO₂ content is shown as columns corresponding to the capture and emission of biogenic CO₂ during the reference study period cf. the -1/+1 method.

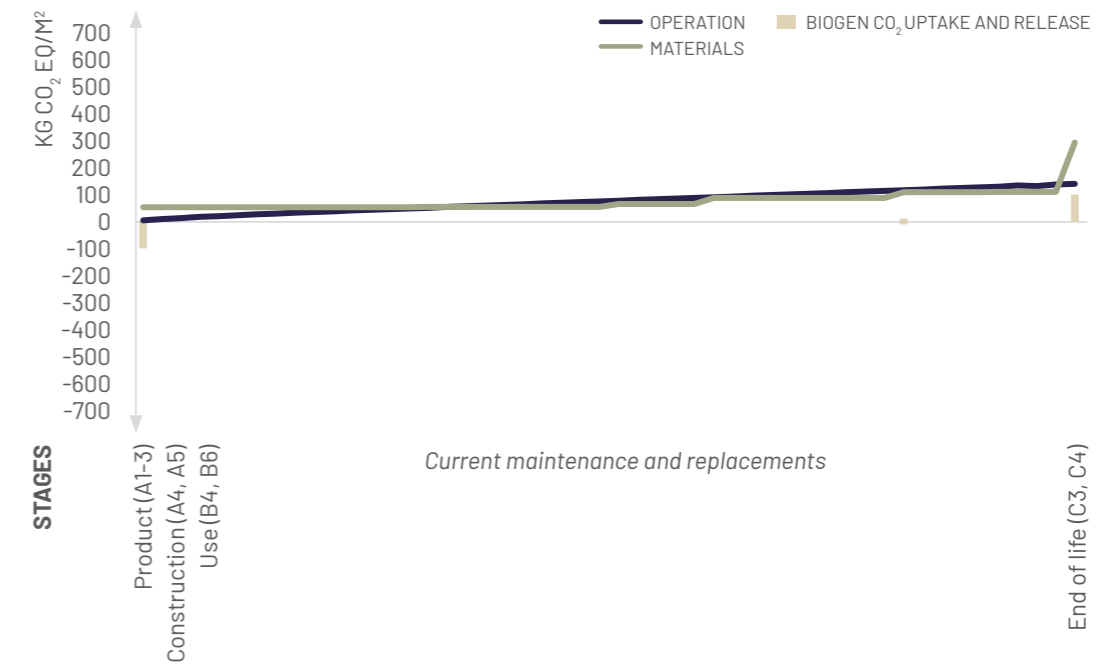
Figure 3. CO₂ accounting: life-cycle stages

The horizontal axis shows the distribution of life-cycle stages in the building over a 50-year period. In year 0, there are emissions from the Manufacture and Construction stages (A1-A3 and A4 and A5, respectively). Between years 1-49, there are emissions from the Use stage (B4 and B6). In year 50, there are emissions from the End-of-life stages (C3 and C4). The vertical axis shows the emission of greenhouse gases stated in CO₂ eq/m² distributed on materials and use. The biogenic CO₂ content is shown as columns corresponding to the capture and emission of biogenic CO₂ during the reference study period cf. the -1/+1 method.

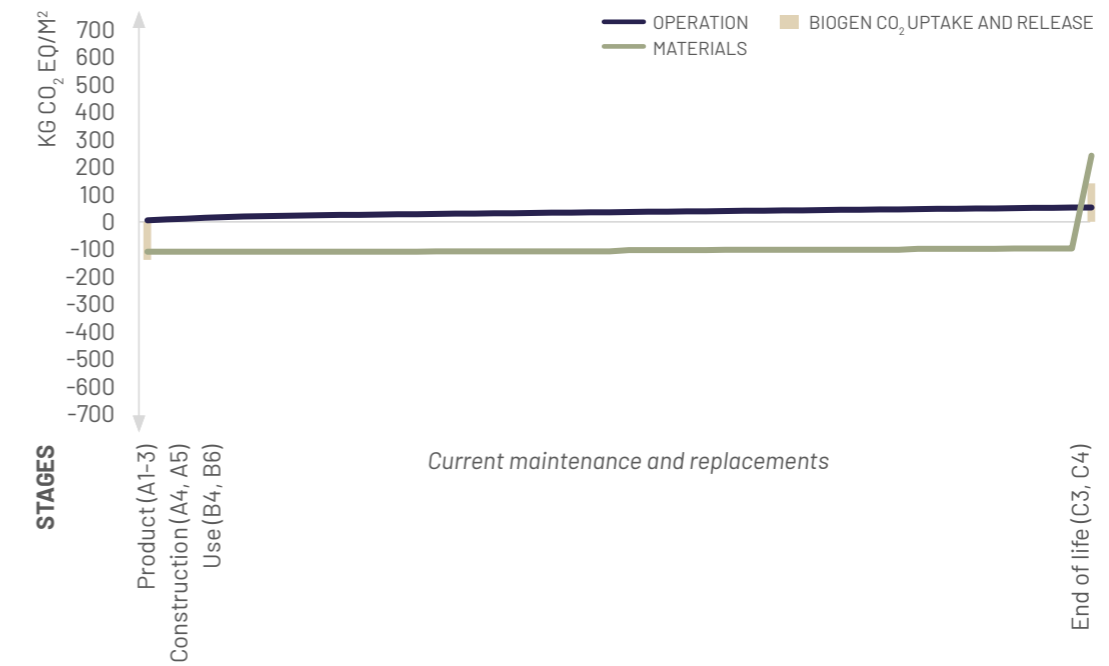
Figure 3. CO₂ accounting: life-cycle stages

The horizontal axis shows the distribution of life-cycle stages in the building over a 50-year period. In year 0, there are emissions from the Manufacture and Construction stages (A1-A3 and A4 and A5, respectively). Between years 1-49, there are emissions from the Use stage (B4 and B6). In year 50, there are emissions from the End-of-life stages (C3 and C4). The vertical axis shows the emission of greenhouse gases stated in CO₂ eq/m² distributed on materials and use. The biogenic CO₂ content is shown as columns corresponding to the capture and emission of biogenic CO₂ during the reference study period cf. the -1/+1 method.
