RESEARCH ARTICLE

Damage imaging in composites using nonlinear vibro-acoustic wave modulations

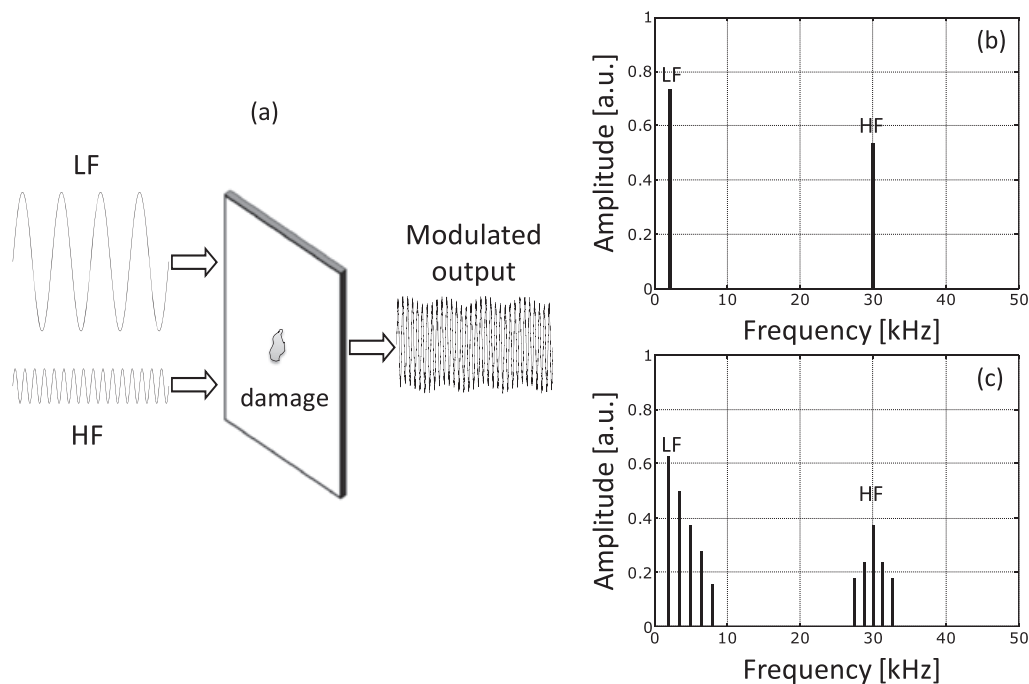
FIGURE 1 The principle of the nonlinear vibro-acoustic modulation technique: (a) schematic diagram illustrating the method; (b) power spectrum of a response signal for an undamaged structure; (c) power spectrum of a response signal for a damaged structure

The nonlinear vibro-acoustic modulation technique relies on an intensive LF (modal) excitation and a weaker HF ultrasonic wave that are introduced to the structure simultaneously,^[15] as illustrated in Figure 1a. The assumption is that, when the monitored material sample is undamaged, response signal spectra exhibit only the major frequency components, that is, the propagating acoustical wave and LF excitation (Figure 1b). However, when the sample is damaged, the spectrum of the response signal reveals additional frequency components such as higher harmonics and modulation sidebands around the HF component (Figure 1c). As mentioned in Section 1, the method—originally developed for fatigue crack detection—has been also successfully applied to impact damage detection in composites.

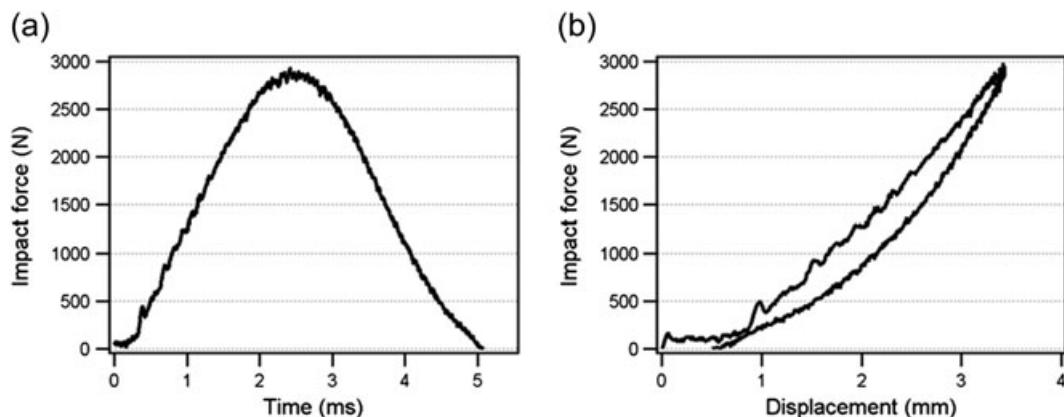
FIGURE 3 Impact characteristics: (a) force-time curve and (b) force-displacement curve

Low velocity impact test was performed on the plate to introduce damage. The plate was simply supported on a rigid post with a rectangular opening in the center, and an instrumented drop-weight testing machine was employed to impact the plate in the central location. The plate was impacted with the energy of 3.9 J, which was obtained by selecting the appropriate drop height of the impactor. The absorbed energy was evaluated by measuring (by an infrared sensor) the velocities of the impactor immediately before and after the impact; the contact force was measured by means of a semiconductor strain-gage bridge bonded to the indenter. The force-time curve and the force-displacement curve acquired during the impact test are presented in Figure 3.

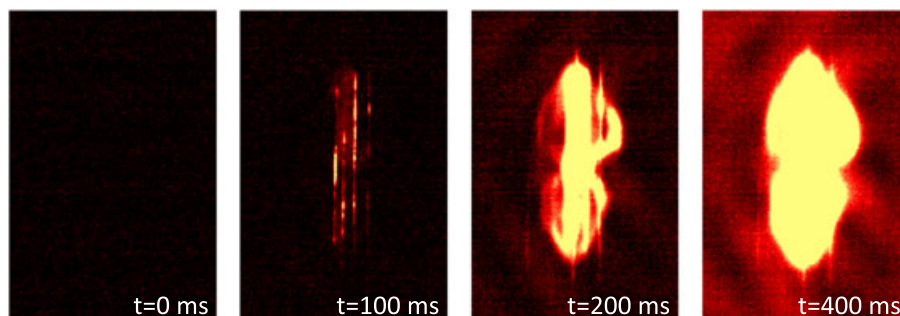
FIGURE 4 Results of the vibrothermographic measurement on the composite plate—Surface temperature distribution at different time instances

The results from the vibrothermographic inspection are shown in Figure 4. This figure presents temperature distribution measured on the surface of the plate in the central area marked by the dashed line in Figure 2. Background temperature distribution, measured just before the beginning of the test, was subtracted from the results to improve the contrast. There are four different time instances shown in Figure 4. Time $t = 0$ ms corresponds to the start of the ultrasonic excitation of the sample. Here, the temperature distribution is uniform and only the thermal camera detector noise is present. After $t = 100$ ms, the vertical surface matrix cracks are becoming visible in the thermal picture. After $t = 200$ ms, a characteristic butterfly like delamination on the $0^\circ/90^\circ$ interface further from the impact side is revealed. Finally, after $t = 400$ ms, the picture starts to become blurred. This is mainly due to the temperature being conducted away from the source, which in the case of vibrothermography is the damage itself. The area of delamination after the 3.9 J impact was identified from the test as approximately 300 mm^2 . In summary, the NDT test performed revealed the shape and size of damage.

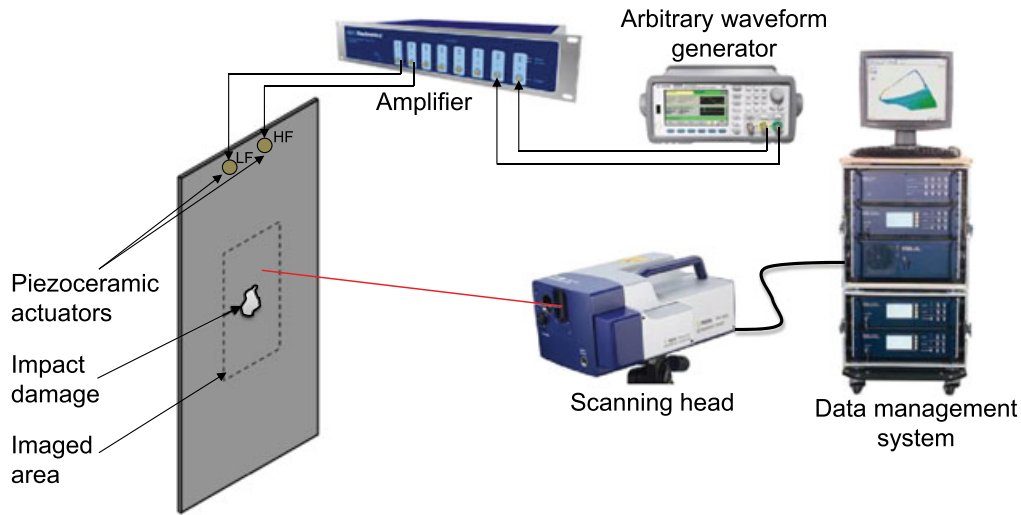
FIGURE 5 Experimental set-up used for the nonlinear acoustic imaging

Subsequently, experimental modal analysis was performed to confirm the findings from the numerical model. The experiment was performed using the arrangements shown in Figure 5. The *Noliac CMAP4* piezoelectric stack actuator was driven with a white noise signal. The excitation voltage amplitude was equal to $80 V_{p-p}$. The scanning laser vibrometer was used for non-contact measurements of vibration responses at 435 points on a 15×29 measurement symmetrical rectangular grid. The

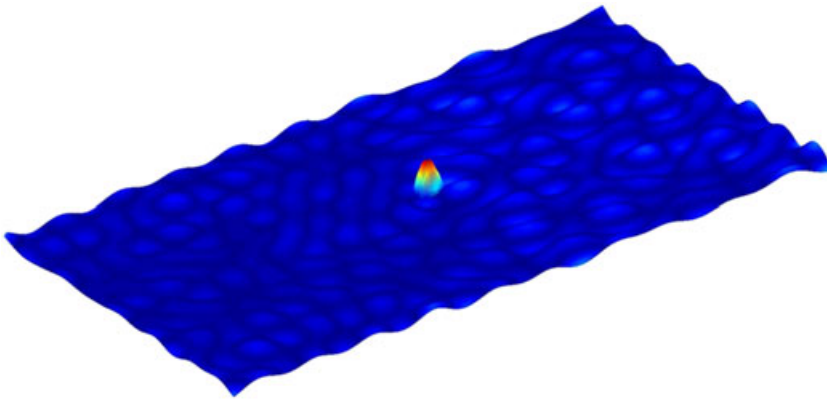
FIGURE 6 Mode shape of the local defect resonance frequency at 29 852 Hz revealed by numerical simulations

Once the model was developed, modal analysis was performed. Natural frequencies and mode shapes were obtained by solving the free undamped vibration problem. The contact interaction and friction at the delaminated interface were therefore not modeled to simplify the problem. The *MSC.Nastran* FE solver was used to perform numerical computations. The normal modes solution (SOL103) was applied to find vibration mode shapes of the delaminated composite plate. Following these investigations, the LDR was identified for the frequency of 29,852 Hz excitation. The corresponding mode shape is presented in Figure 6.

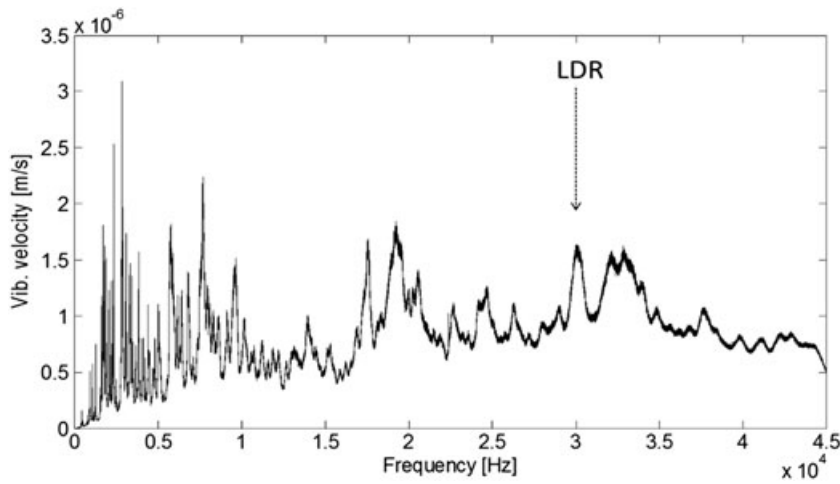
FIGURE 7 Experimental FRF for the analyzed damaged composite plate

analysis was performed in the frequency range from 0 to 45 kHz. Figure 7 gives the averaged frequency response function (FRF)—estimated from the responses in the central part of the plate—for the analyzed frequency range. The analysis of modes shapes between 25 and 35 kHz revealed the LDR frequency at 30 095 Hz. This frequency value was very close to the value predicted from the numerical model.

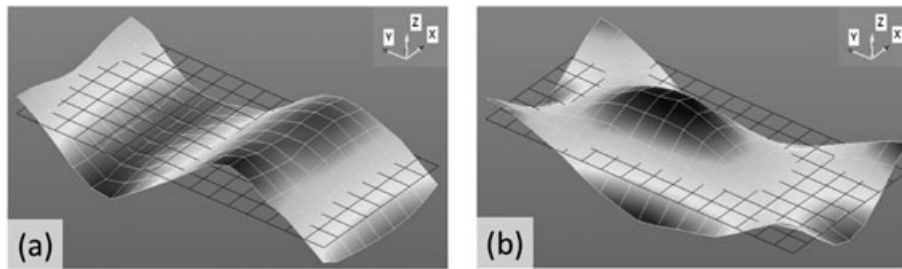
FIGURE 8 Mode shapes corresponding to f_{LF1} (a) and f_{LF2} (b) frequencies selected as low-frequency excitation in vibro-acoustic modulation tests

Once the LDR frequency was identified, the LF frequency had to be selected. The frequency of one of the first structural responses is typically chosen for the LF excitation in the nonlinear vibro-acoustic modulation technique used for damage detection. The frequencies of $f_{LF1} = 461$ Hz and $f_{LF2} = 491$ Hz, corresponding to the strong LF resonances, were selected in the current investigations. The delamination, located in the center of the plate, was located around the node of vibrations for the first mode and around the antinode of vibrations for the second mode, as can be seen in Figure 8a,b, respectively. The motivation behind this choice was to verify possible influence of the LF mode shape on the damage imaging quality.

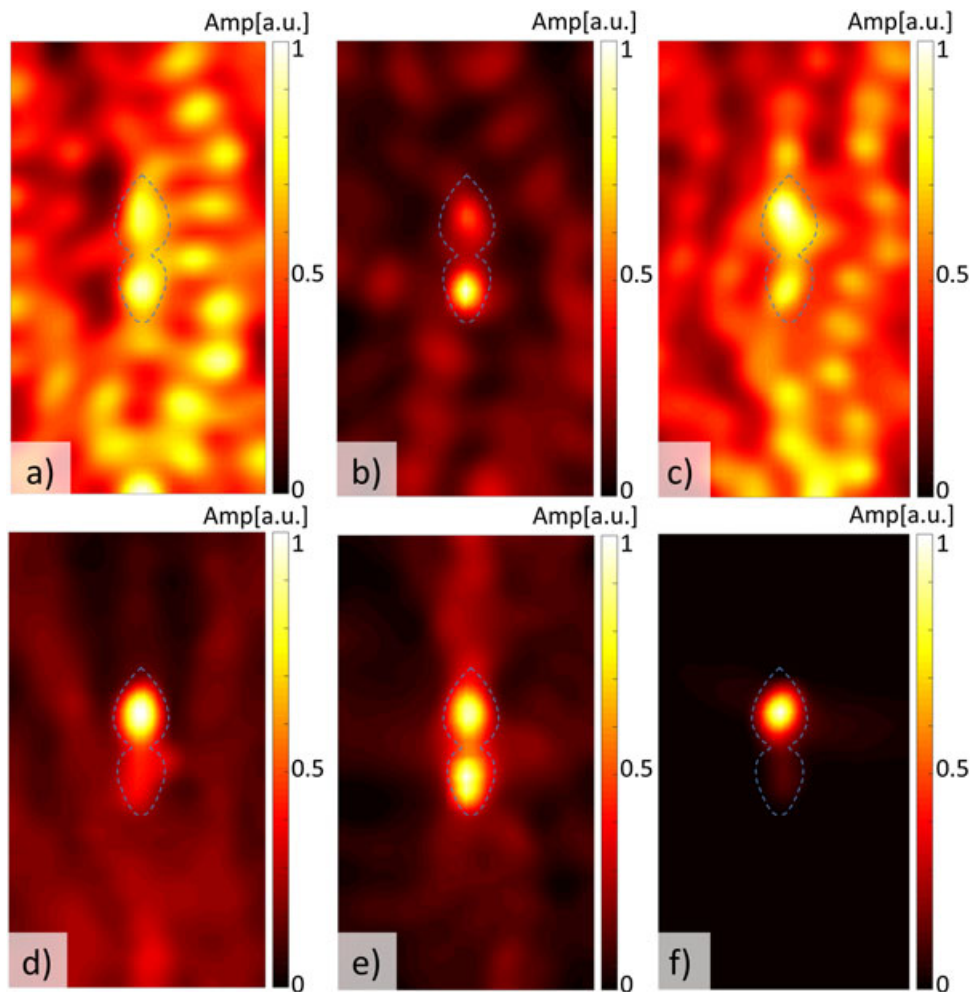
FIGURE 9 Linear (a–c) and nonlinear (d–f) imaging based on higher harmonics generation. Spectral intensity maps for the excitation frequencies equal to: (a) $f_{HF1} = 43$ kHz; (b) $f_{HF2} = 30.095$ kHz; (c) $f_{HF3} = 50$ kHz and for their second harmonics (d) $2f_{HF1} = 86$ kHz; (e) $2f_{HF2} = 60.190$ kHz; (f) $2f_{HF3} = 100$ kHz. Contour of damage is indicated with a dashed line

Single-harmonic excitation corresponding to the selected HF frequencies, that is, $f_{HF1} = 43,000$ Hz; $f_{HF2} = 30,095$ Hz, and $f_{HF3} = 50,000$ Hz were used in the damage detection imaging technique on the basis of higher harmonic generation. The experimental results from these investigations are presented in Figure 9. Spatial mapping of the spectral amplitudes corresponding to the first harmonic components (Figure 9a–c) and the second harmonic components (Figure 9d–f) are presented. The amplitudes are presented in linear scale and have been normalized to allow easier comparison between different frequencies. In case of linear images for f_{HF1} and f_{HF3} presented in Figure 9a,c, no clear indication of the presence or location of damage can be observed.

Spectral amplitude levels on BVID are comparable to the amplitude levels in the surrounding. The linear image for f_{HF2} corresponding to the LDR frequency (Figure 9b) already indicates the presence and the location of the BVID in the central part of the image. In contrast, the nonlinear images for all frequencies, shown in Figures 9d–f, clearly indicate the presence and the location of damage. The results confirm the localization effect of higher harmonics known from the literature. In addition, the results clearly show that the excitation with the LDR frequency enhances damage detection. The location of delamination can be clearly identified in all three cases, but the nonlinear image involving the second harmonic of the LDR frequency in Figure 9e exhibits the shape of the analyzed delamination in a more precise way. It is, however, important to note that the previous research studies—reported in^[51]—demonstrate that other selected excitation frequencies in this test may produce less clear damage images.

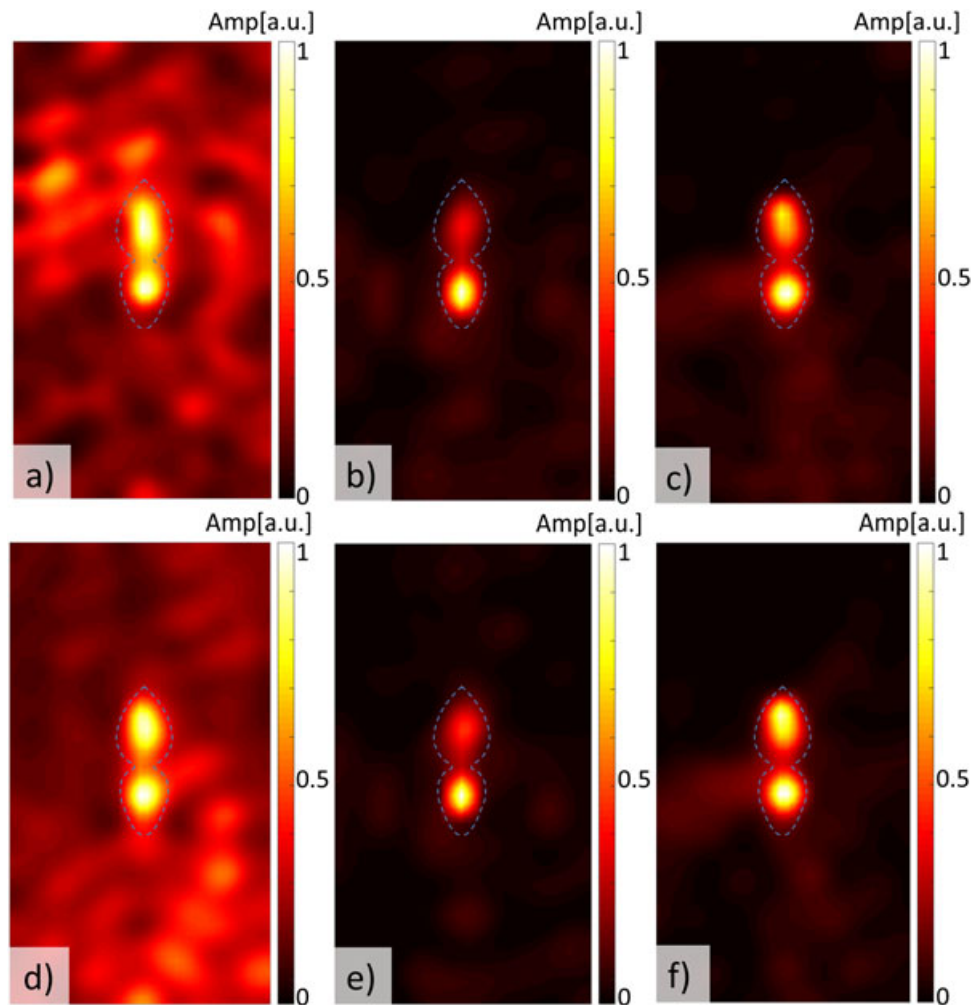
FIGURE 10 Vibro-acoustic modulation sideband imaging results for (a) $f_{LF1} = 461$ Hz and $f_{HF1} = 43$ kHz; (b) $f_{LF1} = 461$ Hz and $f_{HF2} = 30.095$ kHz; (c) $f_{LF1} = 461$ Hz and $f_{HF3} = 50$ kHz; (d) $f_{LF2} = 491$ Hz and $f_{HF1} = 43$ kHz; (e) $f_{LF2} = 491$ Hz and $f_{HF2} = 30.095$ kHz; (f) $f_{LF2} = 491$ Hz and $f_{HF3} = 50$ kHz. Contour of damage is indicated with a dashed line

Subsequently, the proposed imaging procedure based on the nonlinear vibro-acoustic modulation sidebands was applied to the damaged composite plate. Figure 10 presents the results of the imaging procedure. The modulation intensity defined by the mean value of the first modulation sidebands amplitudes is mapped and analyzed in these figures. Figure 10a–c correspond to the first selected natural frequency of the plate at $f_{LF1} = 461$ Hz (shown in Figure 8a) combined with three HF excitations: $f_{HF1} = 43$ kHz, $f_{HF2} = 30.095$ kHz and $f_{HF3} = 50$ kHz, respectively. Figures 10 d–f correspond to the second selected natural frequency of the plate at $f_{LF2} = 491$ Hz (shown in Figure 8b) and the same set of high frequencies as before. As can be seen, the damage can be easily identified in all considered cases. The amplitude contrast between the damaged area and the surrounding

is different for the particular combinations of excitation frequencies. However, the location and shape of the BVID can be clearly seen in the central part of the plate irrespectively of the frequency combinations. The results confirm that the localization effect of the modulation sidebands is strong around the nonlinearity source, similarly to the case of higher harmonics components. Moreover, the selection of excitation frequencies is not critical for the imaging process. In particular, the results obtained for two different modal frequencies f_{LF1} and f_{LF2} are nearly the same, as can be seen in Figure 10. Moreover, the LDR frequency at $f_{HF2} = 30.095$ kHz produced the results (shown in Figure 10b,e) comparable with the results obtained with an arbitrarily selected an arbitrarily selected $f_{HF3} = 50$ kHz (shown in Figure 10c,f). This was not the case for the higher harmonics imaging where the selection of LDR excitation clearly enhanced the imaging quality.

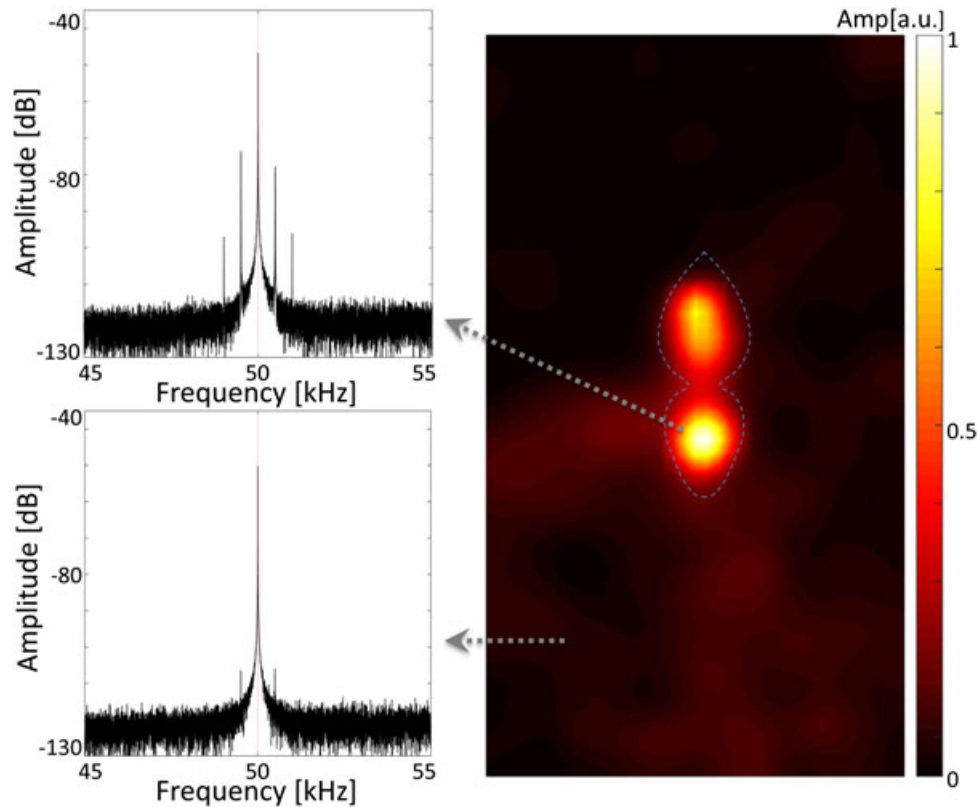
FIGURE 11 Comparison of frequency spectra measured at two different locations on the plate for excitation frequencies equal to $f_{LF2} = 491$ Hz and $f_{HF3} = 50$ kHz

Finally, Figure 11 shows the comparison of frequency spectra measured at two different locations on the plate for excitation frequencies equal to $f_{LF2} = 491$ Hz and $f_{HF3} = 50$ kHz. As can be seen, the level of modulation sidebands is much higher around the BVID location compared with that in the healthy area of the plate. These results show a great potential for the proposed nonlinear damage imaging procedure. However, they also indicate that a proper choice of the measurement point for the classical nonlinear vibro-acoustic modulation testing is very important. Although the modulation sidebands can be seen in all measurement points across the plate, the amplitude level of sideband components is significantly different depending on the location on the plate. The inappropriate choice of a measurement location may lead to an unsuccessful detection in the presence of measurement noise or in a difficulty to select a proper detection threshold.
