AIAS 2018 International Conference on Stress Analysis

A sensitivity analysis on the damage detection capability of a Lamb waves based SHM system for a composite winglet

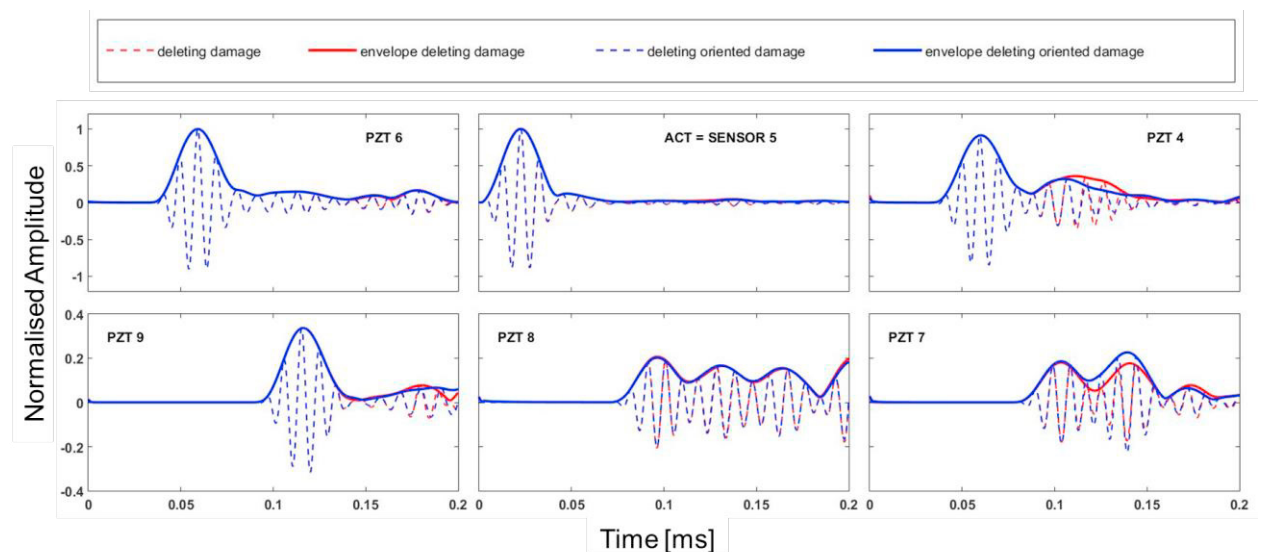
Fig. 3. Numerical signals referred to both 45° and 0° oriented damages, modelled according to the deleting technique.

In order to improve the results readability, only signals recorded at sensors 4, 6, 7, 8 and 9 (sensors closest to the damage) have been reported in Fig. 3 and 4. Specifically, according to these figures, it can be noticed that, the damage orientation produces clear effects when the damage is modelled according to the deleting technique.

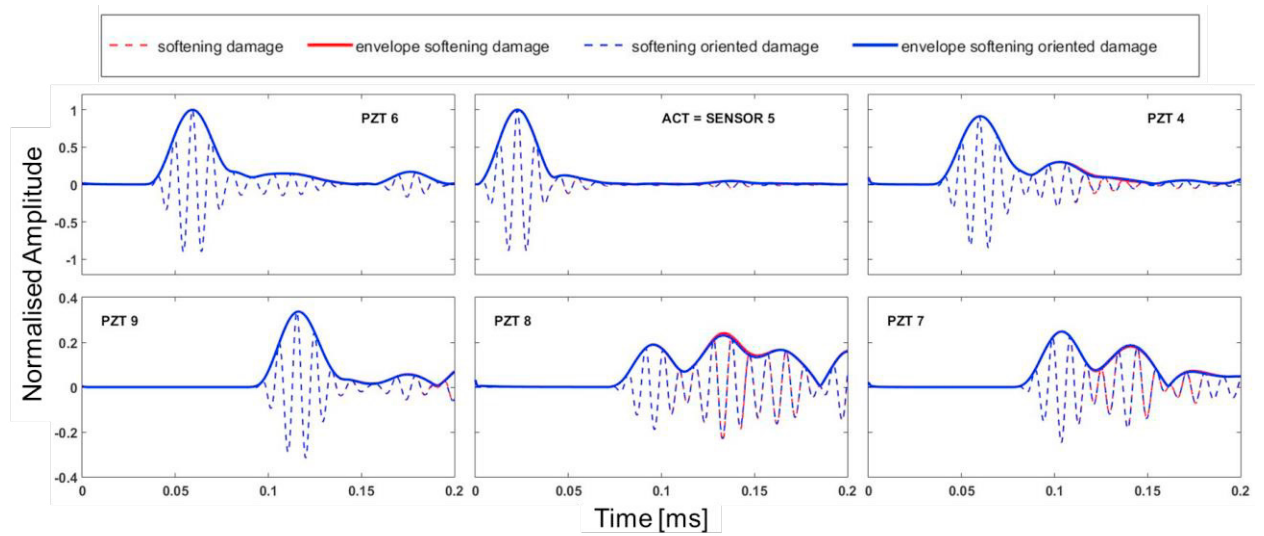
Fig. 4. Numerical signals referred to both 45° and 0° oriented damages, modelled according to the softening technique.

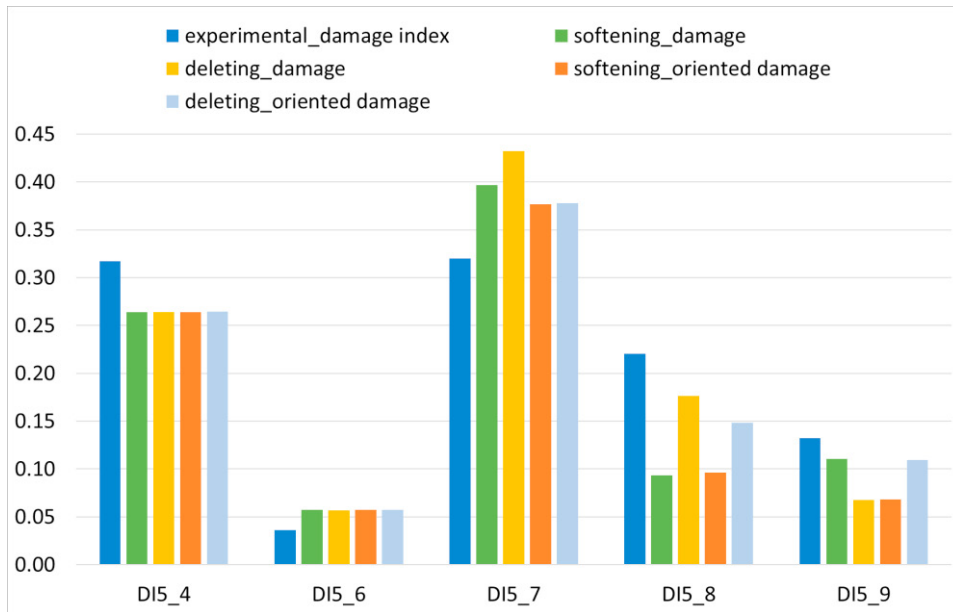
Fig. 6. Damage indexes comparison.

Fig. 6 shows the comparison of the RMSD damage index values, achieved by the experimental tests and by all performed simulations. Only the damage indexes calculated with reference to the sensors surrounding the damage (sensors 4, 6, 7, 8 and 9) have been reported in Fig. 6.

Damage indexes shown in Fig. 6 have been calculated by comparing only the first waves package of the pristine and “damaged” recorded signals. This choice depended on the fact that, during the experimental tests, only the S_0 waves mode has been recorded. By a numerical point of view, this justifies even more the use of shell elements, which are more efficient in the modelling of the Symmetric modes.

According to Fig. 6, it appears that the damage modeled with reference to the deleting technique and oriented with an angle of 45° provides a better level of accuracy, with reference to the experimental DIs, in terms of damage index prediction.

Moreover, from Fig. 6 it can be noticed that the highest value of damage index is provided by sensor 7. This can be justified by the fact that, according to Fig. 7, the damage is positioned along the pattern actuator 5 (ACT 5) – sensor 7 (PZT 7). As a result, the most difference between the baseline signal and the recorded signal is expected exactly here. The second highest DI has been recorded at sensor 4 (PZT 4). This can be addressed to the largest amount of damage scattered waves; a waves package, in fact, is reflected back from the upper right damage free edge (Fig. 7).

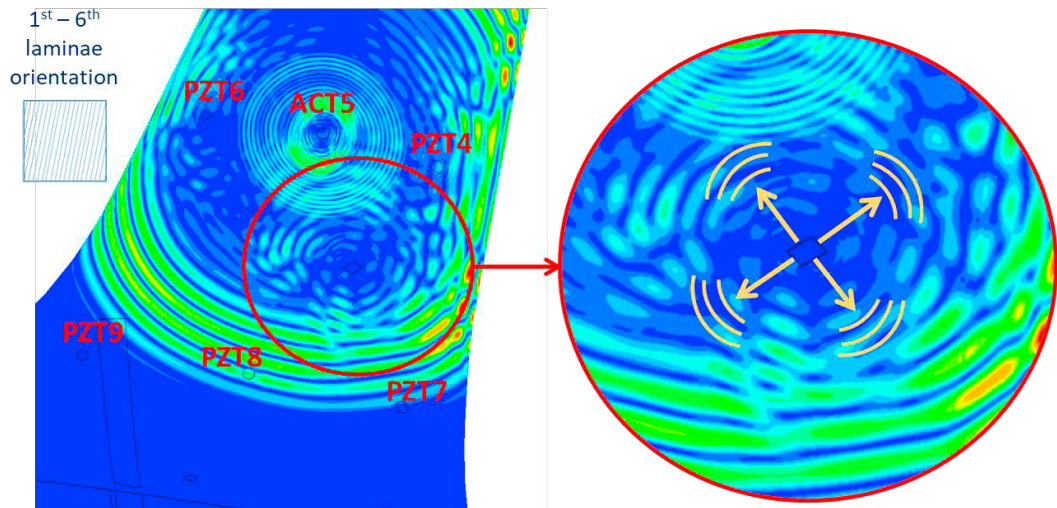
Fig. 7. Damage scattered waves.

The third highest DI is recorded at PZT 8 because it is closer to the damage than PZT 9 and PZT 6. The little difference between the DIs recorded at PZT 6 and PZT 9, which are quite equidistant from the damage, can be addressed to presence of the spar (Fig. 7) which is placed between ACT 5 and PZT 9. DI recorded at PZT 9, in fact, is slightly higher by both numerical and experimental point of views than the DI recorded at PZT 6.
