Synthetic Resin Reinforcement of Timber Joints Deteriorated by Termites

Abstract. *Timber has been widely adopted as a global structural material. However, timber sometimes deteriorates due to various factors such as termite infestation, which may reduce its strength and durability. It is difficult to ascertain the degree of deterioration of timbers by visual inspection because deterioration by termites causes severe damage to the inner parts of the timber. Therefore, the damage is often discovered after the deterioration progresses. The restoration and refurbishment method currently implemented is removing the degraded parts and partially replacing them with new healthy wood. Although it is as desirable to reinforce the original part as it is to restore its strength, especially for historical timber structures, this approach has not yet been put into practical use. This study investigates the possibility of restoring timber deteriorated by termites with little changes in its appearance by using resin filling. Deterioration by termites occurs at the base of the timber. Therefore, the specimen is assumed to be the joint of a foundation and column. First, the deteriorated specimen w

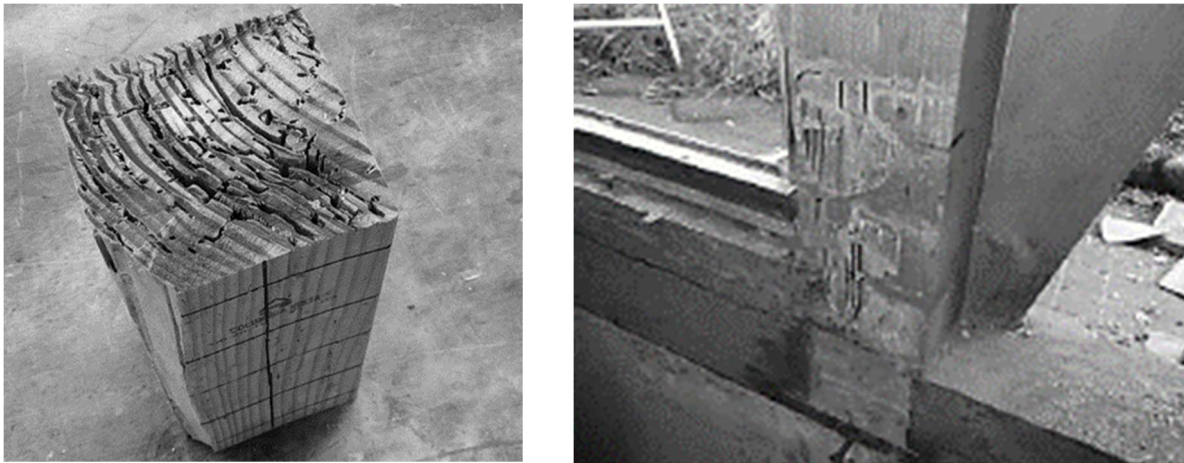
Figure 1. Timber damaged by termites. (Source: KAWATA Tasturo, 2017)

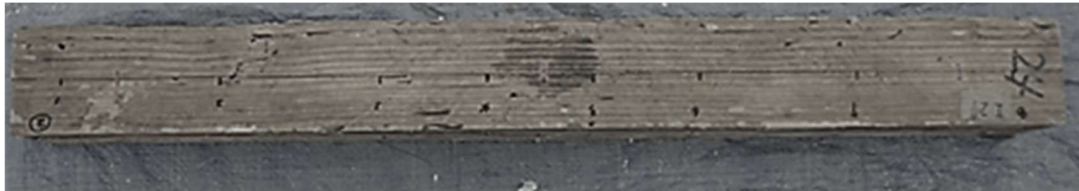
Figure 2. Timber filled with resin.

The authors examine the reinforcing method of injecting synthetic resin into the deteriorated parts of the timber. The reinforcing method is characterized by a little change in appearance, as shown in Figure 2.

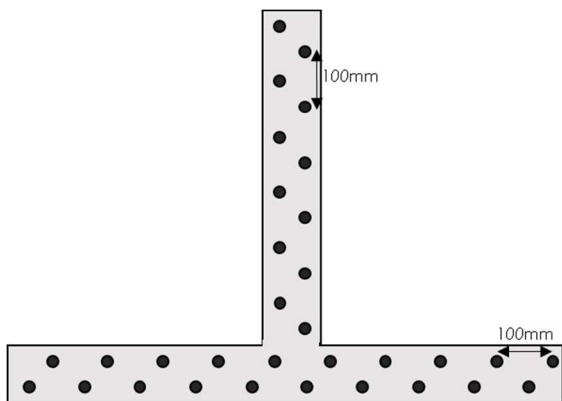
Figure 3. Image of filling hole.

The objective of this experiment was to examine the reinforcing effect of filling the synthetic resin on the restoration of timbers deteriorated by termites. The reinforcing method is as follows. First, the entire surface of the specimen is covered with tape. Next, the side of the specimen is drilled in a staggered manner at 100-mm intervals (Figure3). Finally, using a static mixer, the synthetic resin is injected through the hole into the specimen (Figure4).

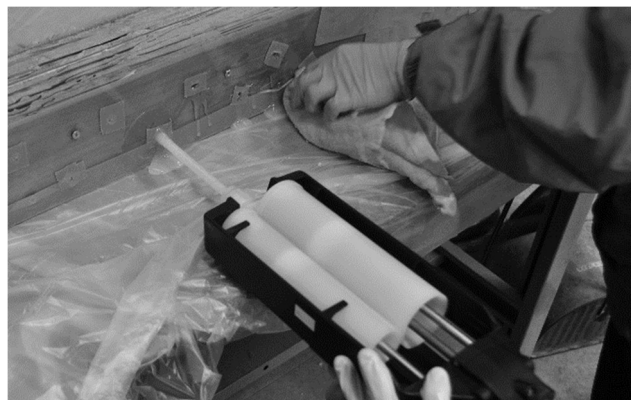
Figure 4. Resin filling work.

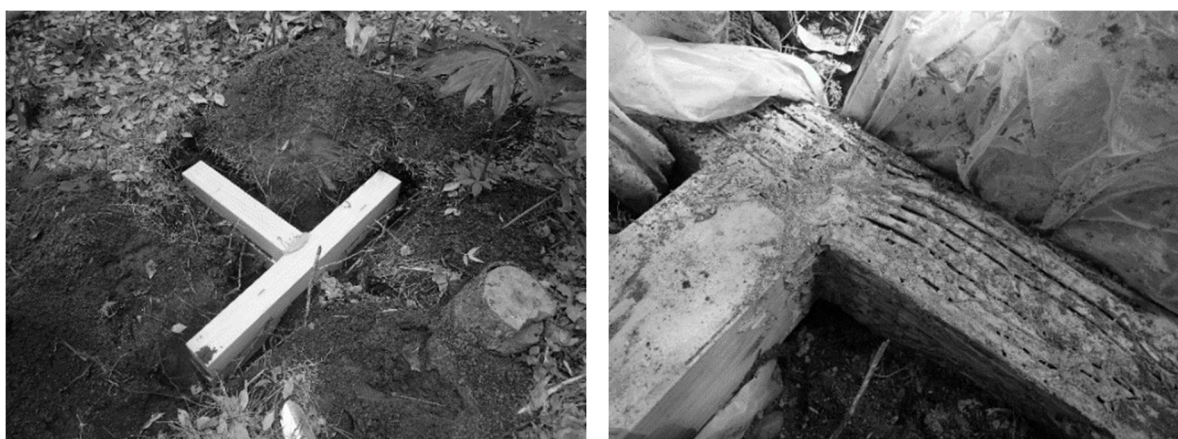
Figure 5. Soil exposure due to feeding damage caused by termites.

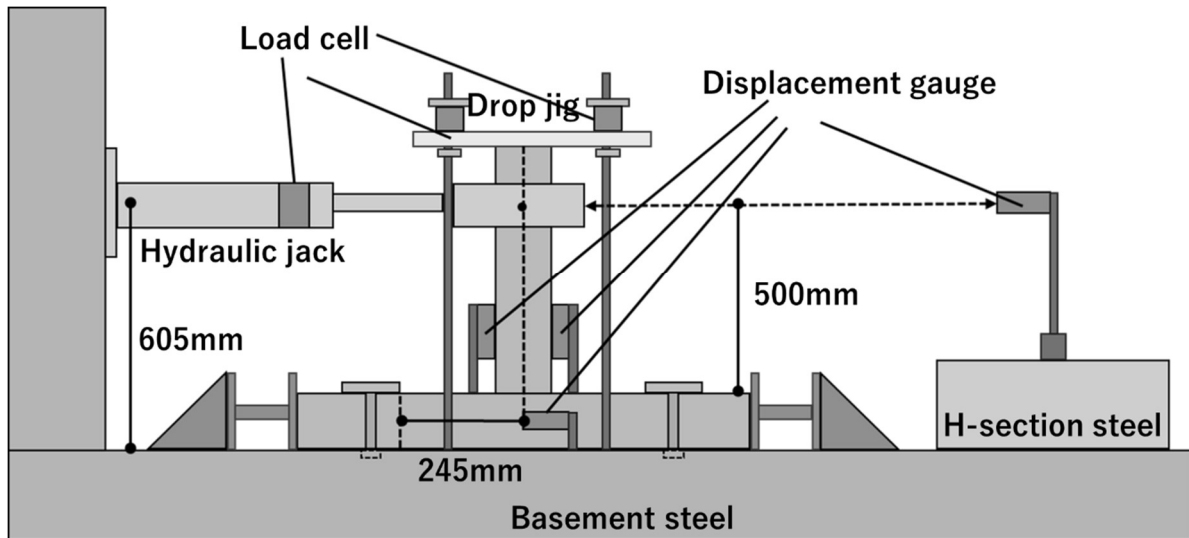
Figure 6. Experimental setup of flexural shear test.

The experimental setup of a joint member with a column and base is shown in Figure 6. The base was fixed to the foundation steel member by passing bolts through the steel plate on the left and right sides and tightening each bolt with a strength of 20 N. In addition, by assuming the actual building weight, an axial load of 10 kN was applied to the column through a drop jig. Then, a positive and negative cyclic load testing was applied 500 mm height from the upper surface of the base portion. The applied rotation angle (θ) was $1/450$, $1/300$, $1/200$, $1/150$, $1/100$, $1/75$, and $1/50$ [rad] in each three cycles, and then $1/30$, $1/15$, and $1/10$ [rad].

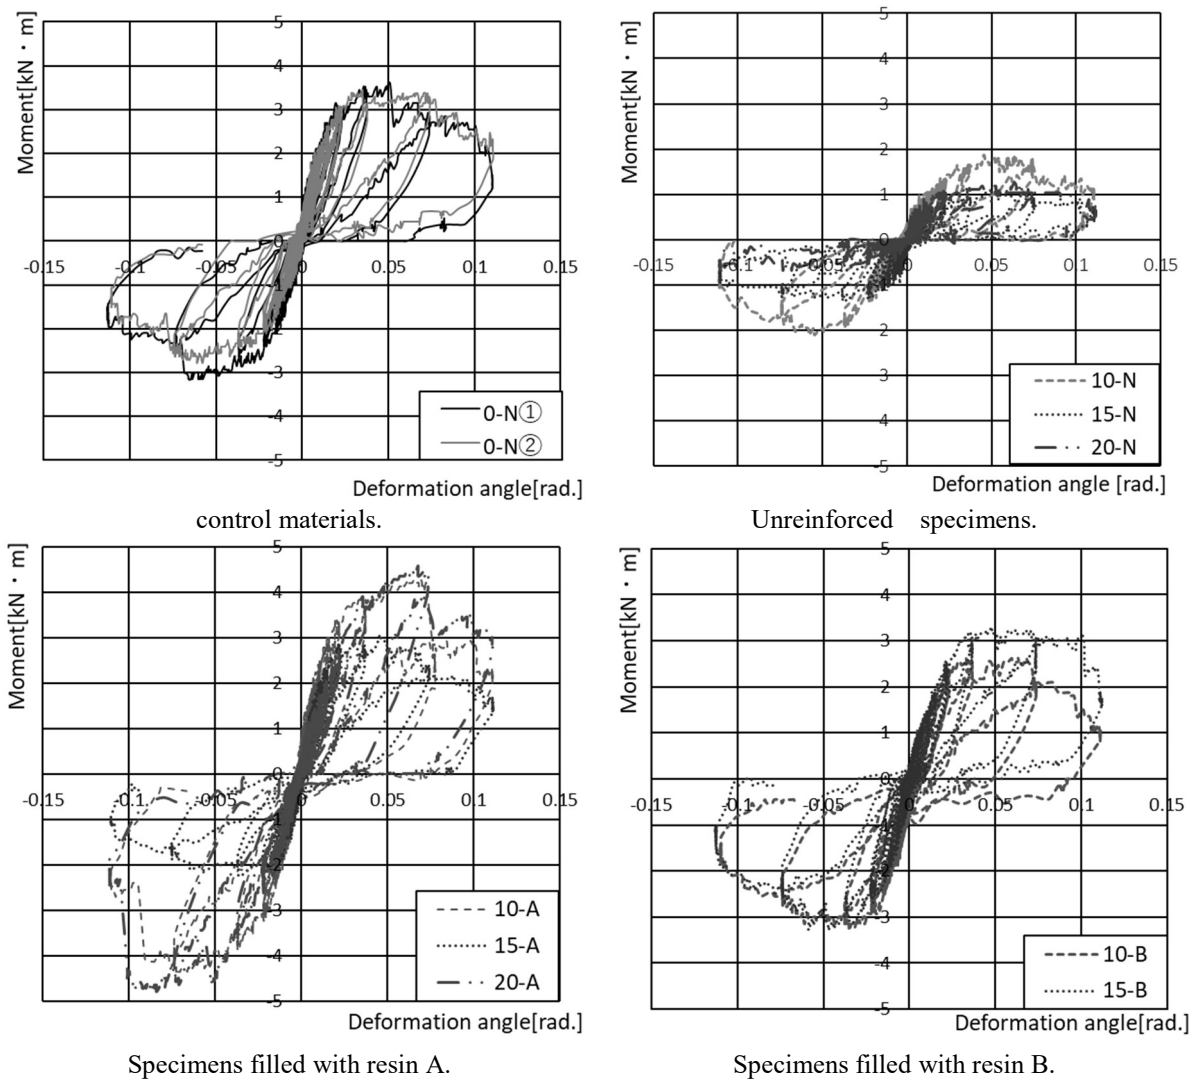
Figure 7. Relationship between the moment and deformation angle.

Figure 7 shows the relationship between the moment and deformation angles of joint specimens. “0” means without termite damage. “10”, “15,” and “20” represent 10%, 15%, and 20% weight losses due to termite damage, respectively. For 0-N, 10-N, and 20-A, the bending moment was increased up to $1/30$ rad (0.03 rad), and for the others, it was increased up to $1/50$ rad (0.02 rad). It can be observed that the strength significantly decreased with an increase in damage rate. Furthermore, the decreased strength was significantly restored by resin reinforcement.

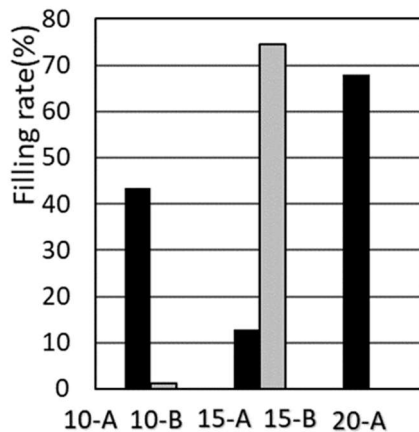
Figure 8. Filling rate.

The volume ratio of the resin to be filled into the specimen was calculated by using its density information and the mass reduction rate of the deteriorated specimens, as shown in Figure 8. All specimens were filled with resin as described above, and a significant difference in the filling rate for each specimen was confirmed.

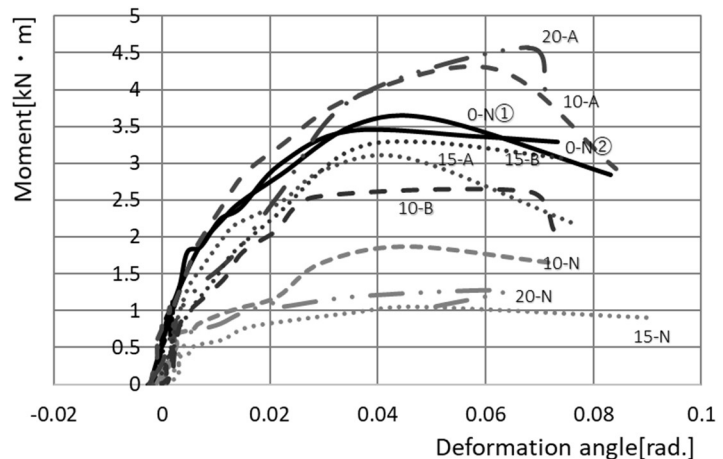
Figure 9. Relationship between moment and deformation angle

Figure 2 shows the skeletal curve between the moment and the deformation angle. Regarding the specimens without filling, the values of both rigidity and strength were lower than that of 0-N as a reference specimen. Regarding the specimens filled with resin A, a significant recovery in both rigidity and strength was observed. The rigidity and strength of 10-A and 20-A were higher than those of 0-N. The filling ratio of 15-A was about 10%. Therefore, it was observed that there would not be a considerable recovery of rigidity and strength because of insufficient filling. Overall, when the deteriorated timbers were filled with resin A, they exhibited a possibility of recovery in rigidity and strength. In contrast, the strength and rigidity of the specimens filled with resin B did not match that of 0-N. They exhibited higher strength and

rigidity than those without filling for the same feeding rate.

It was observed that the strength and rigidity of 10-B did not recover because of insufficient filling. In the case of 15-B, which had the highest filling rate, a complete recovery was not confirmed. This result might indicate that the low elasticity of resin was not effective for reinforcement. Despite the filling rate of approximately 40%, 10-A exhibited similar rigidity and strength to 0-N. If the filling level increased beyond a certain value, it might be unnecessary to fill the specimen completely. The variation in the filling rate was caused by bubbles generated due to the heat reaction of resin during curing. It will be necessary to evaluate the effect of the filling rate, filling position, and curing temperature of the resin on the mechanical properties of deteriorated timber members in the near future.

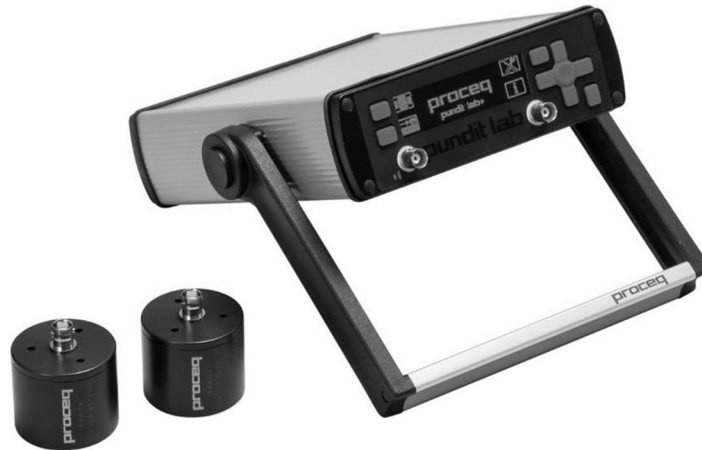
Figure 10. Ultrasonic testing machine. (pundit)

The damage caused by termites is significantly hidden inside the timber and often invisible. The ultrasonic testing machine (pundit) shown in Figure10, would be an effective method for detecting internal defects in timber. Ultrasonic pulse velocity can be measured by sandwiching both sides of the specimen. Filling conditions and restoration might be confirmed by evaluating the rate of change in ultrasonic velocity before and after resin filling.

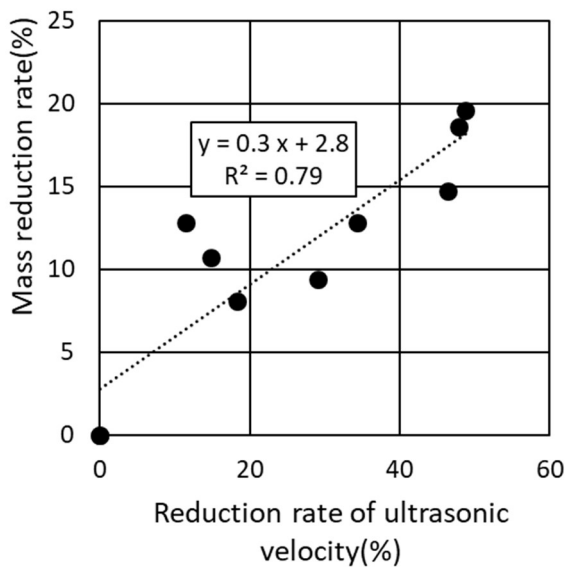
Figure 11. Relationship between mass reduction rate and reduction of ultrasonic velocity before and after feeding damage.

Figure11 shows the relationship between the mass reduction rate and the reduction in ultrasonic velocity before and after damage treatment. The reduction rate of ultrasonic pulse velocity is defined as the rate of the velocity to the velocity of the sound timber. A high correlation was observed between the mass loss rate and the reduction rate of ultrasonic velocity, as shown in Figure11. Hence, the mass loss rate can be identified by measuring the ultrasonic pulse velocity. As a result, it was suggested that the ultrasonic pulse velocity test might be effective in evaluating the deterioration by termites.

- A high correlation was confirmed between the mass loss rate and the reduction rate of ultrasonic velocity. Thus, it was suggested that the ultrasonic pulse velocity test might be effective in evaluating the deterioration by termites.

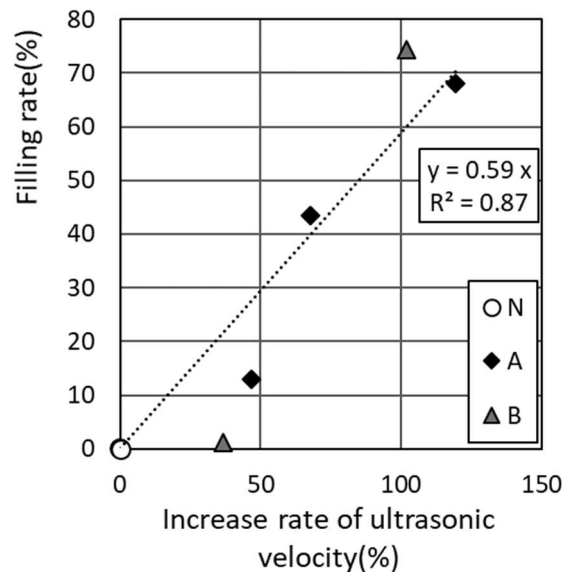
Figure 12. Relationship between filling rate and increase rate of ultrasonic velocity.

The relationship between the filling rate and the increased rate of ultrasonic velocity is shown in Figure 12, a high correlation was observed between them. Hence, the effectiveness of resin filling was confirmed by an increase in the ultrasonic pulse velocity

- A high correlation was observed between the filling rate and the increased rate of ultrasonic velocity. Therefore, the filling rate can be confirmed by an ultrasonic pulse velocity test in a non-destructive manner.
