## Long-term Performance of Repairs to Reinforced Concrete Exposed to Coastal Conditions

**Abstract.** Reinforced concrete (RC) specimens were treated using different combinations of surface coating and/or patch repair methods and materials, left in a coastal region with frost damage risk, and their properties characterized after 25 years of exposure. Specimens were prepared by chipping away concrete from one section of concrete block with embedded reinforcement bars to expose the bars, followed by patch repair and then surface coating. Four types of material were used for patch repair: cement mortar, styrene-butadiene rubber (SBR) polymer cement mortar, rust-resistant SBR polymer cement mortar, and lightweight epoxy mortar. Two types of material were used for surface coating: multi-layer textured and thin textured coating. Following exposure, cracks were visible only on the surfaces of untreated specimens, apparently due to rebar corrosion; they were absent from all specimens that had undergone surface coating and/or patch repair. In addition, the corrosion resistance of these methods and materials was investigated by measuring and comparing the surface areas of corroded rebar be

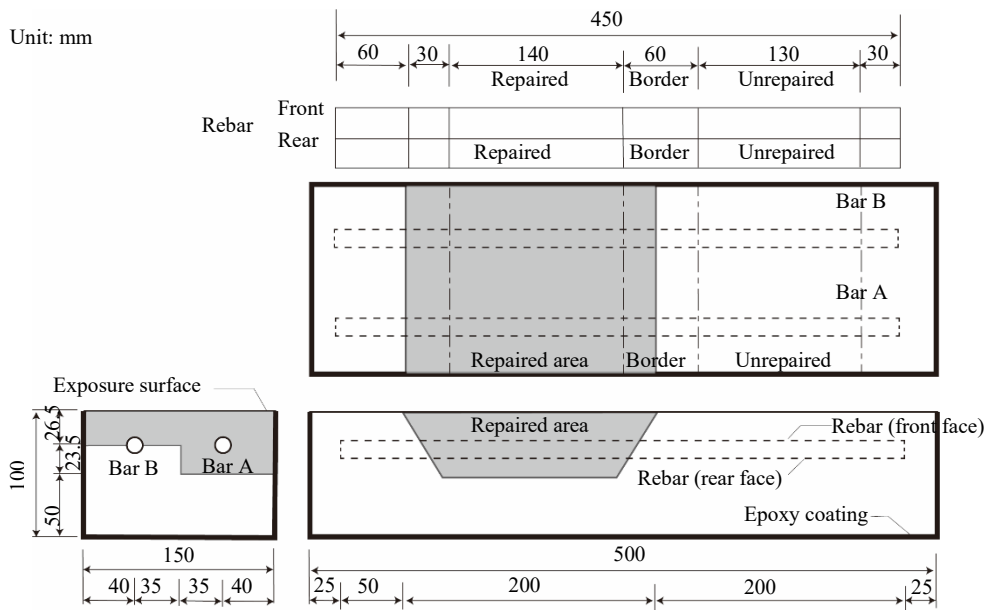
**Figure 1.** Schematic of RC specimen.

Table 1 shows the types of materials used in the repairs. Table 2 details the content and properties of the concrete; Table 3 shows its mix composition. The concrete used had a 28-day compressive strength of 30.8 N/mm<sup>2</sup>. Figure 1 is a structural schematic of the RC specimens. First, concrete was chipped away from a designated area of the RC slab, which had two reinforcing steel bars (“rebar”) embedded in it. Next, this area was patched and its surface coated using a specific combination of materials. Concrete was removed to two different depths (“chipping depth”), defined relative to the embedded rebar: (A) chipping extended below the bar, allowing it to be completely covered with mortar, or (B) chipping reached the same depth as the rebar axis, meaning only half of it was covered with mortar. Figure 2 explains the notation of the specimen IDs in the Results section. Two-symbol IDs denote RC specimens, while three-symbol IDs denote the rebars embedded in them.

Next, rust was removed from the extricated bars by immersion in 10% di-ammonium citrate. Each bar was sectioned into three parts according to Figure 1 (Repaired, Border, and Unrepaired), and the corrosion mass loss calculated for each part (Nishimura N. *et al.*,2012, Kakegawa, M.*et al.*,2012). Corrosion speed was then calculated based on the mass loss using the following equation (Sato K. *et al.*,2002).

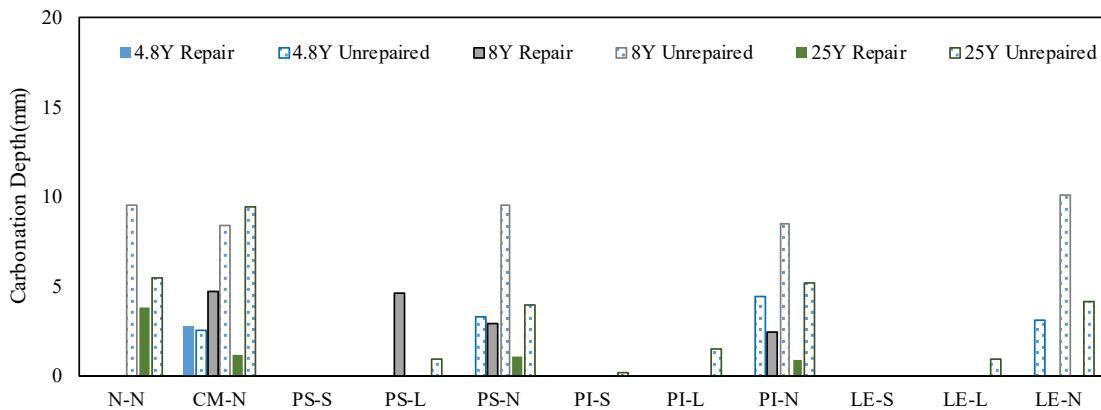
Figure 5. Carbonation depth.

Figure 5 shows the measurement data for carbonation depth. Carbonation depth was most affected by the presence of surface coating itself, consistently measured deeper in specimens whose surfaces had not been coated at all (-N). When present, multilayer textured coating (-S) provided superior protection to thin textured coating (-L): specimens treated with it experienced almost no carbonation at all, irrespective of patching mortar type, evidencing its excellent resistance to carbonation.

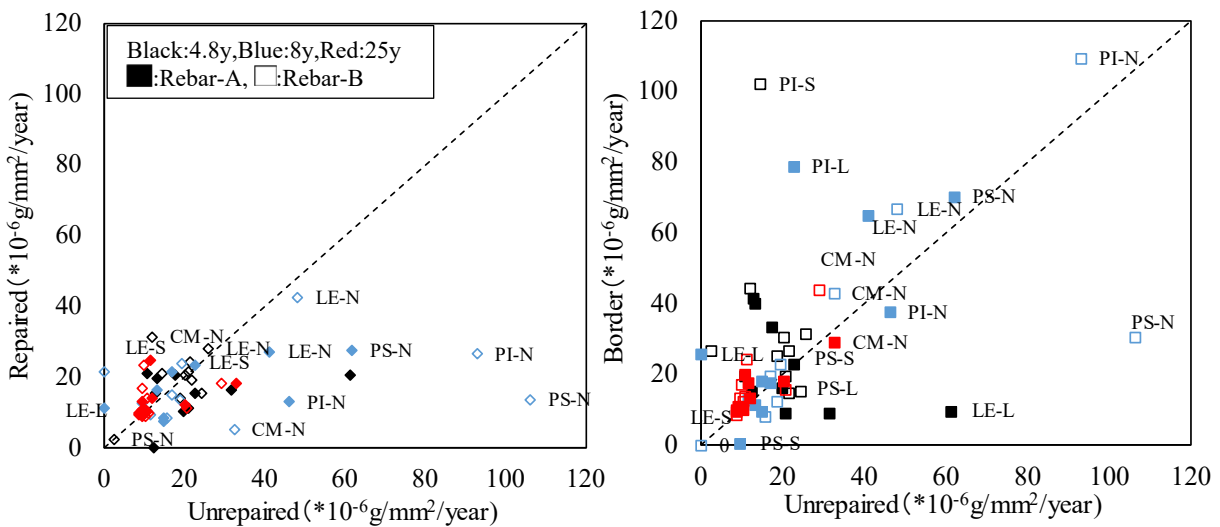
Figure 7. Rebar corrosion speed.

$$\Delta W_s = \frac{\Delta W_c \times W_0}{\varphi \times l \times \pi \times t} \quad (1)$$

Where  $\Delta W_s$  is the rebar corrosion speed ( $10^{-6}g/mm^2/y$ ),  $\Delta W_c$  is the mass loss due to rust (%),  $W_0$  is the initial weight of the rebar (g),  $\varphi$  is its diameter (13 mm),  $l$  is its length in the part under analysis (mm), and  $t$  is the exposure length (year).

Figure 7 depicts correlations of rebar corrosion speed in the unrepaired versus border and repaired sections. Corrosion was effectively prevented by the repair techniques utilized, by and large proceeding at slower speeds in repaired than unrepaired rebar. Corrosion speed was quite high in the border region after eight years of exposure following repair with the rust-resistant SBR polymer cement (PI). This behavior could be attributable to a macrocell formed by a major differential in corrosion potential between the repaired and unrepaired parts due to the anti-rust additive in the mortar. However, the same tendency was not apparent in the 25-year-old specimens repaired using the same material, suggesting this variation likely originated in individual differences between specimens.

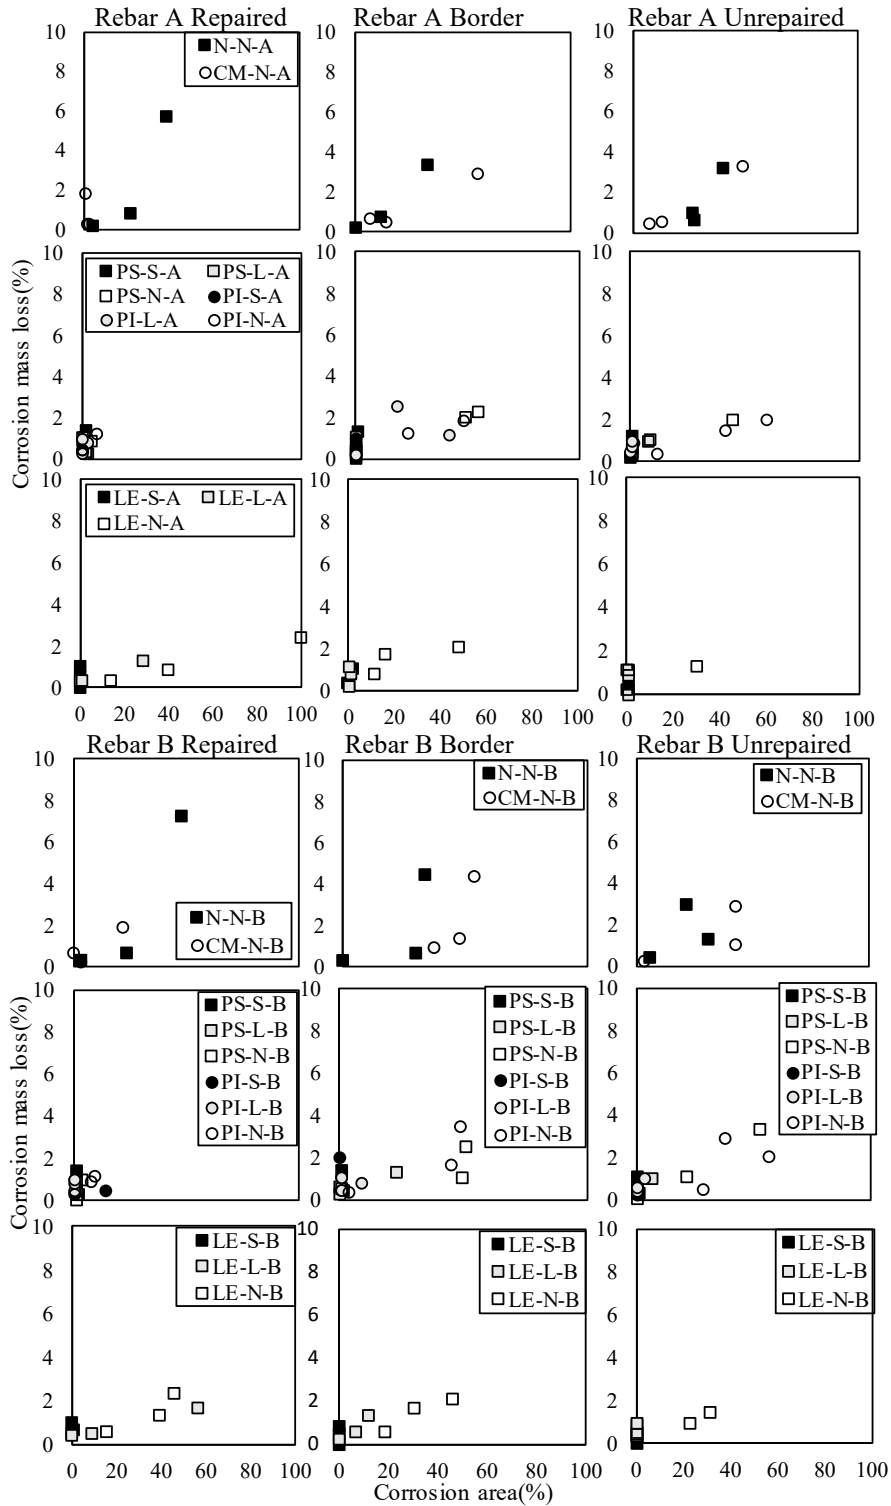
Figure 8. Rebar corrosion area versus mass loss by repair material and chipping depth.

Figure 8 separately depicts the associations between the rebar corrosion area (itself affected by chipping depth) and corrosion mass loss by type of patching material. Specimens not treated by patch repair or surface coating (N-N-) experienced major mass loss, directly proportional to

corrosion area. In addition, corrosion progressed not only along the surface of rebar, but also towards its interior. When cement mortar was used for patch repair (CM-), the corrosion area and mass loss of the repaired region tended to be greater for B rebar than for A rebar. This suggests that chipping away enough concrete so that the entire area surrounding the rebar can be coated with patching mortar should effectively protect against corrosion. In addition, the corrosion area and mass loss of the repaired region were lower when SBR-type polymer cements (PS, PI) were used as the patching mortar than for lightweight epoxy (LE), evidencing the former materials' superior ability to protect against corrosion in patch repairs. Corrosion was prevented rather poorly by LE: when it was used, corrosion tended to spread widely across the rebar surface in the repaired region. No matter which material was used for patch repairs, the usage of multi-layer textured coating (-S-) was associated with significant drops in both corrosion area and weight loss, suggesting this material effectively resists corrosion and block the penetration of chloride ions. The only difference between PI and PS is the presence of an anti-rust additive in the former. Figure 8 shows that both materials well protect against rebar corrosion in the repaired region, with only marginal benefits afforded by the anti-rust compound.

However, specimens repaired using PI or PS tended to experience greater rebar corrosion along the border and non-repaired parts, especially in the absence of finish: this suggests the occurrence of macro-cell corrosion due to differential susceptibility to chloride penetration between the repaired and unrepaired segments. Notably, the multi-layer textured finish was the thickest of all types tested, achieving high chloride resistance and little penetration in the border and unrepaired segments on the whole. This characteristic may be why serious rebar corrosion was never really observed in the border and unrepaired parts of specimens coated with it.
