DIGITIZATION OF CULTURAL HERITAGE BUILDINGS FOR PREVENTIVE CONSERVATION PURPOSES

Keywords: Historical Constructions, Preventive Conservation, Digital Documentation, Geospatial Database, PlusCare System, Internet of Things

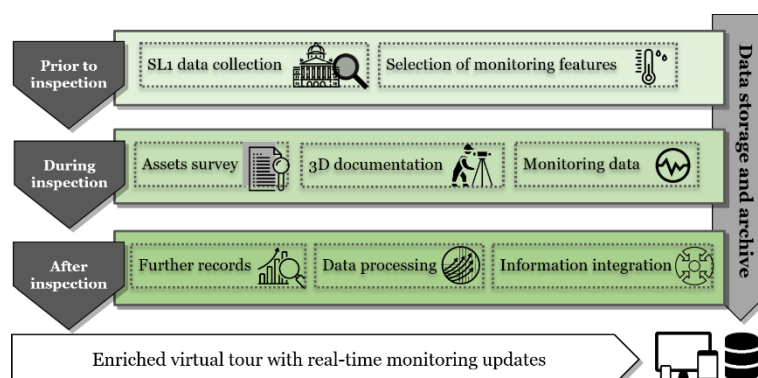
Figure 1: PlusCare protocol of the HeritageCare preventive conservation system.

On the other hand, the PlusCare protocol (SL2) provides a more extended knowledge of the heritage ensemble by complementing and integrating the information collected during SL1 with an in-depth documentation of the building state, including detailed inspections of indoor assets, high-resolution surveys, monitoring of relevant parameters and recording of any supplementary data that can contribute to increase the level of knowledge about the actual condition of the buildings/assets (Figure 1). As better described in the next section, the implementation of this protocol relies on a dual Web-GIS tool that allows the integration and georeferentiation of different data sources, while providing an intuitive environment from which the non-expert users (owners and managers) can access the most significant information for the preventive conservation of their buildings.

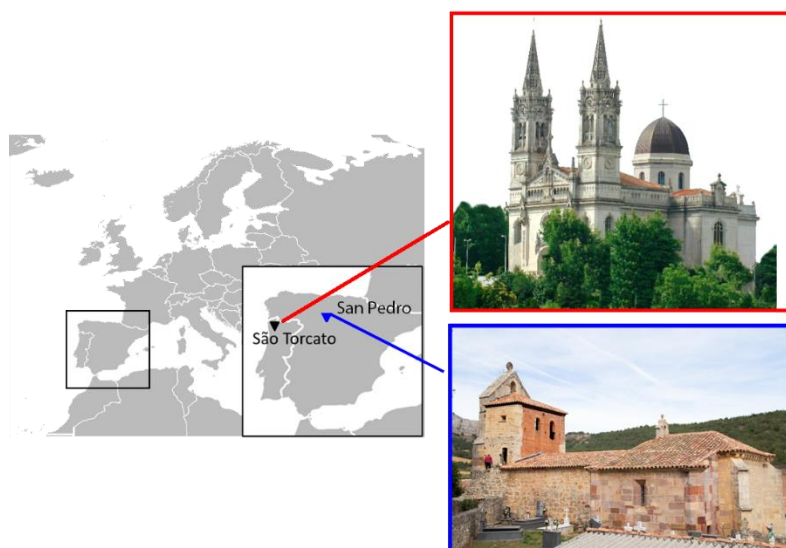
Figure 2: Location and exterior view of the study cases: in red the church of São Torcato and in blue the church of San Pedro.

During the project, the HeritageCare protocols and related tools were successfully tested across a notable number of heritage buildings among Portugal, Spain, and Southwestern France. As an example, this section summarizes the application of the PlusCare protocol to two complementary case studies (Figure 2): a large Neo-Manueline church situated nearby Guimarães, Portugal, and a small Romanesque church located in Becerril del Carpio, Palencia, Spain.

The catholic temple of San Pedro is located in the municipality of Becerril del Carpio in Palencia, Spain (Figure 2). This building was originally erected in Romanesque style with a single nave solved by means of a barrel vault, while the apse was erected in Late-Gothic style with a groin vault of eight sides. In the past the church suffered a settlement in the north part of the nave, suffering visible deformations and cracks along the tower, choir, and main nave. During 2007 an extensive diagnostic investigation was carried out with the aim of evaluating the stability of the structure as well as the degradation state of the assets and, during 2011, a major restoration took place. On the one hand, the structure was retrofitted by enlarging the foundations placed below the buttresses in order to reduce the stresses on the soil (this solution was built in reinforced concrete); additionally, the extrados of the vaults covering the main nave were strengthened with a textile reinforced mortar made of basalt fibers and a lime matrix. On the other hand, cleaning and restoration actions were performed on the assets with the aim of enhancing their understanding and avoiding their impairment and loss of value. However, a preventive conservation protocol that could allow to maintain both the structure and its indoor assets in good conditions was not designed.

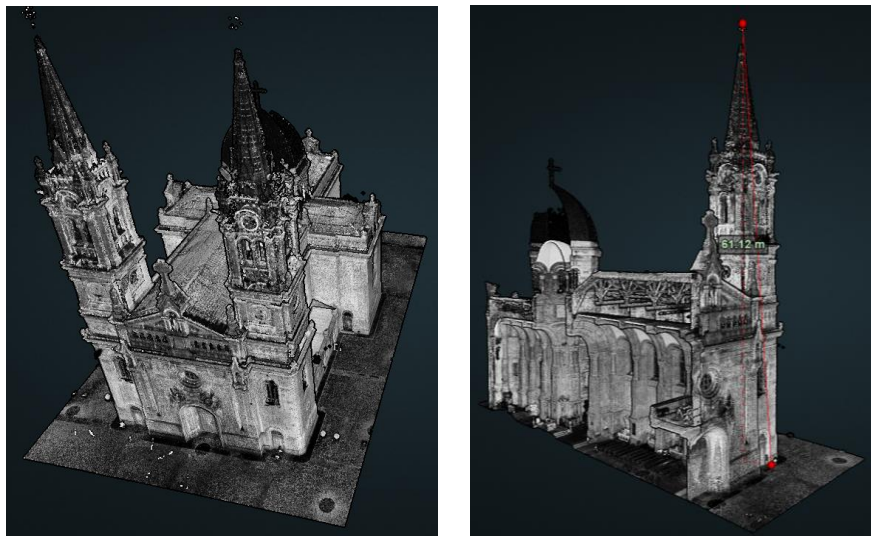
Figure 4: Point clouds of São Torcato church. Exterior view (left) and longitudinal section (right).

A laser scanner survey was carried out using a Leica ScanStation P20 in order to obtain high-resolution 3D data for accurate geometrical representation and geo-referenced damage mapping. With a maximum capture rate of 1,000,000 points per second, this tool allowed to collect in one working day millions of points carrying precise volumes of information about exterior and interior of the church, thus constituting a valuable reference source of the current conservation state of the heritage (Figure 4). This 3D model required the work of two technicians during 3 weeks and 174 scan stations, obtaining a 3D point cloud made up by 3 billion of points. Then, this point cloud was reduced by different filters to 17 million of points. In parallel, the as-built 360° camera Ricoh theta V camera was employed to take 360° panoramic images both inside and outside. This camera is equipped with two 180° fish-eye lenses that allow to obtain, in a direct way, a 360° panorama. About 110 minutes were necessary to capture 42 panoramas for the virtual environment (2-3 minutes per panorama). Both point cloud and photos were stored into the PlusCare system - along with the rest of information collected about the church - and used as imagery input to create an enriched virtual tour by

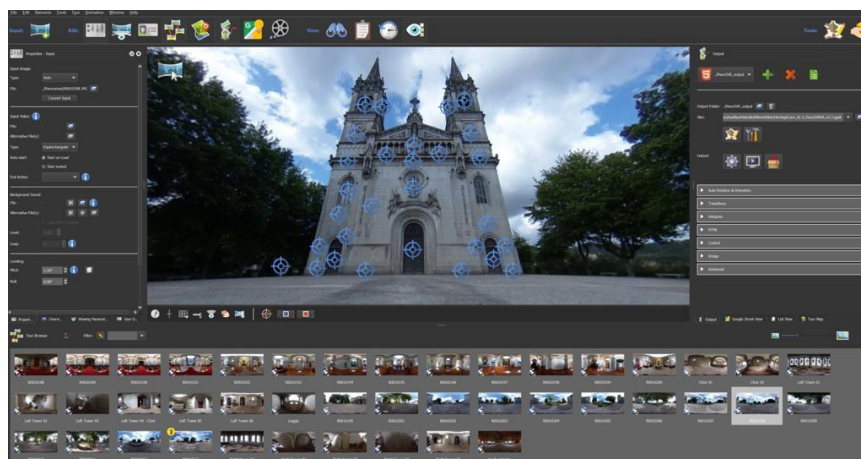
a)

Figure 5: PlusCare system: (a) virtual tour creation through HeritageCare4Pano2VR; (b) final output of São Torcato church.

means of the low-cost software Pano2VR® as well as the in-house plugin HeritageCare4Pano2VR (Figure 5a). This complement allows to use virtual tours for preventive conservation, adding some extra features that can be consulted in Sánchez-Aparicio et al. [2]. Through this visual tool, the owner was given the possibility to interactively navigate across the church and access fundamental information about its current condition (e.g. type and location of damages, assets condition, geometric details, past monitoring records) through pre-defined hotspots (Figure 5b). It is worth mentioning that each time new data is uploaded to the platform and georeferenced, new hotspots are automatically created inside the virtual tour and linked to the relevant information. Moreover, if a monitoring system is installed, real-time updates of the monitored parameters can be displayed on screen together with the corresponding warning levels to assist the owner in undertaking appropriate condition-based maintenance actions [2].
