## SEISMIC VULNERABILITY OF HERITAGE CHURCHES IN QUÉBEC: THE NÉO-ROMAN TYPOLOGY

**Keywords:** seismic vulnerability assessment, masonry churches, Néo-Roman typology, Québec

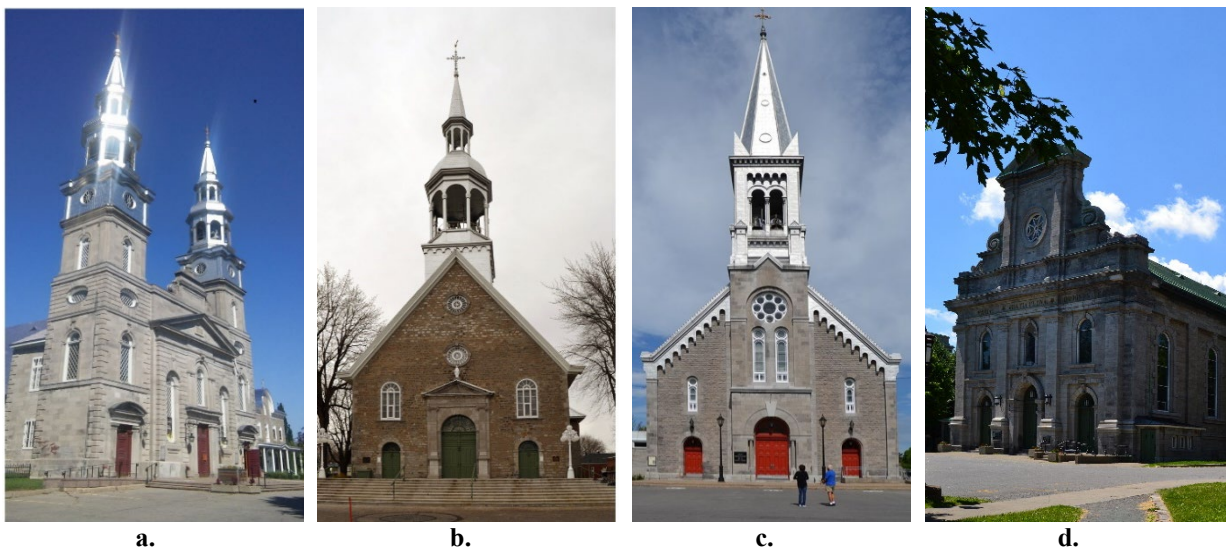
**Figure 2** Main typologies identified in the island of Montreal: **a.** the Baillargé; **b.** the Conefroy; **c.** the Néo-roman; **d.** the Italian baroque.

During a collaborative project between Politecnico di Milano and École de Technologie Supérieure of Montreal some churches from the sample of 108 have been surveyed in detail, identifying among them four main typologies: the Baillargé (1790-1820), the Conefroy (from 1800), the Néo-roman (1880-1930), and the Italian baroque (second half of 1800) (figure 2). Some initial considerations on the seismic vulnerability related to these typologies were expressed and detailed in [15] and are summarized here.

In the Néo-roman typology, the façade is discontinuous, with the bell tower at the center. This is a determinant aspect in the structural response, influenced by the tower position and height. Moreover, in the visited churches, recurring crack patterns were observed in the lateral walls of the nave and in the façade plane in proximity of the bell tower, as well as near openings, suggesting the development of specific damage mechanisms.

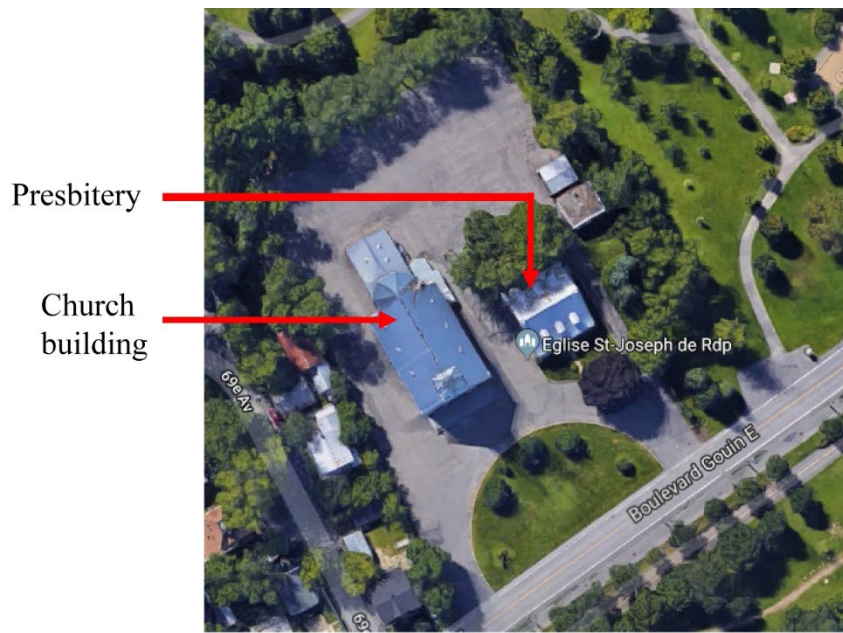
**Figure 5** St. Joseph: the church and the presbitery

The main body of the church is isolated from the presbytery and it is composed of the nave and the apse, and in the back side, of the sacristy (figure 5).

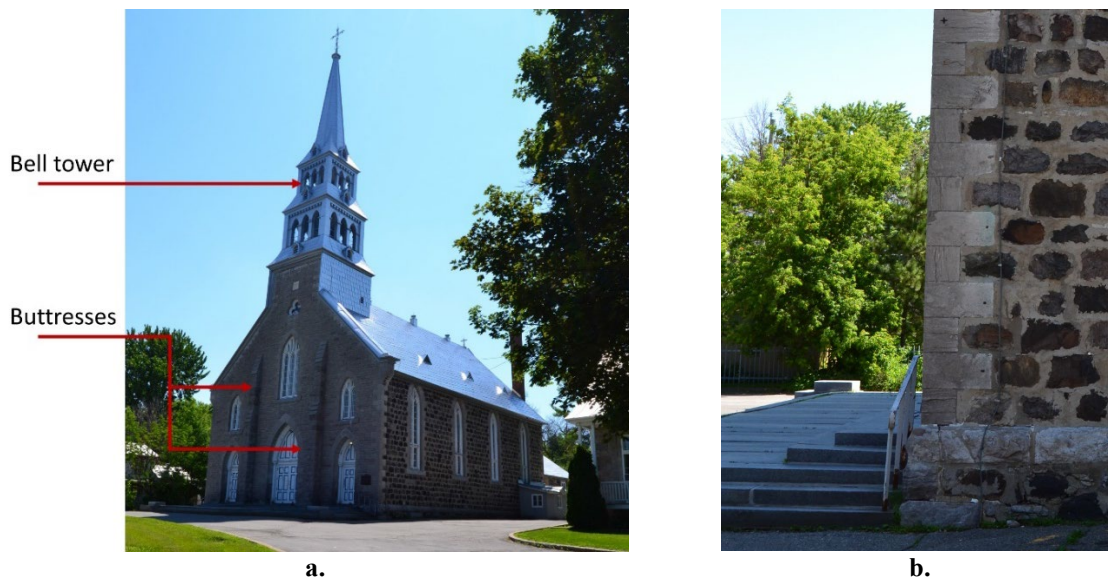
**Figure 6** The exterior of the church: **a.** The principal elevation; **b.** The detail of interconnection between walls.

The façade of this church has a distinguishing aspect. The bell tower, which interrupts the hut shape of the façade at the middle, is flanked by a pair of buttresses (figure 6a). The curtain walls of the church are made of stone masonry. Multi-leaf walls are connected one to the other through well-defined stone blocks (Figure 6b). This solution was frequently observed in the inspected churches and, therefore, it has been identified as a territorial specificity.

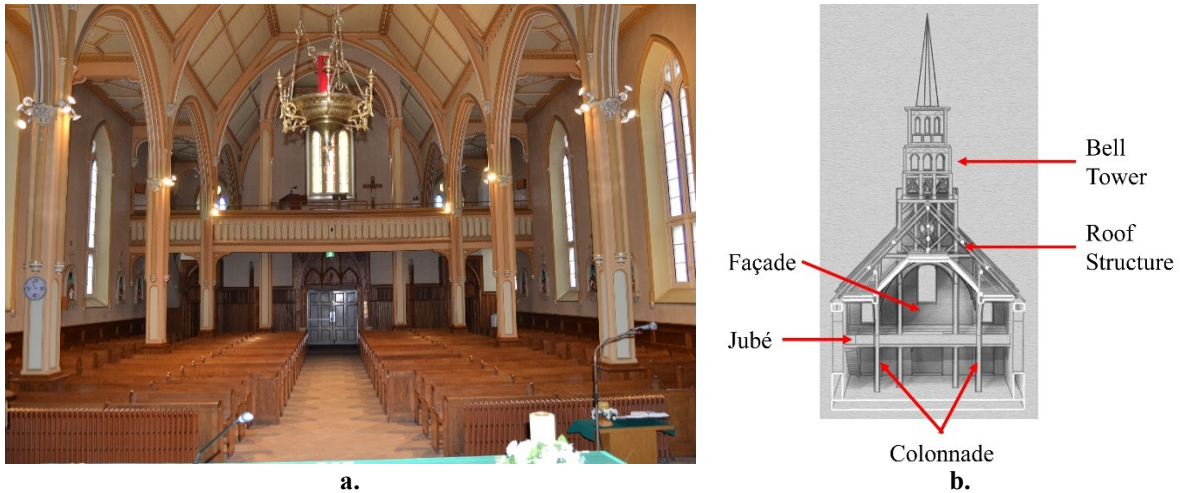
**Figure 7** The configuration of the structure of the church: **a.** Colonnade of the nave and jubé; **b.** Transversal section of the church.

The church has three naves with a timber colonnade that, giving rhythm to the space of the

nave, supports the roof structure together with the lateral walls of the nave (figure 7). An overhanging deck, called “jubé”, hosting the choir and, as in most of the churches, the organ, characterizes the space of the church entrance.

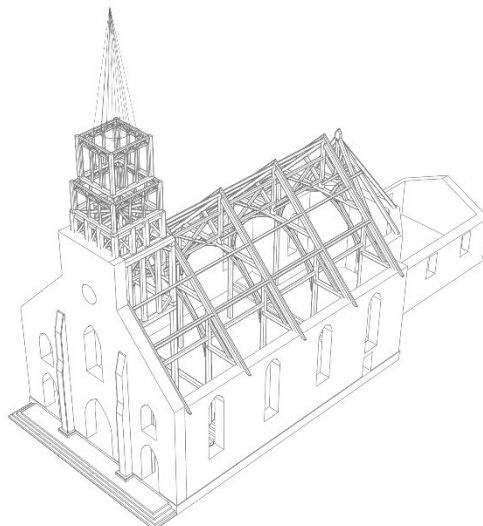
**Figure 8** Three-dimensional geometrical model of St. Joseph.

In order to interpret the structural behavior, also a detailed inspection of the roof and bell tower area was performed. This action was a fundamental step to understand the complexity of the structure of roof and bell tower and the interrelation with the masonry box, which brought to elaborate a complete three-dimensional model (figure 8) [24-26]. This has constituted the basis for a finite element model. During the survey, it was possible to observe the state of conservation of the timber roof structure, the connection between timber elements and between timber elements and masonry, and to detect the presence of existing cracks that, in case of earthquake, could be the starting point of damage and mechanism development.

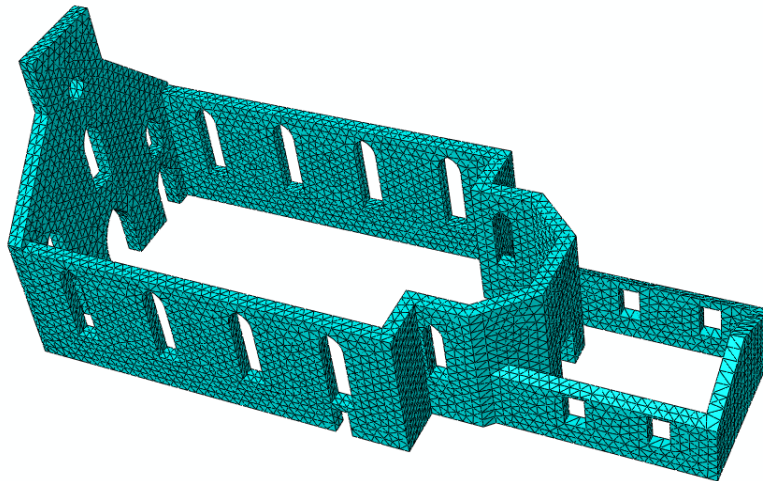
Figure 9 Tetrahedral mesh of the global model of St. Joseph.

A finite element model was elaborated in Abaqus [27] to investigate the global structural behavior of the church. A first stage of the study concerned the masonry structure, with the aim at understanding the role of the main structural elements on the response. At this step, linear analyses were implemented, while non-linear analyses were not performed due to the lack of extensive damage data, as it occurs in the Italian territory. Indeed, such comparison would allow the calibration of the results, considering them reliable. A mesh of over 36000 tetrahedral elements was developed, with two elements in the thickness of the walls (figure 9).

The heterogeneity of the masonry was neglected in the model and an equivalent homogeneous isotropic material was defined, with the following properties: Young's modulus  $E = 2200$  MPa, and weight density  $w = 20$  kN/m<sup>3</sup>. The contributions of the roof and the bell tower were included in the model considering the mass of the wood structure, with weight density  $w = 4.5$  kN/m<sup>3</sup>.
