27th International Conference on Fracture and Structural Integrity (IGF27)

# Tensile behaviour of a hot work tool steel manufactured via Laser Powder Bed Fusion: effect of an innovative high pressure heat treatment

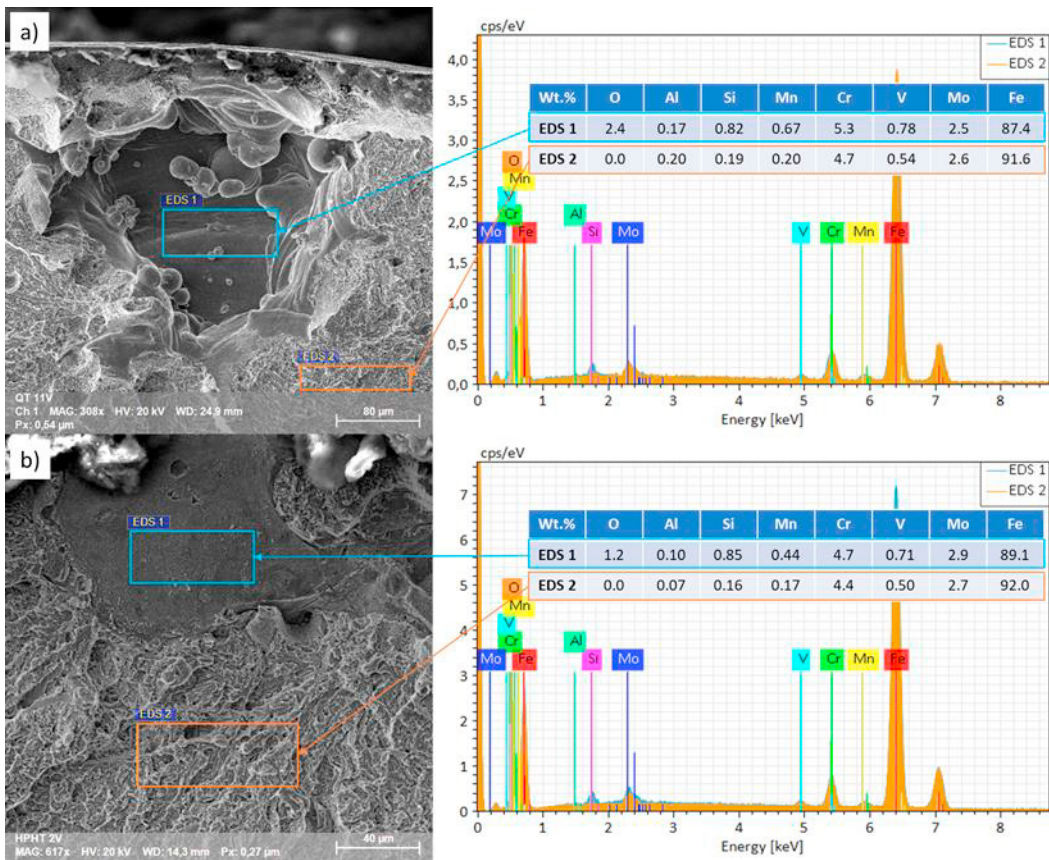
Fig. 7. Killer defects at crack initiation sites in CHT (a) and HPHT (b) samples and SEM-EDS analyses showing the local enrichment of Cr, V, Mn, Si and O.

To confirm the supposed unstable crack propagation failure mechanism, Linear-Elastic Fracture Mechanics (LEFM) were applied by calculating the mode I-stress intensity factor  $K_I$  at killer defects observed at the crack initiation sites on fracture surfaces, examples of which are reported in Figure 7.  $K_I$  was calculated using the formula

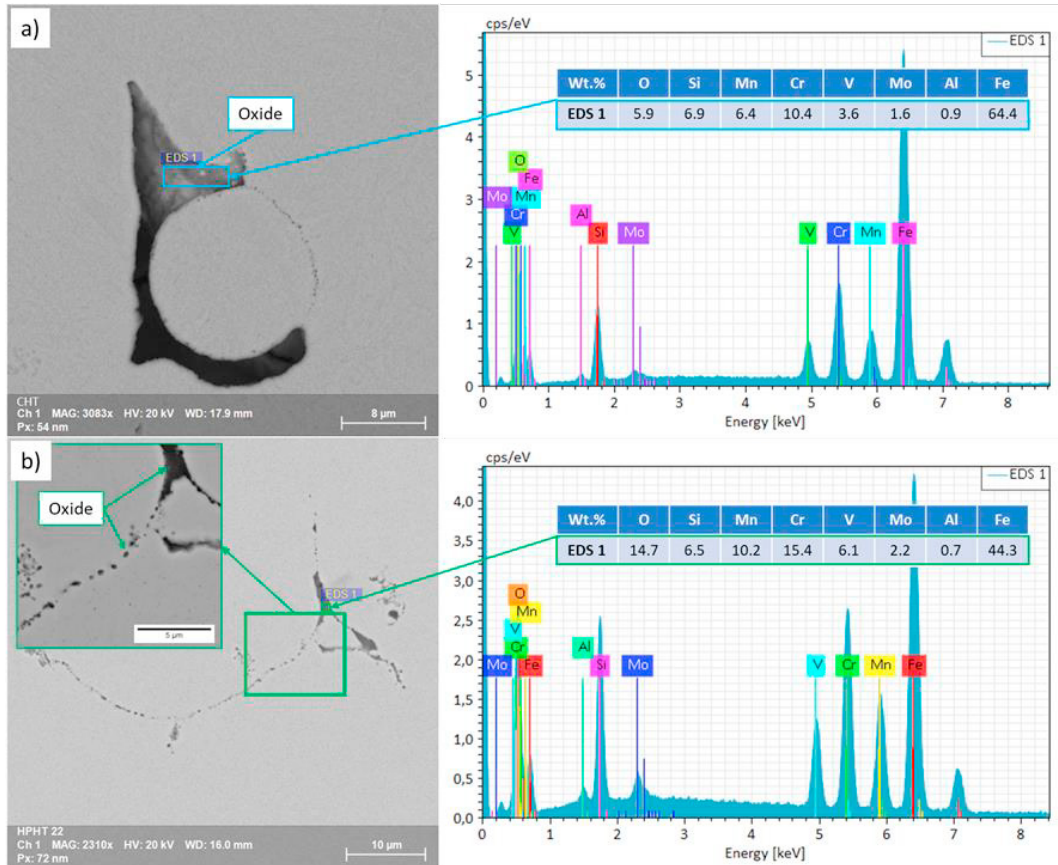
Fig. 10. Examples of defects found on metallographic sections: *Lack of Fusion* in a CHT sample (a) and shrunk *Lack of Fusion* filled with oxides in a HPHT sample (b).
