Interfacial bond strength and failure modes of traditional and modern repair materials for historic fibrous plaster

Fibrous plaster ceilings, interface, adhesive tests, tensile load, pull-off strength, adhesive failure, cohesive failure.

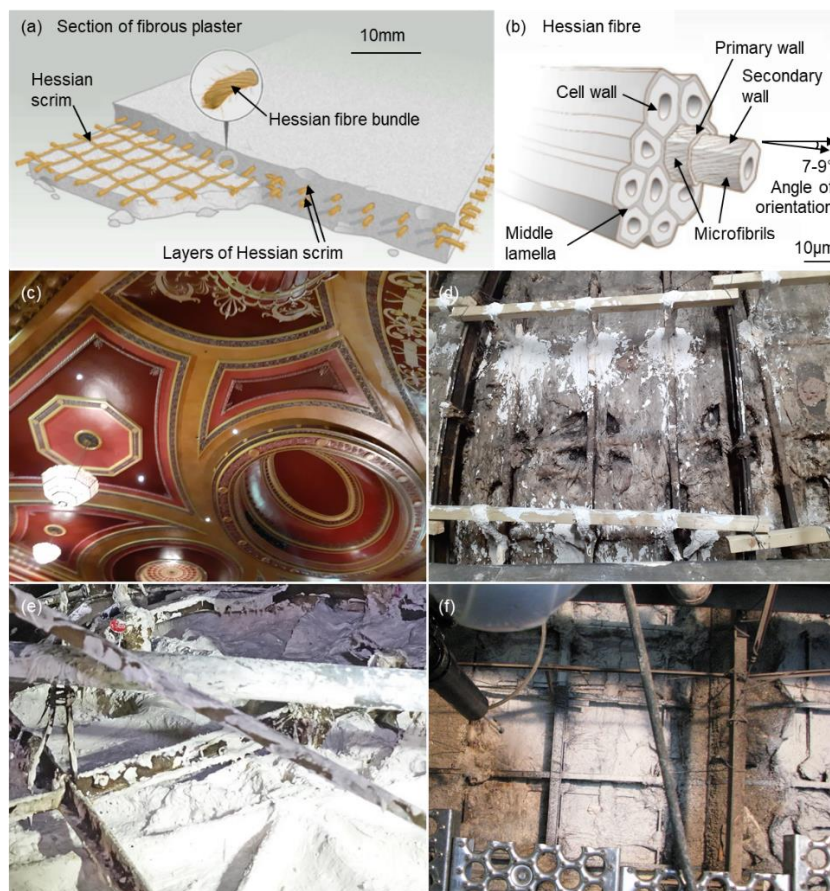
144
 145 *Figure 1 – Historic fibrous plaster ceiling structure and examples of modern repair methods. (a), (b)*
 146 *Axonometric drawing of fibrous plaster element with hessian scrim and Illustration of hessian fibre*
 147 *structure (Source: [14]). (c) A theatre's fibrous plaster ceiling underside showing decoration and ornate*
 148 *features (Source: Author). (d) An example of newly applied fibrous plaster composite wads (Source:*
 149 *Author). (e) Laminations of an acrylic modified plaster with alkali-resistant quadaxial fibreglass*
 150 *reinforcement on the topside of a ceiling (Source: [12]). (f) The application by spraying of a thin*
 151 *lamination of HPCP RE Aramid Gel™ on to a ceiling topside (Source: [19]).*

67 Figure 1b showing a close-up drawing of a hessian fibre structure [14]. Figure 1c shows the
68 decorated underside of a fibrous plaster ceiling.

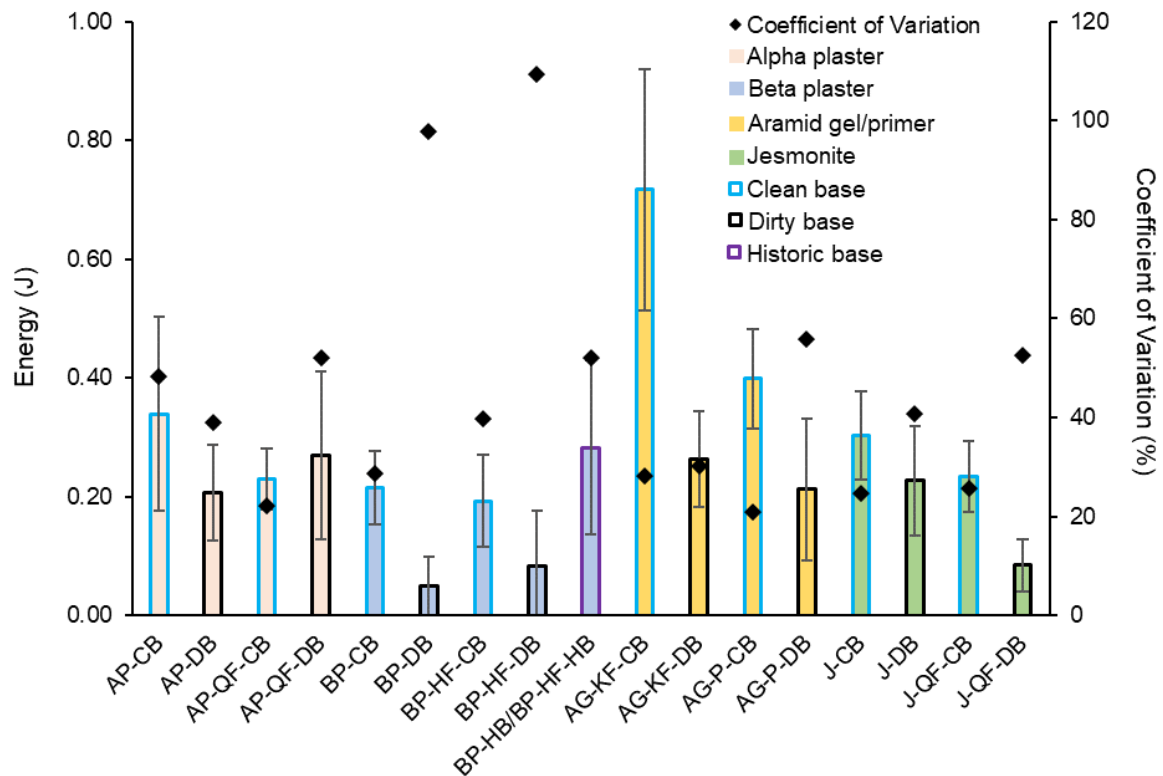
Figure 7 – Mean values of the work done, expressed in energy, of specimens in each sample group, with error bars denoting standard deviation and ♦ representing the coefficient of variation.

460 Figure 7 integrates the area under the force-displacement curves shown in Figure 4 to measure
461 the work done in loading the specimens to failure, expressed in terms of energy (in Joules) for
462 the sample groups, with the standard deviation and coefficient of variation also represented as
463 per Figure 5 and Figure 6.

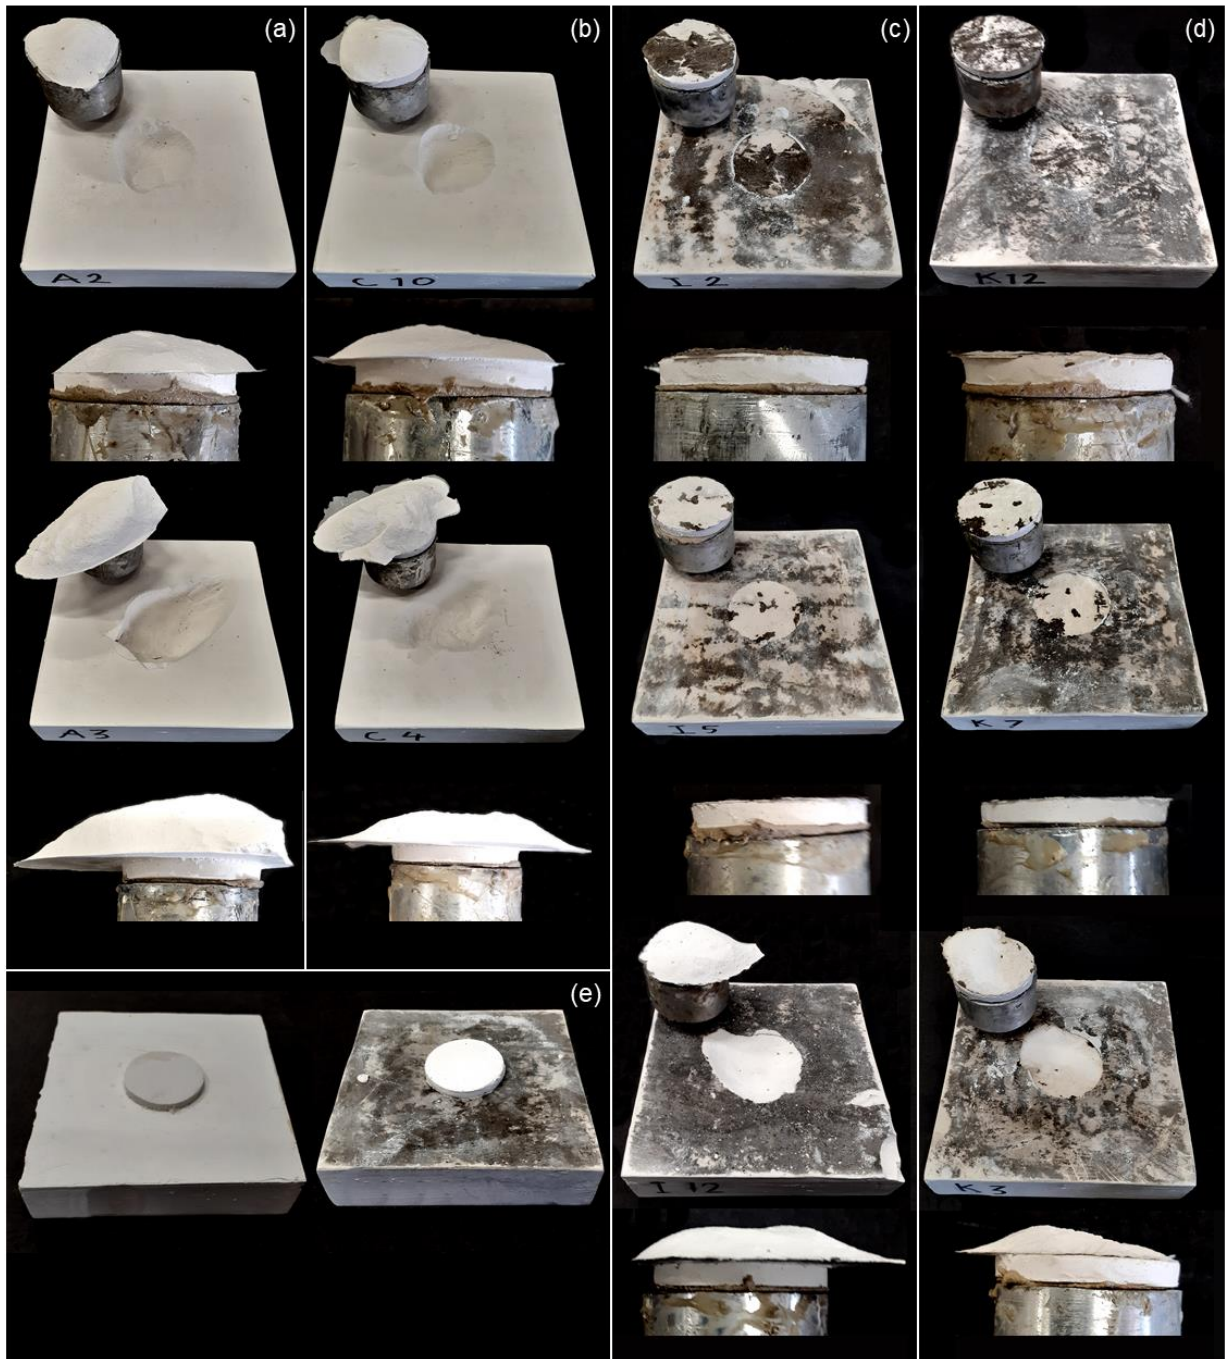
594 *Figure 9 - Tested specimens from groups AP-CB, AP-QF-CB, AP-DB, and AP-QF-DB. (a) Group AP-*
 595 *CB, cohesive failure of base material. (b) Group AP-QF-CB, cohesive failure in bases. (c) Group AP-*
 596 *DB, partial cohesive failure of base material (top, middle) and cohesive failure (bottom images). (d)*
 597 *Group AP-QF-DB, partial cohesive failure of base material (top, middle) and cohesive failure of base*
 598 *material (bottom). (e) Clean based (left) and dirty (right) specimens. Cylinders 50 mm Ø and base*
 599 *dimensions 150 mm x 150 mm.*

548 Images of selected specimens from sample groups AP-CB, AP-QF-CB, AP-DB and AP-QF-
549 DB showing the range of failure types are presented in Figure 9. Figure 9a depicts specimens
550 from sample group AP-CB, which featured Alpha plaster on clean bases and showed cohesive
551 failure of the base with varying extents of material pulled out of the base with the least amount
552 pulled out in the top image and the most in the bottom image. Figure 9b shows specimens
553 from sample group AP-QF-CB, which used Alpha plaster with quadaxial fibres on clean bases;
554 again these all showed cohesive failure with varying extents of material pulled out of bases,
555 the least in the top image and most in the bottom image; the set primer applied to the bases
556 prior to the cylinders being affixed can also be seen on the material around the circular area
557 on the metal block in both the top and bottom specimen images.

558 Figure 9c illustrates specimens from sample group AP-DB, which used Alpha plaster on dirty
559 bases. Group AP-DB largely showed partial cohesive failure in the base, with small quantities
560 of base material being removed, the least amount in the top image, the most in the middle
561 image and in the bottom image is the one instance of cohesive failure in the sample group with
562 a bulk quantity of material pulled from the base; this may be due to less dirt being present in
563 the circular area on this specimen. Figure 9d depicts specimens from sample group AP-QF-
564 DB, with Alpha plaster and quadaxial fibres on dirty bases. Specimens showed partial cohesive
565 failure with small quantities of base material being removed as shown in the top and middle
566 image; again there was one exception as shown in the bottom image which can be classed as
567 cohesive failure and a bulk quantity of base material pulled off. Figure 9e shows specimens

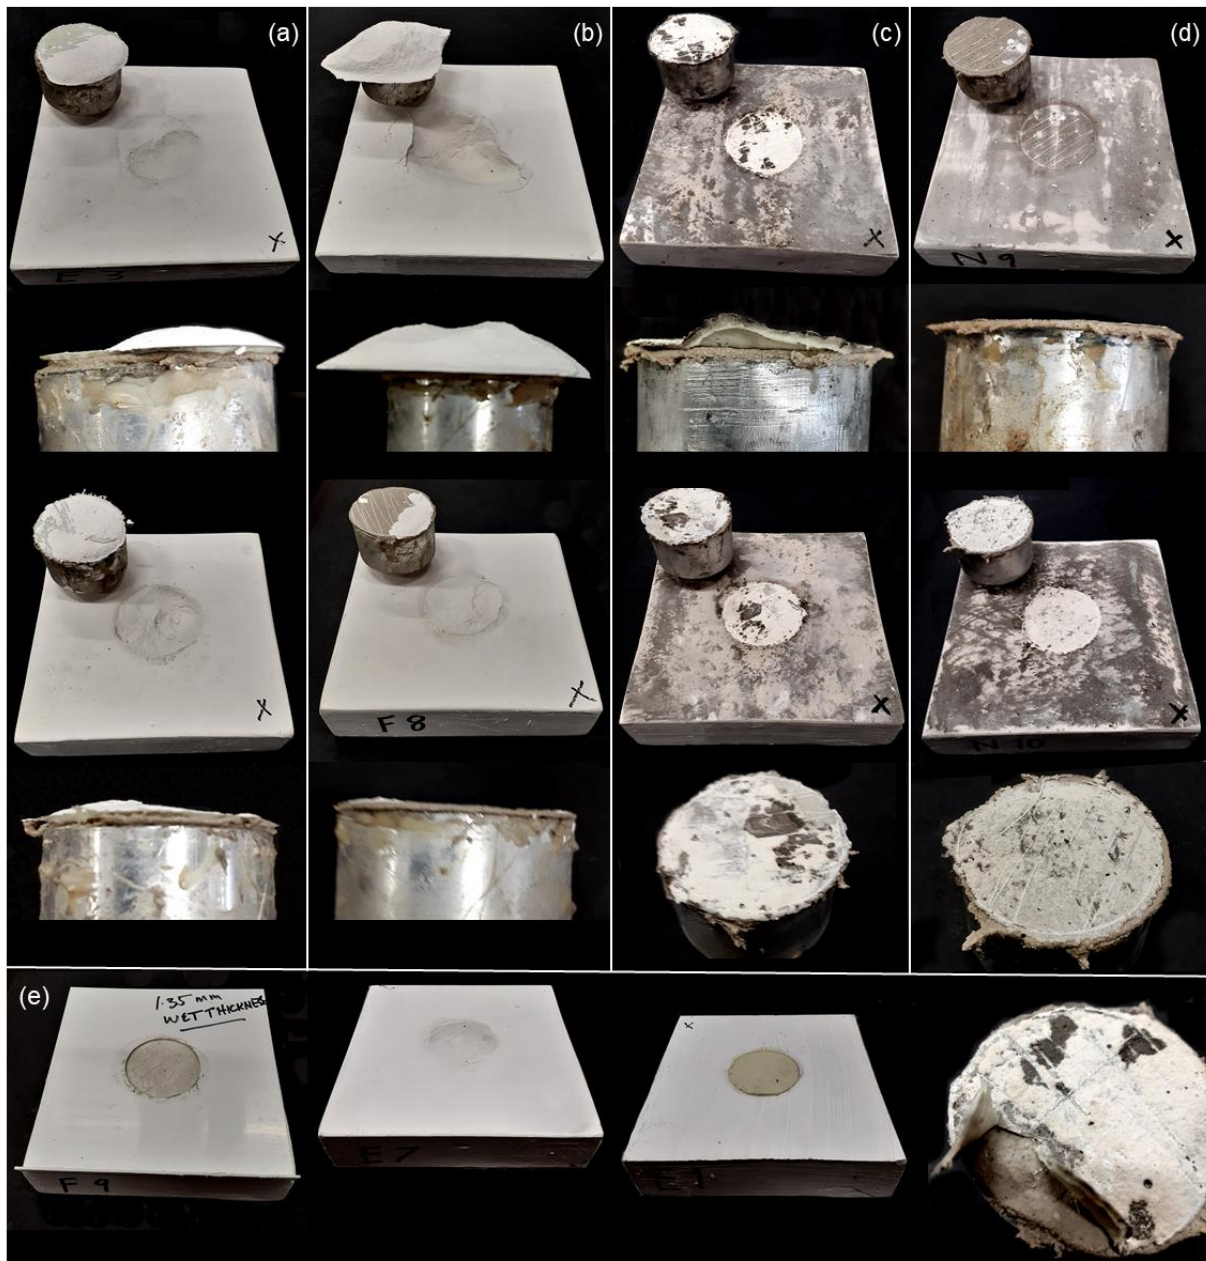
601 *Figure 10 – Tested specimens from groups AG-KF-CB, AG-P-CB, AG-KF-DB, and AG-P-DB. (a) Group*
 602 *AG-KF-CB, adhesive and cohesive failure with partial cohesive failure of base material. (b) Group AG-*
 603 *P-CB, cohesive failure with base material removed (top) and partial cohesive failure of base material*
 604 *(lower). (c) Group AG-KF-DB, partial cohesive failure of base material. (d) Group AG-P-DB, partial*
 605 *cohesive failure with base material evident on cylinders. (e) Left to right: template with aperture on a*
 606 *base, a clean base specimen with just primer, a clean base specimen with gel/fibres/primer and a close-*
 607 *up illustrating the ductility of cured HPCP RE Aramid Gel™. Cylinders 50 mm Ø, base dimensions 150*
 608 *mm x 150 mm.*

572 Selected images showing the range of failure types from sample groups AG-KF-CB, AG-KF-
573 DB, AG-P-CB and AG-P-DB are shown in Figure 10. Figure 10a illustrates specimens from
574 sample group AG-KF-CB with HPCP RE Aramid Gel™ (including DuPont™ Kevlar® fibres) and
575 HPCP CO S-20™ primer on a clean base; this group exhibited both elements of adhesive and
576 cohesive failure to varying extents as shown in both specimen images. Figure 10b shows
577 specimens from sample group AG-P-CB, which featured just primer on a clean base; this
578 sample group ranged from fully cohesive failure (shown in the top image) to partial cohesive

579 failure (lower image). Figure 10c shows specimens from sample group AG-KF-DB, which
580 featured gel/fibres and primer on a dirty base. Specimens in this group all showed partial
581 cohesive failure with varying extent of base material evident on the cylinders as shown in the
582 top and bottom images); it can be seen in the close-up on the metal block of the top image
583 specimen that the cured product is pliable rather than stiff.

584 Figure 10d shows specimens from sample group AG-P-DB, with just primer on dirty bases.
585 This group also showed partial cohesive failure on all specimens with base plate material
586 evident on the pulled-off cylinders to varying extents (as shown on both example specimen
587 images). The Sika glue on the metal block is clearly visible in the top specimen image. Figure
588 10e shows from left to right, the template with aperture on the top of a base, a clean base
589 specimen with just primer, a clean base specimen with gel/fibres/primer and a close-up further
590 illustrating the ductility of the cured gel product, which can be manoeuvred by hand and is not
591 rigid. This ductility allows movement in in-situ applications as building elements, to which
592 fibrous plaster ceilings are connected to, commonly deflect over time.

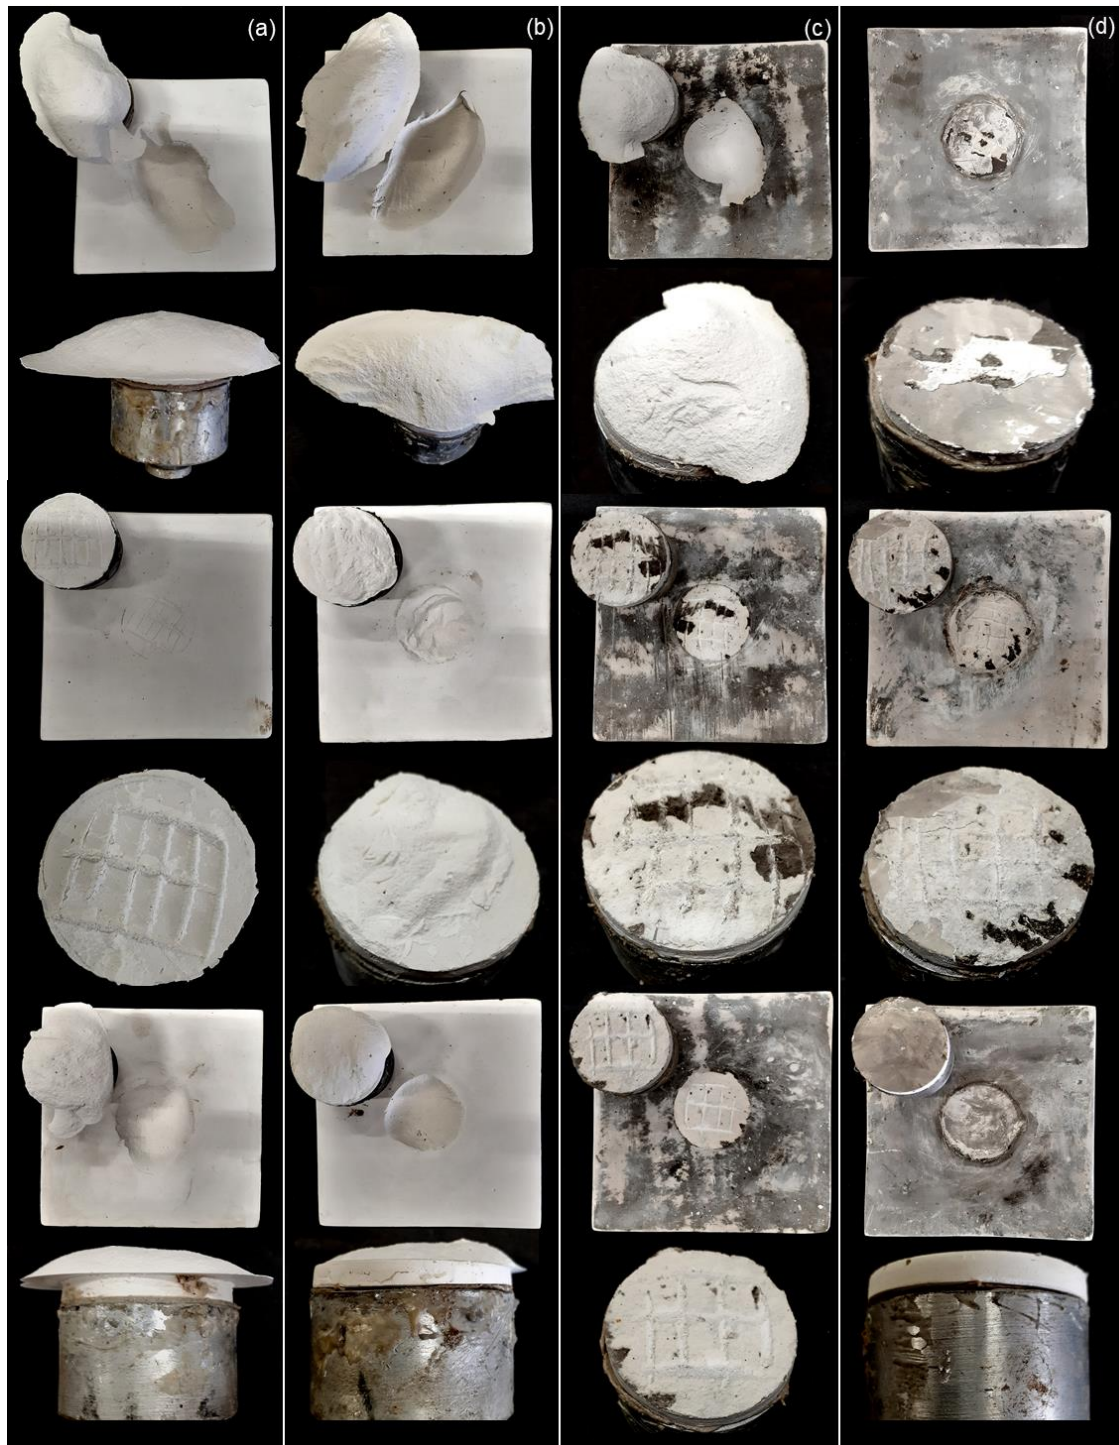
611 *Figure 11 - Tested specimens from groups J-CB, J-QF-CB, J-DB, and J-QF-DB. (a) Group J-CB,*
 612 *cohesive failure in the base (top and lower) with one exception of largely adhesive failure where 'keying'*
 613 *is evident (middle). (b) Group J-QF-CB, cohesive failure in base material. (c) Group J-DB, cohesive*
 614 *failure (top) and partial cohesive failure of base (middle, lower). (d) Group J-QF-DB, partial cohesive*
 615 *failure of base material (top, middle), adhesive failure (lower). Cylinders 50 mm Ø, base dimensions 150*
 616 *mm x 150 mm.*

618 Selected images showing the range of failure types from sample groups J-CB, J-QF-CB, J-DB
619 and J-QF-DB are shown in Figure 11. The 'criss-cross' keying to aid bonding between the
620 plaster base and cylinder is particularly visible in these images. Figure 11a illustrates
621 specimens from group J-CB, featuring Jesmonite on a clean base. All specimens in this sample
622 group failed in a cohesive manner with varying quantities of bulk material pulled out of the
623 plaster base (as shown in the top and bottom specimens), with one exception which featured
624 largely adhesive failure, with approximately 80% of the circular area being smooth material
625 and 20% of the circular area was partial cohesive failure with a thin layer of material was pulled
626 off the base plate (as shown in the middle specimen image). A strong 'key' applied to the base
627 plate prior to cylinder application is in evidence and while intuitively one might consider this
