Identifying Trends in Underground Coal Mine Incidents Caused by Roof Falls

Department: Mining & Nuclear Engineering
Major: Mining Engineering
Faculty Advisor(s): R. Larry Grayson, Ph.D., P.E.
Advisor's Department: Mining Engineering

Identifying Trends and Contributing Causes of Underground Coal Mine Fatal Roof Fall Incidents

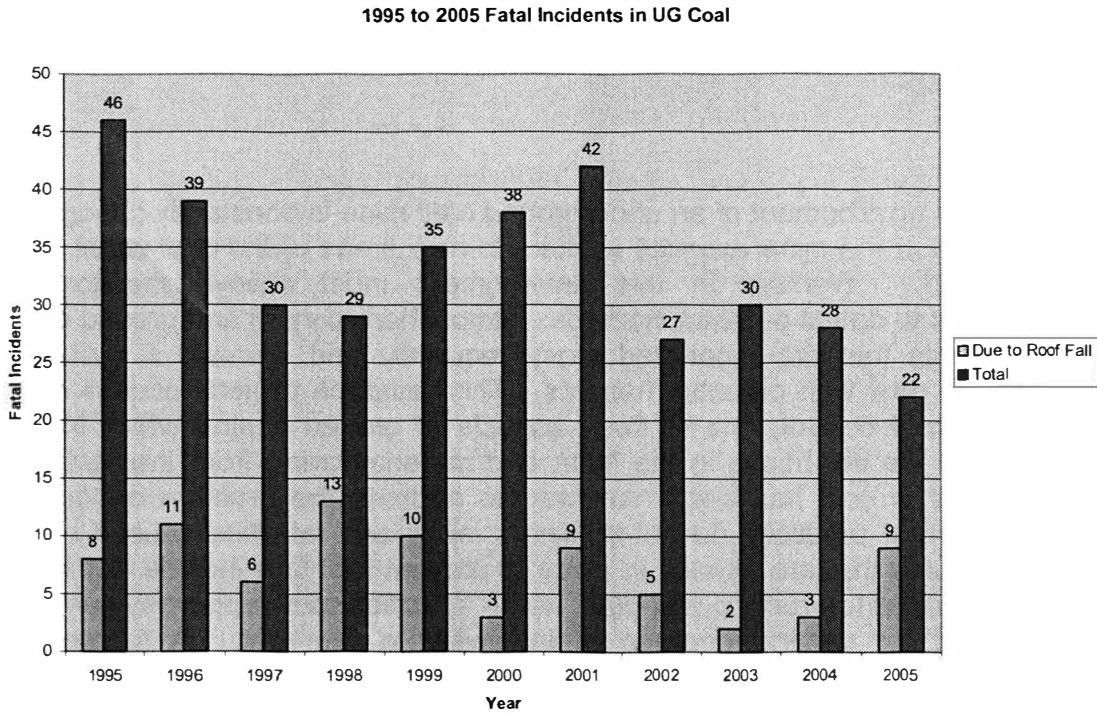
Figure 1 1995 to 2006 Fatal Incidents in UG Coal

A brief initial search was conducted to determine the number of fatalities that were caused by roof falls in the underground coal mining industry as a whole. Data from 1995 to 2005 was collected from the Mine Safety and Health Administration (MSHA) and compiled in a spreadsheet. Figure 1 below illustrates the initial findings.

Through the eleven years studied, roof falls continued to be a contributing cause of deaths in the underground coal industry. The lack of any rate of increase or decrease in the amount of deaths caused over this time period could be explained by variances in total man hours worked in the industry, or stagnation in the advancement in technology or industry practice. Examining the changes in the fatal incident rates (fig. 2) indicates that the variances in total man hours worked do not account for the changes in the number of deaths occurring each year. The initial study did not show a decreasing trend in fatalities, leading to the conclusion that the current state of the industry was not able to reduce the number of roof fall fatalities occurring. This prompted a more in-depth study of what may be causing roof fall fatalities in underground coal mines.

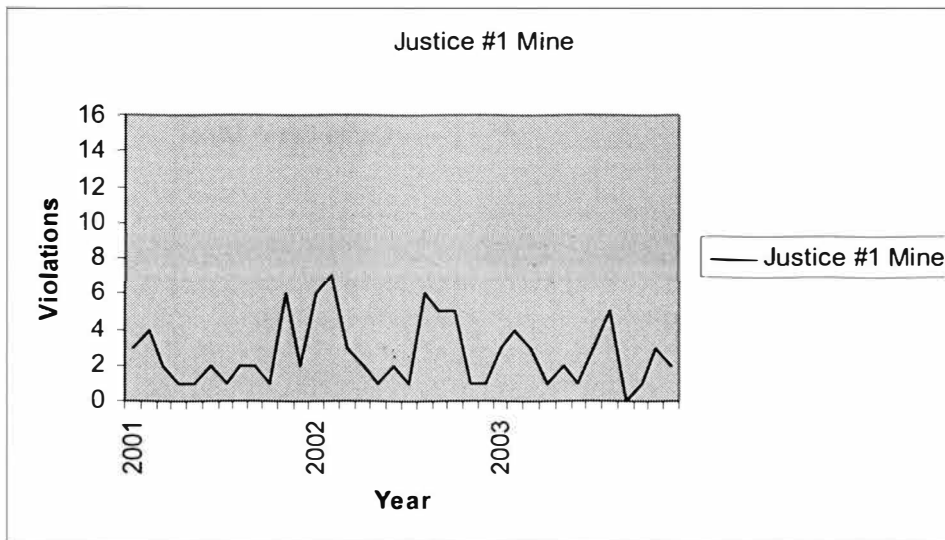
Figure 4 Number of Violations per Month at the Justice #1 Mine

Research from the incident summary project indicated that the majority of fatal incidents were accompanied by violations of CFR 30 Subpart C standards 75.200 – 75.223. Data was obtained from the MSHA data retrieval system on fourteen randomly selected mines that were studied in the incident summaries. The number of roof control-related violations was recorded for each month from January 2001 through December of 2003. The complete spreadsheet data is included in attachment 3. Three mines studied exhibited notable trends in the number of violations received each month. The Justice #1 mine and Upper Big Branch Mine (fig. 4 and 5) have sustained periods where at least one to two citations are issued each month. These trends in roof control violations could be due to poor management of the workforce, complacency of the workers, or a combination of both. The Camp Creek Mine (fig. 6) has a single month with a substantial number of violations followed by about two years of decreased violations. This trend could be caused by exceptionally unstable roof conditions followed by a change in roof control procedures. The possibilities for the causes of these unique trends cannot be pinpointed by this study. An individual analysis of each mine that contains more detailed information would be better suited to explain the trends found in these graphs.
