THIN, FACE-NAILED HARDWOOD STRIP FLOORING

June 1952

(Report) No. R1925

W. G. YOUNGQUIST, Engineer

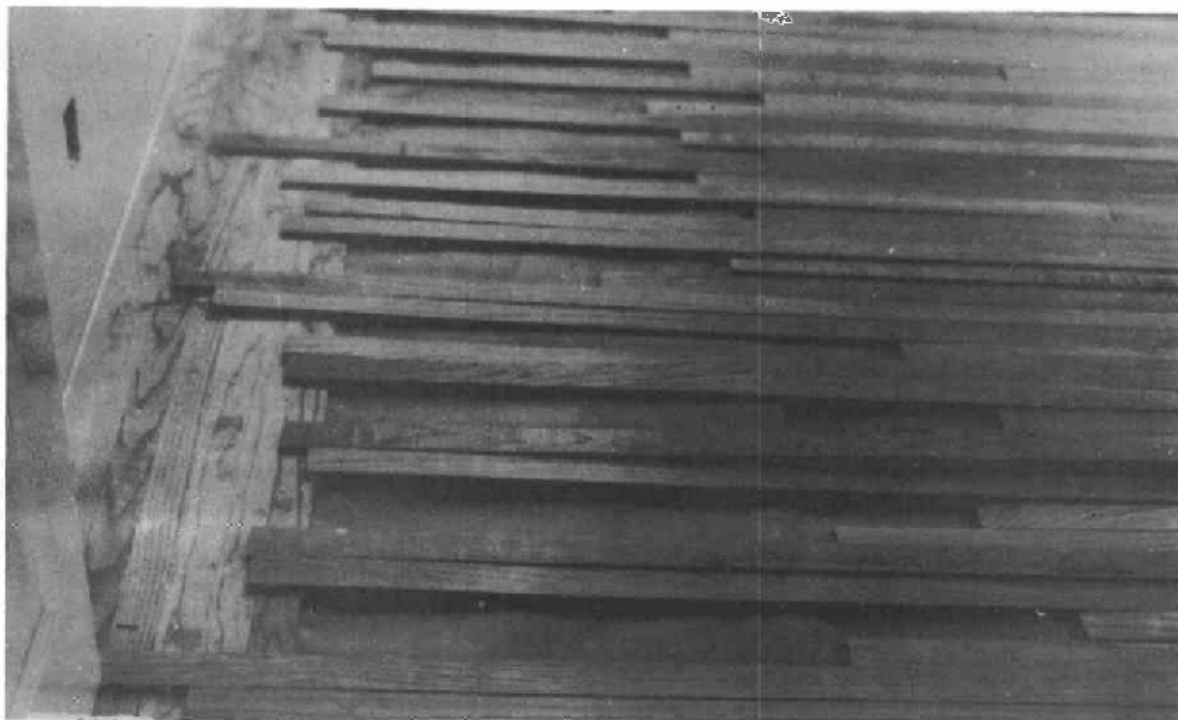
Z X 98698 F

Figure 1. --Strip floor under construction in San Francisco area. Flooring is usually fitted in place over the entire area before it is nailed. Note border at the wall.

The strip flooring was carefully cut and fitted for each room when laid. Figure 1 shows a room with some of the strips nailed in place and with other strips loosely laid in place and ready for cutting and fitting. The ends of the strips are simply butt-jointed. It is quite common practice to lay about six strips of flooring parallel with the wall around the room to form a border and the rest of the flooring lengthwise of the room.

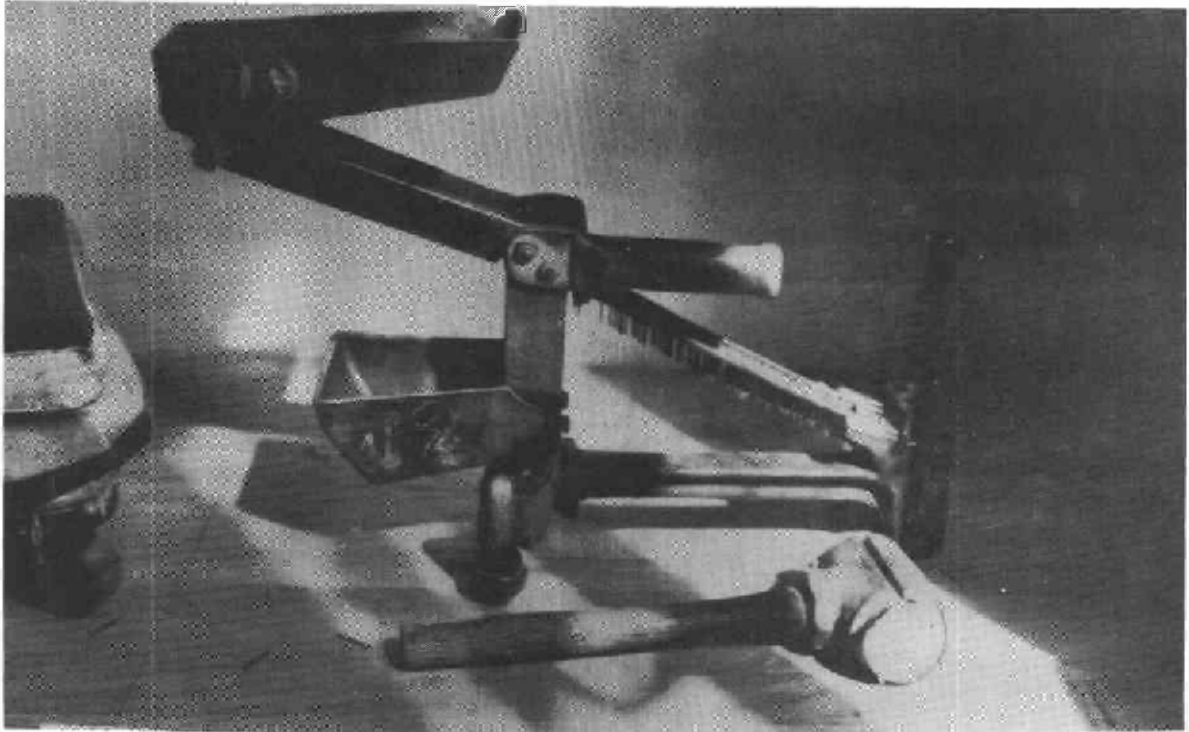
Z M 98699 F

Figure 2. --Nailing machine used for face-nailing flooring in San Francisco area.
Nails are driven and set with one blow of the hammer on the plunger. Operator's stool shown at left.

After the flooring is fitted and in place, each strip is face-nailed with 1-inch brads on each edge 6-1/2 inches apart along the length of the strip. For this operation a device called a nailing machine was used. The word "machine" may convey the wrong impression, since its function is somewhat limited. As shown in figure 2, the unit consists of a frame supported by three castors, with a hopper to hold the brads and a plunger that drives the brads into the floor. The brads feed one at a time from the hopper to the plunger. In using the machine, the operator rolls it to the spot to be nailed and then strikes the plunger one blow with a hammer, driving and setting the brad in one operation. The plunger sets the nail about 1/16 inch below the surface. The operator sits on a stool supported by castors to facilitate operation of the machine and to reduce operator fatigue. With this machine and an experienced operator, the nailing of a floor was accomplished rapidly.

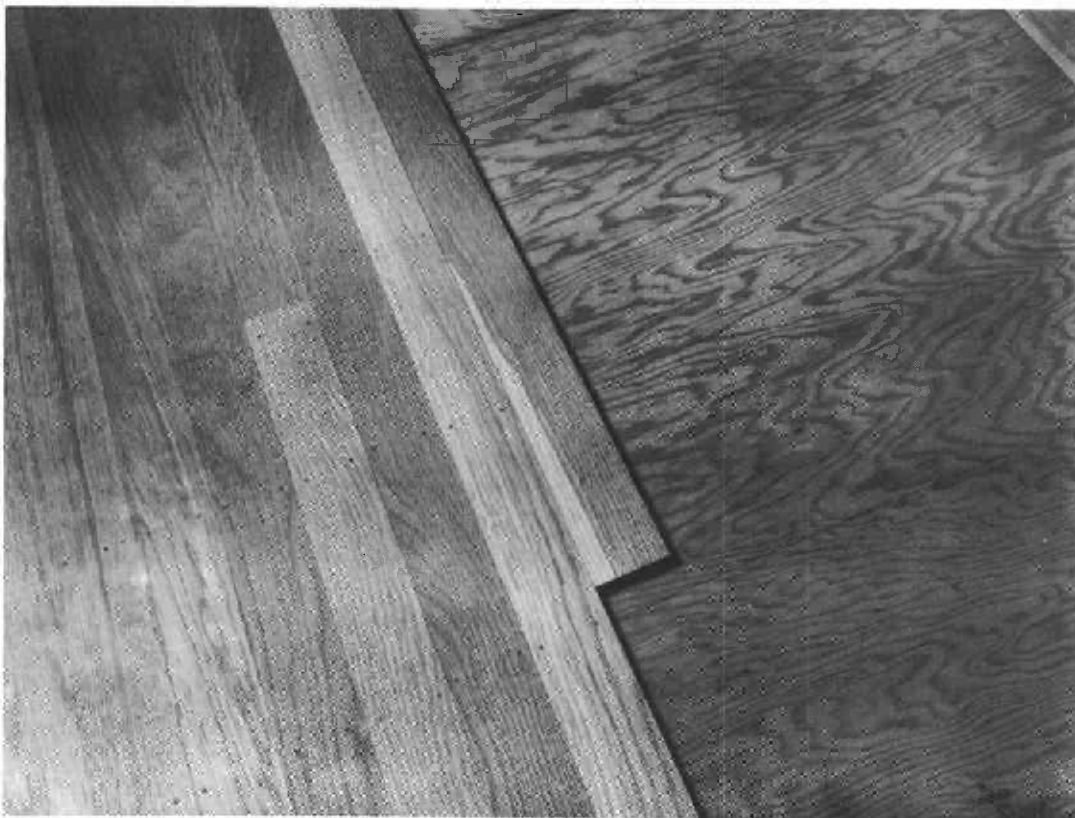
Z M 86774 F

Figure 3. --Forest Products Laboratory office face-nailed, thin-strip white oak flooring during laying (March 5, 1951).

An experimental floor of the type described was laid in one of the offices at the Forest Products Laboratory in March of 1951. White oak strips, kiln-dried to a moisture content of 9 percent were used. The strips were nailed to a subfloor of 3/4-inch-thick Douglas-fir plywood sheets bolted to the underlying concrete floor. Figure 3 shows the floor during construction. A nailing machine was not available, and the brads were therefore driven flush with the surface with a hammer and then set about 1/16 inch deeper with a nail set.

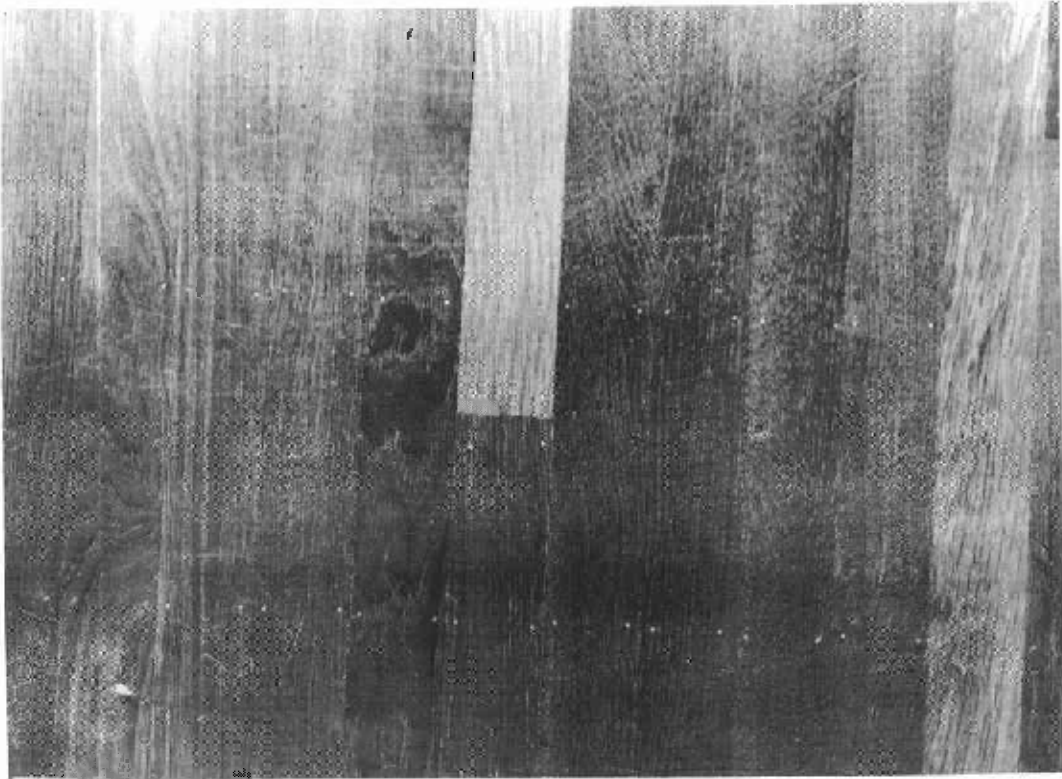
Z M 86775 F

Figure 4. --Completed Forest Products Laboratory office floor immediately after laying. Floor has been sealed with two coats of sealer. Note nailing of butt joints.

Figures 4 and 5 show two views of the floor immediately after completion. The nail holes were filled with a white-lead putty and appear quite prominent in the picture. The commercial firms use a darker putty which blends more closely with the wood. The floor was finished with two coats of sealer. The contrast between the appearance of the puttied nail holes and the finished floor appears more prominent in the photographs than was actually the case. The putty used appeared to darken with age, and at the present time the nail holes can be found only by rather close inspection. We have found that visitors who stop to inspect the floor do not notice that it has been face-nailed until this is pointed out to them.

Figure 6 shows the same section of the floor shown in figure 4 after about a year's use in an office. It will be noted that the floor appears to be in good condition. The nail holes again appear more prominent in the photograph than is actually the case.

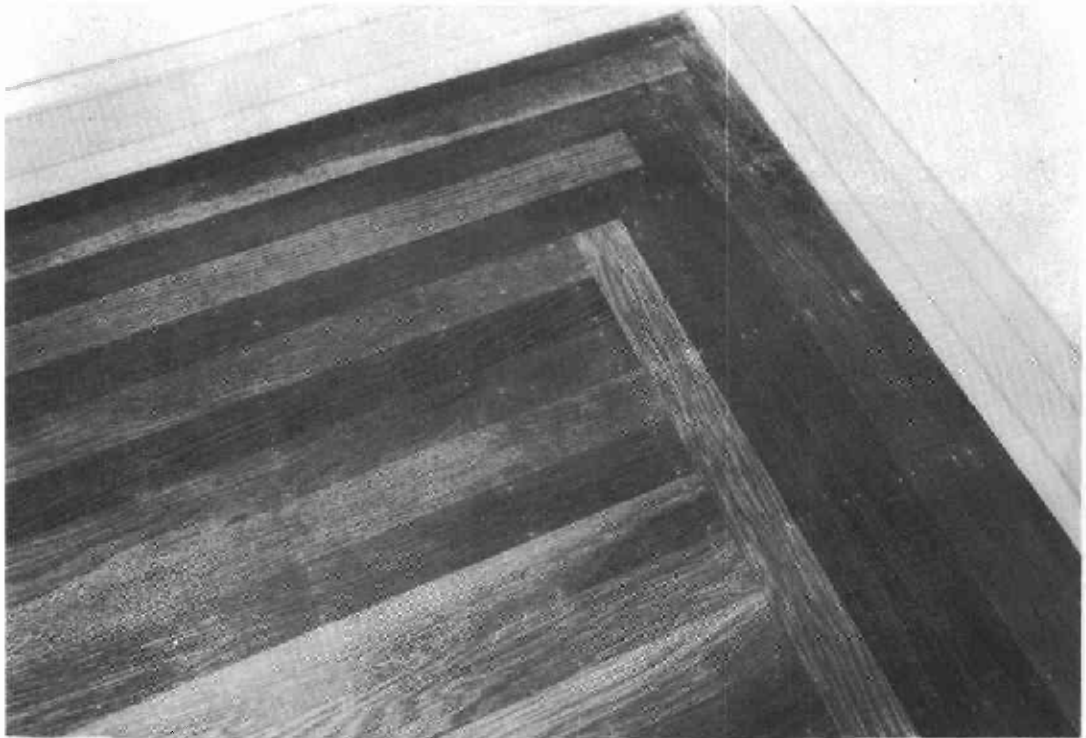
Z H 86776 F

Figure 5. --Completed Forest Products Laboratory office floor showing border and corner detail.

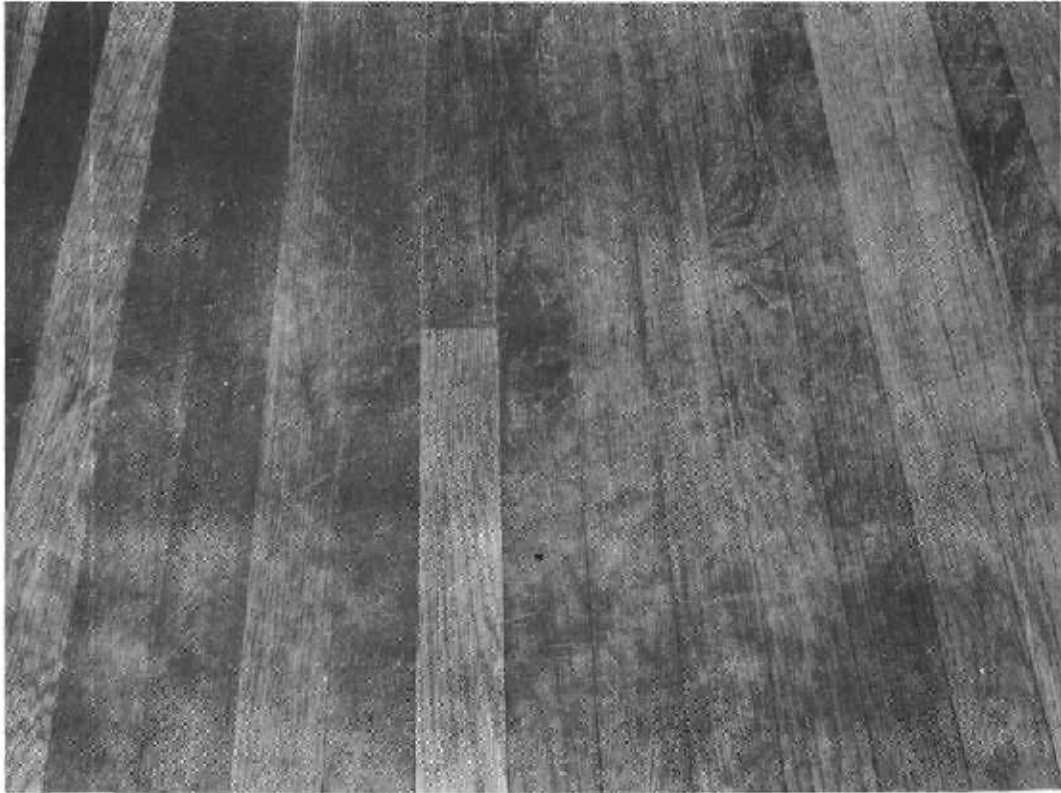
Z N 90207 F

Figure 6. --View showing the same section of the floor as shown in figure 4 after about 1 year service as an office.
