AN ABSTRACT OF THE THESIS OF

Joonkee Kim for the degree of Doctor of Philosophy in Civil Engineering presented on November 12, 1997.

Title: Development of a Low-Cost Video Imaging System for Pavement Evaluation.

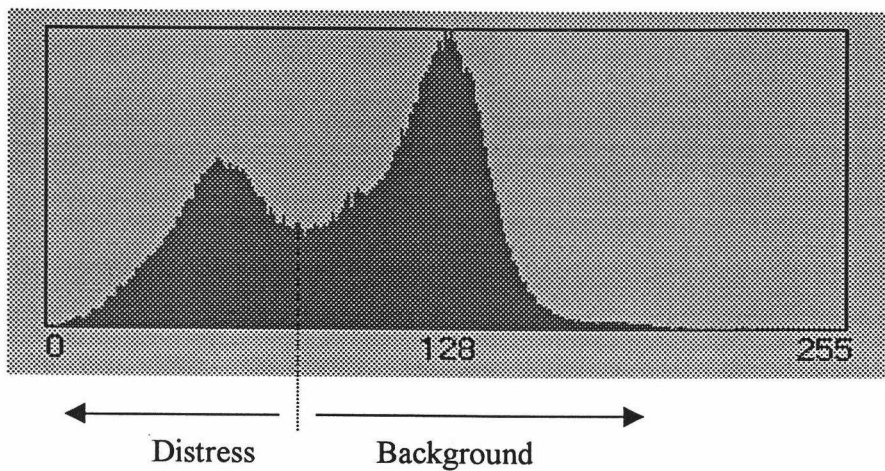
Figure 2.1 Gray-Scale Pavement Image and Histogram.

Most image processing for pavement analysis uses gray scale rather than color, as shown in the histogram in Figure 2.1. Based upon visual shadowing, pavement cracks thus can be detected. Given that a pixel value of 0 is black and 255 is white, cracked or damaged regions in an image have low pixel values, due to shadowing that is much darker than the surrounding pavement [Ritchie, 1990]. As shown in Fig 2.2, digital image processing steps include data acquisition, digitization, restoration, enhancement, segmentation, and feature extraction and cluster classification [Ritchie, 1990]. The latter two, image segmentation and feature extraction and cluster classification, are the most important processing steps.

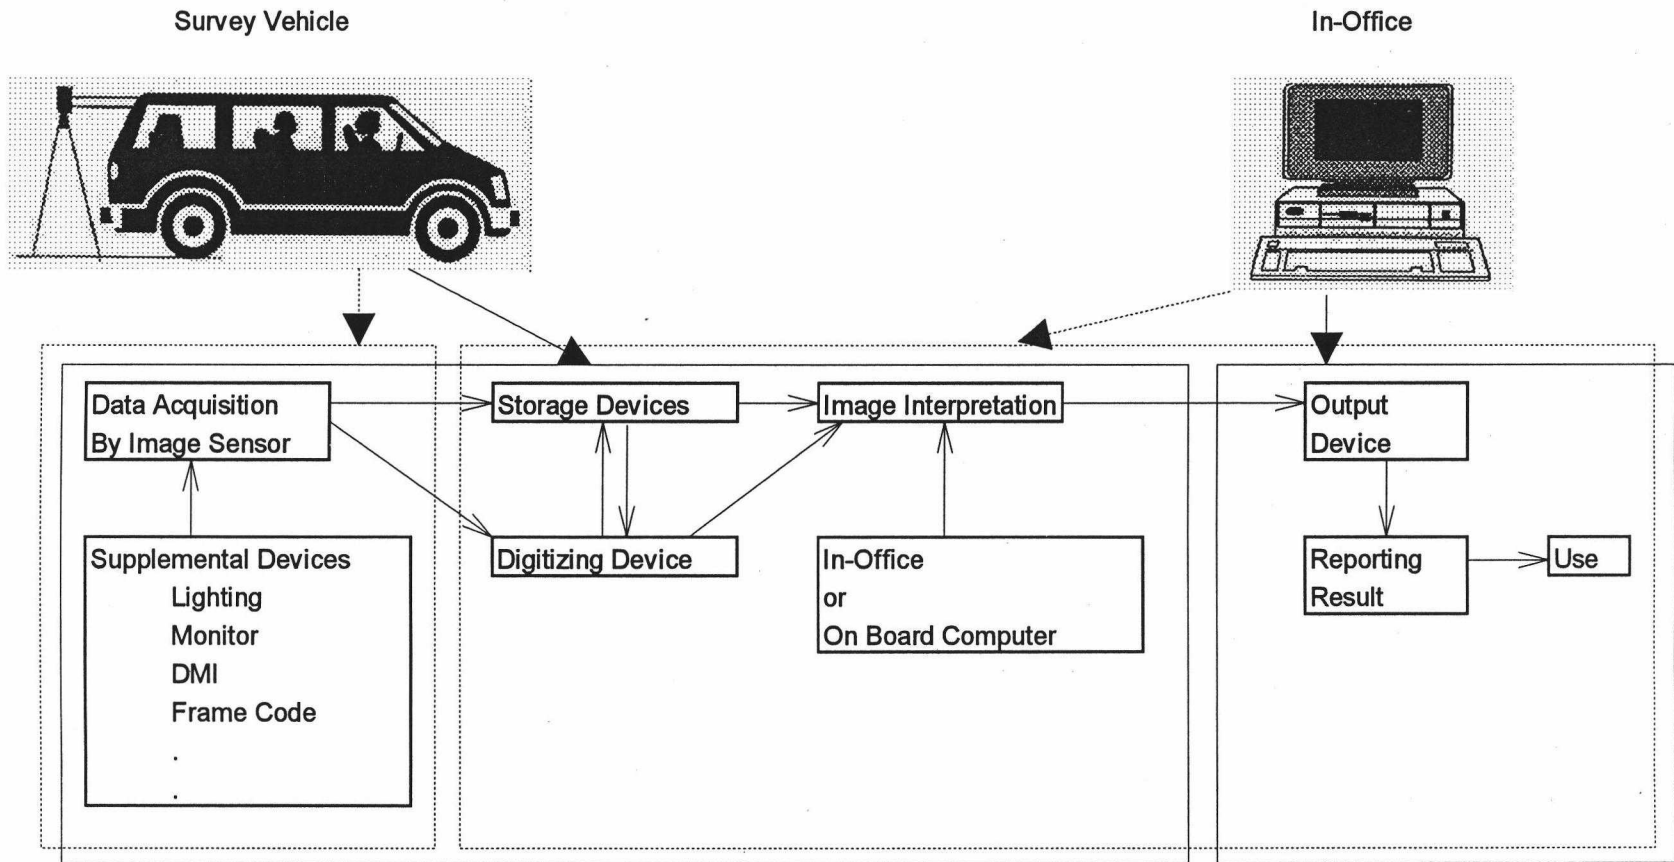
Figure 3.1 Elements of a Pavement Imaging system.

An automated pavement imaging system consists of a number of elements. As shown in Figure 3.1, the activities in a pavement-imaging system include data acquisition, data storage, image processing, reporting condition data, and using data for various applications. For most actions, various combinations of hardware, software, and procedural elements can be used and not all system structures require each of the activities indicated in Figure 3.1 [Haas and McNeil, 1990].

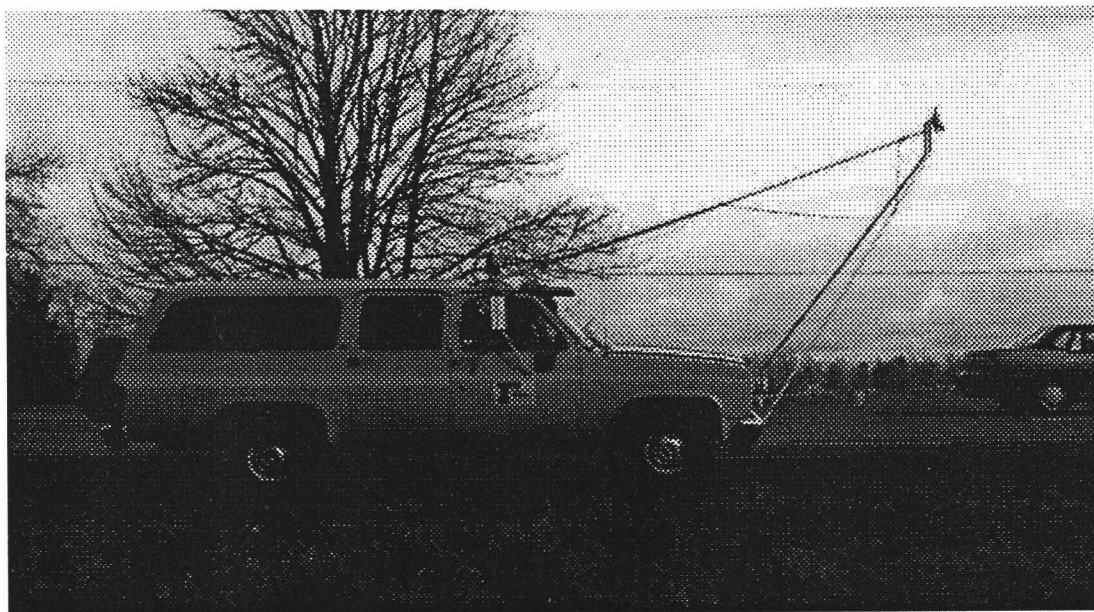
Figure 3.2 Survey Vehicle and Camera Mounting Devices.

After several meetings with ODOT, it was decided to use their video logging vehicle for this study without major modifications of their current equipment structure. Therefore, the Burle camera was connected directly to the vehicle battery and then linked to other vehicle equipment. Equipment in addition to that listed above was not installed, since the purpose of this investigation was to develop a low cost video imaging system. Figures 3.2 and 3.3 show the exterior and interior of the survey vehicle used in the study.

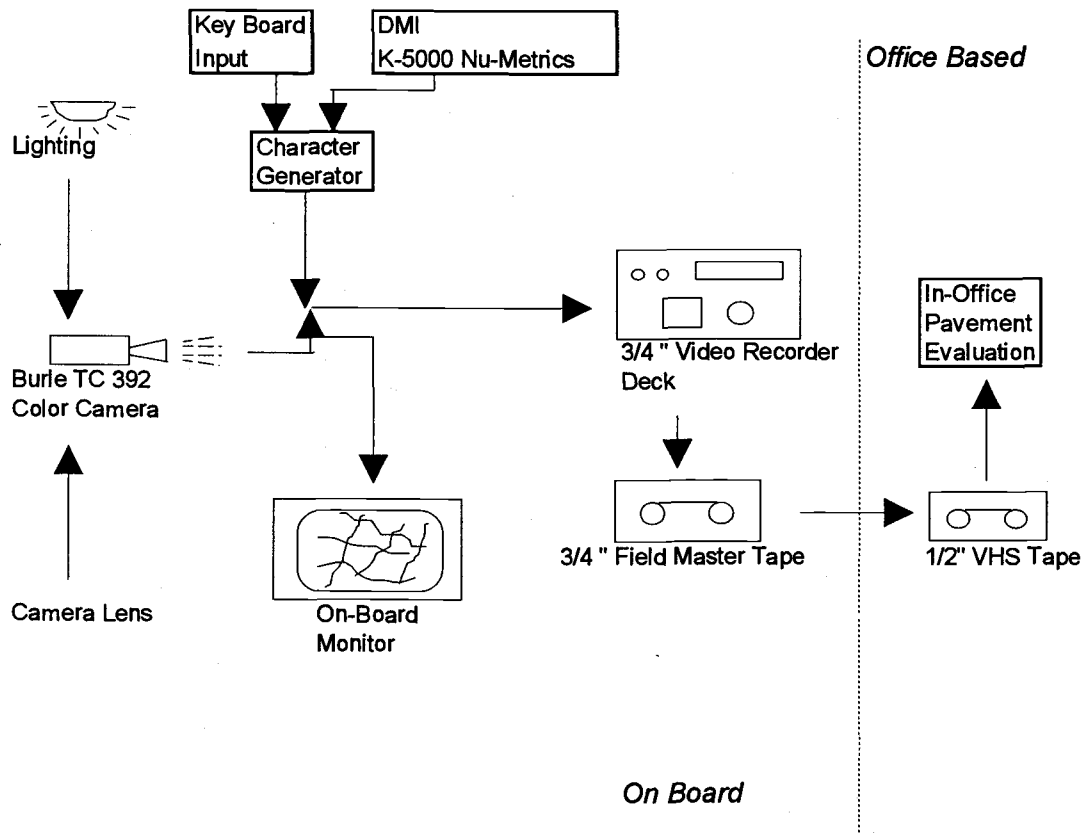
Figure 3.5 System Architecture for Video Image Collection.

Based on the selected elements, the image-collection system was organized as shown in Figure 3.5.

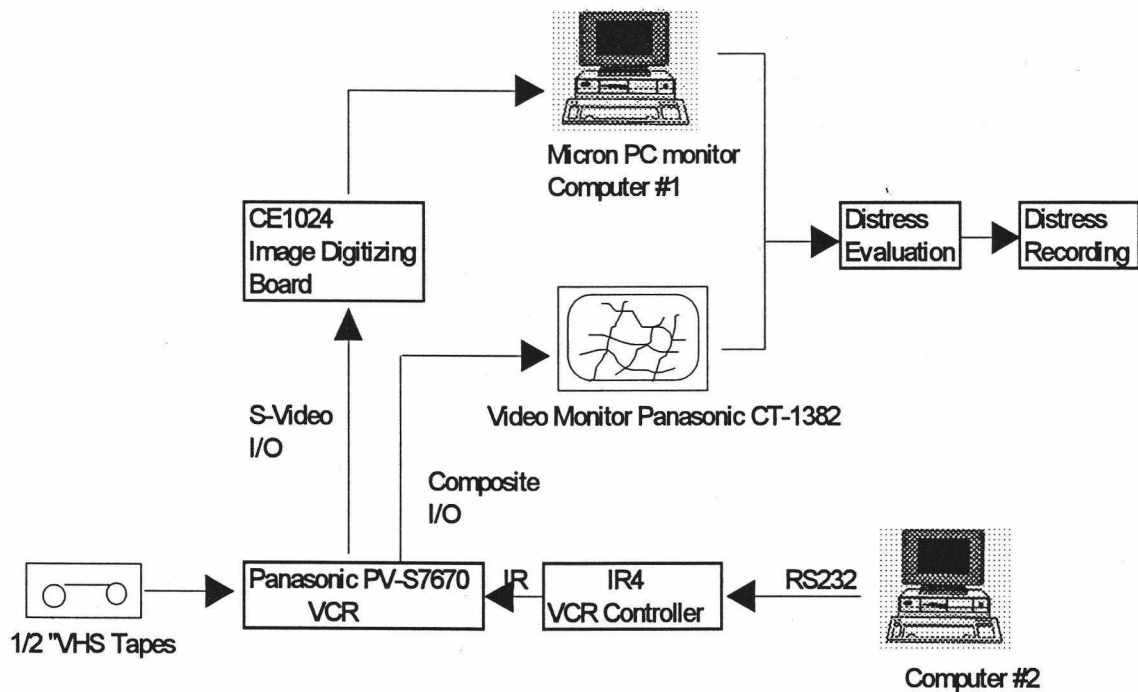
Figure 3.6 Diagram of In-Office System.

The in-office system was designed to provide a desktop image-retrieval system for collected video data. The several devices, as assembled, are described in the diagram shown in Figure 3.6.

Videotapes (3/4") taken from field video surveys were converted to a 1/2" VHS videotape format for processing in-office using an IR4 infrared controller (Akman, Inc.) with the VHS tape player. The controller was designed for use with all types of infrared

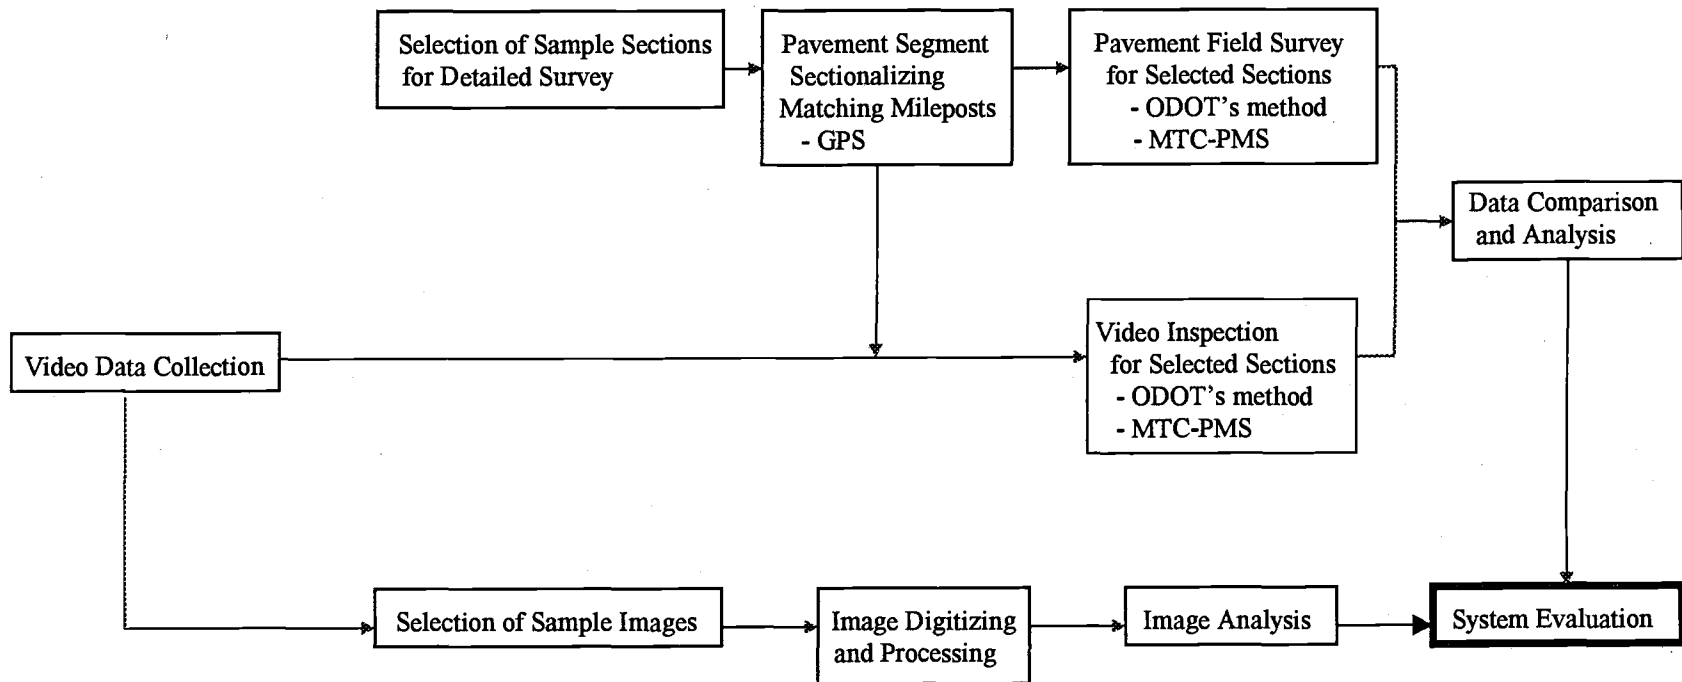
Figure 5.1 System Evaluation Process.

In order to evaluate the performance of the proposed video imaging system, a systematic validation process is needed. The validation process includes video-image inspection, manual field distress inspection, digital image analysis, and performance evaluation. The validation process is described in Figure 5.1.

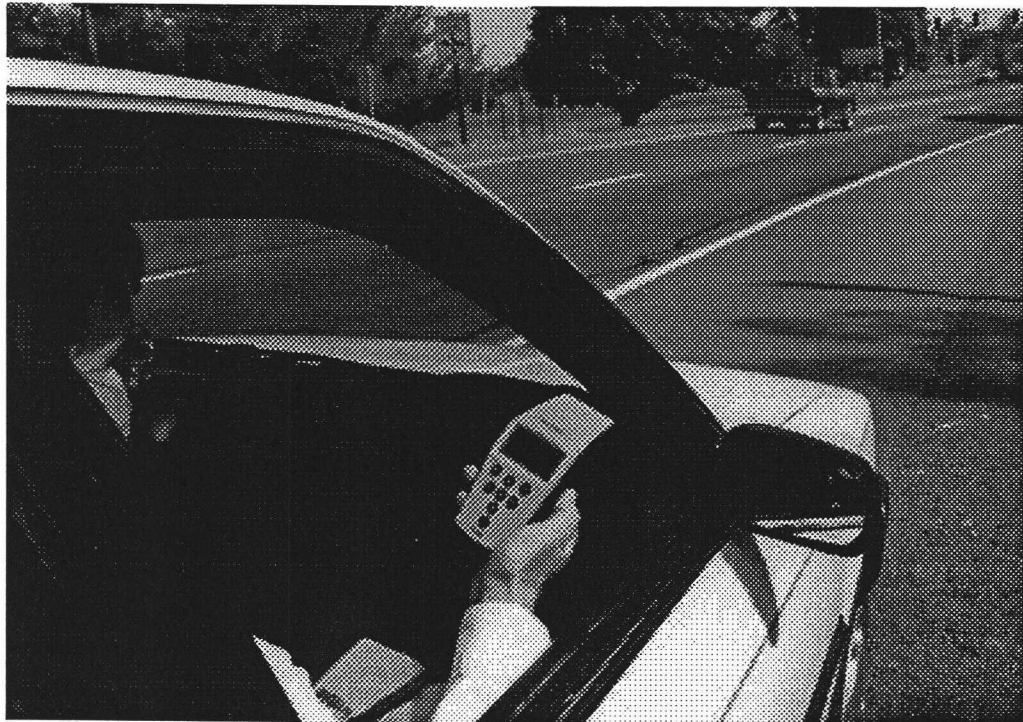
Figure 5.2 The GPS Device for Highway Location Positioning.

Global positioning system (GPS) technique was used to measure distances from video checkpoints to the nearest mileposts, since the GPS provides an accurate and simple approach to the acquisition of information for the linear features of roadways. The GPS is a method of positioning points based upon data collected from orbiting satellites [Simmons, 1996]. The GPS device named GeoExplorer II was used to measure distances for seven video checkpoints. This operation was initiated with opening a file for a starting point in the roadway. When activated, the GeoExplorer II began tracking visible satellites to calculate location information at regular time intervals during movement (i.e., either walking or driving), by storing data in the opened file [GeoExplorer II, 1996]. When the end points were reached, the file was closed and the location information was saved. Figure 5.2 shows the GPS device and the GPS work for highway location positioning.

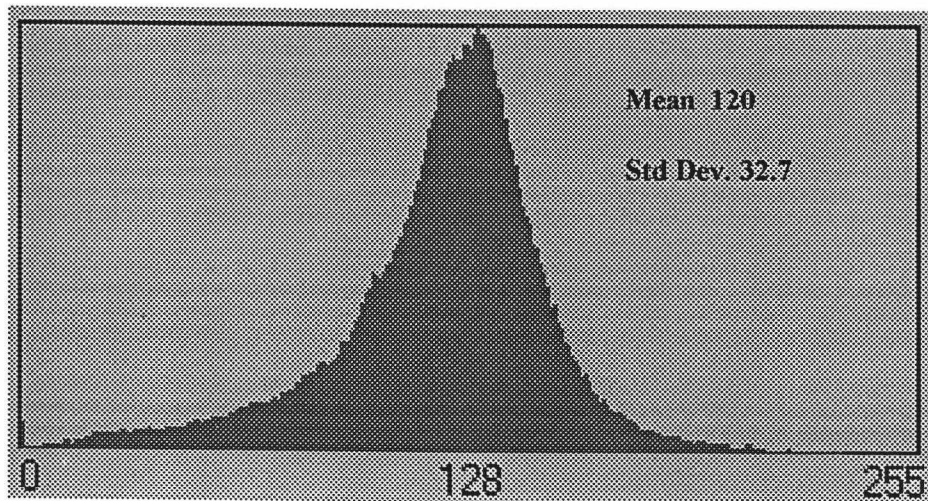
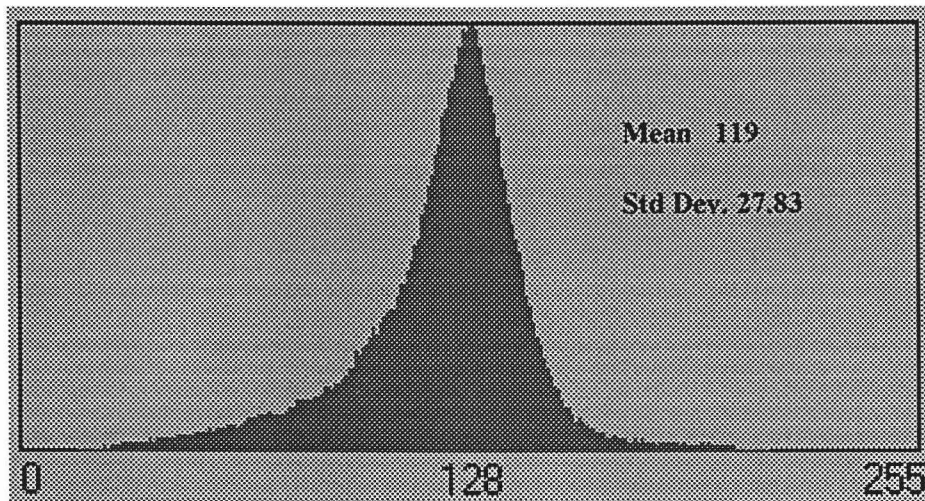
Figure 5.4 Comparison for Original Captured Image and Filtering Applied Image.

An image enhancement process was applied to digitized images to improve their appearance for visual and mechanized analysis. Following several trials, smooth edge filtering using ProImage version 1.0 software was applied to the images. This smooth filtering was applied to reduce background noise and to smooth blocky image data [Avery and Berlin, 1992]. In Figure 5.4, images and histograms are compared between the originally captured images and filtered images. As shown, filtered images showed a reduction in excessive crack edge effect without degradation of crack sharpness. The image histograms show there were no significantly large differences between the two images. However, the histogram standard deviation for filtered images was less than for the original images, implying some degree of noise reduction and smoothing.

(a) Original Image, (b) Filtering Applied Image

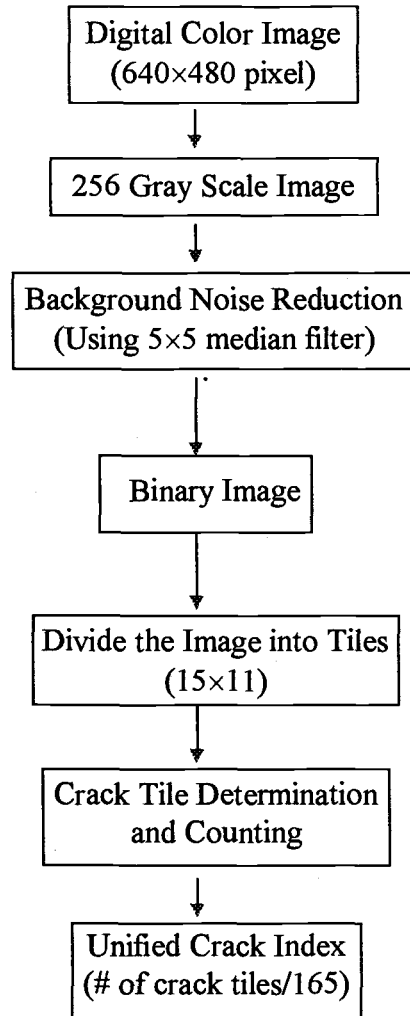
Figure 5.5 Crack Analysis Module of PicCrack Program.

The program crack analysis module consists of several steps, as shown in Figure 5.5. The 640×480 pixel color image was converted to a 256 gray-scale image and a median filtering technique was applied. A binary image was obtained using thresholding by regression analysis technique. Each pavement image was then divided into 15×11 square tiles. By counting the number of cracked tiles, a unified crack index (UCI) was calculated, defined further as the ratio of crack area to total pavement area, expressed as a percentage [Jitprasithsiri et al., 1996].
