ACOUSTIC MICROSCOPY OF CERAMICS*

L. W. Kessler, D. E. Yuhas and C. L. Vorres
Sonoscan Inc.
530 E. Green Street
Bensenville, Illinois

The scanning laser acoustic microscope (SLAM) is applied to the problem of nondestructive testing of ceramic materials. The employment of a very high resolution ultrasonic imaging instrument provides capabilities which supplement ultrasonic pulse-echo testing. In addition, by means of showing a picture of the flaw, the SLAM technique provides its own capabilities which alleviate some of the limitations of other techniques. Flaws of various types are documented in this paper.

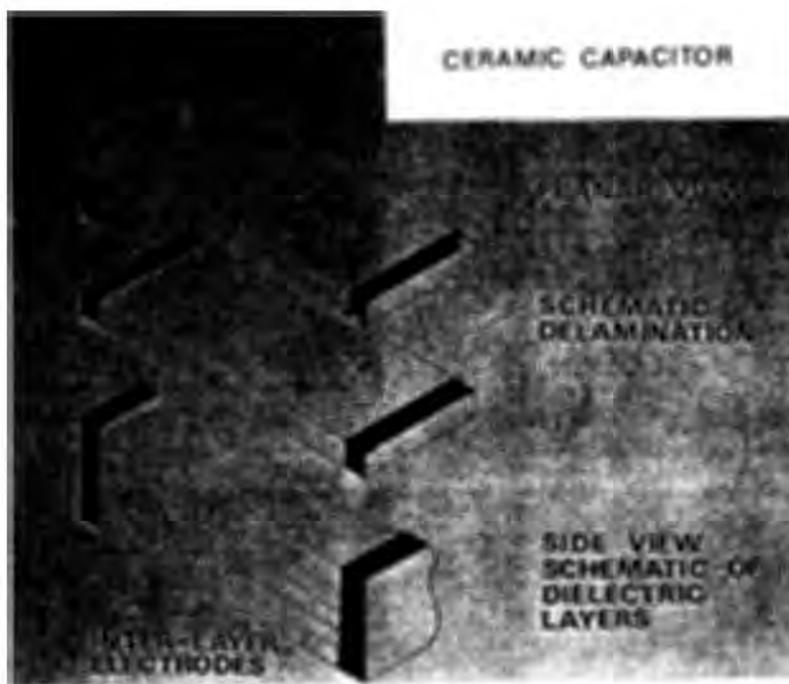
Fig. 2 - Schematic diagram of a ceramic chip capacitor consisting of multilayers of barium titanate.

Several types of flaws such as delaminations, cracks, surface cracks and solid or void type inclusions in materials will be described. Figure 2 shows a ceramic chip capacitor which is an electronic component constructed of many layers of barium titanate ceramic material separated by interlayer metal electrodes. Figure 3 is a magnified optical image of a capacitor that has been destructively cross-sectioned. The thickness of each ceramic layer is approximately 25 microns and each electrode layer is about 2 1/2 microns. This image shows typical defects that are found, for example, delamination at the electrode layer and distributed porosity in the ceramic material. When an acoustic micrograph is produced of this component, the acoustic energy is directed up through the stack rather than parallel to the layers.

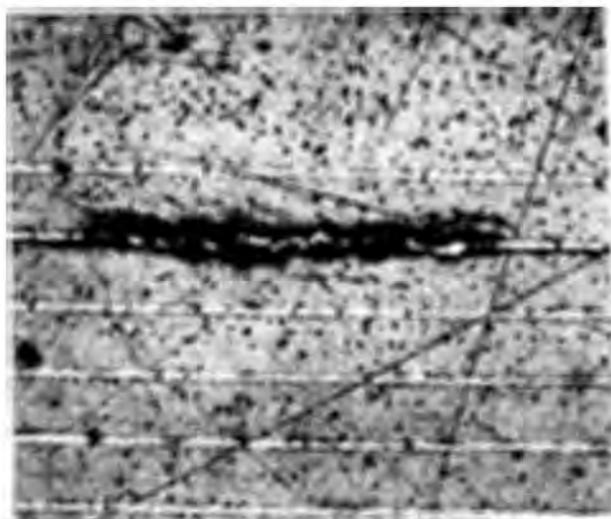
Fig. 3 - Optical view of a cross-sectioned ceramic capacitor revealing delamination at the electrode as well as porosity in the ceramic material.

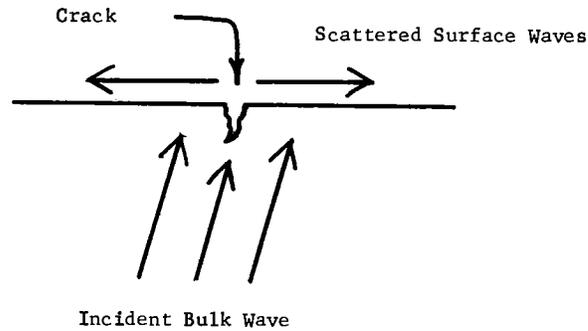
Fig. 7 - Insonification of a sample having a shallow surface crack will result in acoustic energy scattered into modes which propagate along the surface.

Suppose that a sample has a surface crack. As shown in Fig. 7 acoustic energy incident upon the crack from below, will partially convert into propagating modes that travel along and parallel to the surface. The discussion here is particularly relevant to cracks that are shallow, that is, perhaps not more than a few wavelengths of sound deep; at 100 MHz, 25-100 microns would be typical. Referring to the diagram, the area to the far right of the crack at the top surface of the sample has acoustic energy from two sources, a surface mode originating from the crack and a transmitted bulk wave from the bottom. The two waves, which are coherent, will interfere and cause a characteristic cone-shaped pattern in the acoustic micrograph. Figure 8 shows an acoustic micrograph of a hot pressed silicon nitride sample which has a ground (not polished) surface and a surface crack (arrow) produced by a Vickers hardness tester instrument. The cone-shaped interference pattern is quite evident and extends well beyond the flaw site. This latter observation is useful for easily locating surface flaws since the pattern, not the crack itself, is all that need be detected. Looking at the surface in the SEM, Fig. 9, one sees the physical indentation due to the Vickers diamond stylus. Beneath the indent there is a half-penny shaped crack which cannot be seen.

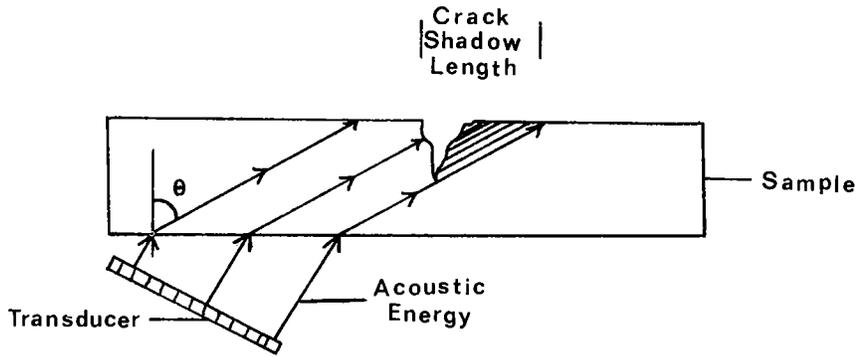
Fig. 10 - Schematic diagram illustrating insonification of a sample having a deep surface crack. A characteristic shadow is produced in the acoustic image whose dimensions are determined by the crack depth and the angle of insonification.

If the crack is deep as illustrated in Fig. 10, and if the incident waves are at an angle with respect to the surface normal, there will be an acoustic shadow, (low transmission area) because the ultrasound will not jump across the air-filled opening. The measured width of the shadow will permit one to determine the depth of the crack provided the angle of insonification is known.

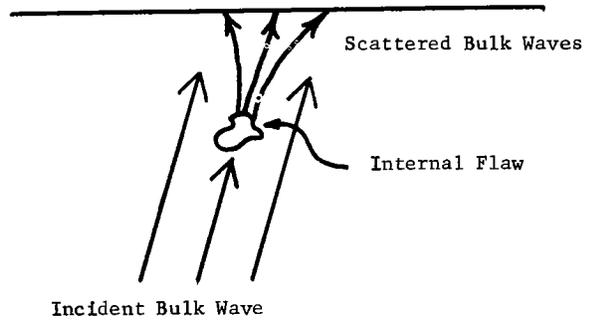
Fig. 12 - Insonification of sample having a void or inclusion deep beneath the surface.

If an inclusion or a void is buried deep beneath the surface of a material and viewed in the SLAM there will be scattered and transmitted energy which will interfere with each other giving rise to a diffraction pattern. This is illustrated in Fig. 12.

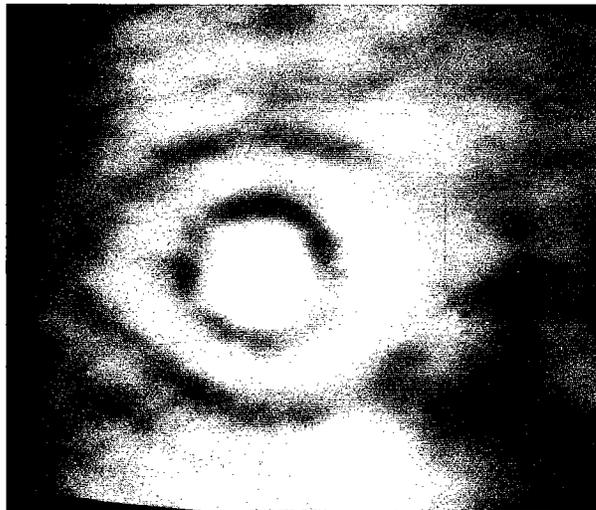
Fig. 13 - An iron inclusion, 400 microns in diameter, is located 3 mm below the surface of a hot pressed silicon nitride sample giving rise to this diffraction pattern.

Figure 13 is the acoustic micrograph of a 400 micron iron inclusion implanted within a silicon nitride disc. It is located about 3 mm below the surface which is beyond the near field zone of the flaw. There is a characteristic bright diffraction ring in the center and some higher order rings surrounding it. As the flaw gets closer to the surface the image characteristic changes in a well defined manner. A series of acoustic micrographs was generated by sequentially grinding the surface thereby moving it closer towards the flaw. This sequence is shown in Fig. 14. Note that as the flaw gets closer to the image plane (the surface) the diffraction effects are reduced. These effects are an inevitable consequence of any imaging system. In order to determine the flaw size from the image we measure the image of the flaw to the first ring, then the flaw depth by stereo-metry. With these two data points the flaw size is determined. In the near field of the flaw we don't see diffraction rings and the flaw size is the same as its image.

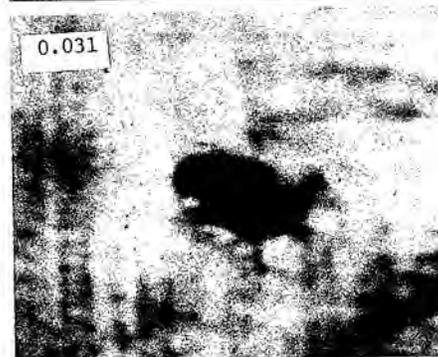
Fig. 14 - Acoustic micrographs (100 MHz) of the same iron inclusion as Fig. 12 as the thickness of the sample was reduced by grinding to bring the flaw closer to the surface. The grooves in each image are due to the rough grinding operation. The depths were measured by a simple stereoscopy technique with the acoustic microscope. The numbers in the flaw location are in millimeters below surface.

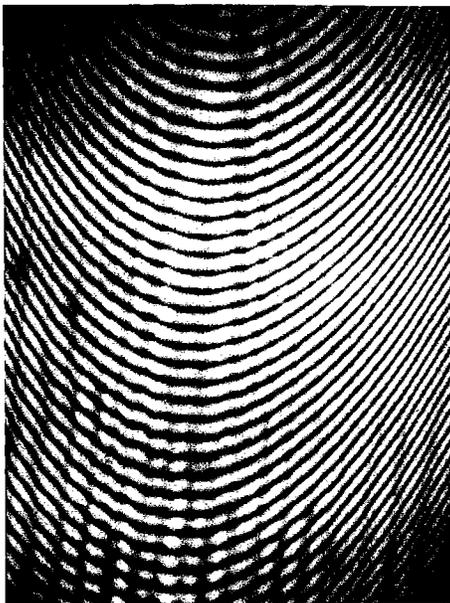
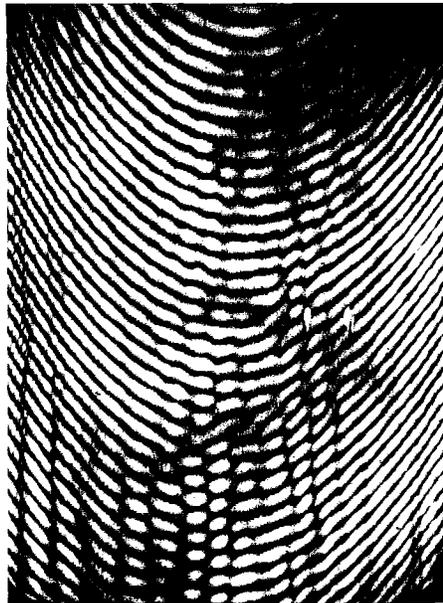
Fig. 17 - Acoustic interferograms of a typical (left) and a suspiciously flawed (right) cylindrical tensile test bar shown in Fig. 16.

In addition to flat and test samples, the SLAM can be adapted for use on complex geometries. Work has already been performed on turbine blades, tubes and other odd shaped components. In each of these cases, it is up to the investigator to select and optimize an entrance and exit port for the ultrasonic energy. Curved samples will necessarily cause corresponding curvatures to the interference fringes. For example, preliminary experiments have been performed on cylindrical ceramic test bars that are going to be subjected to tensile strength testing. The material is silicon nitride and a photograph of the sample is shown in Fig. 16. An interferogram of a good zone as compared with a suspicious zone is shown in Fig. 17 and it is evident that the differences are clearly distinguishable even though the fringes are curved.
