## ACOUSTIC MICROSCOPY OF CERAMICS\*

L. W. Kessler, D. E. Yuhas and C. L. Vorres  
Sonoscan Inc.  
530 E. Green Street  
Bensenville, Illinois

The scanning laser acoustic microscope (SLAM) is applied to the problem of nondestructive testing of ceramic materials. The employment of a very high resolution ultrasonic imaging instrument provides capabilities which supplement ultrasonic pulse-echo testing. In addition, by means of showing a picture of the flaw, the SLAM technique provides its own capabilities which alleviate some of the limitations of other techniques. Flaws of various types are documented in this paper.

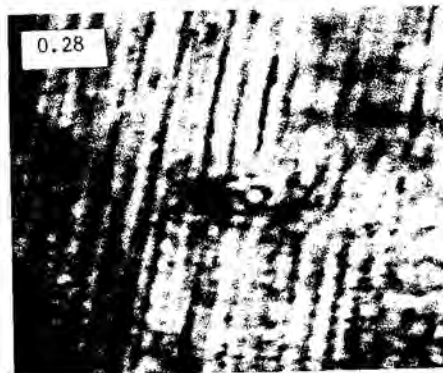
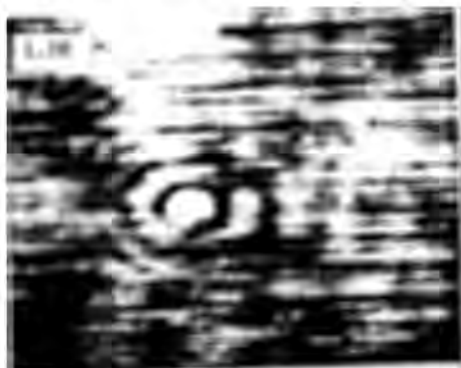
Fig. 14 - Acoustic micrographs (100 MHz) of the same iron inclusion as Fig. 12 as the thickness of the sample was reduced by grinding to bring the flaw closer to the surface. The grooves in each image are due to the rough grinding operation. The depths were measured by a simple stereoscopy technique with the acoustic microscope. The numbers in the flaw location are in millimeters below surface.

Figure 13 is the acoustic micrograph of a 400 micron iron inclusion implanted within a silicon nitride disc. It is located about 3 mm below the surface which is beyond the near field zone of the flaw. There is a characteristic bright diffraction ring in the center and some higher order rings surrounding it. As the flaw gets closer to the surface the image characteristic changes in a well defined manner. A series of acoustic micrographs was generated by sequentially grinding the surface thereby moving it closer towards the flaw. This sequence is shown in Fig. 14. Note that as the flaw gets closer to the image plane (the surface) the diffraction effects are reduced. These effects are an inevitable consequence of any imaging system. In order to determine the flaw size from the image we measure the image of the flaw to the first ring, then the flaw depth by stereo-metry. With these two data points the flaw size is determined. In the near field of the flaw we don't see diffraction rings and the flaw size is the same as its image.

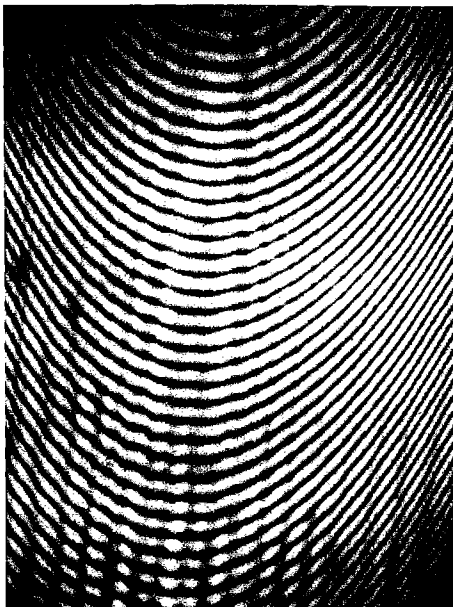
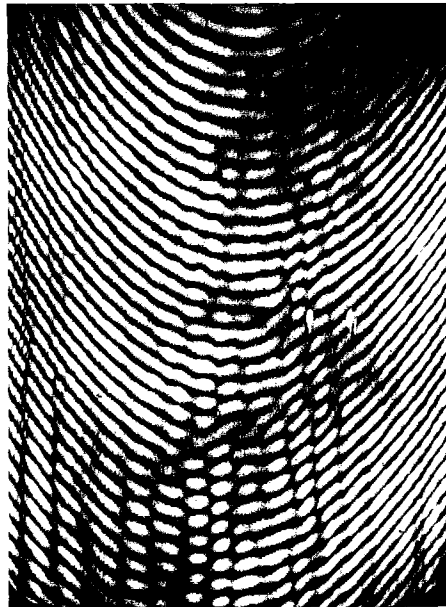
Fig. 17 - Acoustic interferograms of a typical (left) and a suspiciously flawed (right) cylindrical tensile test bar shown in Fig. 16.

In addition to flat and test samples, the SLAM can be adapted for use on complex geometries. Work has already been performed on turbine blades, tubes and other odd shaped components. In each of these cases, it is up to the investigator to select and optimize an entrance and exit port for the ultrasonic energy. Curved samples will necessarily cause corresponding curvatures to the interference fringes. For example, preliminary experiments have been performed on cylindrical ceramic test bars that are going to be subjected to tensile strength testing. The material is silicon nitride and a photograph of the sample is shown in Fig. 16. An interferogram of a good zone as compared with a suspicious zone is shown in Fig. 17 and it is evident that the differences are clearly distinguishable even though the fringes are curved.
