## ULTRASONIC EVALUATION OF TRANSIENT LIQUID PHASE BONDING IN SINGLE CRYSTAL SUPERALLOY CASTINGS

David K. Hsu, John J. Peters and Rahul Singh  
Center for NDE  
Iowa State University  
Ames, IA 50011

Paula D. Freyer and Robert E. Shannon  
Westinghouse Science and Technology Center  
Pittsburgh, PA 15235

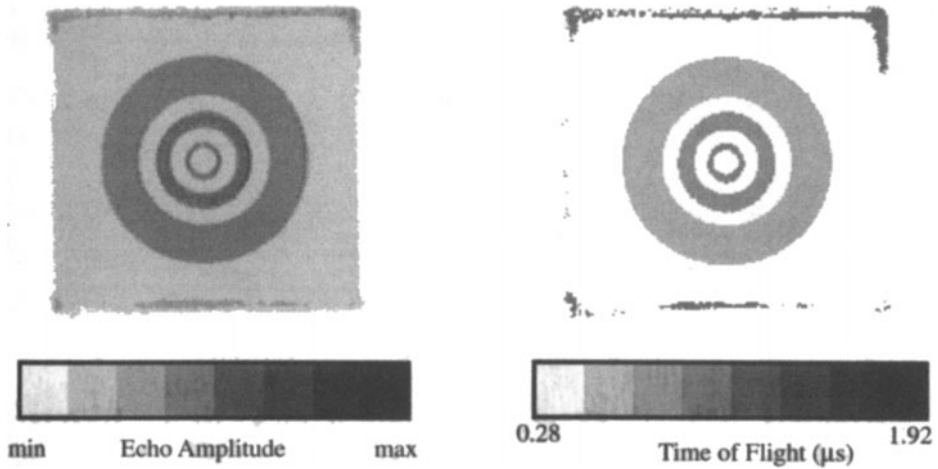
Fig. 2 Amplitude and time of flight C-scan images of a calibration sample containing three circular channels.

One calibration sample contained three concentric circular channels at the bondline. The largest outer channel was 0.2" wide by 0.050" deep, and the smallest inner channel was 0.050" wide by 0.010" deep. Ultrasonic C-scans clearly imaged the three circular channels. The time of flight values of the three rings corresponded to their actual depth. These

results are shown in Fig. 2. This sample was well bonded and showed no sign of unintended disbonds. To simulate fit-up mismatch, shallow grooves were machined into one half of the single crystal plates before bonding. The depths of the machined grooves in this calibration sample were 0.010" (horizontal grooves), 0.050" (vertical grooves) and 0.002" (diagonal grooves). Ultrasonic images of this sample, depicted in Fig. 3, showed that the transient liquid phase bonding process did not cause the grooves to become filled, even for the shallowest depth of 0.002" with the exception of only one place near the upper left corner. Quantitative measurement of the time of flight on the C-scan image yielded the following depth for the three grooves: 0.009", 0.004" and 0.002", which were in good agreement with their machined depths. In addition to the machined grooves, this sample showed a number of unbonded regions of irregular shape.

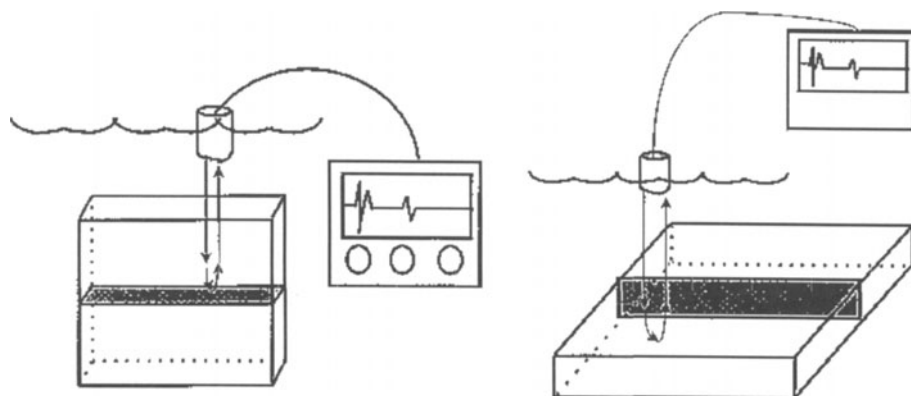
Images based on amplitude and time of flight from bondline.  
20Mhz center frequency,  
1/8" diameter, no focus

Images based on amplitude and time of flight of backwall surface echo.  
20Mhz center frequency,  
1/8" diameter, no focus

Fig. 4 Ultrasonic imaging of bonded CMSX-4 plates in the end-on and flat-on geometries.

Having established the flaw detection sensitivity of the ultrasonic scan technique, the procedure was applied to the evaluation of a series of bonded plates of single crystal CMSX-4. The plates were typically 3" x 3" x 0.4" in size and contained a butt joint with a 0.4" x 0.4" x 3" bond plane. The bond plane conditions were evaluated by conducting "end-on" C-scans with a 20MHz, 1/8" diameter, unfocused transducer. In order to evaluate the base metal near the bondline for possible spurious grain growth, the plates were also scanned in the "flat-on" geometry using the same transducer. Figure 4 shows the two scan geometries.

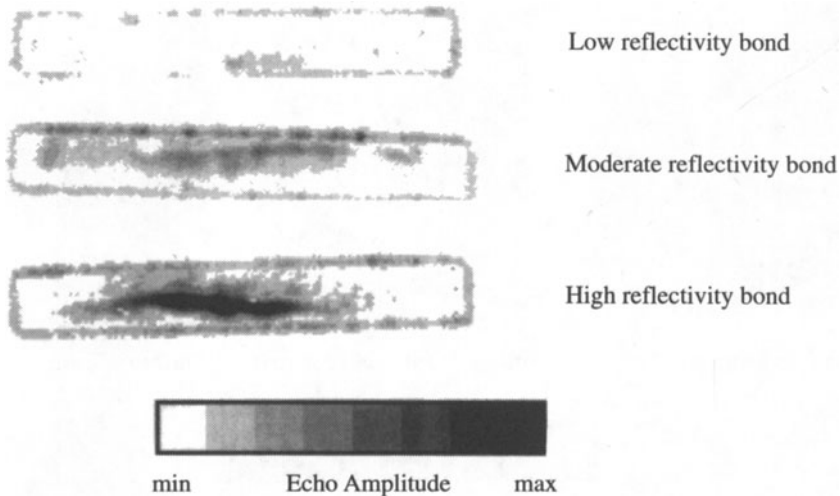
Fig. 6 Ultrasonic amplitude C-scan images of three bonded CMSX-4 plates with different reflectivity for ultrasound.

The integrity of a transient liquid phase bond in nickel based alloys may be judged from its reflectivity to ultrasound. Since the TLPB technique produces a thin bondline with very little chemical and structural changes, a TLPB bond free of unbonded regions and porosity is expected to have a very low ultrasonic reflectivity. This has generally been confirmed by the experimental results obtained in this study. For the bonded CMSX-4 plates, the bondline conditions were examined by conducting ultrasonic scans in the end-on configuration. The transducer used for these scans was a 20 MHz, 1/8" diameter, unfocused immersion transducer. The images were based on the amplitude of the echo reflected from the bondline. Figure 6 shows the end-on scan images of three bonded plates with widely different reflectivity. The top sample had very low reflectivity, the middle sample had moderate reflectivity, and the lower sample had high reflectivity in its central region. Several considerations should be taken into account in the interpretation of the end-on scan images. First, the sidewalls of the plate may have constrained and affected the propagation of the ultrasonic pulse in the end-on scan geometry. Secondly, the size of the beam at the bondline was not expected to resolve small unbonds or pores on the bondline. For these reasons, the presence of a high reflectivity region in the center portion of the lower plate in Fig. 6 does

not necessarily indicate a continuous region of unbond. In fact, this plate has subsequently been sectioned perpendicular to the bondline into five bars. The side surface of the sectioned samples were polished and micrographed. The bondline of the center portion was found to contain some porosity, whereas no pores were found near the outer ends of the plate. Results of the destructive examination were consistent with the ultrasonic reflectivity of the bondlines. These polished surfaces were also etched for crystallographic examination. Etching clearly revealed the dendrites along the crystal growth direction (perpendicular to the bond). The location of the bondline was easily seen because the two sets of dendrites on the two sides of the bond did not line up. Other than having different amounts of porosity, the etched images of the bondline at the center portion and at the outer ends appeared to be very similar.
