IMPACT-INDUCED DELAMINATIONS IN THERMOSET AND THERMOPLASTIC COMPOSITES

D. K. Hsu and B. E. Lucht

Center for NDE
Iowa State University
Ames, Iowa 50011

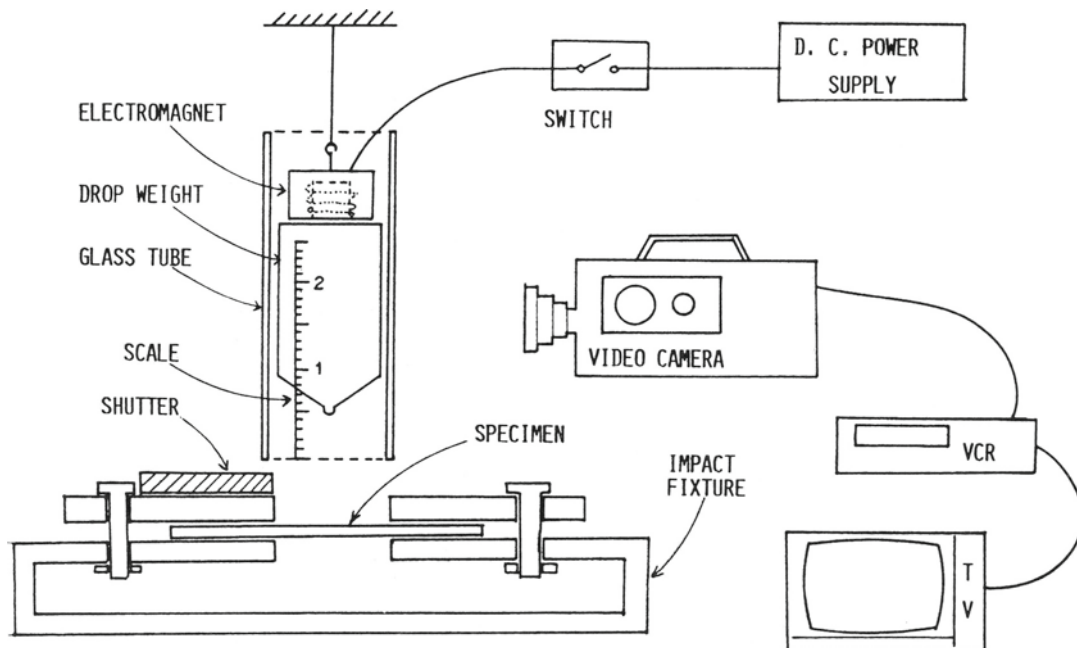
Fig. 1. Schematic diagram of the experimental setup for impact tests of composite laminates.

The experimental setup for carrying out the impact damage tests, shown in Fig. 1, is similar to those reported in the literature. It uses a 9.8 pound 2" diameter drop weight with a 0.5" diameter hemispherical tup as the impactor. The steel weight is suspended by an electromagnet and is released with zero initial velocity by turning off the current to the electromagnet. The weight falls in a glass guide tube. A scale on a transparent thin plastic sheet is adhered to the outside of the glass tube. Tests were also made to insure that frictional force of the guide tube wall has negligible effects on the results. The weight impacts composite coupons clamped in a heavy steel fixture and bounces back. A wooden "shutter" is moved over the coupon to prevent multiple hits. Two clamping conditions were used in the experiments: 5" square and 3" diameter circle.

The falling and rebounding of the impactor behind the transparent ruler are filmed with a videocamera with a high shutter speed. The impact event is then replayed on a television screen connected to a VCR with a single frame advance feature. Since the mass of the impactor is known, the incident and rebound energy and momentum are easily measured from the height and velocity. The standard 30 frames per second speed of the VCR serves as a convenient clock in the velocity measurements. The energy lost by the impactor is the difference between the incident energy and the rebound energy. It was assumed that the energy lost by the impactor is equal to the energy dissipated in the panel, which in turn causes delaminations, matrix cracking and, in some cases, fiber breakages.

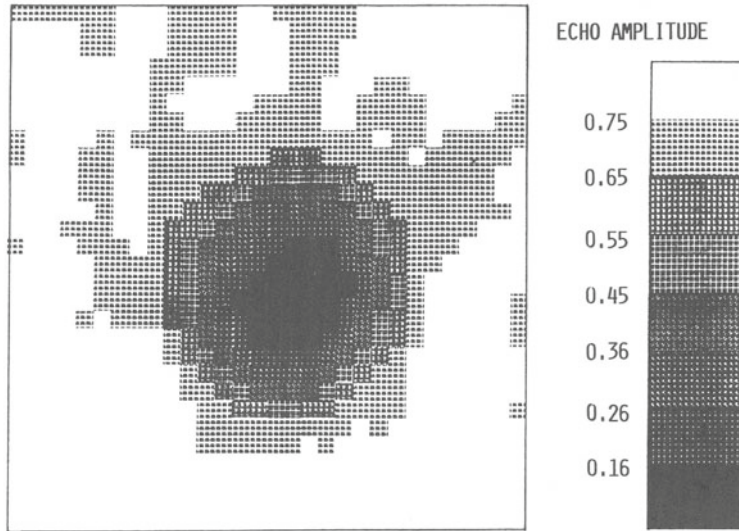
Fig. 2. Ultrasonic C-scan map of an impacted 16-ply woven glass-epoxy panel. The total scanned area was 1.5" x 1.5".

Ultrasonic pulse echo C-scans were made on the impacted panels by recording the amplitude of the back surface echo with the gated peak detector. The scan results were then displayed in eight levels of gray, as shown in Fig. 2. The scan patterns showed a series of concentric circles. The innermost circular area had approximately the same size as the circular delamination visible from the impact side. The largest circle was about the same size as the circular delamination visible on the bottom side. Using the same "trapezoidal model", the total delamination area can also be estimated from C-scan results. The total delamination area so obtained agreed fairly well with those based on direct visual measurements.

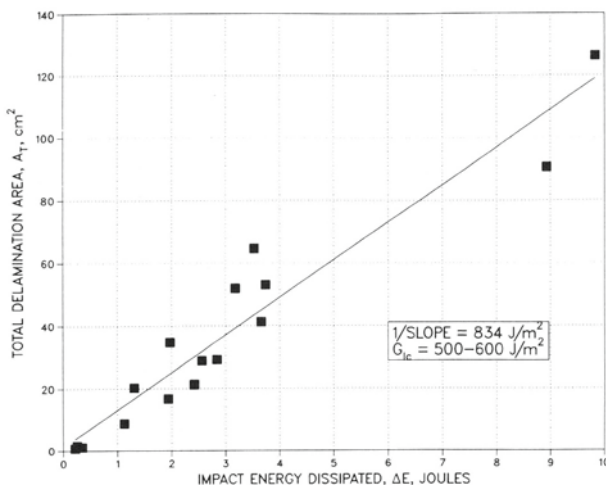
**TOTAL DELAMINATION AREA VS. ENERGY LOST BY IMPACTOR
FMC GLASS/EPOXY**

Fig. 4. Correlation between total delamination area and dissipated energy in woven glass-epoxy panels.

caused by an impact, such a correlation would possibly reveal the fraction of energy consumed by the creation of delaminations. Figure 4 shows the total delamination area determined by C-scans versus the energy dissipated. The inverse slope gives a value of 834 J/m². Considering that the C-scan and the trapezoidal model overestimates the area by about 20%, the inverse slope is approximately 1000 J/m². It is interesting to compare this value with the manufacturer provided mode-I fracture toughness G_{IC} of 500-600 J/m². This implies that, if one accepts the notion that G_{IC} is the energy needed to create a unit area of delamination, then about 50-60% of the energy lost by the impactor and dissipated in the panel is consumed by the formation of the delaminations. The remaining portions of the dissipated energy are presumably used up by matrix cracking, fiber breakage, fiber-matrix debonding and other damages.

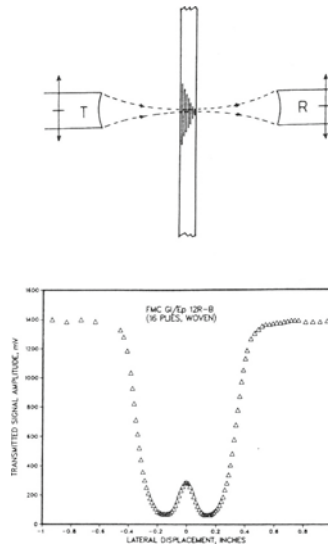
Fig. 5. Through-transmission line scan of an impacted glass-epoxy laminate.

Delaminations in composite laminates are quite effective in blocking the interrogating ultrasound, however, the degree of opacity depends on the frequency and focusing of the beam and on the contact conditions of the delaminated surfaces. For example, local stress could hold the surfaces in contact (the "kissing disbond"). Measurements were therefore conducted to investigate the degree of transmission through delaminations. Figure 5 shows the configuration for making a through-transmission line scan on an impact damaged 16-ply glass-epoxy panel. The transducers were 1/2" diameter 5 MHz focused probes with a focal length of 4" in water. Also shown in Fig. 4 is the transmitted signal amplitude versus lateral distance. As can be seen the signal amplitude decreased rapidly when the beam moved into the damaged zone, however, even at the lowest signal level of 70 mV, there was still a definitely observable transmitted echo. The maximum and minimum signals in the scan were 1.4 V and 70 mV, differing by a factor of 20. The small peak at the center of the scan corresponds to the often observed central low damage spot under the impact point.

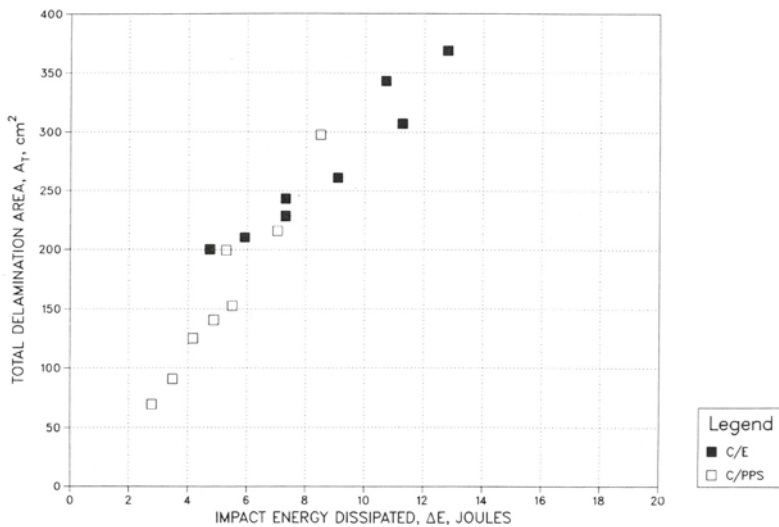
IMPACT OF CARBON/EPOXY AND CARBON/PPS LAMINATES

Fig. 6. Comparison of impact results in carbon-epoxy and carbon-PPS laminates.

Because susceptibility of composite laminates to impact delamination has been a weak point of such materials, there has been a continuous effort by the materials manufacture industry to improve the toughness and impact resistance of composites. Different resin systems have been formulated, some are thermosets and some are thermoplastics. In this section, results are presented to show the comparison of impact damages in carbon-epoxy and carbon-PPS laminates. The panels used were 48-ply with [45/0/-45/90]_{6S} layup. The panels were clamped between two 1" thick steel plates with 3" diameter cutout holes. The impactor was again the 9.8 pound weight with a 1/2" diameter hemispherical tup. The total damage area was estimated from ultrasonic C-scans while assuming that the area of the top delamination to be zero in the trapezoidal pattern. (For nonwoven carbon fiber reinforced laminates, the trapezoidal pattern is essentially a triangle). Figure 6 shows the experimental results. As can be seen, the impact resistance of the two systems are quite similar.

Detailed dependence of impact resistance on mechanical properties such as interlaminar shear strength (ILSS), G_{Ic} and percent elongation to break is not within the scope of this work. However, it is interesting to point out that the percent elongation to break for epoxy and PPS are both in the 4-5% range whereas that of PEEK, a much more impact resistant material, is 25-30%. Moreover, the similarity in damage area in carbon-epoxy and carbon-PPS at the same impact energy has also been observed in other studies.
