# STRAIN LOCALIZATION AND HYDROGEN-RELATED FRACTURE IN MARTENSITIC STEELS INVESTIGATED BY COMBINED DIGITAL IMAGE CORRELATION AND ELECTRON BACKSCATTER DIFFRACTION

Xiaodong Lan, National Institute for Materials Science, Japan  
LAN.Xiaodong@nims.go.jp

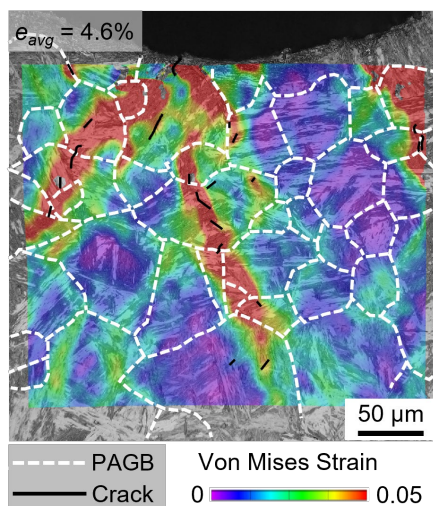
*Figure 1 Local strain distribution map of the hydrogen-charged specimen ( $e = 0.89\%$ ,  $H_D = 5.18 \text{ wt. ppm}$ )*

extract quantitative information about how hydrogen-related fracture takes place. In this study, the local plasticity accompanying hydrogen-related fracture in a low-carbon (Fe-0.2wt.%C) martensitic steel was investigated by correlative analysis combining digital image correlation (DIC) and electron backscatter diffraction (EBSD). The DIC strain distribution maps were analyzed in connection to the EBSD maps to investigate whether any microstructural features correspond to the preferentially deformed regions. Figure 1 shows the meso-scale strain distribution map that covers multiple prior austenite grains in the hydrogen-charged specimen. It shows that martensitic steel was deformed in a highly heterogeneous manner. Upon deformation, strain localization appeared in the bulk of martensite blocks and at some prior austenite grain boundaries (PAGB). Such heterogeneity in local strain evolution would in turn lead to a spatially heterogeneous hydrogen accumulation and hydrogen-related cracking, and thus, play an important role in the process of fracture. One can easily find that there is a distinct correlation between the cracking sites and the highly deformed regions. The comparative study of specimens with and without hydrogen pre-charging revealed that hydrogen enhanced strain localization during deformation and facilitated the nucleation and propagation of cracks. The quasi-cleavage cracking was closely related to the local plastic deformation and increasing hydrogen content decreased the local strain level for quasi-cleavage cracking. It is also found that strain localization appeared around the intergranular cracking, which suggests that strain localization is also involved in the sequence of hydrogen-assisted intergranular cracking.
