Kajian Eksperimental Kegagalan Sambungan Balok-Kolom Bambu Laminasi *Hollow Section* Menggunakan *Glue in Rod-Bracket*

Laminated Hollow Section Beam-Column Joints using Glue-in-Rod Bracket)

Achmad Saiful Arifin¹, Karyadi², Nindyawati³

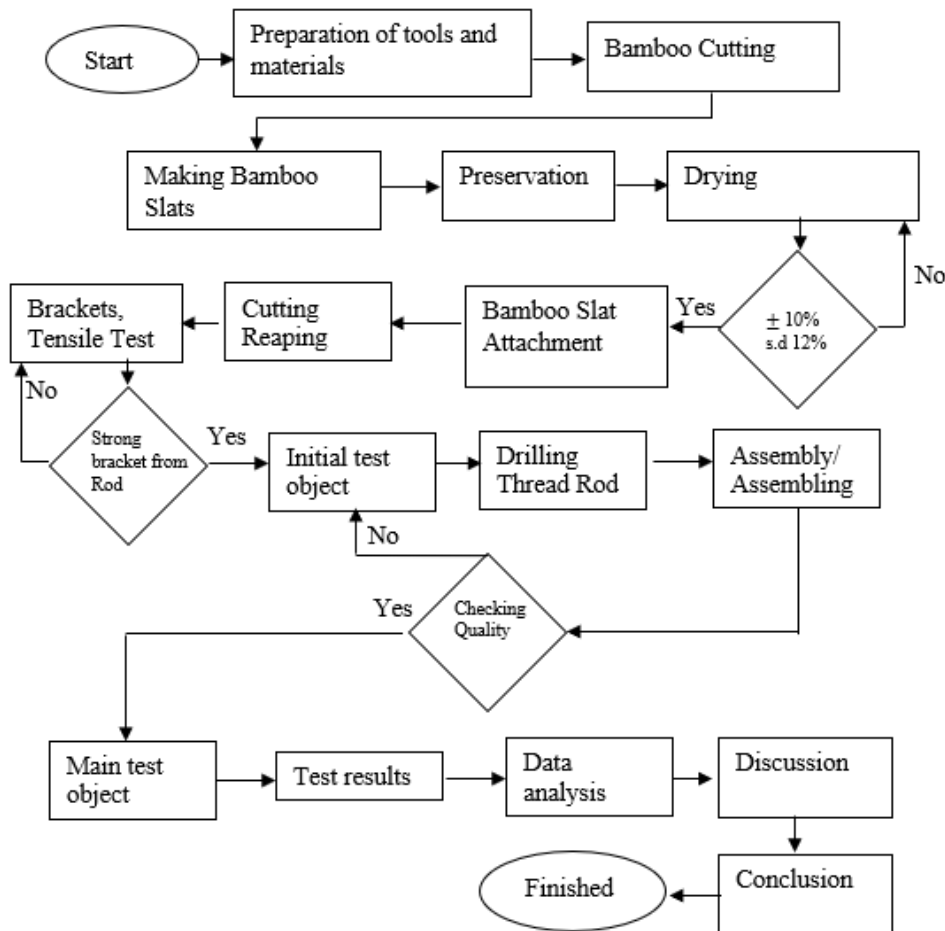
Figure 5. Research Flowchart

The research conducted is an experimental study on the failure of laminated bamboo hollow section beam-column joints using glue-in rods and brackets. A descriptive analysis method is employed to understand the joints' failures concerning existing standards. The independent variables in the research are the number of embedded thread rods and the diameter of the thread rods, while the dependent variables are the types of joint failure and failure modes. The flowchart of the research can be seen in Figure 5.
