A Study on Damage Detection Using Ouput-Only Modal Data

Kharrazi, M. K. H.; Ventura, Carlos E.; Brincker, Rune; Dascotte, Eddy

Published in:
Proceedings of IMAC 20

A STUDY ON DAMAGE DETECTION USING OUTPUT -ONLY MODAL DATA

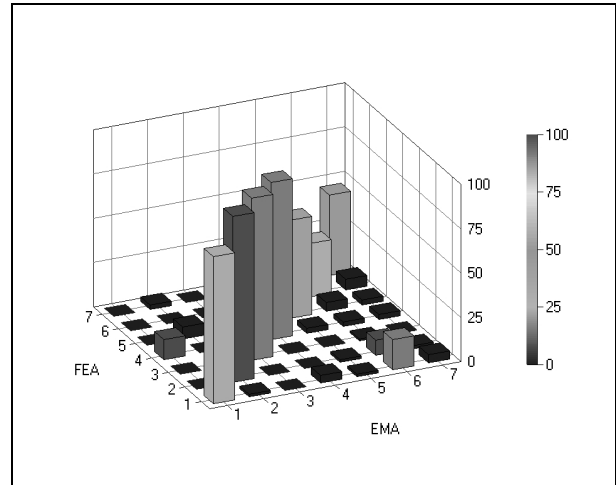
Fig. 5. Modal Assurance Criteria (MAC) for the benchmark finite element model.

To evaluate the correlation of the prepared finite element model with the tested model, Modal Assurance Criteria (MAC), FRF Pairing and Shape pairings options in FEMtools[®] were utilized. Figure 5 shows the final MAC for the updated model. The updated finite element was used as benchmark for comparison with the damaged model in order to detect the damage.

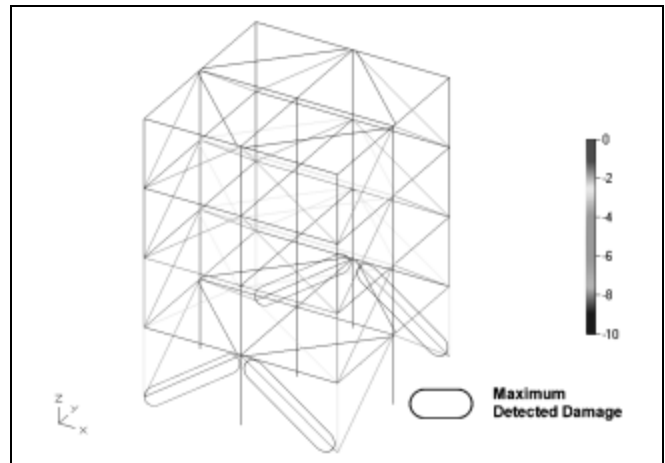
Fig. 6. Detected damage in for case III, determined in the ground storey and in the braces of the north side.

Fig. 6 to 9 shows the updated model of the damaged cases. The members with the maximum reduction in properties are marked in these figures. In Fig. 6, the detected damage was located in the cross-sectional area of the east-west braces of the first storey. In Fig. 7, the detected damage was located in the cross-section area of the north-south braces of the second storey. However, while the damaged element was not determined, the approximate location and element type was in good agreement with the actual damage cases.
