# Observation of Damage Initiation for Trans-laminar Fracture Using in situ Fast Synchrotron X-ray Radiography and ex situ X-ray Computed Tomography

**Keywords** Fracture · Fracture Toughness · CT Analysis · Synchrotron X-ray Radiography

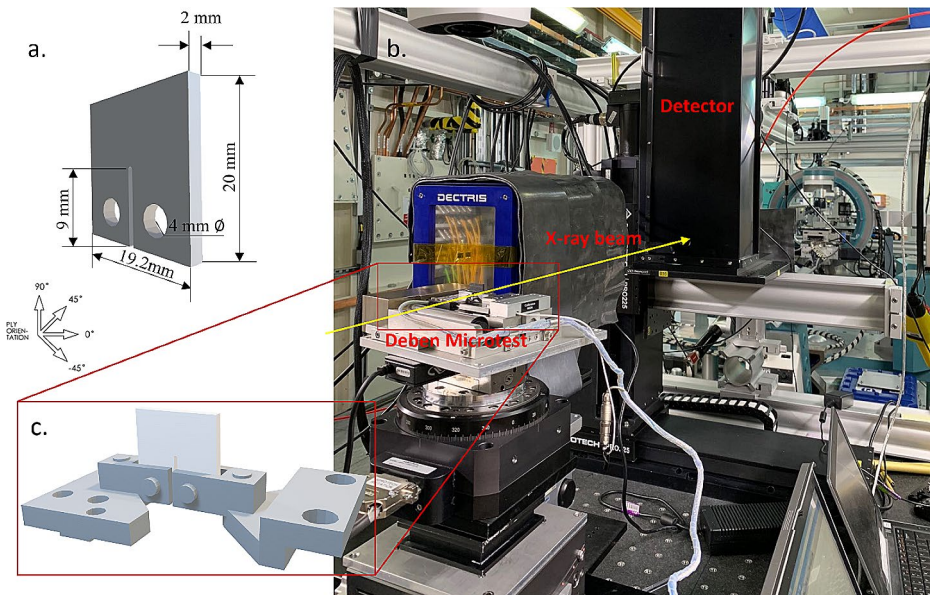
**Fig. 1** (a) Engineering drawing of the carbon/epoxy composite compact tension specimen; (b) In situ synchrotron X-ray radiography set-up; (c) Customized Deben micromechanical test jig

three specimens (S4, S5, and S6) for interrupted tests followed by ex situ computed tomography (CT) scans. An engineering drawing of the specimen and an illustration of the ply orientations are shown in Fig. 1a.

A test jig (Fig. 1c) was designed to perform compact tension testing on a Deben MT5000 micromechanical testing stage, for both in situ synchrotron X-ray radiography and the interrupted tests for ex situ CT scanning. The specimen was held upright to avoid the potential interference of the steel jig to the X-ray beam.

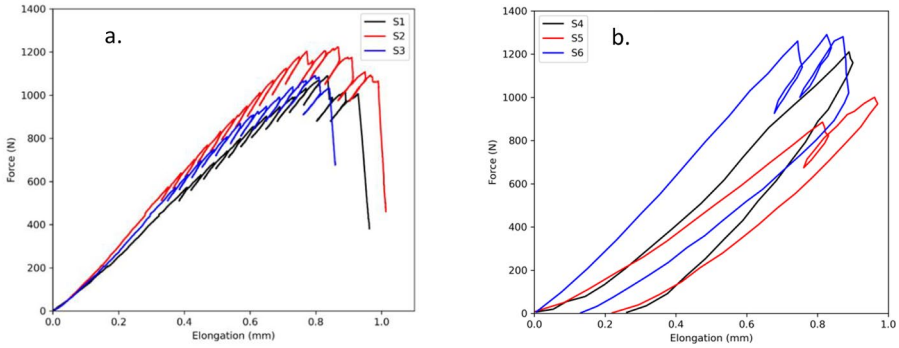
**Fig. 2** Deben Force-elongation curves for (a) S1, S2 and S3 during in situ radiography experiments; (b) S4, S5 and S6 during interrupted experiments before X-ray CT

Prior to the ex situ CT scanning, three interrupted tests were performed involving three different load-unload regimens for each specimen as shown in Fig. 2b. In the first specimen (S4), the specimen was loaded until a load drop was observed at 1200 N. In the second specimen (S5), the specimen was loaded until a load drop occurred, at which point the specimen was partially unloaded and then loaded again until a second load drop was observed at 1000 N. Finally, for the third specimen (S6), the specimen was loaded and unloaded until three load drops were observed with the last load drop at 1280 N. The measured displacements from the interrupted tests in Fig. 2b are not used for any assessments. After the three interrupted tests, S4, S5 and S6 were scanned using the NeoScan S80 CT scanner with a 5 μm pixel size.

ous measurements of splitting during trans-laminar fracture initiation before fibre fracture occurs. In Fig. 2a, the load-displacement curves from the in situ radiography experiments show consistent trends for all three specimens. Fig. 6 shows the presence of fibre fracture after the last load drop in Specimen S6 (1280 N), but no fibre breakage was observed in S4 (1200 N) and S5 (1000 N). Therefore, it is not expected to have fibre failure in Specimens S1 to S3 under 1200 N.

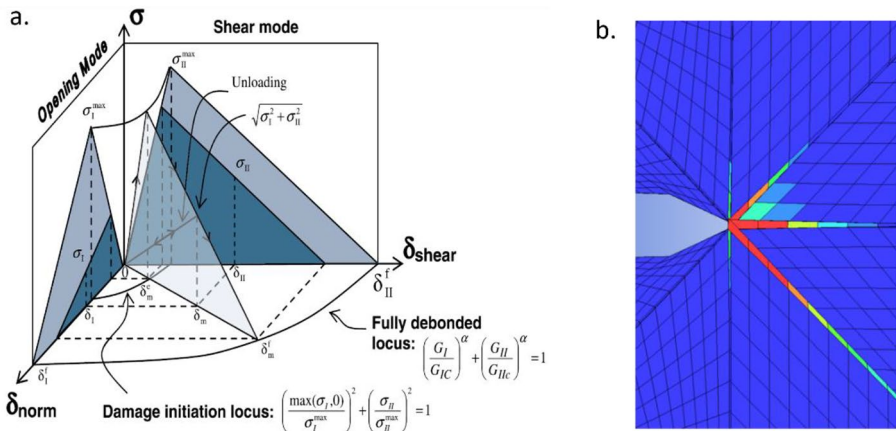
**Fig. 3** A detailed FE method for predicting damage initiation using cohesive elements with (a) Traction-separation relationship [18]; (b) Failed cohesive elements in red

Xu et al. [15] developed a detailed ply-by-ply FE model with a sharp notch in LS-Dyna using cohesive elements for intralaminar splitting and interlaminar delaminations. The traction-separation law for cohesive elements is shown in Fig. 3a. The input properties used were  $G_{IC} = 0.2$  N/mm,  $G_{IIc} = 1$  N/mm,  $\sigma_I^{max} = 60$  MPa and  $\sigma_{II}^{max} = 90$  MPa.

It was found that the  $0^\circ$  splits increase linearly with strain energy release rates without considering fibre failure. By revisiting the previous model [15], new results are extracted for all splits represented by the failed cohesive elements as shown in Fig. 3b. The predicted maximum split length is in the surface  $45^\circ$  plies. The predicted maximum split lengths at different strain energy release rates are compared against the experimental results.

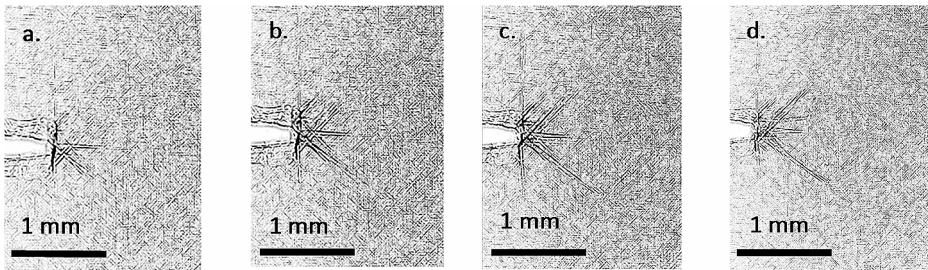
**Fig. 4** Representative radiograph images taken from S3 during the in situ radiography experiment (cycle 1, 5, 9, 13) at (a) 585 N; (b) 754 N; (c) 958 N; (d) 1074 N

In situ radiography offered continuous examination and a good resolution. This is preferable when studying splitting also because the specimen is loaded so the cracks are open. The multiple matrix crack propagation near the crack tip was successfully visualized. Fig. 4 shows the typical radiographic images at different loads during an in situ test. These radiographic images show the overall damage zone including 0°,  $\pm 45^\circ$  and 90° splits in all plies, but no obvious fibre failure by 1074 N. The maximum split length in the specimen can be measured which is in the 45° plies.

Compared to the CT scan images in Fig. 5 from the interrupted tests, the in situ X-ray radiographic images in Fig. 4 provide sufficient phase contrast and resolution for continu-

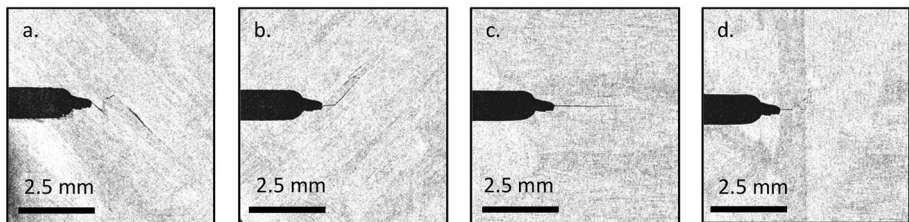
**Fig. 5** CT images showing damage from S6 after the peak load at 1280 N in (a) 45° ply; (b) -45° ply; (c) 90° ply; (d) 0° ply

While in situ radiography provided continuous examination of overall damage evolution, ex situ CT scanning was also done to show the cracks at different depths (plies) through the specimen thickness. This is difficult to observe in in situ radiography images because the damage in all plies is overlapped. Typical CT scan images in Fig. 5 show the damage states in different plies of Specimen S6 interrupted after 1280 N. It shows that fibers broke in the  $\pm 45^\circ$  and 0° plies at the final load drop, but further examination prove that fibers did not break at the first load drop in S4 and the second load drop in S5 as shown in Fig. 6. Splitting is visible in Fig. 5 except for the 0° ply in Fig. 5d. This is because the splitting was closed when the specimen was scanned after being unloaded.

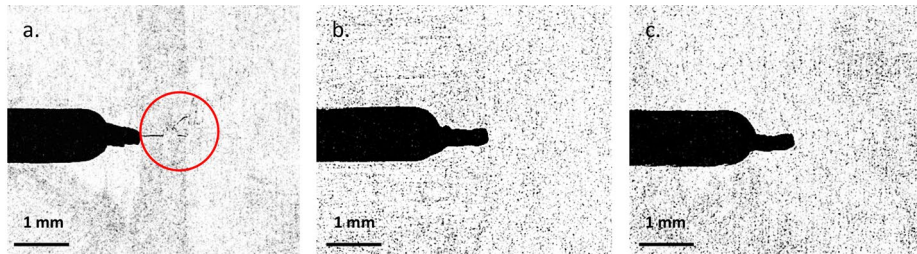
**Fig. 6** CT images showing fibre breakage circled in the  $0^\circ$  plies in (a) S6, and lack of fibre breakage in (b) S5 and (c) S4 after peak loads

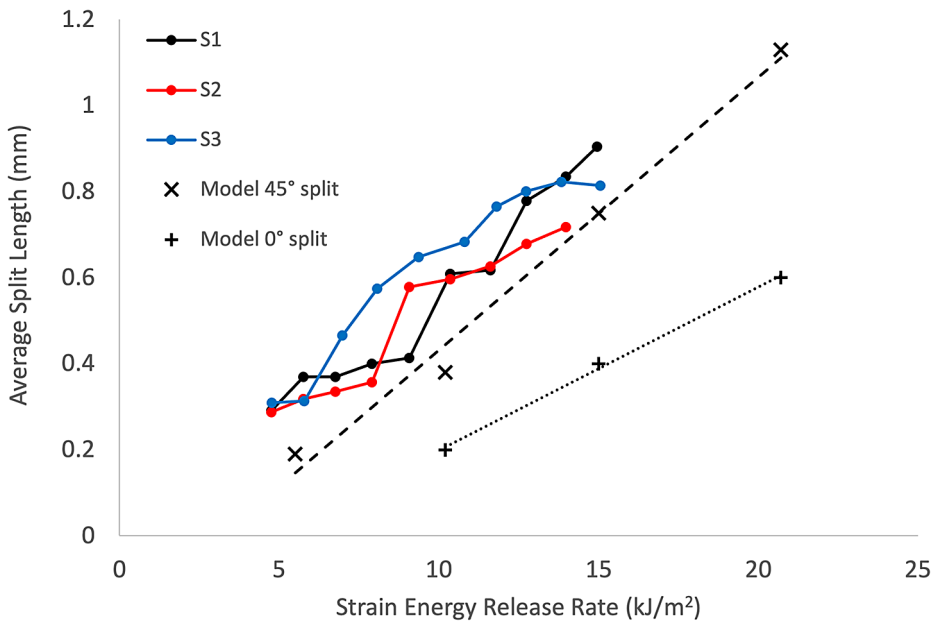
**Fig. 7** Maximum split length – strain energy release rate graph from in situ radiography experiments and FE model

The strain energy release rate of each specimen is determined by the initial crack length according to Eq. 1 to 3. Therefore, the maximum split length of three specimens (S4, S5 and S6) in relation to strain energy release rate is established as shown in Fig. 7. Among all the splits, the  $45^\circ$  splits are the longest and the most prominent in the images, so they are measured for comparison. The results show that the maximum split lengths grow approximately linearly with strain energy release rates.

Another recent detailed numerical study of trans-laminar fracture [19] was mainly focused on the prediction of R-curve behaviour during fracture propagation, which followed an earlier numerical work on fracture process zone development [15]. In Fig. 7, the currently measured slope is similar to that for the maximum splits predicted using the detailed model [15]. This suggests that the maximum splitting is driven by the same strain energy. The independent in situ radiography results in this work can confirm the findings of the detailed FE results. It is noted that the current slope for the maximum splitting in Fig. 7 is different from the previously reported slope for the  $0^\circ$  splitting, with the former being steeper.
