Repair of acrylic/glass composites by liquid resin injection and press moulding

Alp BOLLUK, Machar Devine, James A. Quinn, Dipa Ray*

School of Engineering, Institute for Materials and Processes, The University of Edinburgh, Sanderson Building, Robert Stevenson Road, Edinburgh, EH9 3FB, Scotland, United Kingdom.

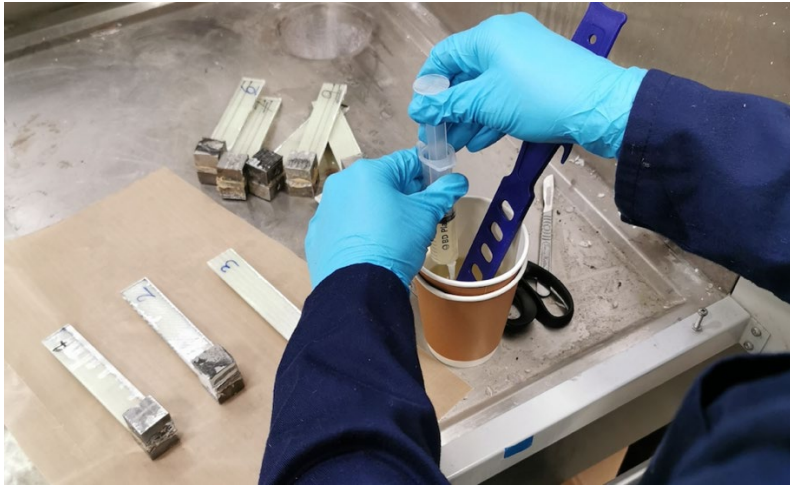
Fig. 1. Preparation of injection repair process

The resin-catalyst mixture was drawn into a syringe of 1 mm needle diameter (Figure 1) and injected into the separated mid planes of specimens, one specimen at a time, from the pre-crack film tip (Figure 2). Figure 2 shows schematically the injection repair process and formation of a semi-IPN at the joining interface. Step 1 in Figure 2 shows the injection of the liquid monomeric resin at the debonded interface. The acrylic monomeric resin dissolves the acrylic matrix at the interface and penetrates within the adjacent layer, as shown in step 2. It then polymerises forming a semi-IPN. The interpenetrating network structure at the joining interface makes it stronger than the bulk composite.

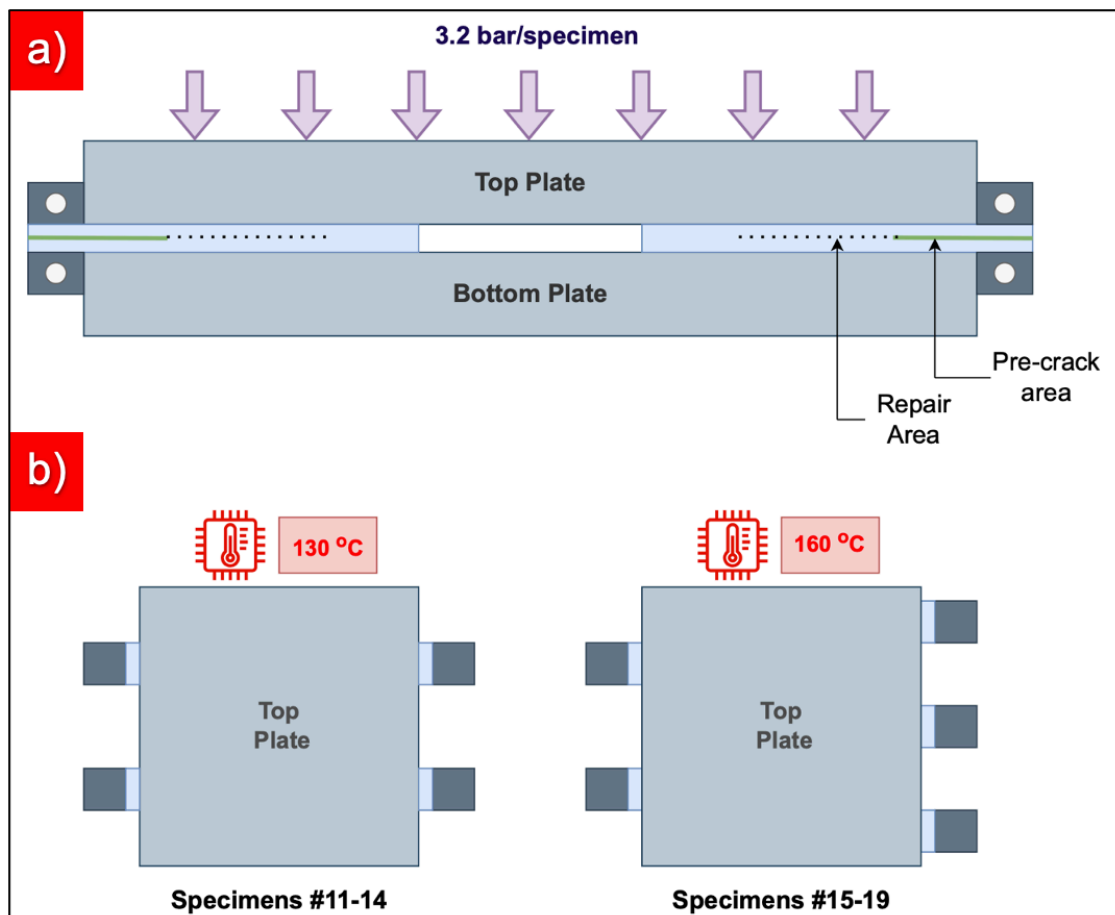
Fig. 5. Schematic diagram of heated press setup a) side view; b) plan view; (not for scale)

The press repairs were performed on a PEI Lab 450 Hydraulic Press with active cooling. Two sets of parameters were used for the repair activity. The DCB debonded specimens were placed between two separate pairs of steel plates, around the edges, in a manner that loading blocks were left hanging outside the plates, to be excluded from the pressed area (schematically shown in Figure 5).

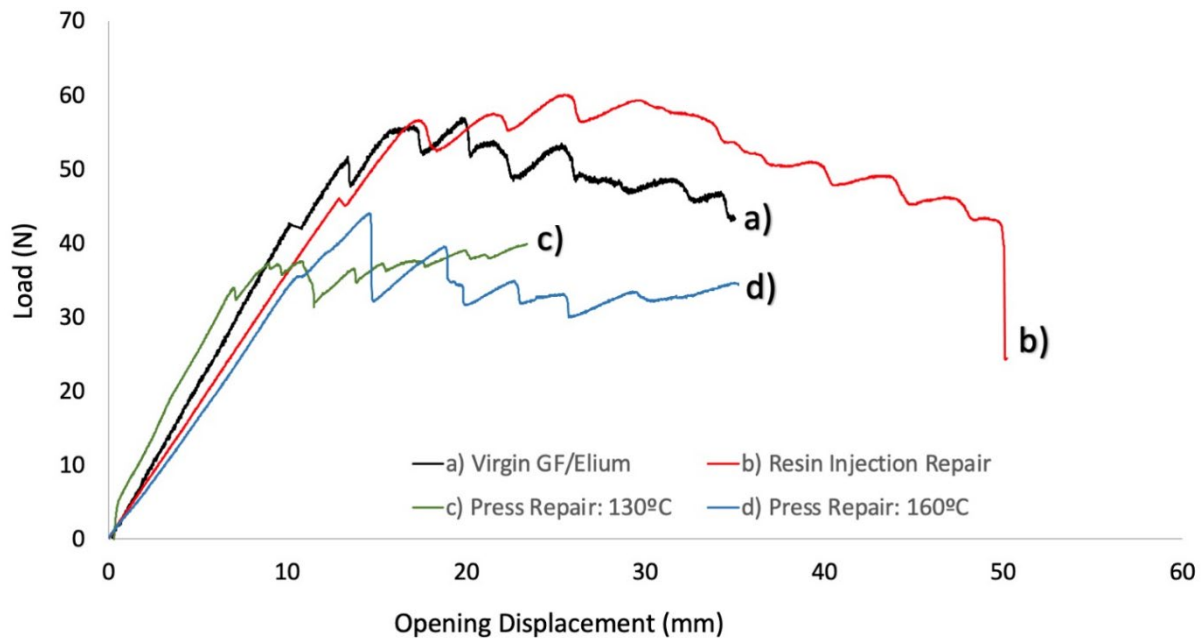
Fig. 7. Representative Load-Displacement curves of a) virgin b) RI c) 130) d) 160P

For comparison between the groups, all calculated values below correspond to the 0-35mm crack length (a) range, from pre-crack tip ($a_0 = 0$). This is because 35mm was the maximum tested delamination length of RI specimens. The Load-Displacement curves are direct indicators of crack growth behaviour in DCB tests. Recorded tip opening displacements (δ) were plotted against corresponding applied loads (P) to maintain the constant 5 mm/min extension rate, at each 0.1s instance. The representative curves for each set of specimens are presented in Figure 7.

Prior to crack propagation, each set of specimens demonstrated a linearly increasing trend. At this stage, specimen openings and corresponding loads were increased steadily, until the crack-initiating load was reached at the pre-crack tip. Lower peak loads for 130P (39.8 N) and 160P (43.8N) specimens were observed compared to virgin specimens (56.4N), indicating fracture toughness properties could not be fully restored after heated press repairs. Especially for 130P specimens, the results indicate low levels of molecular inter-diffusion and weak bonding at the repair bond line. Meanwhile, RI specimens did not only recover the virgin peak load but exceeded it (60.1N), revealing a toughening effect introduced via resin injection repair. The maximum opening displacements and crack propagation times (up to 35 mm crack length) were mostly proportional to peak loads (Table 2). The delamination time for a fixed crack length is another direct indicator of fracture resistance and the results further prove toughening via resin injection. Under lower loads, 160P specimens showed slightly longer crack times and displacements compared to virgin specimens, revealing that bonding was achieved to a certain extent.

Upon crack initiation, all four curves (Figure 7) exhibited a *jagged* pattern, which is indicative of unstable crack propagation [10]. These trends show similarity to most thermoplastic composites DCB results in published literature [11]. It is evident that the crack growth advances discontinuously in a series of rapid growth and arrest phases, in terms of load drops and small oscillations, which reveals *stick-slip behaviour* [12]. A stick-slip mechanism in composite fracture is caused by the delaminated surfaces' sporadic sliding and locking during crack propagation due to factors such as surface roughness and presence of interfacial bonding and/or fibre-bridging [13]. The crack tip proceeds haltingly because of this irregular "sticking" and "slipping", causing fluctuations in load and displacement measurements. Moreover, these rapid oscillations may also be due to interlaminar discontinuities, such as GF fabric twists, gaps, or crimps, which can develop localised tough or vulnerable spots along the crack path [14].

bridges were ruptured during virgin testing (Figure 8b). Hence, stick-slip behaviour of RI specimens was most likely due to ductile deformation of the injected in-situ thermoplastic layer, as well as varying concentrations of semi-interpenetrating network formation along the crack plane. The sharp drop at the end of the curve (Figure 7) represents the *snapping of RI specimens* at the 35mm delamination mark.

The 160P specimens displayed sharper load drops against extension (Figure 7), revealing fast crack jumps, which may indicate that fusion bonding of specimens did not occur uniformly across the mid plane. The 130P specimens exhibited a flatter curve (Figure 7) than other specimens during crack propagation. This might be due to the fact that pressure was not distributed uniformly during repair, with increased contact deeper into the crack zone, i.e., further away from press plate edges (please refer to Figure 5). These effects are less pronounced for 160P specimens, as higher inter-diffusion levels and stronger interlaminar bonding were achieved at the higher temperature. Higher fibre-bridging effects were seen in

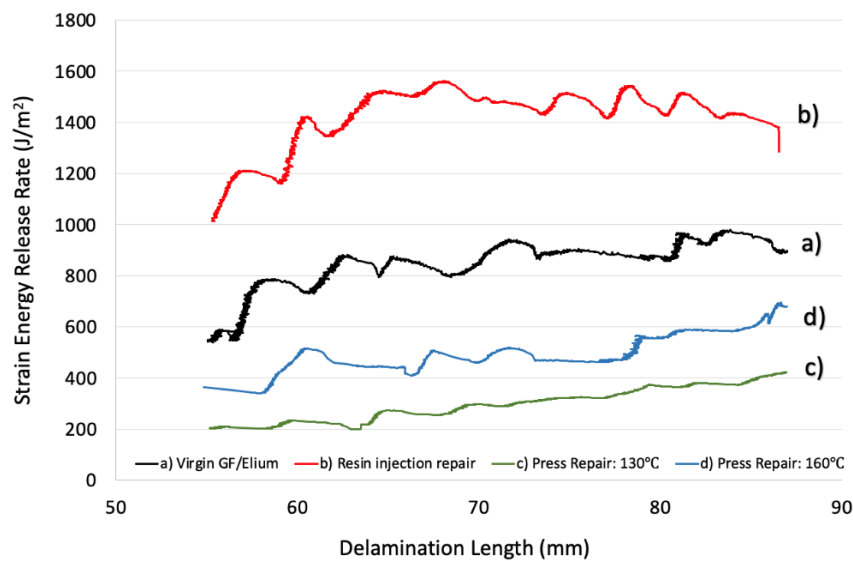
Fig. 10 Resistance curves obtained from DCB testing of a) virgin acrylic/GF laminates and repaired acrylic/GF laminates (b)resin injection repaired or RI, (c) press repaired at 160 C or 160P and (d) press repaired at 130C or 130P).

As for 160P specimens, $G_{IC-Init}$ and $G_{IC-Prop}$ values were 309.59 J/m^2 and 607.46 J/m^2 respectively, exhibiting 74% and 62% mode-I fracture toughness recovery compared to the virgin state. These results align well with reference studies [8]. The values were lowest for 130P specimens with 56.33 J/m^2 of $G_{IC-Init}$ and 284.64 J/m^2 of $G_{IC-Prop}$, proving that 130°C is an insufficient temperature to induce fusion bonding repair of debonded interlaminar surfaces of acrylic/GF composites at 3 bar pressure and 60 min time. The representative resistance curves (R-curves) and charts comparing mean mode-I fracture toughness values are presented in Figures 10 and 11 respectively.

All R-curves in Figure 10 were trimmed to start at the longest pre-crack distance between 4 groups (55 mm) and to end at shortest crack length (87mm) for coherency.

Curves of virgin and RI specimens appeared to remain relatively constant over the plateau region (Figure 10). It is believed that the fracture toughness of damaged virgin specimens was further increased by resin injection because the added acrylic layer transferred the crack locus throughout its thickness before reaching the original separated surfaces [17]. Long polymer chains forming the semi-IPNs enhanced the ductility of the mid plane area, developing a tough 'buffer' layer that sits on the crack path, providing increased material resistance [18]. It is also likely that injected resin formed strong bonds with some ruptured acrylic-compatible fibres, further improving interlaminar stiffness. Sudden drops in RI specimen curve (Figure 11) might have occurred due to entrapped air bubbles in the injected resin mixture.

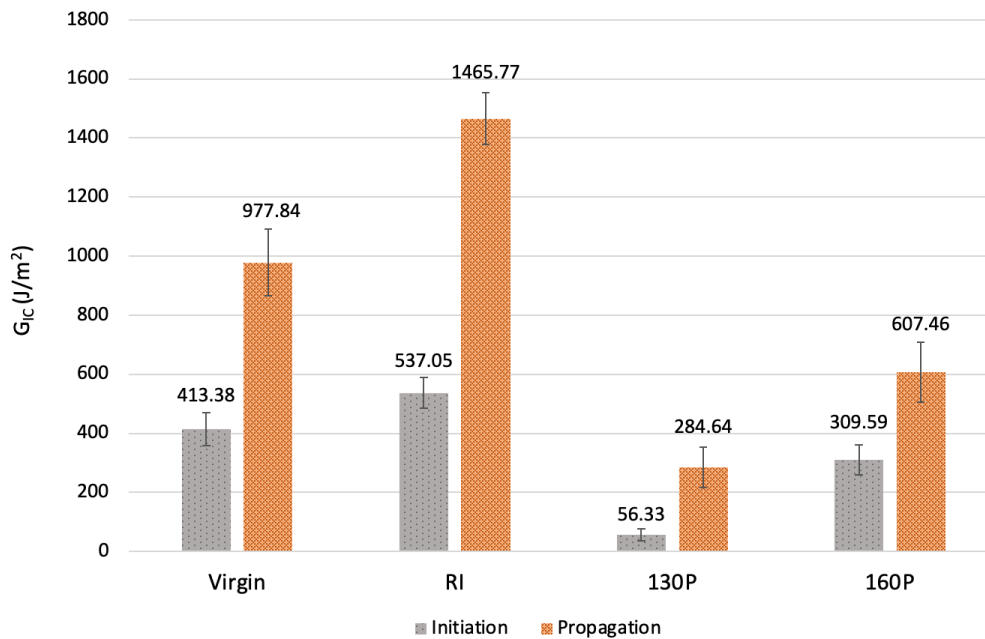
Fig. 11. Comparison of mean $G_{IC-Init}$ and $G_{IC-Prop}$ values for 4 DCB test groups.
