Serafim C, Peacock R, Calatroni S, Djurabekova F, Fontenla ATP, Wuensch W, Sgobba S, Grudiev A, Lombardi A, Sargsyan E, Ramberger S and Bellodi G (2024), Investigation on different materials after pulsed high field conditioning and low-energy H⁻ irradiation. *Front. Phys.* 12:1308455. doi: 10.3389/fphy.2024.1308455

Investigation on different materials after pulsed high field conditioning and low-energy H⁻irradiation

During operation, the radio-frequency quadrupole (RFQ) of the LINAC4 at CERN is exposed to high electric fields, which can lead to vacuum breakdown. It is also subject to beam loss, which can cause surface modification, including blistering, which can result in reduced electric field holding and an increased breakdown rate. First, experiments to study the high-voltage conditioning process and electrical breakdown statistics have been conducted using pulsed high-voltage DC systems in order to identify materials with high electric field handling capability and robustness to low-energy irradiation. In this paper, we discuss the results obtained for the different materials tested. To complement these, an investigation of their metallurgical properties using advanced micro

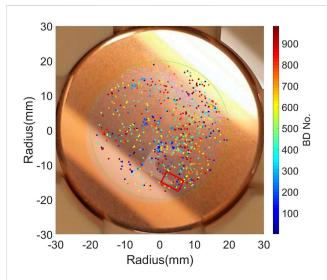
FIGURE 4 Image of the irradiated Cu-OFE cathode overlaid with the breakdown locations colored from dark blue to dark red as the first to last breakdown. The red rectangle represents the location of the SEM imaging shown in Figure 5A.

Figure 4 displays the breakdown locations on the irradiated electrode where clusters occurred in different areas of the beam halo and not at all of the beam center area, suggesting that blisters are not the only cause of or may not have any effect on breakdowns. It is possible that the clusters on the halo are a result of the irradiation

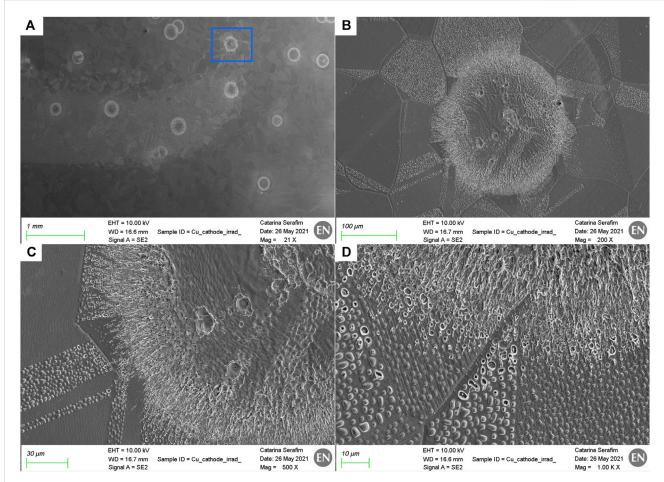
FIGURE 5
(A) SEM imaging, using the secondary electron detector, showing partially the transition zone (the irradiated zone corresponds to the zone less dark) and some of the breakdowns provoked by the high energy pulse. (B, C) (D) SEM imaging with different magnifications, using the secondary electron detector, showing a breakdown in the transition zone of the electrode. The location of this breakdown is marked with a blue rectangle in (A).

Figure 5A–D show the results of Cu-OFE after the electrode had been irradiated with the H⁻ beam and then subjected to high electric field pulsing in the LES. We can observe from Figure 5A that the breakdowns are well-distributed on the surface and do not seem to be correlated with the irradiated zone (zone less dark due to the blistering effect). Figures 5B–D show a breakdown in the transition zone, designated as the area where we start to see a decrease in the density of blistering. In this zone, it is visible that only some grains are affected by blisters. The fact that the phenomenon of blistering is more evident in just some of the grains may be correlated with the grain orientation of the material. Figures 5B, C also suggest that the

The breakdowns have a circular shape between approximately $100~\mu m$ and $200~\mu m$, with splashes of melted material on their surroundings. The heat generated from the plasma formed during a breakdown has been shown to be significant enough to melt some of the blisters close to it, as shown in Figure 5D.

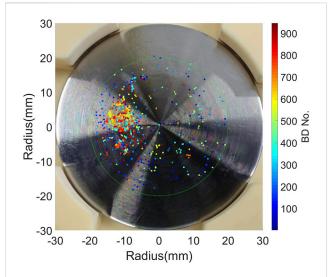
Inage of the Ti6Al4V irradiated cathode overlaid with the breakdown locations colored from dark blue to dark red as the first to last breakdown. The irradiation area is visible in the image with a darker coloration (constrained between the hours of 7 to 1 clockwise).

of both pairs, it would suggest that this is a property of Ti6Al4V rather than a spurious event. This may mean that Ti6Al4V has a tendency to accrue surface damage if conditioned too far. Overall, Ti6Al4V performed very well and was able to re-gain most of the previously achieved electric field without any further issues and maintain a stable field. The irradiated Ti6Al4V had a larger breakdown rate (BDR) at the start of conditioning, which then reduced, suggesting a strong conditioning effect of the irradiation area that improved the performance. Figure 7 shows the breakdown locations for the irradiated Ti6Al4V electrode, where the higher concentration of breakdowns appears to be constrained in the irradiation area.

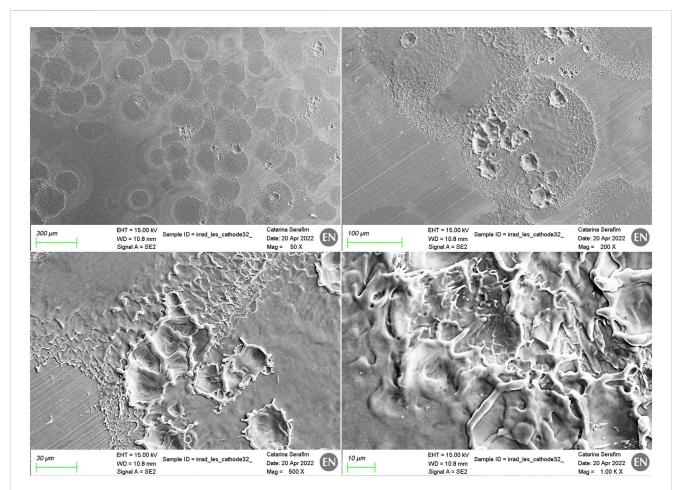
FIGURE 8
SEM imaging with different magnifications, using the secondary electron detector, showing the breakdowns triggered by the LES experiment, on the Ti6Al4V irradiated cathode.

Figure 8 shows the breakdowns on the irradiated Ti6Al4V cathode on the surface. After irradiation, there was no evidence of modification of the surface structure due to irradiation nor appearance of blistering. Discoloration was seen, with a visible difference between the beam center, halo, and non-affected areas. The breakdown craters are similar in diameter to Cu, between $100~\mu m$ and $200~\mu m$, due to the high field reached in the LES. No particular physical material defects were observed in these electrodes, which could explain why the irradiation area of the electrode presents a higher number of breakdowns.
